Igiugig Health Clinic

Alaska Rural Primary Care Facility

Assessment and Inventory Report

September 26, 2002

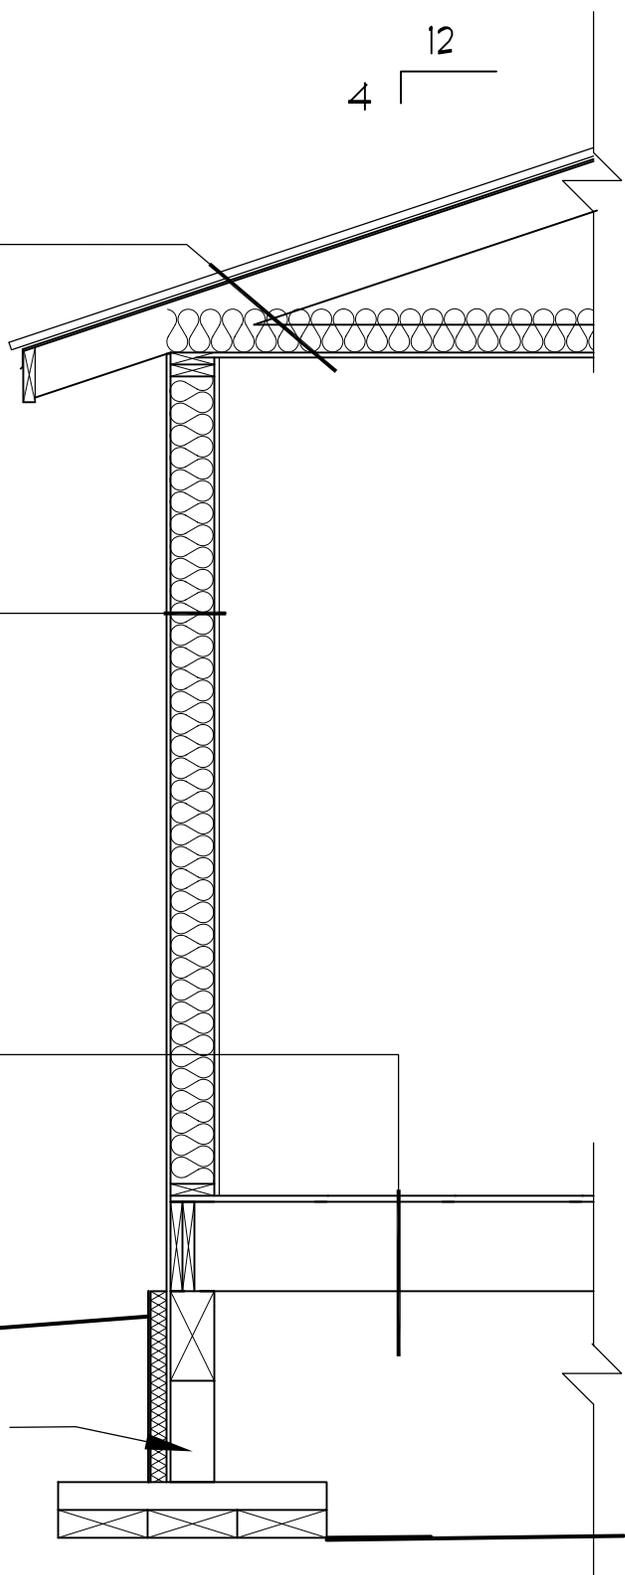
EXISTING WALL SECTION

12x12 VCT
1/2" PARTICLE BOARD
1/2" PLYWOOD SUBFLOOR
2" x 12" JOISTS

POST AND BEAM WOOD
FOUNDATION AND FOOTINGS
