SELAWIK
COMMUNITY HEALTH CLINIC
CODE AND CONDITION SURVEY

Final Report

January 2006
Maniilaq Association

NANA/DOWL Engineers

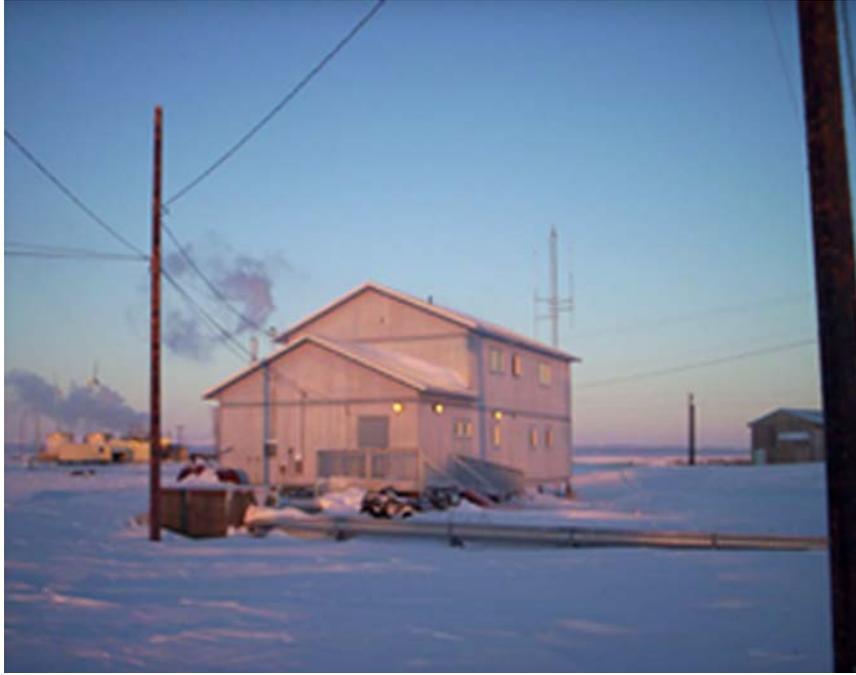
Reference Number: A01

Description: **Ramp and Stair Design**

Existing ramp to trauma entrance is too narrow for trauma access and is not used. Front entrance does not have ramp access. ADA 4.1.2(8). This problem is both a program deficiency at the trauma entry and an accessibility deficiency at the front entry. Entry Stair requires new ADA compliant handrails. Columns in the way of continuous handrails requiring new design for stair. No roof covering over front or rear stairs per IBC 2003 1009.5.2.

Remove ramp at trauma room and provide new stair with five risers, ending at a six-foot square landing. Trauma ramp to be 6 feet wide x 20 feet long terminating on an earth berm. Install new roof covering over trauma stair and landing. Provide new ramp from main entry to grade 24 feet long by relocating existing back door entry ramp to front. Replace entry stairs. Extend entry roof to cover full stair run. Replace main entry landing in the process to tie together with new ramp and stair construction. Propose using steel stringers, pipe handrails with wire mesh infill, fiberglass non-skid treads, landings and ramp panels for stairs and ramps. Propose new pipe columns and wood and beam framed roofs over landings and stairs.

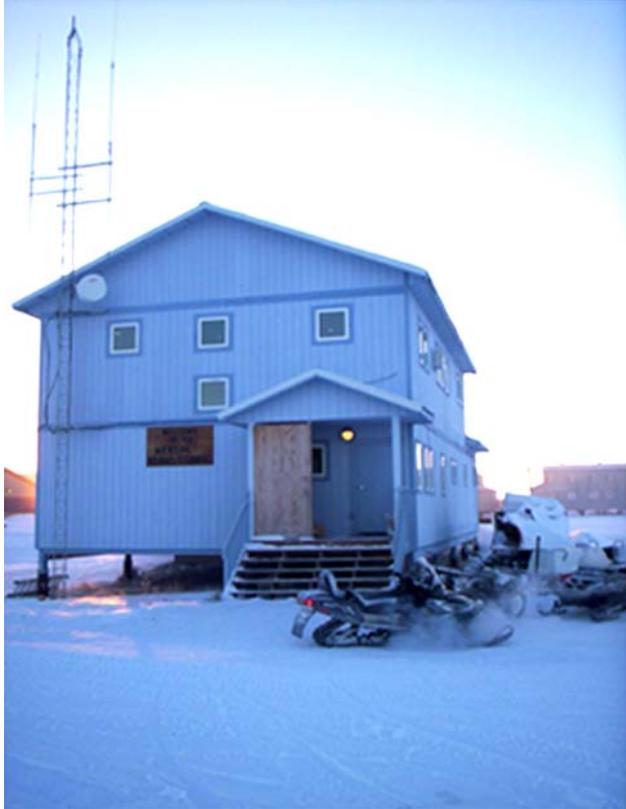
Reference Number:	A02
-------------------	------------

The current site sits low in relation to the surrounding land resulting in spring flooding. The flooding inhibits access to the main entrance and the trauma entrance and water extends under the building. This flooding may contribute to premature melting of subsurface permafrost soils. This report recommends additional fill to raise the building pad by about 12 to 18 inches to divert water away from the building.

Description: **Building sits in water during break-up.**

Provide gravel berms at three locations, the base of the new trauma door access stair, the base of the existing stair and the base of the new entry ramp. Gravel berms to be 18 to 20 inches high and taper at 1:12 slope on three sides away from the ramp or stair bases. Modify entry stair to eliminate three risers at the bottom. Fix handrails and guardrails to fit new stair configuration designed to comply with ADA extension requirements. See A03 for additional gravel fill recommendations.

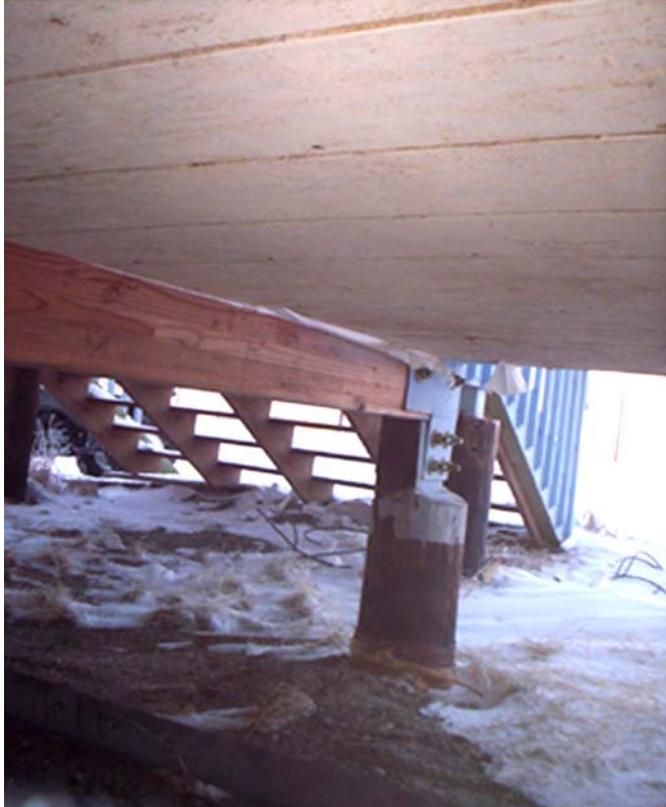
Reference Number:	A03
-------------------	------------

The floor structure of the building rests on a grid of eight inch diameter treated wood piling. Piling spacing is approximately 16 feet along the sides, and 112 and 17 feet on the ends. The depth of piling could not be determined from the drawings. The settlement was evidenced within the building at the intersection of interior partitions with exterior walls and along the interface between the exterior walls and the ceilings. An investigation is needed to analyze the foundations and determine if there is some breakdown of the soil bond, causing some differential settlement.

Description: **Foundation Settlement**

Existing foundation report documents settlement of existing wood pier foundation system. Existing system consists of 16 cresote piles drilled 27 feet into the permafrost. Settlement does not appear to have affected the swing of doors. The settlement may be related to poor drainage around the pilling and the standing water issues mentioned in A02. Utility pipe serving building obstructs access to trauma entry stairs. The settlement is evidenced by cracking along the interior walls.

Provide gravel fill under the building to a depth of 12 to 18 inches and spread out to blend with gravel fill provided for ramps and stairs. This will reduce the air flow under the building, but will prevent the accumulation of standing water and the related melting of the surface ice affecting the stability of the foundations. Additionally, a 4" layer of rigid polystyrene foundation grade insulation should be placed under the gravel fill. Area of insulation and gravel coverage is to 24" outside the building line, approximately 34' x 50'. Provide gravel and grating ramp and bridge to cover twin arctic pipes wide enough for a four-wheeler. Repair drywall damage by floating out wall and ceiling corners. Approximately 150 l.f.

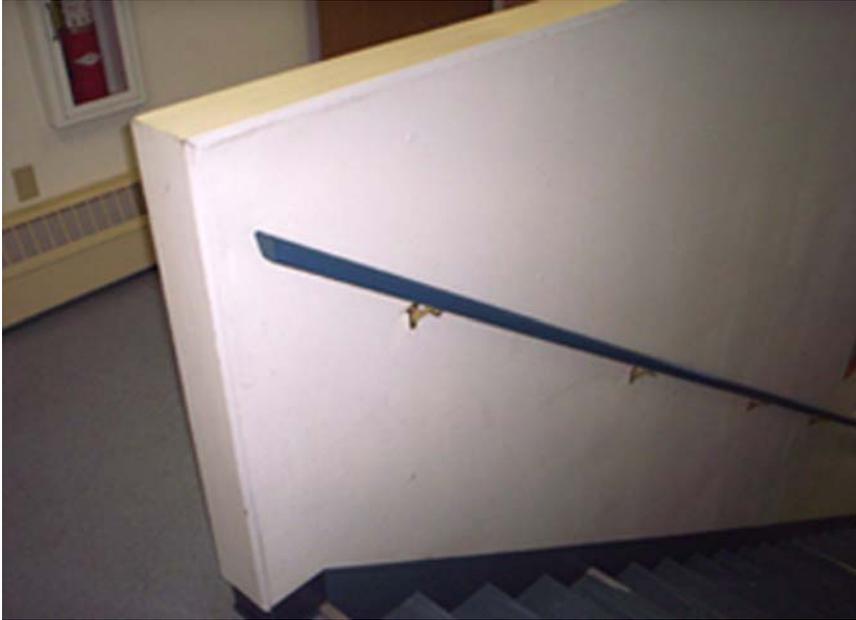
Reference Number:	A04
-------------------	------------

Description: **Interior Accessibility Issues**

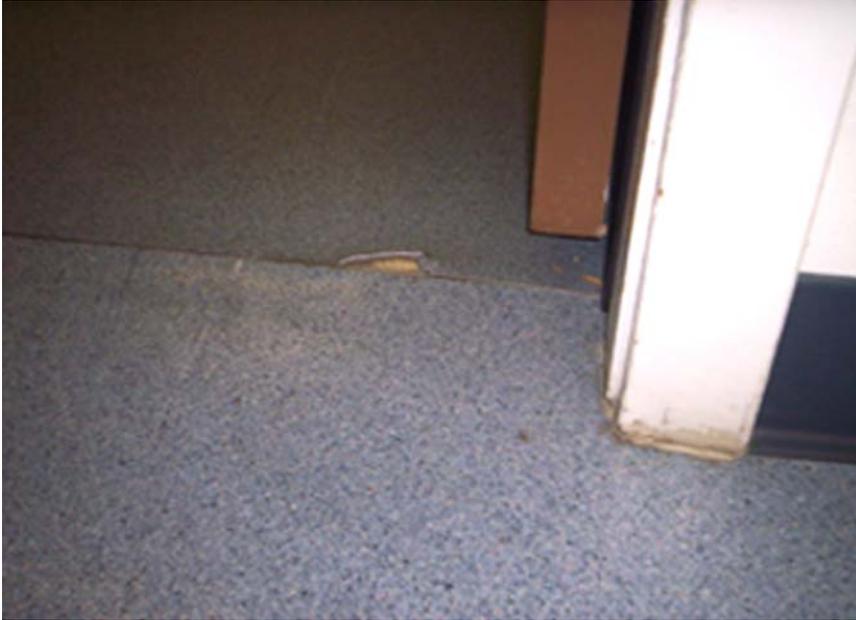
Reference Number:	A05
----------------------	------------

The building interior consists of sheet vinyl floors and painted walls and suspended ceilings. No special impact resistant materials were installed at corners and high-impact areas. There is some carpeting in offices on the upper floor. Joints and cracks occur in the sheet flooring, wall finishes require painting, and carpeting is well worn.

Description: **Interior Finishes**

Recommend removing sheet vinyl, repairing or replacing

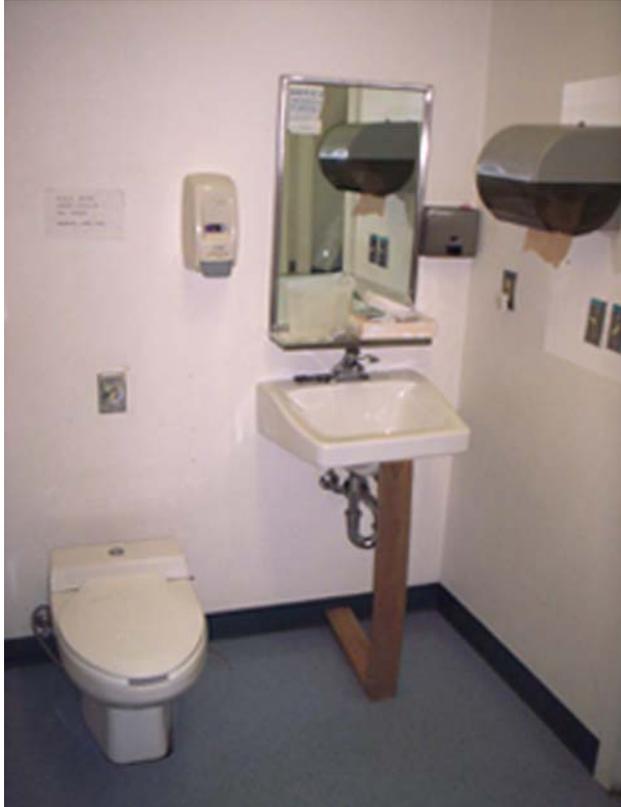
Reference Number: A06

Description: **Toilet Room ADA Compliance**

Install 36" grab bars at +36" at back of two toilets. Coordinate height to miss flush valves. Replace tub with ADA compliant tub installed with proper rim height, patient seat, and adjustable controls. Lower both soap dispensers to 48" to lever. Replace push-button flush valve with a lever operated valve and relocate valve at side of toilet (this requires plumbing the vacuum lines around the corner).

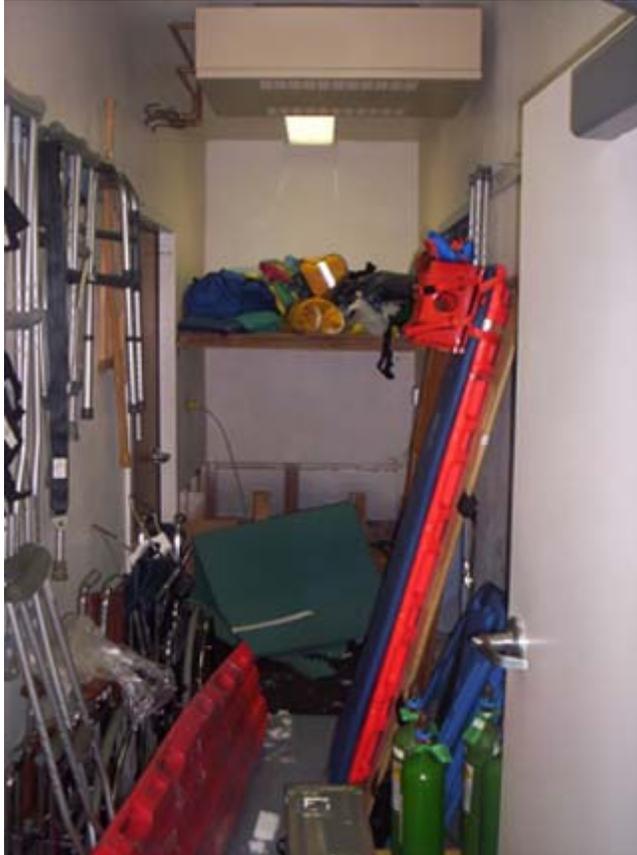
Reference Number:	A07
-------------------	------------

Description: **Life Safety Issues**

Relocate all emergency equipment to an upstairs room or into the trauma room to maintain access to the exit. Note the second exit is not a required exit, just a prudent safety feature. Since the exit exists the occupants will rely on the exit in an emergency and having the exit blocked will contribute to an unsafe condition.

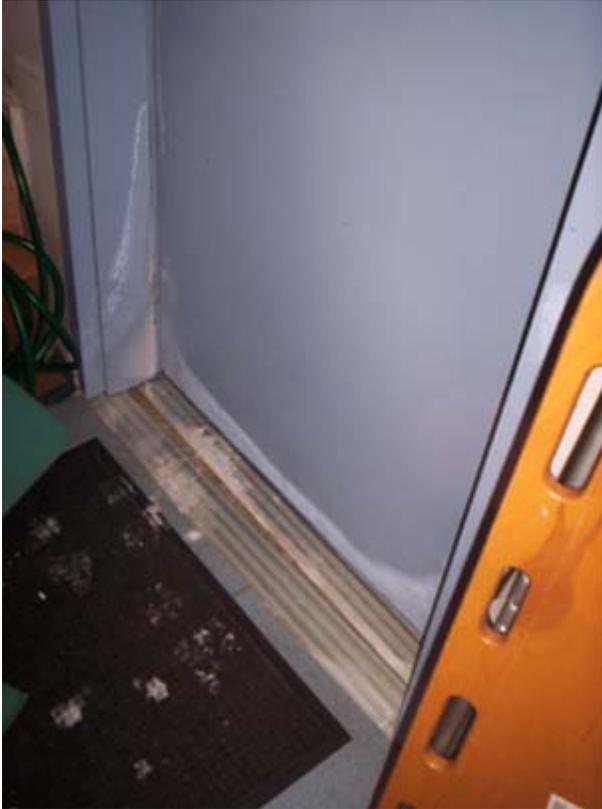
Reference Number: A08

Description: **General Building Construction Items**

Rear door weatherstripping needed. Two broken windows. No finish flooring in the boiler room.

Replace weatherstripping. Send windows to Anchorage for glass replacement and reinstall. Recommend installation of sheet vinyl floor finish in the boiler room to prevent oil saturation of plywood.

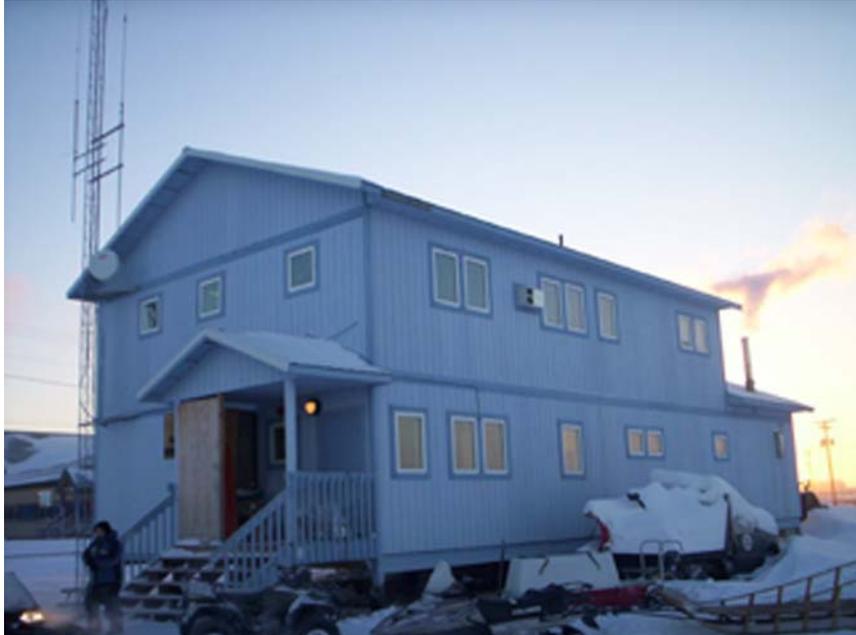
Reference Number:	A09
-------------------	------------

Description: **Attic Ventilation**

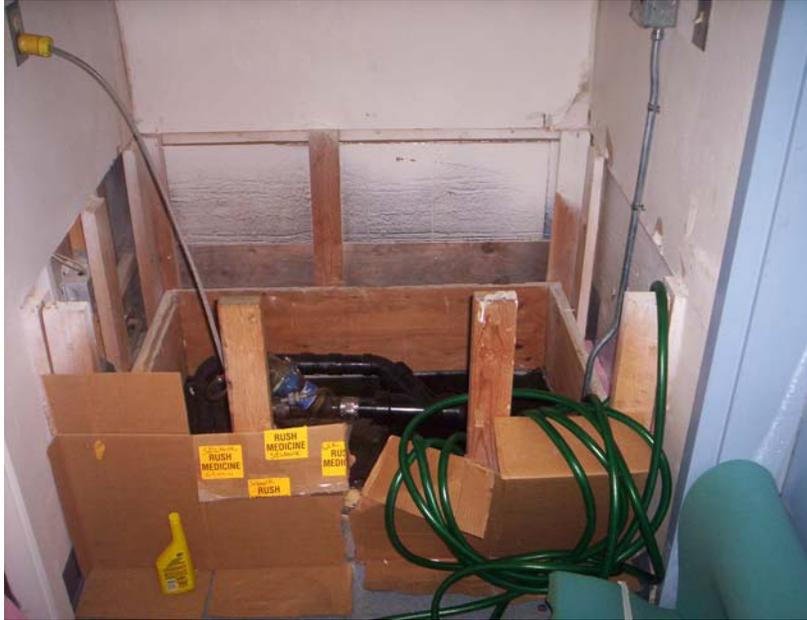
Reference Number:	A10
-------------------	------------

Description: **Sump Pit Open to Hall**

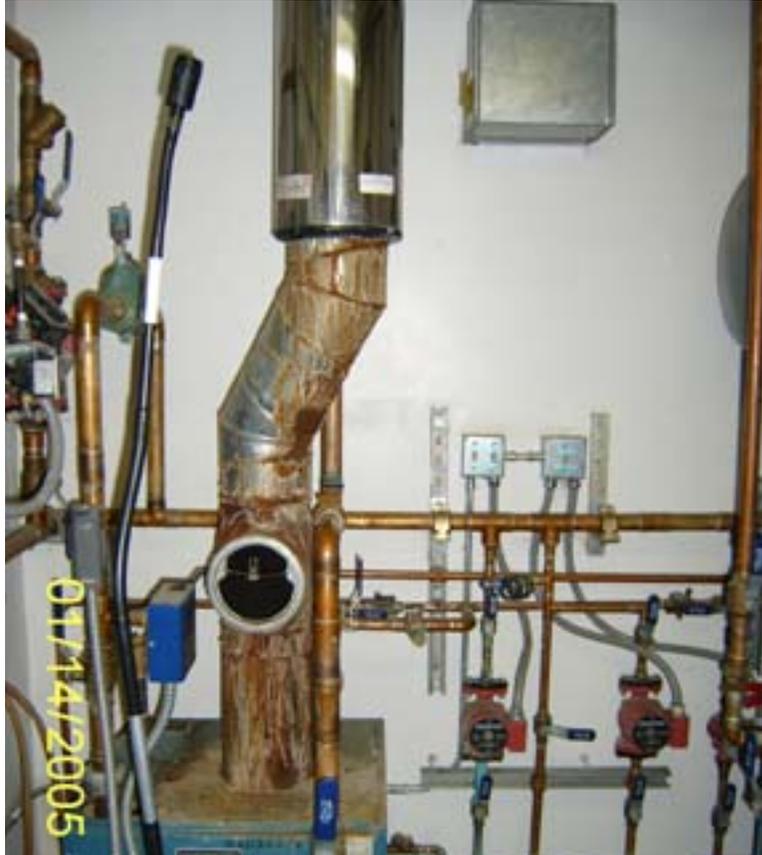
Reference Number:	M01
-------------------	------------

The boiler vent connector is badly corroded, which could create a fire hazard. We could not determine the condition of the double wall flue to the roof, but the single wall vent connector should be replaced as a minimum, and the double wall flue inspected and replaced if needed. If a second boiler gets installed, we suggest replacing the flue system with a larger system capable of carrying the load from both boilers.

Description: **Replace Boiler Vent Connector**

Replace vent connector, inspect chimney.

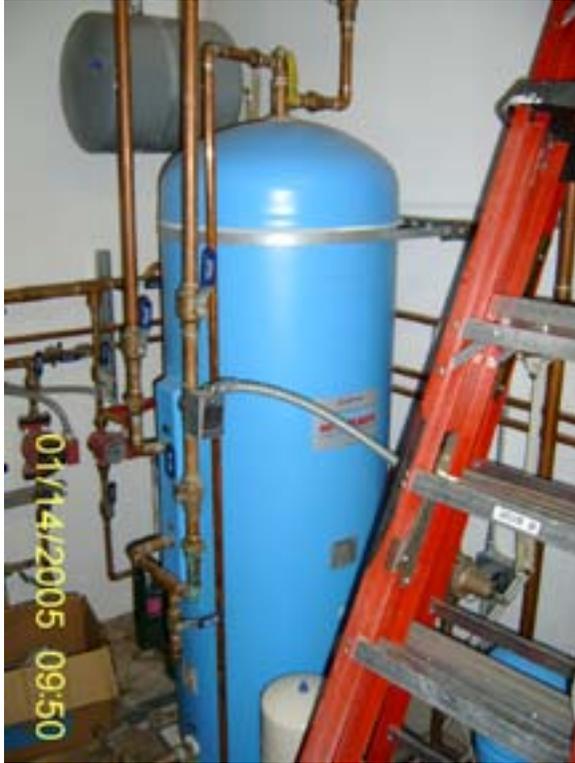
Reference Number:	M02
----------------------	------------

There is copper tubing used to distribute the heated glycol to the baseboard sections in each room, but we could not see any insulation on the piping. This will cause the boiler room to overheat, with an attendant loss of efficiency for the heating system.

Description: **Insulate Heat Piping**

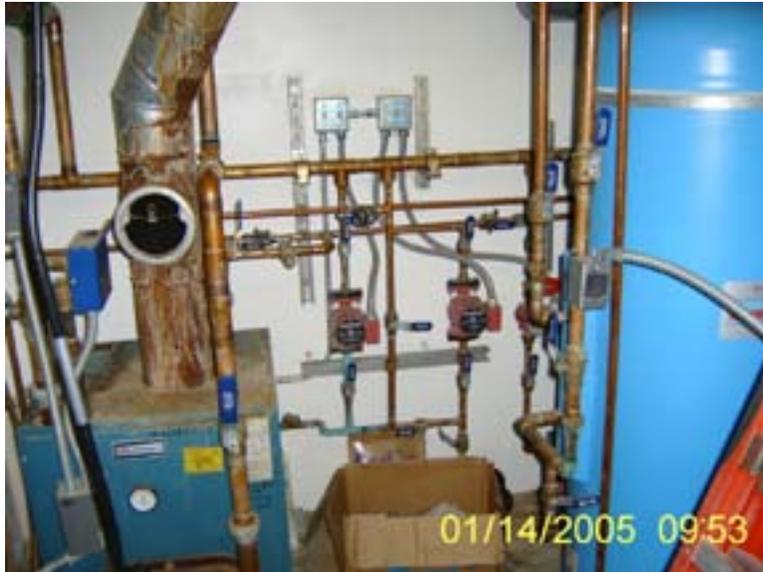
Reference Number:	M03
-------------------	------------

Description: **Barometric Damper**

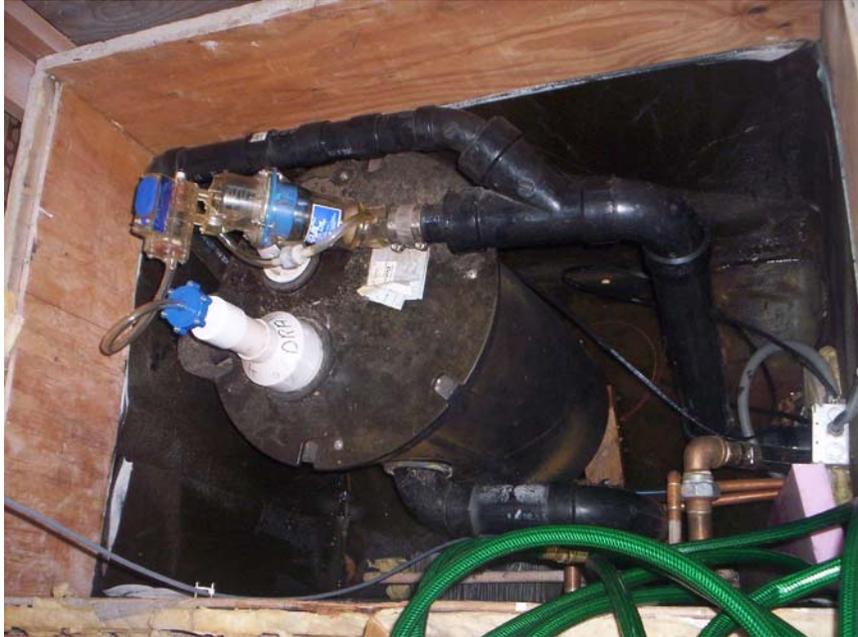
Reference Number:	M04
-------------------	------------

The building has a 4" ABS plastic vacuum waste line leaving the building, with smaller ABS piping located in the crawlspace to connect all of the plumbing fixtures. The toilet waste goes directly through a vacuum valve, and all other waste drains into an accumulator tank that has a vacuum valve. The accumulator tank inlet appears to have a faulty seal, which leaks when the tank fills above the elevation of the inlet, flooding the lift station enclosure base. The seal needs to be replaced as soon as possible.

Description: **Water in Lift Station Enclosure**

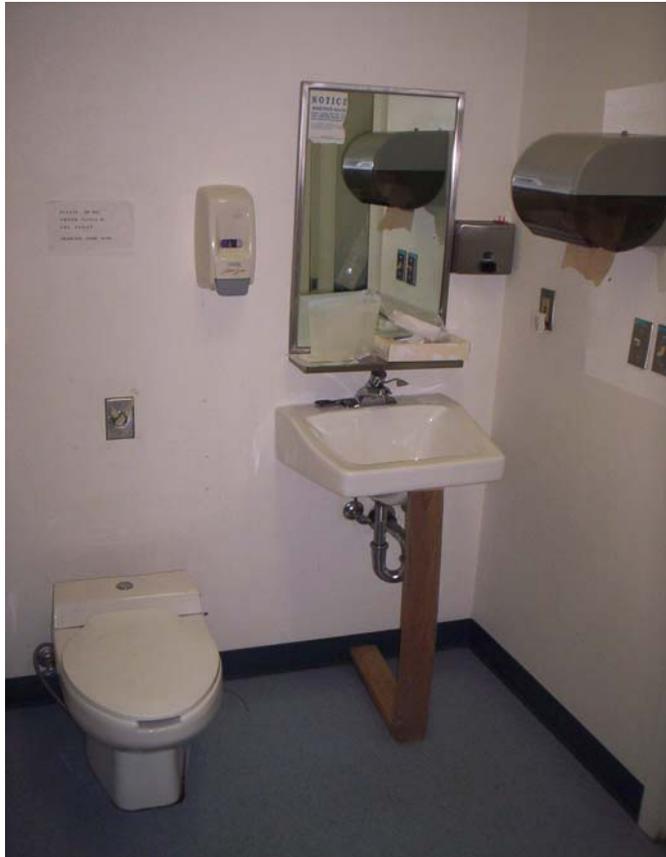
Reference
Number: **M05**

Description: **Loose Toilet Connection**

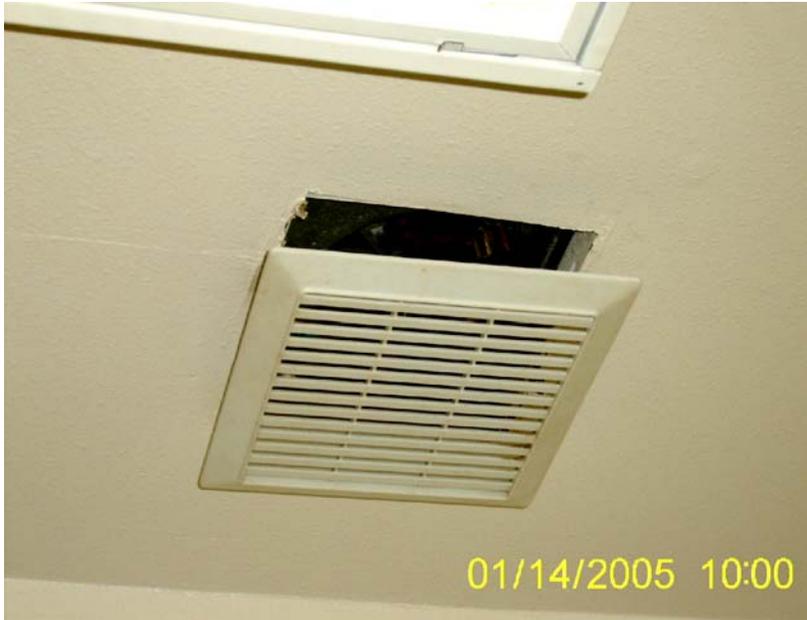
Reference Number:	M06
-------------------	------------

Description: **Repair Toilet Exhaust**

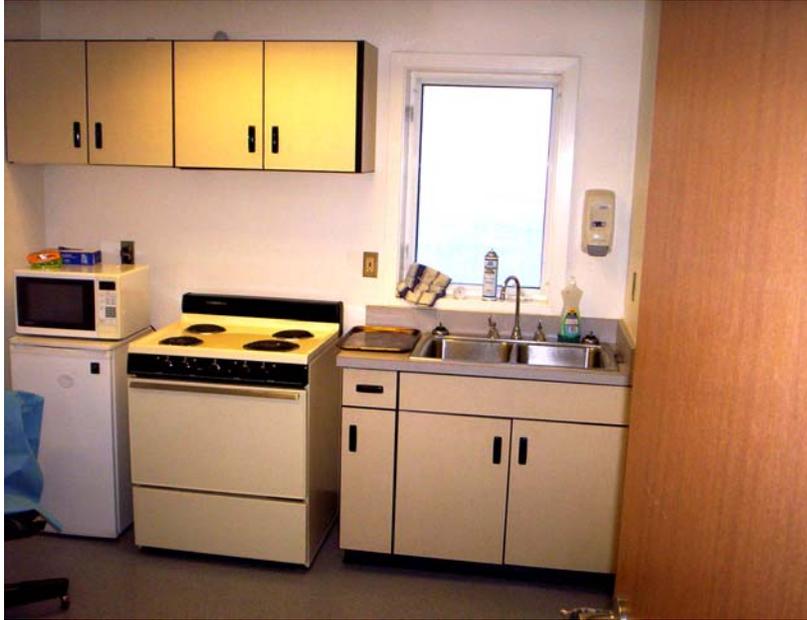
Reference
Number: **M07**

Description: **Missing Range Hood**

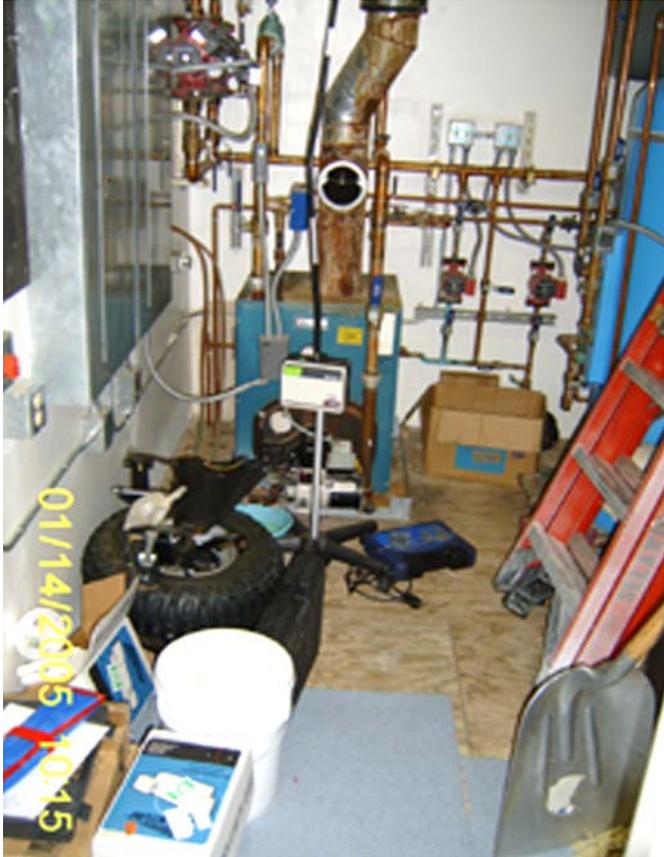
Reference Number:	M08
-------------------	------------

The panels in the boiler room have directories that should be consolidated and updated. This panel has 12 spaces still unused. These panels each have a 225 amp, 120/240-volt, 42-pole capacity, for a total of 84 poles. From the directory, it appears that the panel was installed in July, 1998. The panels are blocked with stored equipment and supplies, in violation of the National Electrical Code.

Description: **Boiler Room Used for Storage**

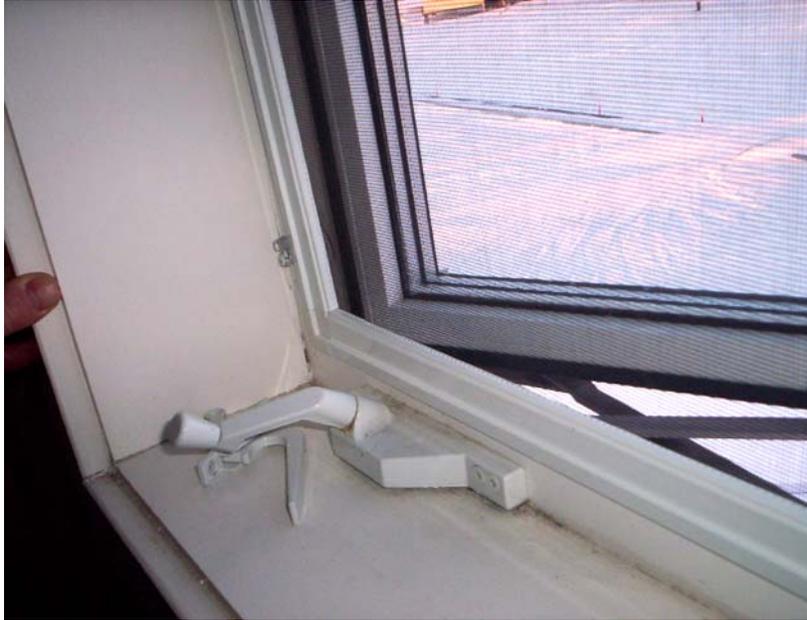
Reference Number:	M09
-------------------	------------

There is no mechanical ventilation system in the building, which relies on operable windows for fresh air exchange. The windows were all closed during our visit. There is a need for some ventilation system, as some spaces, especially the pharmacy, get too hot. We recommend that an HRV be installed, and be ducted to each of the offices and exam rooms to provide ventilation. The HRV should have a pre-heat coil to heat incoming air to 34 degrees to avoid defrost cycles, and to make ventilation air more comfortable with less drafts.

Description: **Inadequate Ventilation**

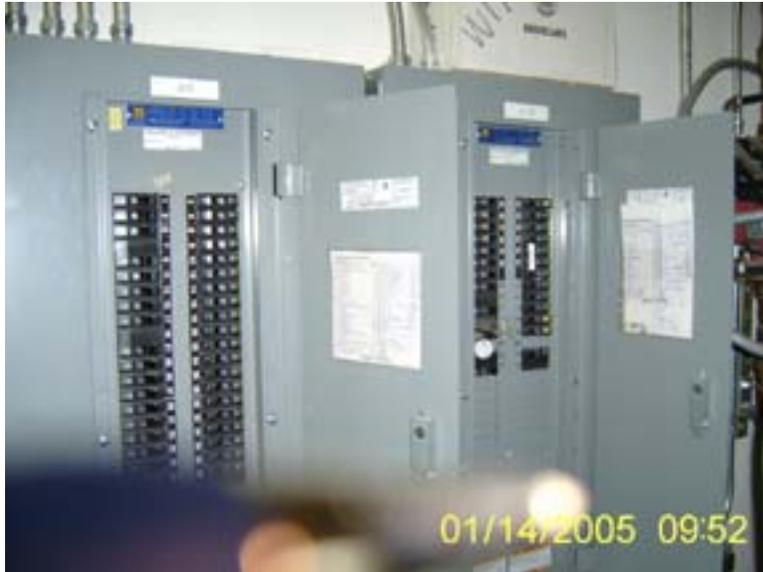
Reference Number: E01

Description: **Electrical Panel Directory**

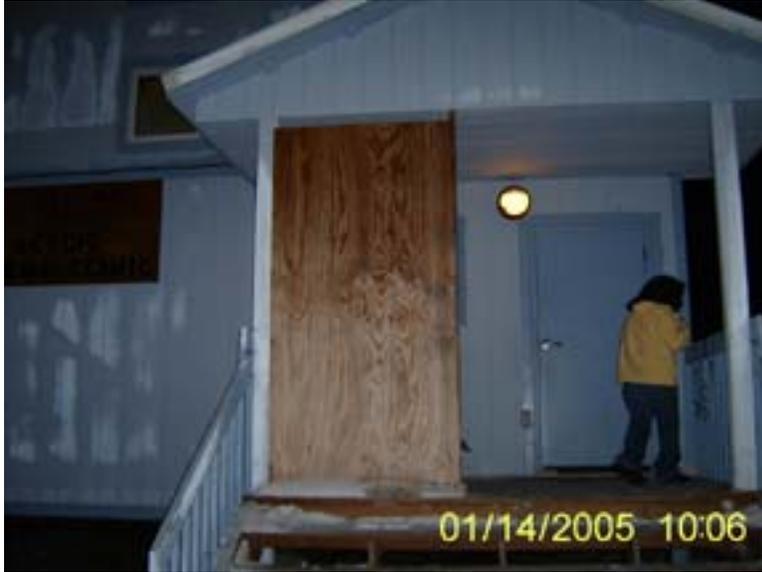
Reference Number: E02

There is only one incandescent porch light fixture on the building, which is totally inadequate for access to the building during dark periods. We recommend wall pack high-pressure sodium light fixtures on at least three faces of the building to assure well-lit access.

Description: **Poor Exterior Lighting**

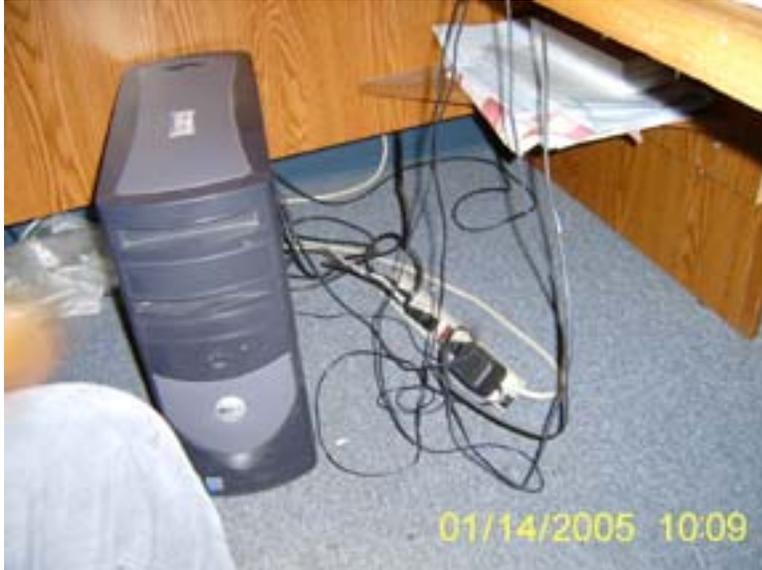
Reference Number:	E03
-------------------	------------

There are inadequate receptacles in the offices, primarily because exam rooms have been converted to offices where this was not envisioned. Also, there is only one outside receptacle, but additional are needed to pre-heat snow machines.

Description: **Inadequate Office Power**

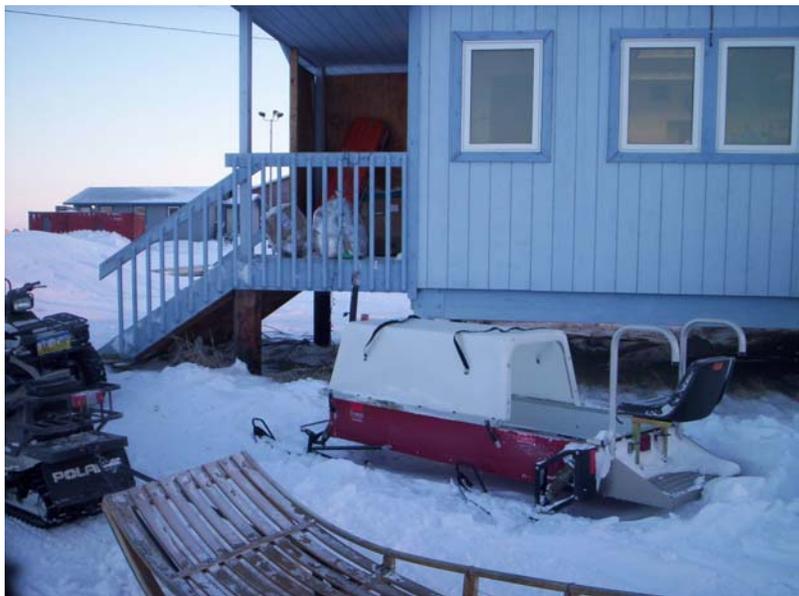
Photo 3: Entry Deck and Unprotected Rescue Sled

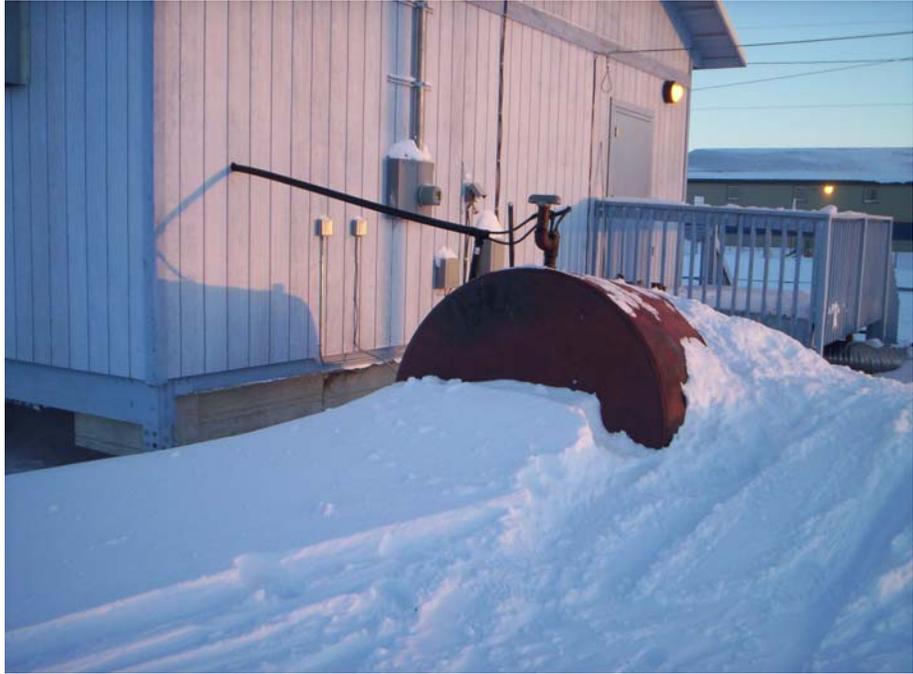
Photo 4: Trauma Entrance Lacks Protection and has Poor Access

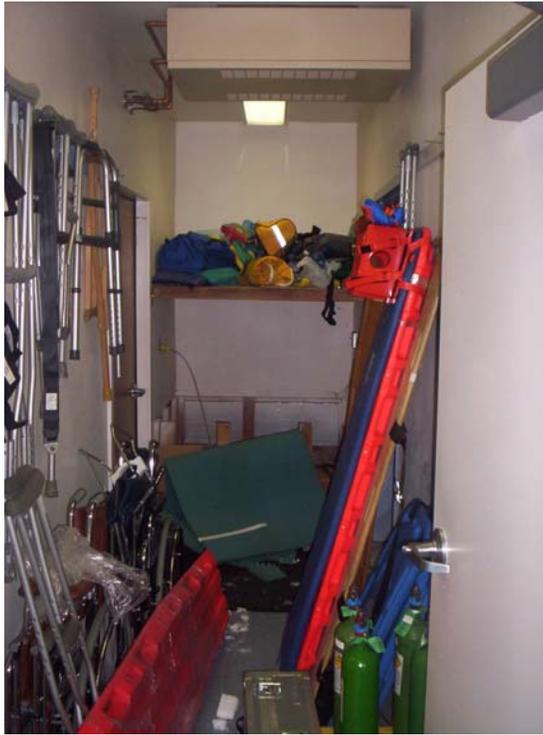
Photo 6: Access to Back Door Blocked by EMS Equipment
