Gustavus Electric Company

January 2007 Monthly Report for the Falls Creek Hydro-electric Project
FERC # P-11659

Falls Creek Hydroelectric Project (P-11659)
MONTHLY CONSTRUCTION REPORT TO FERC
January 2007

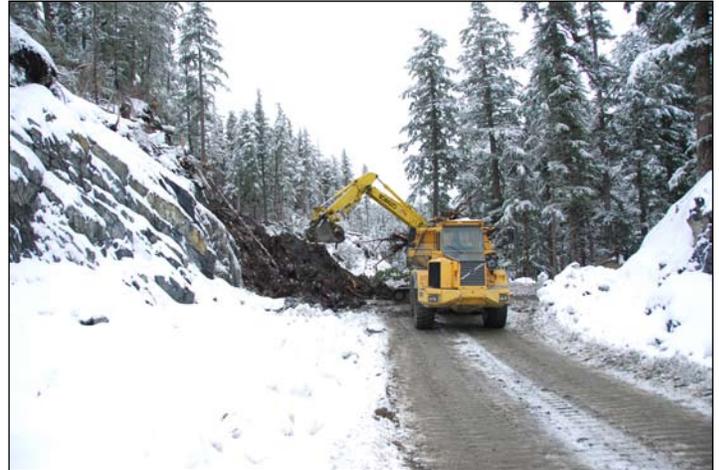
During the month long lay-off, there were minor slides of silt, clay and muck onto the intake service road. These were cleaned up and some slope excavation and benching was done to reduce the chance of reoccurrence. Work continued on bringing the intake access road and pipeline route to final grade. Some rock drilling was required to lower this grade in several spots. No blasting was done this month, but will take place in February.

Small slides along the intake road were cleared first thing upon return from break.

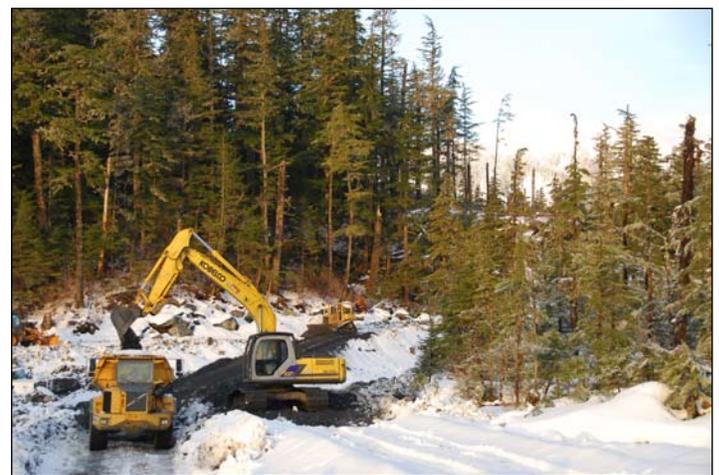
Fine-tuning the penstock grade at the Y.

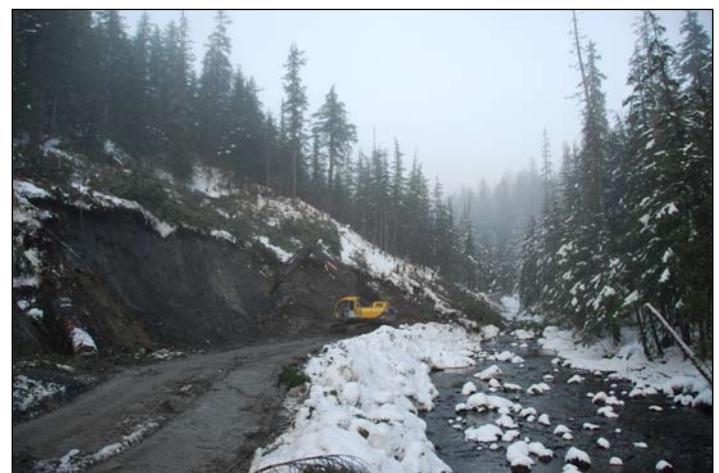
Excavation of the impoundment site in preparation for February blasting.

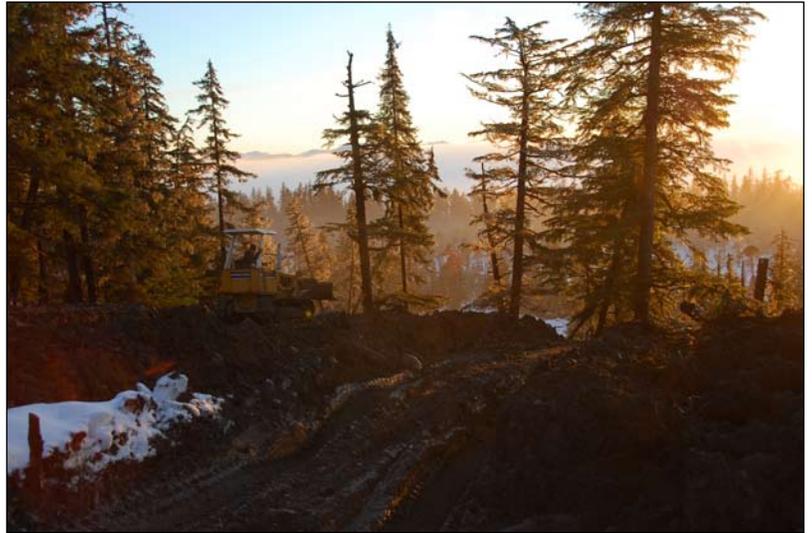
Much of the construction done this month entailed the backhauling of small slides and materials excavated from the impoundment site. This material was dumped at the Strip Fen Y waste site. Due to the a much greater ratio of rock to mud than originally dumped at this site, recent backhauled materials have not contributed to an increase in the surface area of this waste site.

Backhauled materials dumped at the Strip Fen Y waste area have been largely very stable materials.

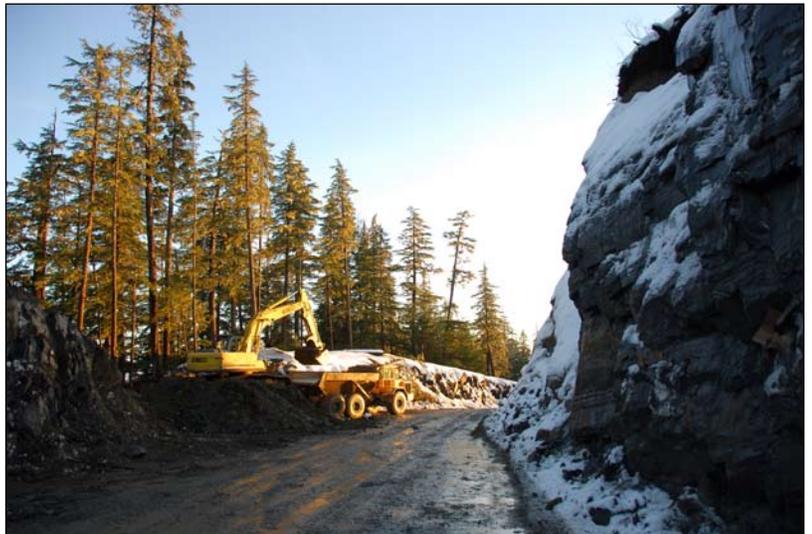
Benching work done in the Blueberry Hill area may require additional efforts to reduce the potential for mass-wasting in this area. Although slopes were graded such that slopes above the road cut should freely drain rain water to the road it will be important to keep an eye on things to make sure the slope above the creek does not become loaded during heavy rain events. In addition, because the vegetation mat and overburden have been largely removed we should consider matting options that lend themselves to eventual natural revegetation and maintain long-term drainage patterns that avoid rain water loading on top of these unstable slopes.

Benching at the Blueberry Hill road cut. Sloping and possible matting will work to keep water from loading.

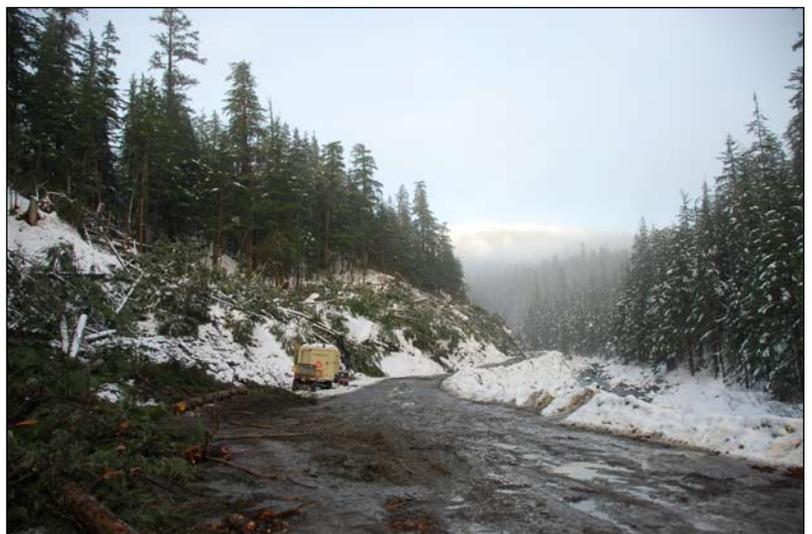
Additional measures intended to reduce the likelihood of sloughing and sliding of slopes immediately above the intake service road have included the removal of an additional ~75 feet of forest. This is being done in order to de-weight slopes where the overburden is generally thin and provides little stability given the road cut immediately below has already compromised the vegetative mat.

Additional forest clearing above the intake service road is being done to improve short term slope stability.

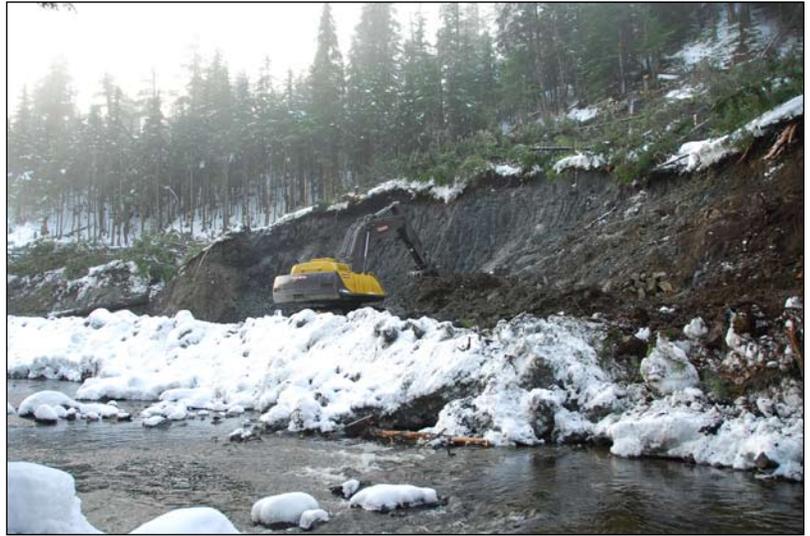
Excavations at the impoundment site were made in preparation for February blasting. It is clear from ongoing work in this area that a great deal of lodgement till lies within and above the excavation area. Although slope stability concerns in this area have been

mentioned in previous reports and records of concern it is worth a reemphasis here prior to scheduled blasting in the area. Winter observations have revealed that all the small streams that cross the service road, the springs in this location are some of the few that continue to flow even during cold snaps. This emphasizes the importance of sediment and erosion control measures, especially proper culverting, in this location.

Excavations at the impoundment site have found a great deal of lodgement till (gray muck) in the area.

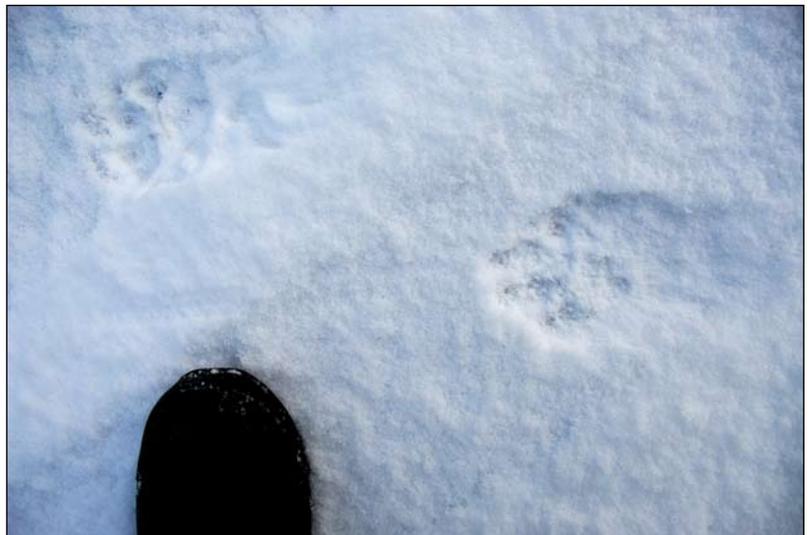
Wildlife activity was generally low during January. Of particular note was the observation of wolverine tracks crossing the intake service road.

Wolverine tracks observed crossing the service road.
