Gustavus Electric Company

August Monthly Report for the Falls Creek Hydro-electric Project
FERC # P-11659

Falls Creek Hydroelectric Project (P-11659)
MONTHLY CONSTRUCTION REPORT TO FERC
August 2006

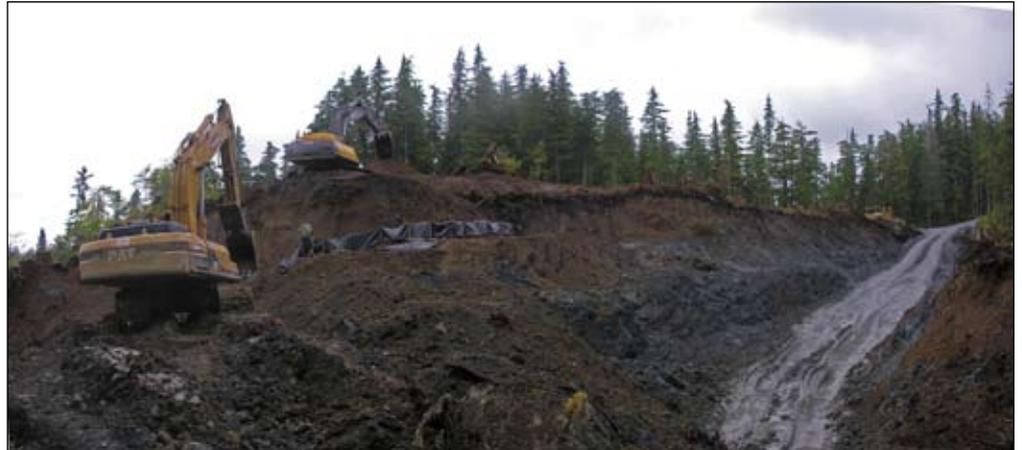
Removal of overburden from the powerhouse access road cut. Bedrock was encountered here and has been blasted once so far. Additional shots will be necessary to get to complete this road segment.

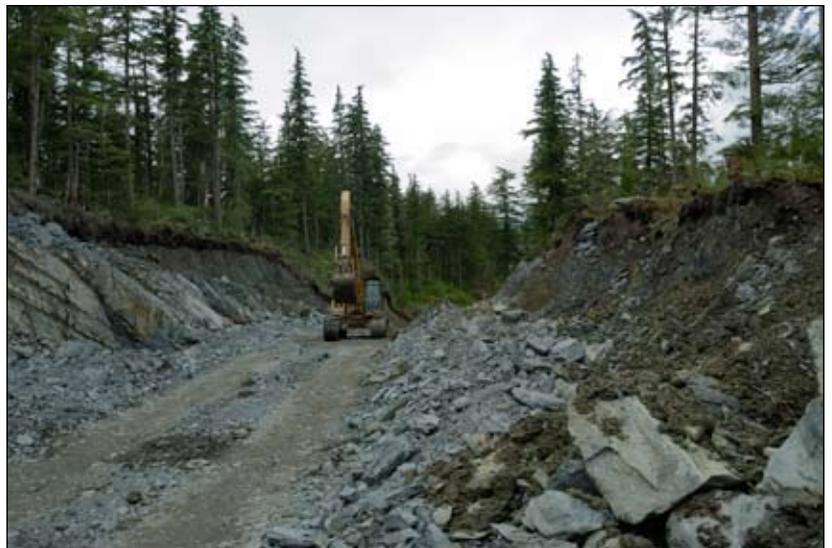
Blueberry Hill road cut. The final road elevation will be ~ 20' below the present condition and will take an additional session of drilling and blasting.

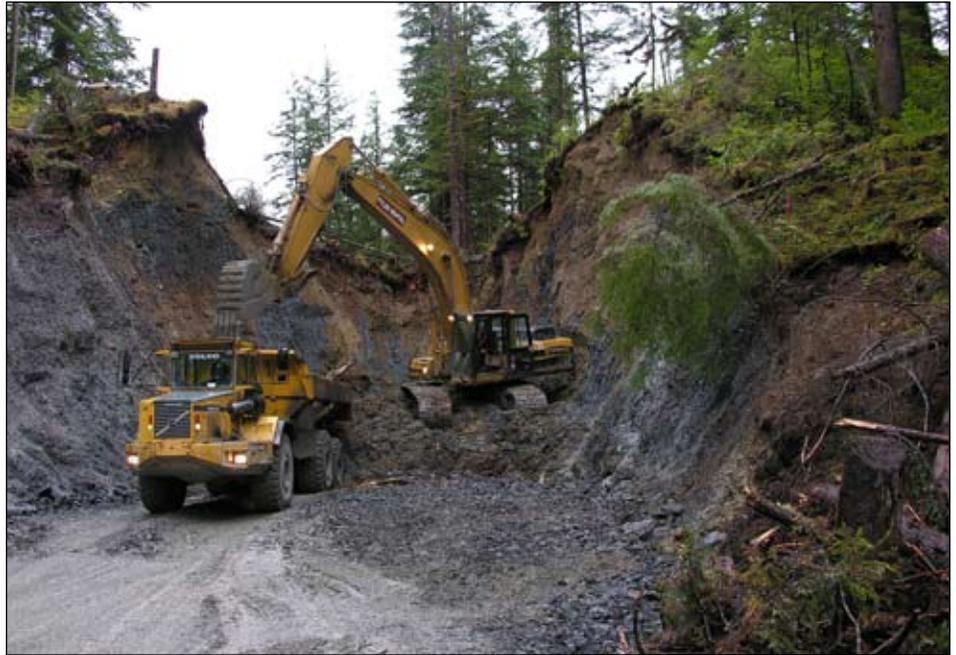
this area. The material was mostly lodgment till clay that had been softened and mixed with weathered clays, muddy gravels and soils by an ancient mass wasting event. When this material was disturbed during excavation it turned semi-liquid, especially during the wetter periods of the month. This made it challenging to control erosion in this area and impossible to control the expansion of the Strip Fen Y disposal site. See the environmental section for more details here.

Deep cut through the Horse Shoe Ridge. Approximately 40,000 yards were hauled back to the Strip Fen Y waste site from here.

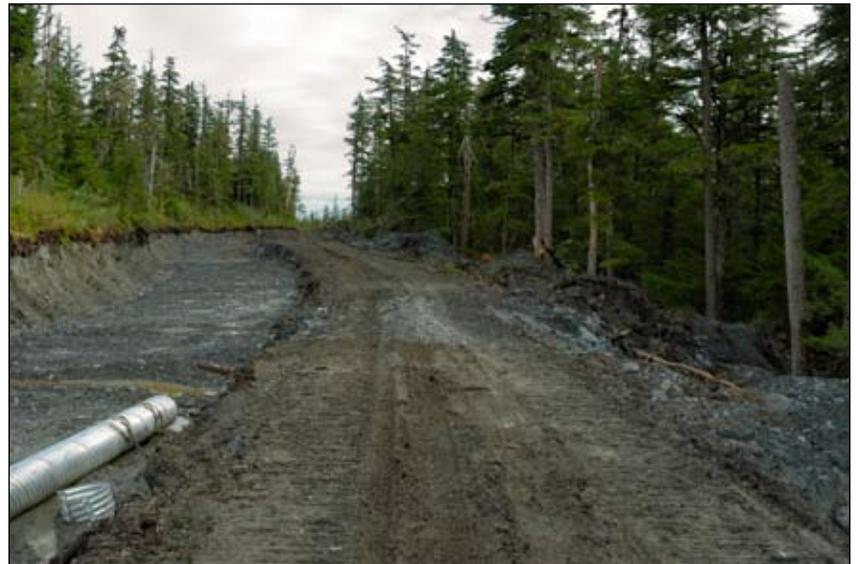
Penstock ditch preparations near the Strip Fen Y.

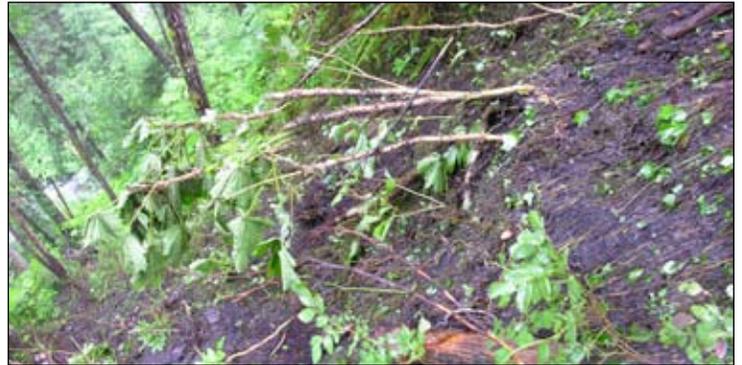
1. A pulse discharge of ~500 -1000 cubic feet of water occurred on August 7 at the powerhouse site approach road. The water had been collected in a sediment pond along side the road and above the creek reach extending from the lower falls. The discharge occurred as a consequence of "mopping out" the pond and loading trucks for backhauling. This event was unlikely to have effected stream turbidity levels for more than a few minutes as flows were high at this time.

Disturbed area from pulse discharge of sediment-pond water at the powerhouse site approach.

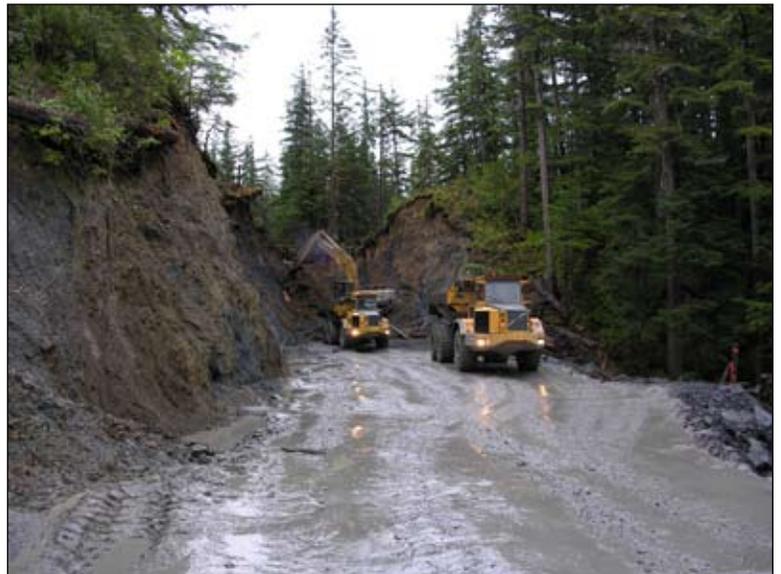
2. Silt was introduced to the creek via two small springs in the vicinity of the Horse Shoe Ridge cut. The overburden material in this area is comprised of a glacial lodgement till that is much softer than most other examples encountered on the project area. The softness of this material is likely due to a mass wasting event that occurred in the ancient past and makes for a generally mucky work environment at both the cut and disposal ends of the operation. Persistent precipitation, heavy at times, has led to a near constant weeping of liquefied till along cut banks and onto the road. The fines in this material make there way through the road gravels and are transported toward Falls Creek by spring waters that travel through the road. The amount of sediment contributed to Falls Creek from this area has been too small to measure at sampling sites and at this point is a non-issue in terms of turbidity management. However, it is possible that a significant number of these small sediment sources could be created along the intake and powerhouse roads so the issue can not be completely ignored. A temporary pond on the uphill side of the road and a practice of "lifting" and burming the road has the situation under control in this area at present. Eventually, additional work on the backslopes, establishing permanent ditches and additional culverts will be necessary for long-term management of the situation.

Silt and mud buildup on the road bed approaching the horse shoe cut. Cutbank weeping of liquefied lodgement till and weathered clay has been persistent in the latter days of the month. This is one area that is currently contributing sediment to Falls Creek, though the overall effect has been nominal.

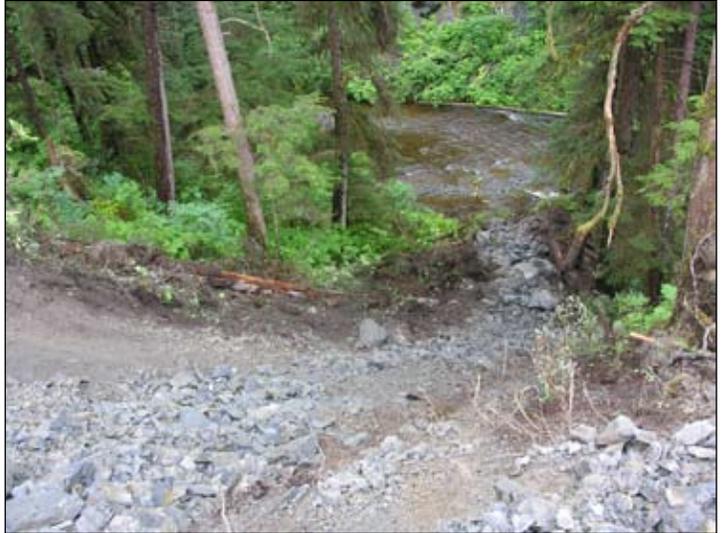
A small rock slide occurred as a result of the first shot at the powerhouse access road cut. Approximately 1,500 yards of mostly rock slid down the steep canyon walls to the very edge of the creek. None of the material actually made it to the creek but the terminal lobe has settled within the flood plain and has been “washed” by one high flow event.

Rock slide from the powerhouse access road cut to the creek bank near the powerhouse site.

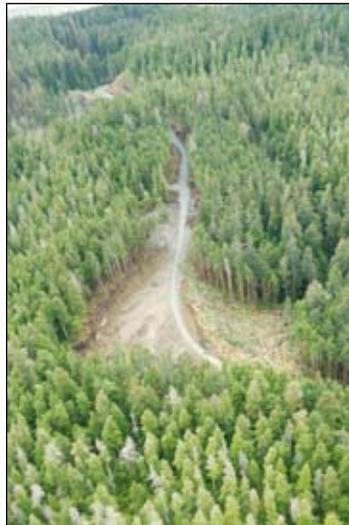
Aerial view of the gravel pit. The area on the right side of the current road alignment has been recently cleared of trees and will eventually be developed as a gravel source.

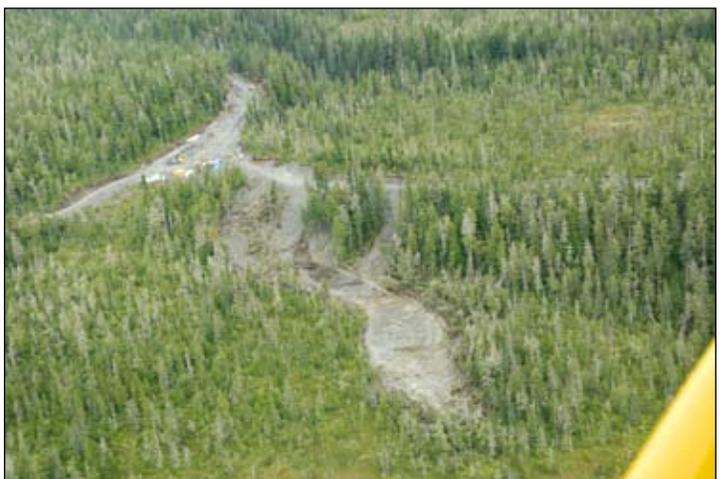
The spoils area near the Strip Fen Y continued to expand “glacially” as hauling back of overburden and waste material from deep cuts for road and penstock grade continued through the month. Persistent precipitation liquefied most haul back materials either at the point of removal or when placed in the dump site. The spoils area now covers approximately 4 acres of what used to be hemlock scrub forest and the terminus is nearing a fen/peat bog margin (wetlands). There has been an estimated 100,000+ cu. yards dumped in this site. We expect this area to continue to expand until the intake road has been completed. Alternative disposal areas and designs have been considered and minor modifications have been made.

Aerial view of the Strip Fen Y spoils area. Mass wasting has occurred along the margins of this dump site, especially at the terminus. The total area covered is now approximately 4 acres.

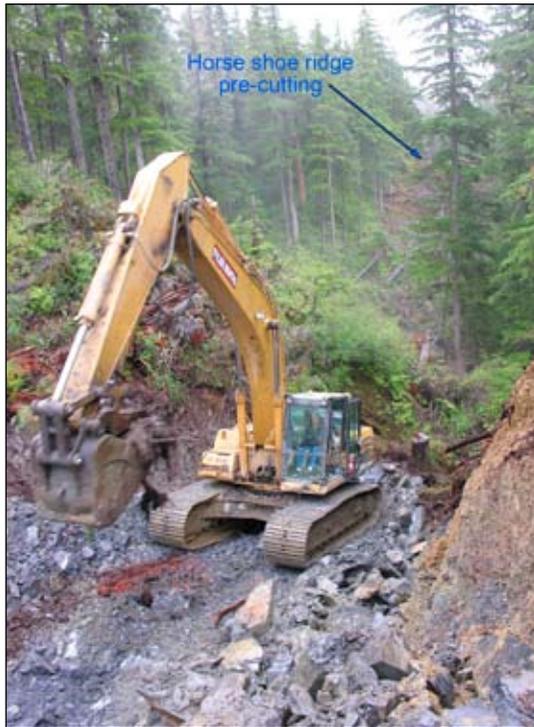
Slope stability in the area between Blueberry Hill and the Horse Shoe Ridge is worthy of concern. Much of the area is steep (>50% slope), wet and comprised of a mixture of previously disturbed lodgement till and weathered clay on bedrock. The construction superintendent should be commended for getting a road through this difficult area without a mass wasting event or significant sediment and erosion control issues during construction. However, it is likely that a mass wasting event of unknown proportions is imminent. The area immediately down-slope leads to Falls Creek. Other than standard erosion and sediment control measures, included ditching and culverting the road to reduce uphill loading from water and sediment, it is unclear what more can be done to prevent such an event - see photos on following page.

This was the situation on August 5th as the road construction crew came out of the Blueberry Hill cut and began side-hill cutting their way to the Horse Shoe Ridge cut. The materials encountered along this road segment were fairly unstable, wet in places and slopes exceeded 50% most of the way. Though no mass wasting event occurred during construction of this segment the probability is still high.

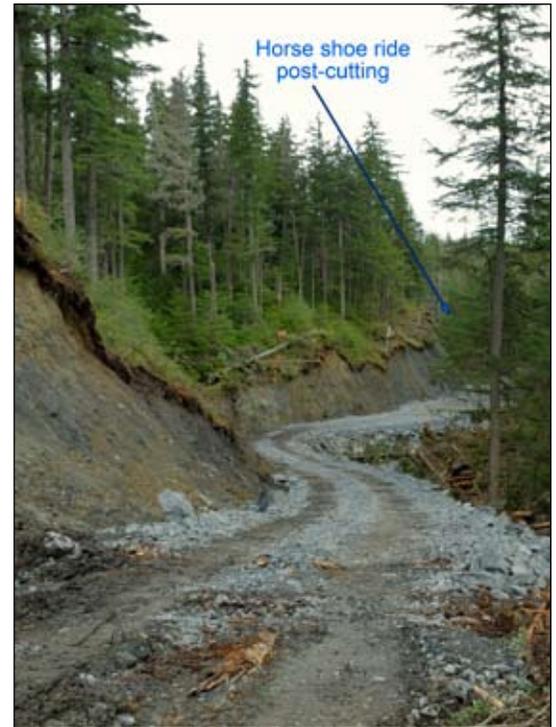
This was the situation on August 30th. The road segment from the Blueberry Hill cut through the Horse Shoe Ridge cut has been completed, minus ditches and culverts. The uphill slopes "weep" liquefied lodgement till and weathered clay onto the side of the road. Additional work on these slopes will be necessary to reduce micro-wasting processes and resultant sediment contributions to Falls Creek.
