**FALLS CREEK HYDRO-PROJECT
MONTHLY CONSTRUCTION REPORT TO FERC
June 2006**

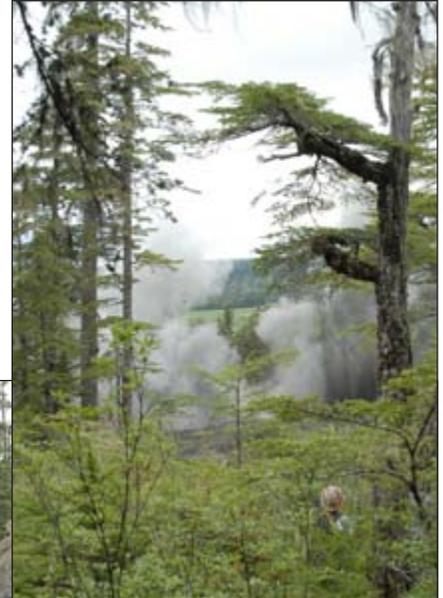
Shooting pit #3.

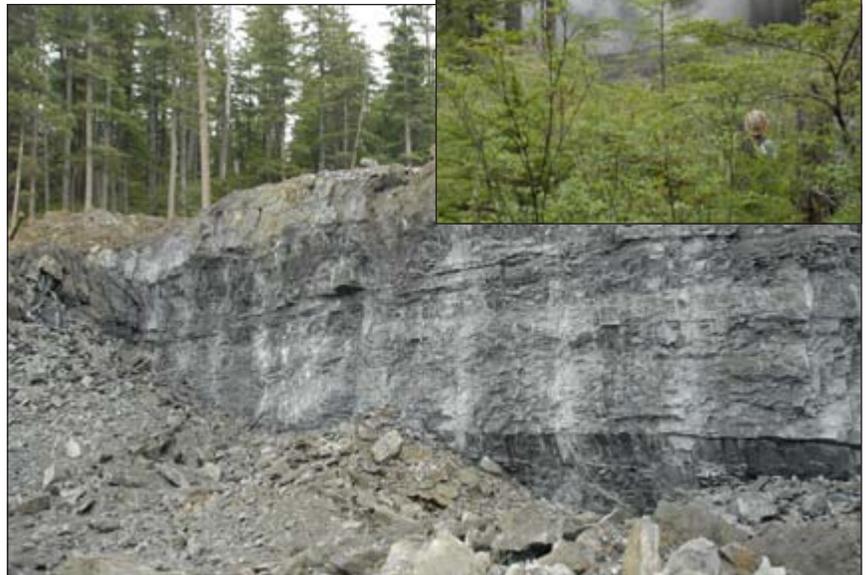
Pit #3 after the second shot.

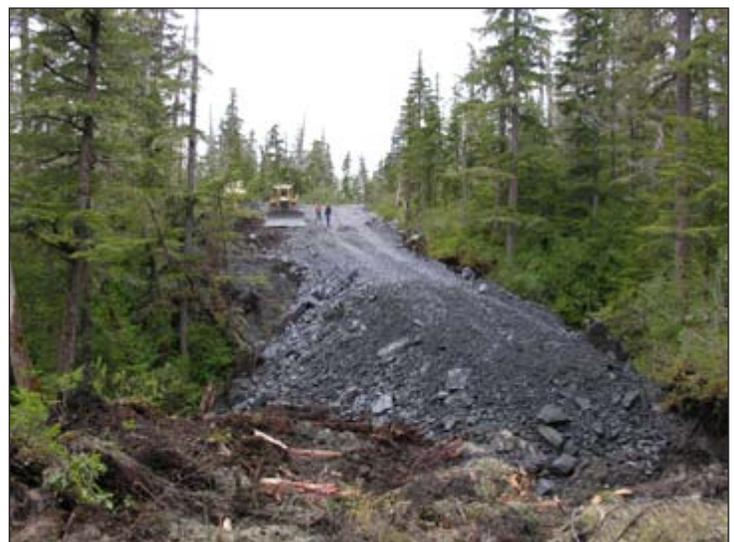
New road construction from pit #3 to the strip fen Y began immediately following the capping of existing road base and the second shot in pit #3. Slope cutting for this stretch of road was fairly minimal although there were a couple large fills needed to bridge ravines in the "bird foot canyon" area (figure 1 and photo below right).

Large fill over creek 1 in bird foot canyon.

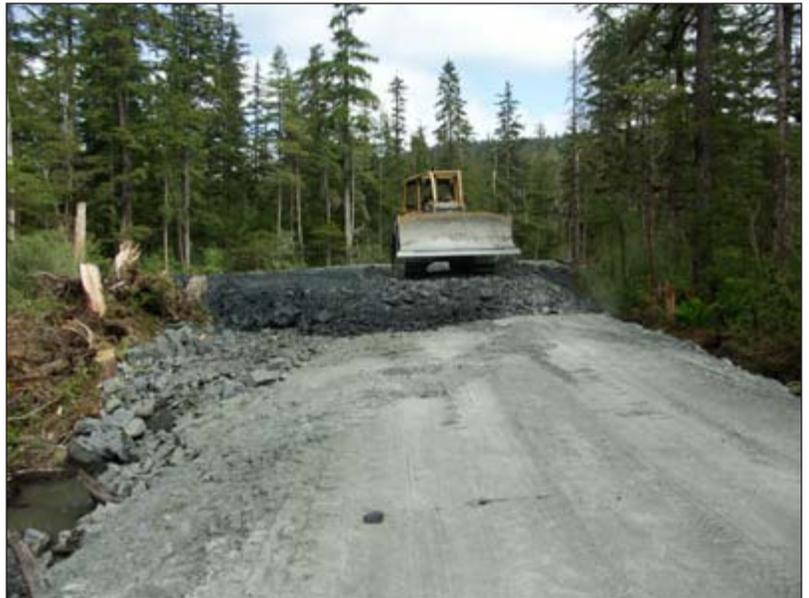
In locations where the lodgement till road base was/is wet the material has a tendency to consume larger quantities of rock before becoming stable. During the rocking process the lodgement till road base was somewhat slippery and drivers had to be extra cautious to avoid running off of the road.

Capping the lodgement till road base.

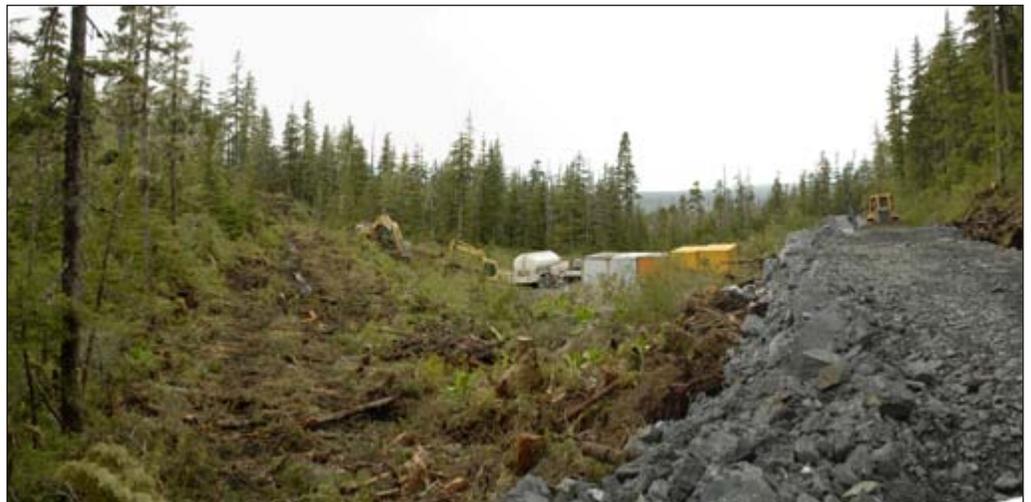
Staging area at the strip fen Y. Cleared area in photo will eventually be rocked to approximately .2 acres.

A staging area of .2 acres was cleared at the strip fen Y. The ECM met with the construction superintendent prior to clearing and grading activities to discuss the need for such an area and the best way to create it with minimal impacts to habitat. A plan of action was agreed upon and consent was given from an environmental compliance point of view. Although the area covers wetlands in addition to those identified as “to be impacted” in the plan it is important to note that there are no other flat areas centrally located that are not also wetland types.

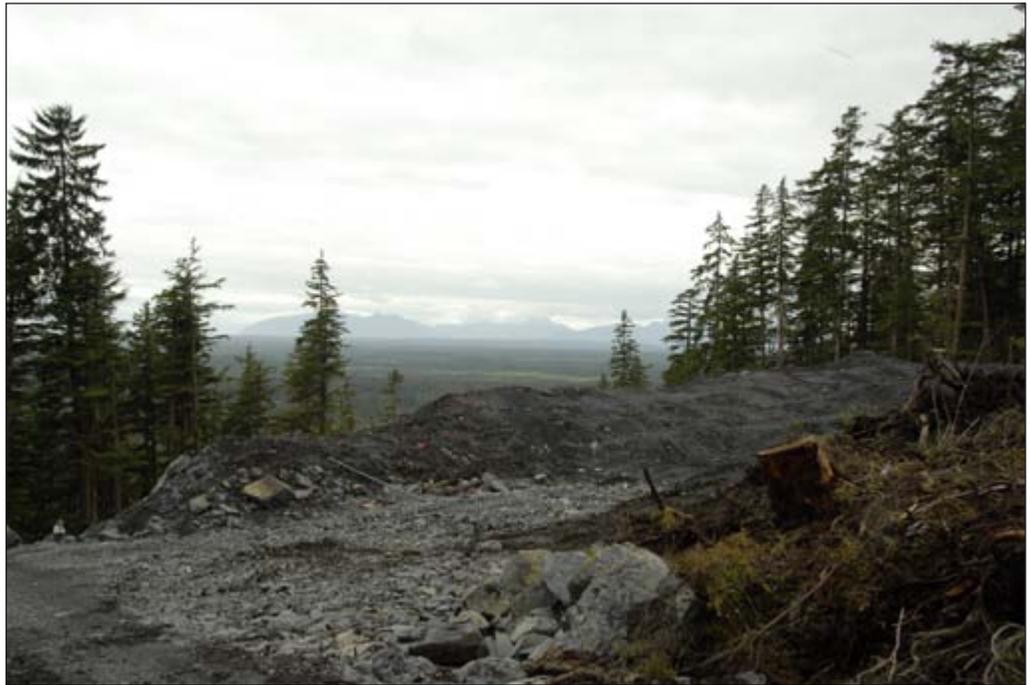
Drilling of shot 3 at pit #3 was completed by June 30 but the shot was not scheduled until July.
