KOKHANOK HEALTH CLINIC

Alaska Rural Primary Care Facility Code and Condition Survey

March 6, 2002

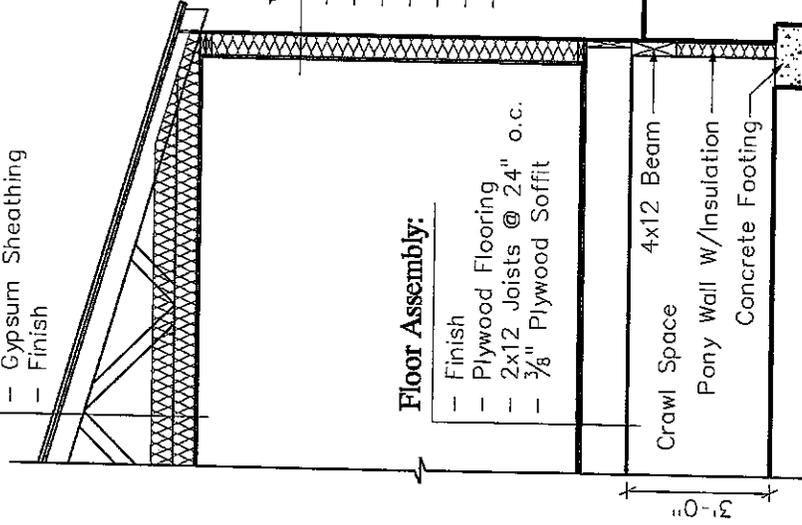
Roof Assembly:

- Prefinished Metal Roofing
- Plywood Deck
- Wood Trusses @ 24" o.c.
- R38 Batt Insulation
- Gypsum Sheathing
- Finish

Wall Assembly:

- Finish
- Gypsum Wall Board
- Vapor Barrier
- 2x6 @ 24" o.c.
- R19 Batt Insulation
- Bevel Cedar Siding
- Finish
