**KASIDAYA CREEK HYDROELECTRIC PROJECT**

**PROJECT NO. 11588**

**MONTHLY CONSTRUCTION REPORT**

**MARCH 2007**

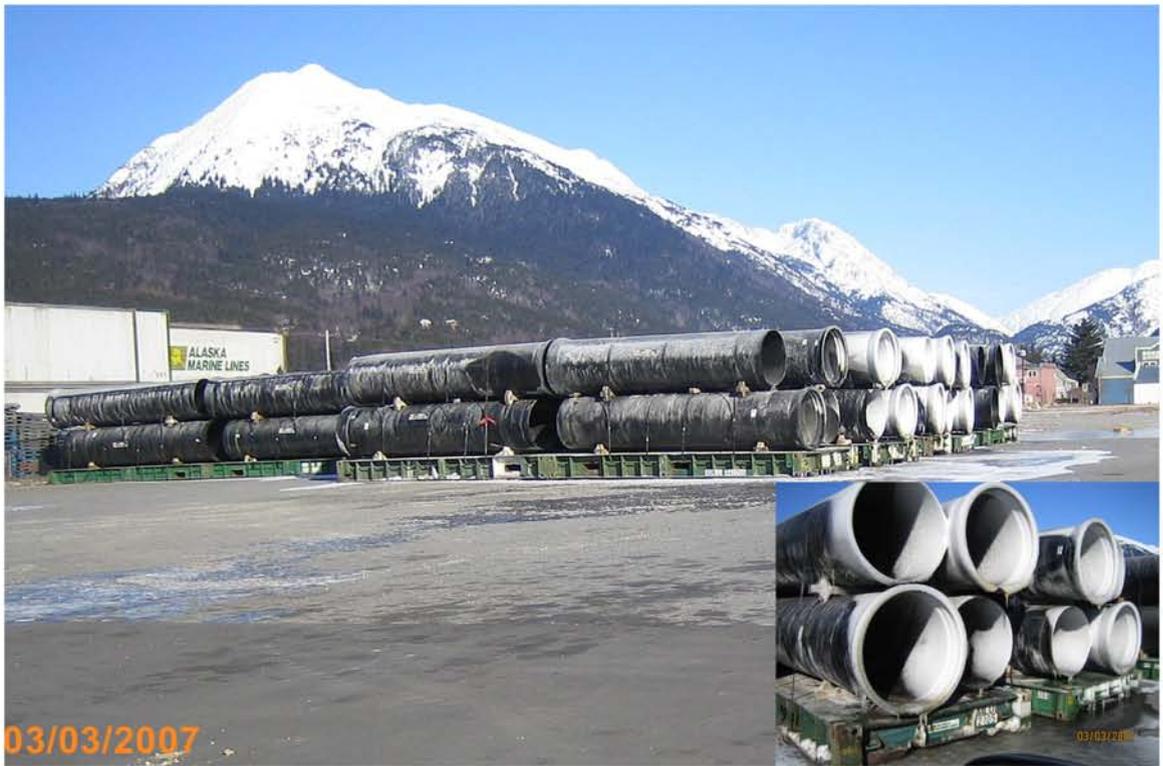
Photo 1

**HDPE PIPE STORED IN SKAGWAY  
NOTE SNOW OR ICE ON PIPE**

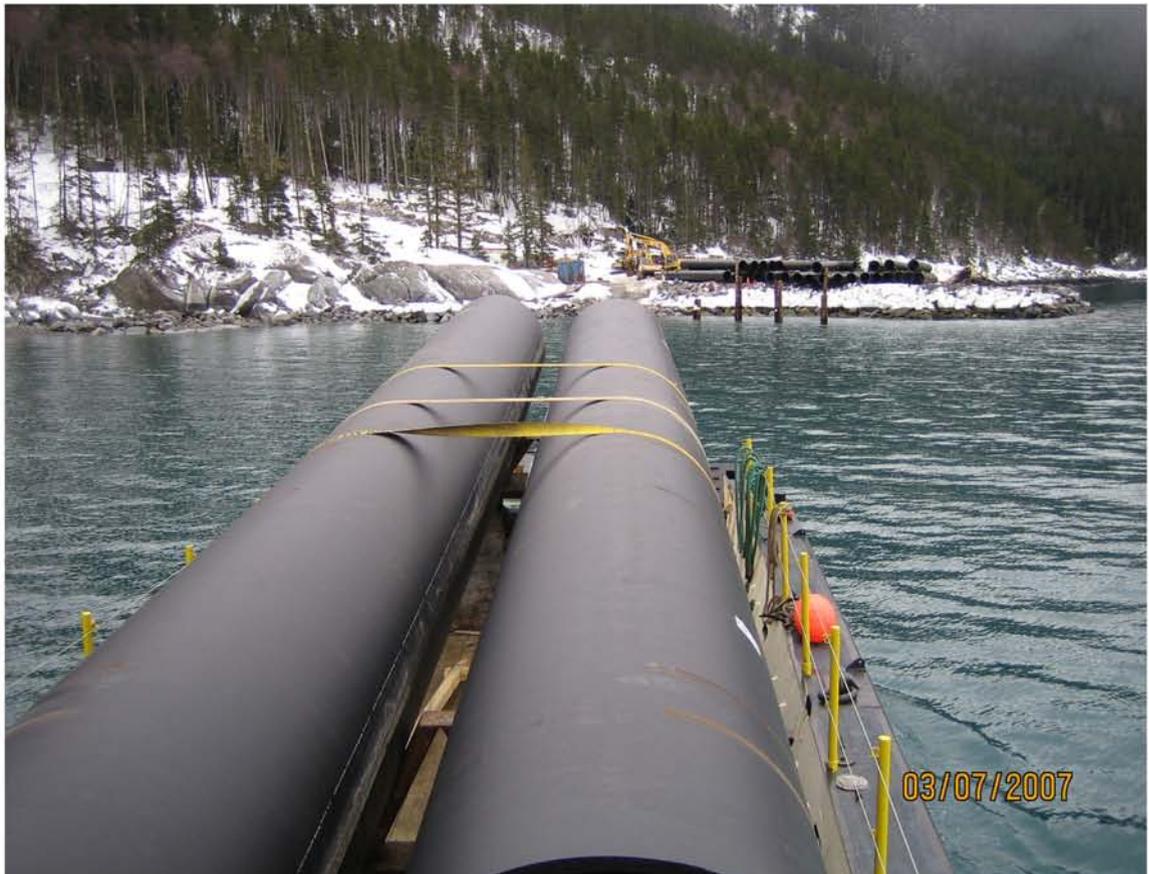
Photo 2

**HDPE PIPE BEING TRANSPORTED TO THE PROJECT**

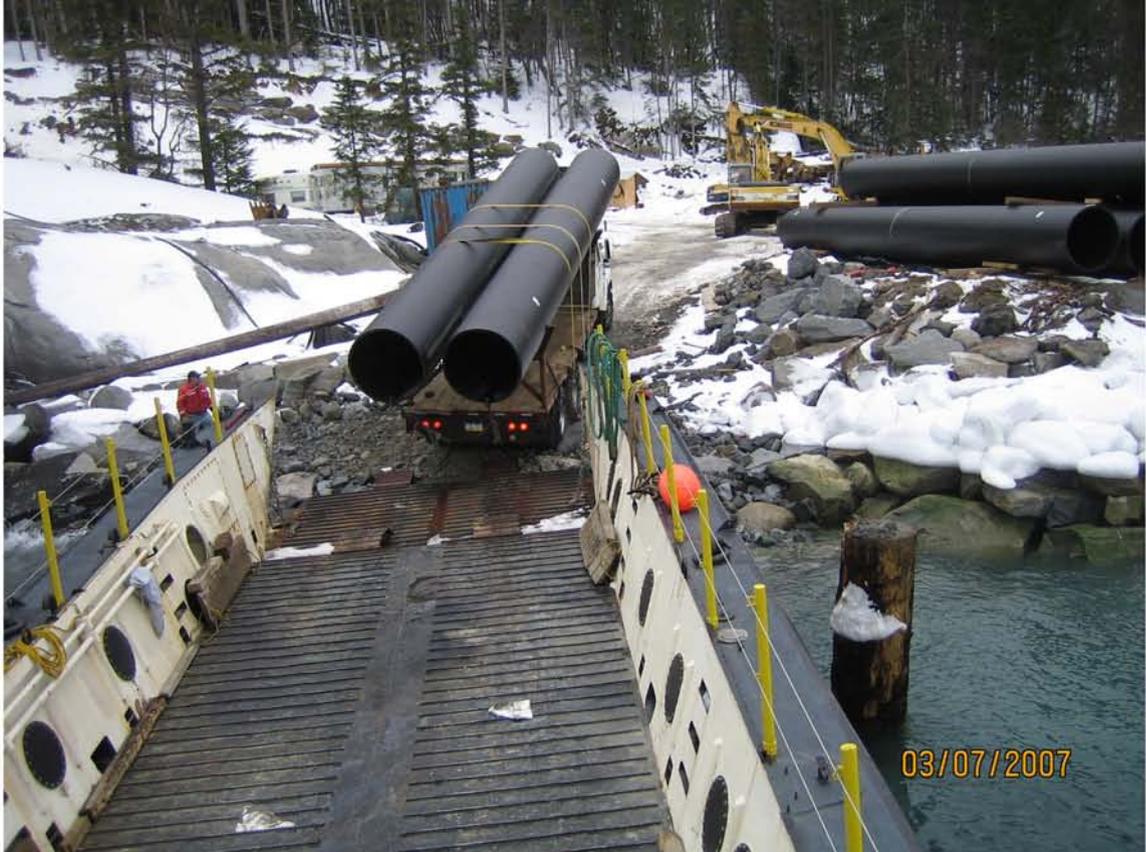
**Photo 3**

**HDPE PIPE BEING OFF-LOADED FROM LANDING CRAFT**

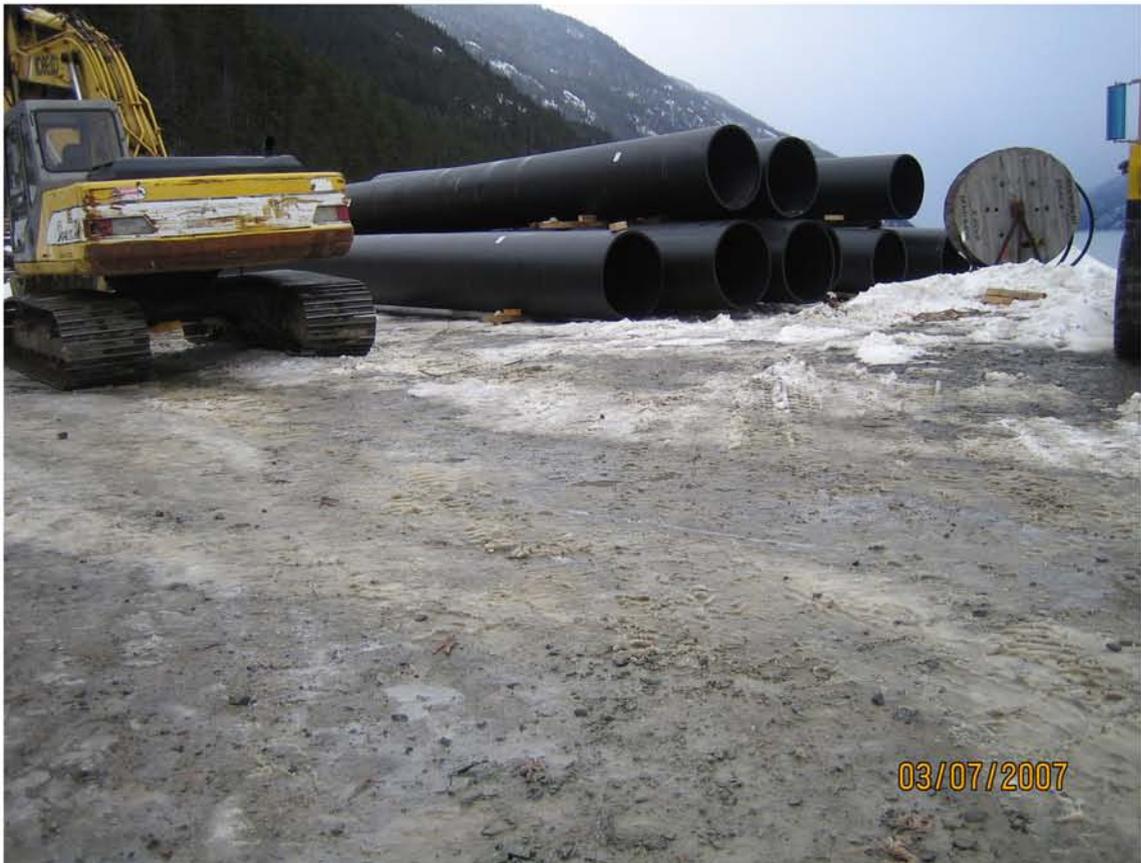
**Photo 4**

**HDPE PIPE STOCKPILED ON STAGING AREA**

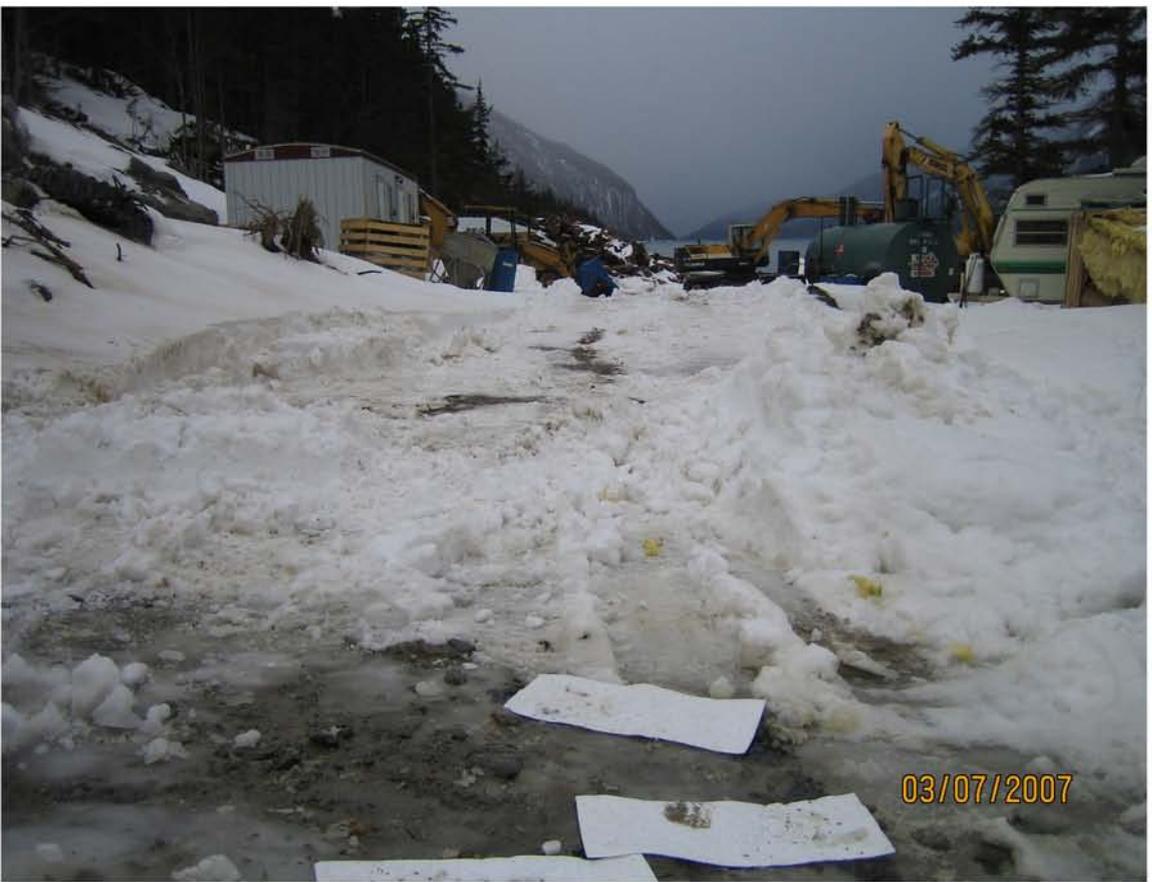
**Photo 5**

**WINTER CONDITIONS AT SEALEVEL AT PROJECT SITE;  
VIEW LOOKING SOUTH FROM POWERHOUSE SITE**

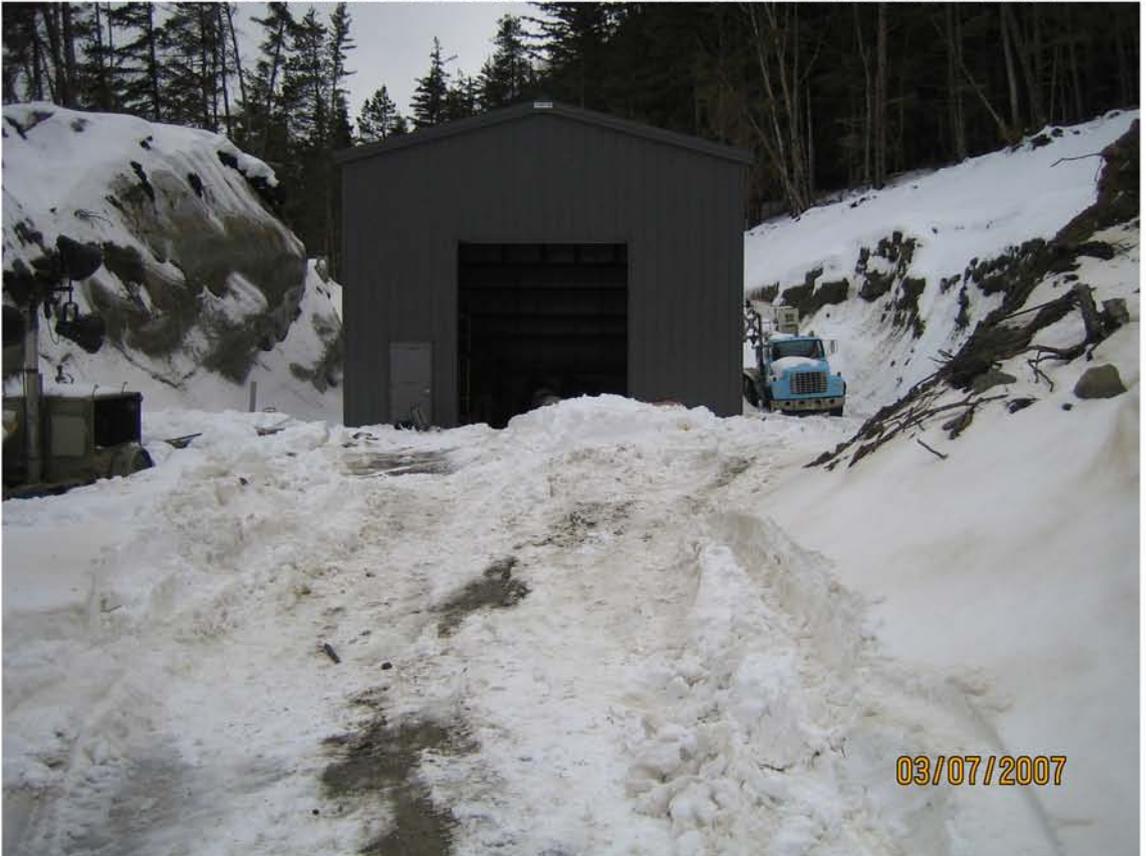
**Photo 6**

**SOUTH SIDE OF POWERHOUSE**

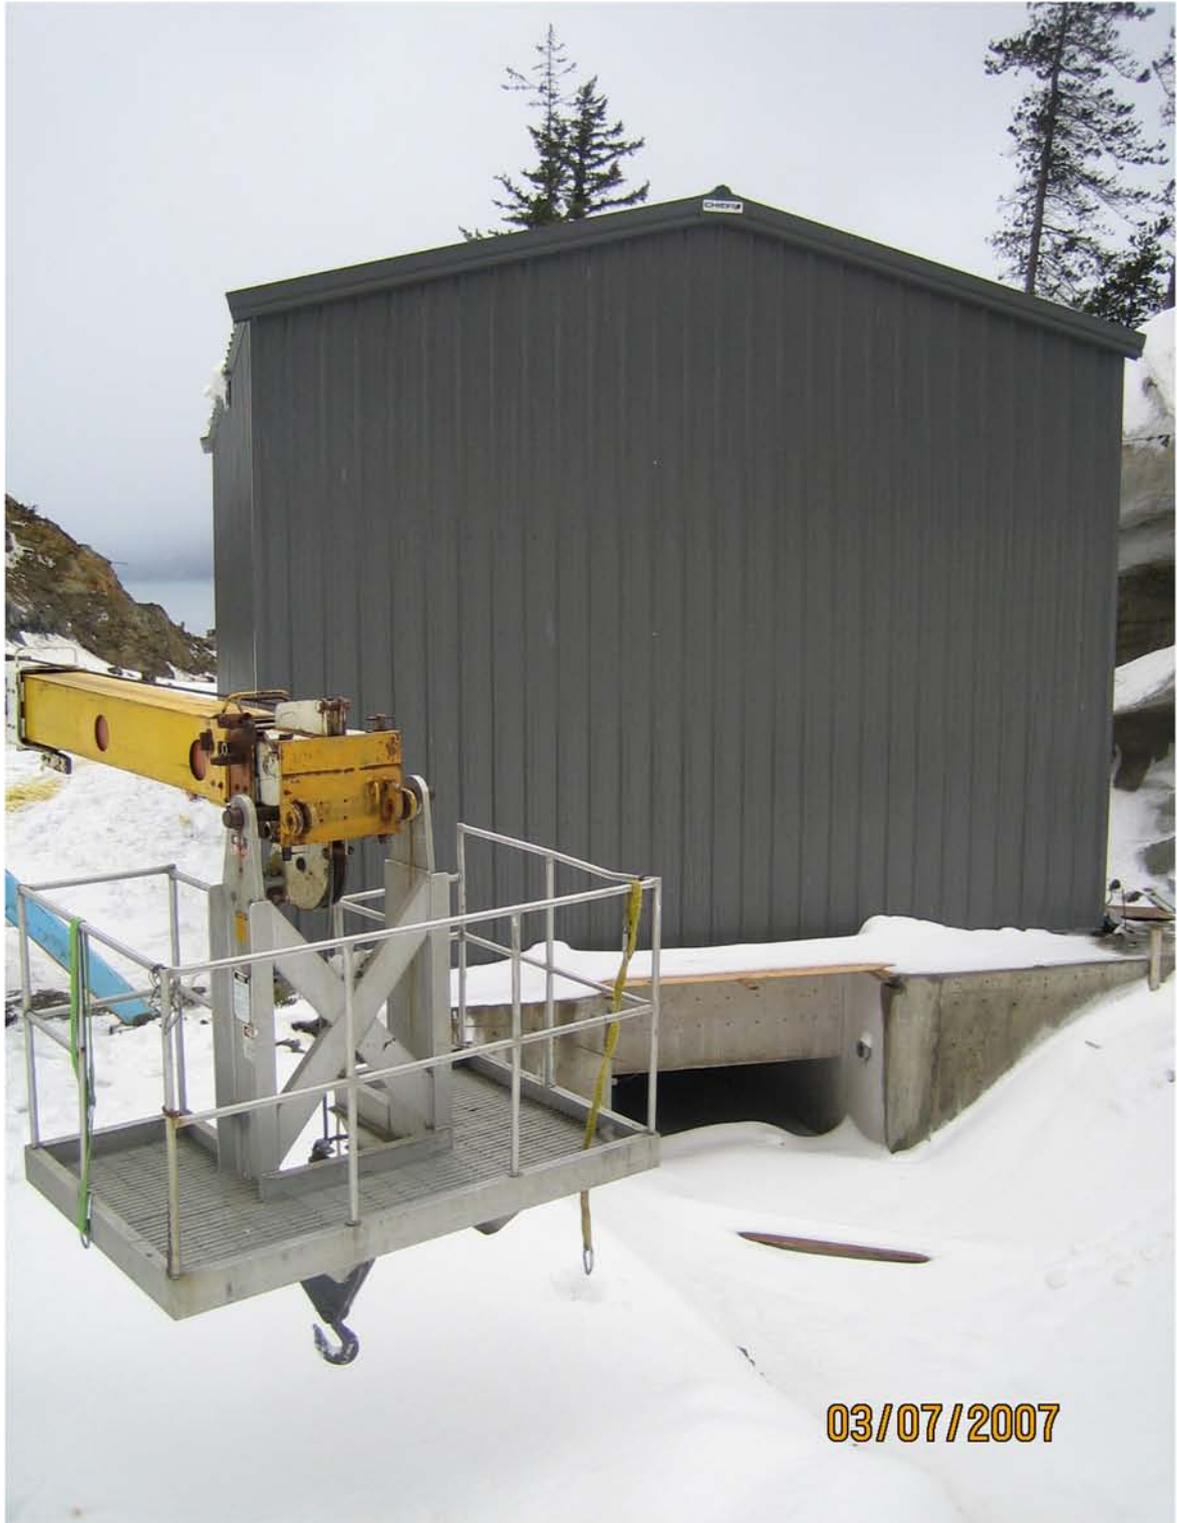
**Photo 7**

**NORTH SIDE OF POWERHOUSE; TAILRACE IS VISIBLE**

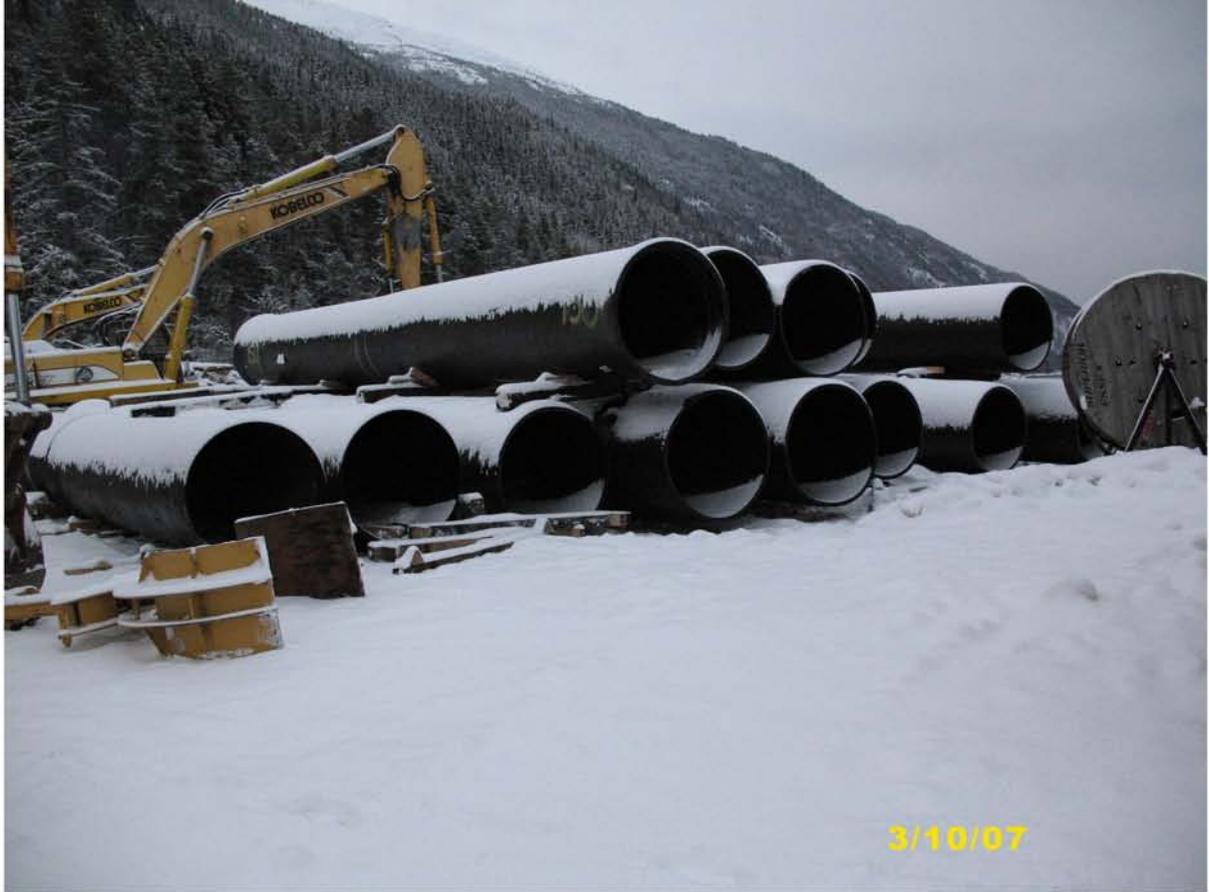
**Photo 8**

**Pipe stacked on the jetty.**

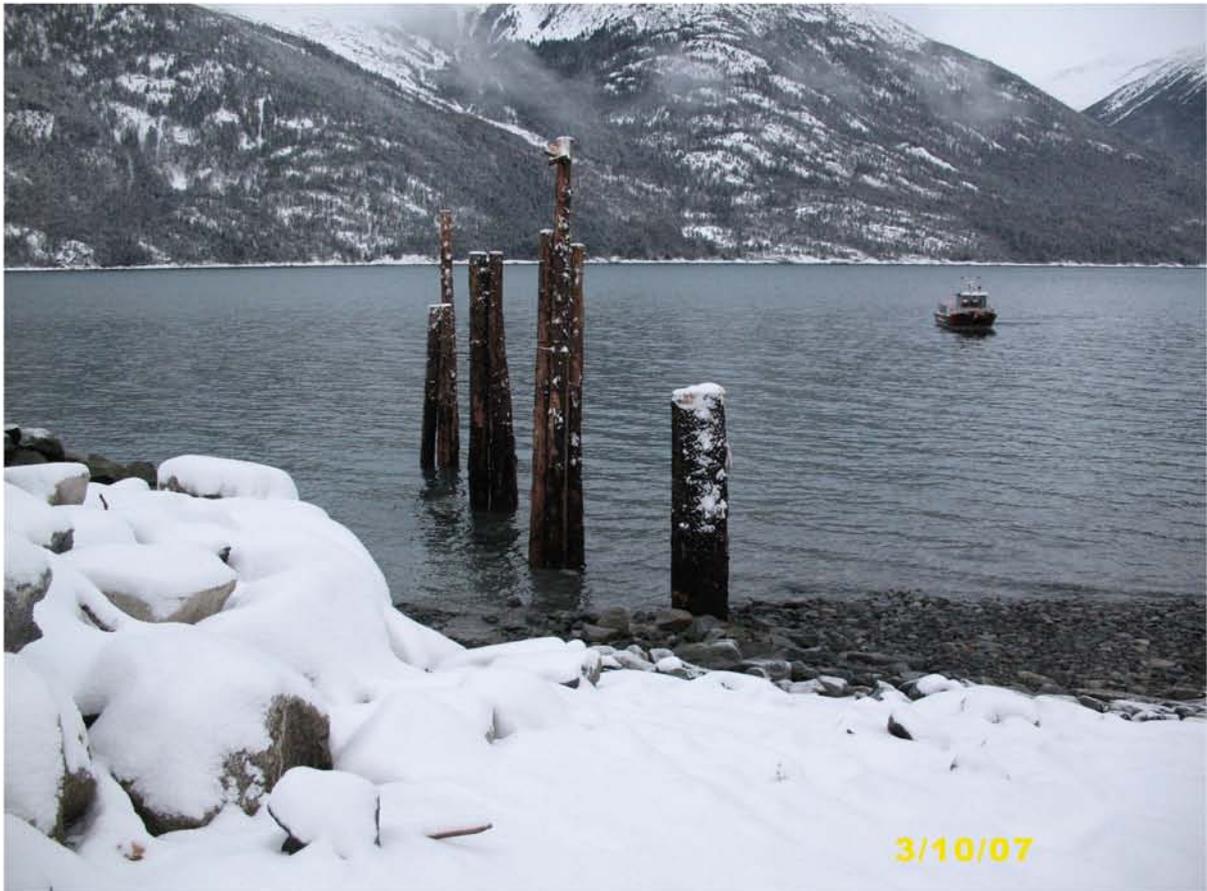
**Photo 9**

**Pilings that were installed on the south side of the boat ramp area.**

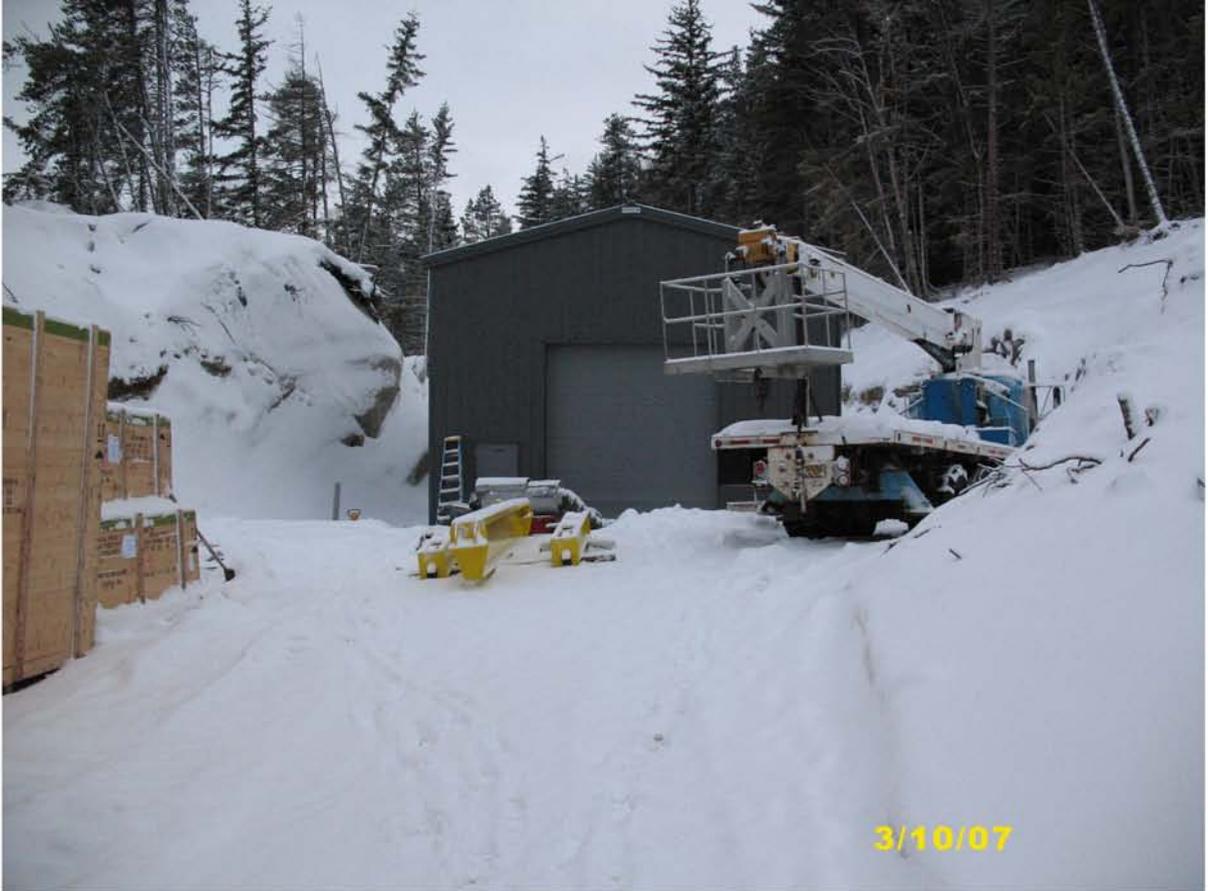
Photo 10

**The south end of the finished Powerhouse.**

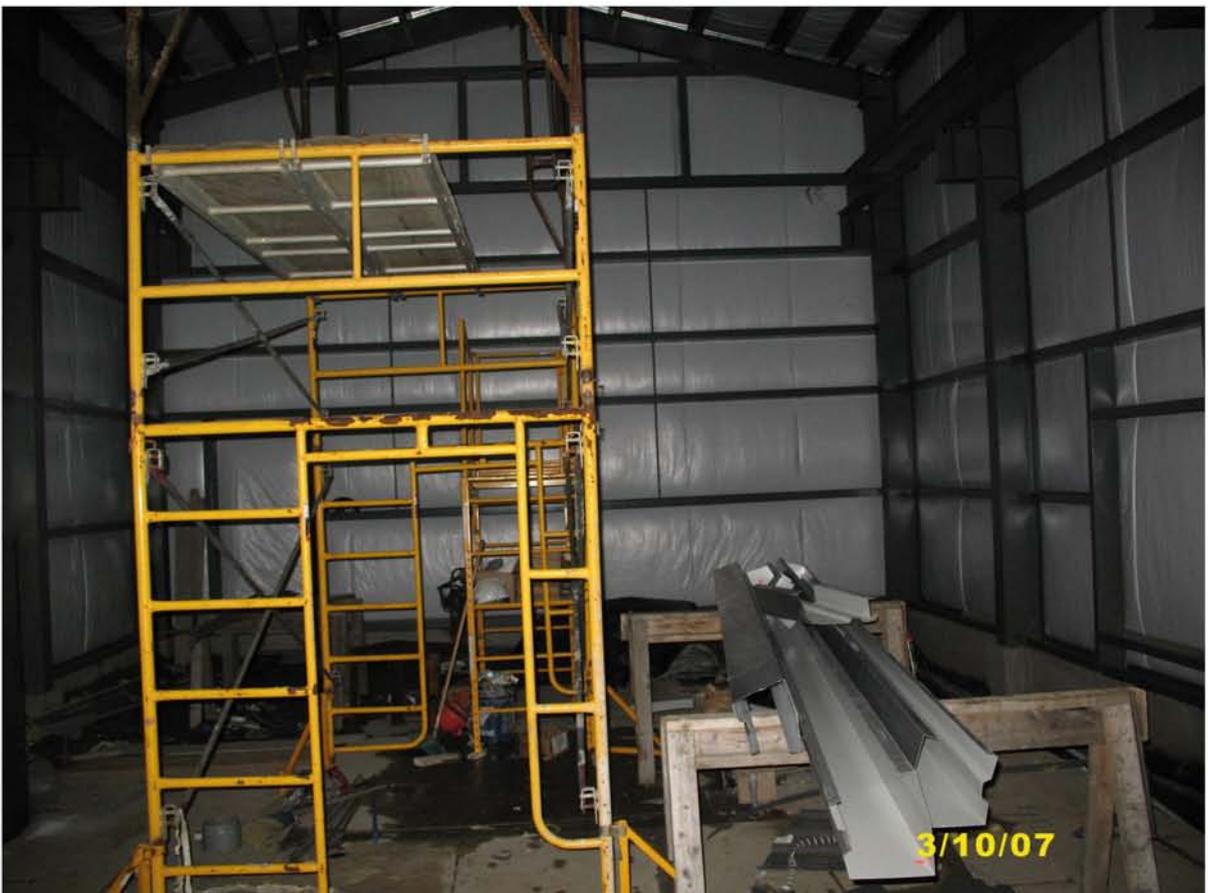
Photo 11

**Looking at the north wall on the inside of the Powerhouse.**

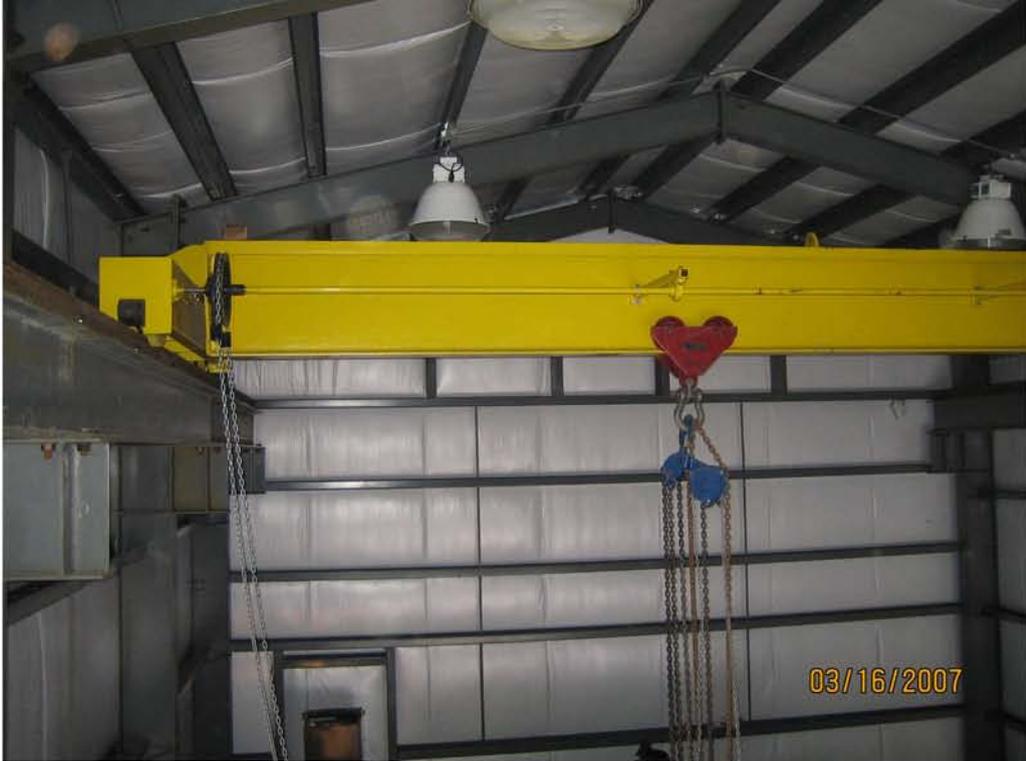
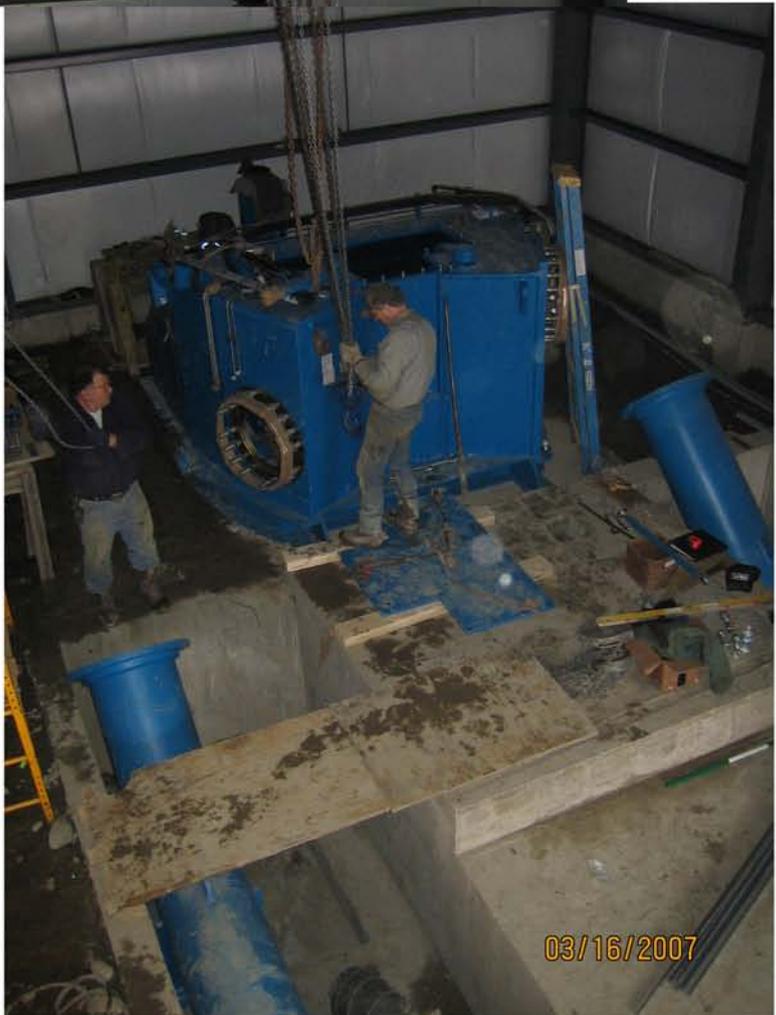
Photo 12\*

**INSTALLATION OF  
TURBINE HOUSING  
AND APPURTENANCES**

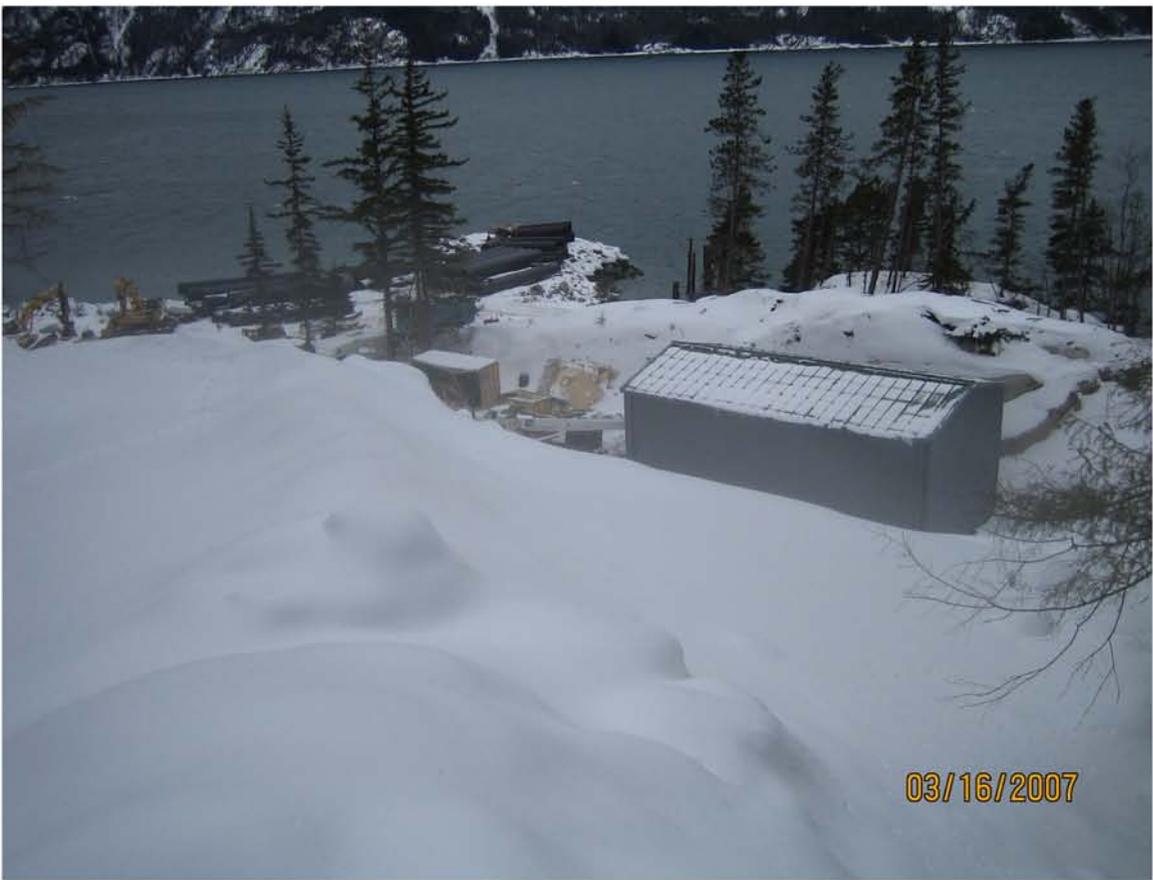
Photo 13

**DEEP SNOW ABOVE POWERHOUSE**

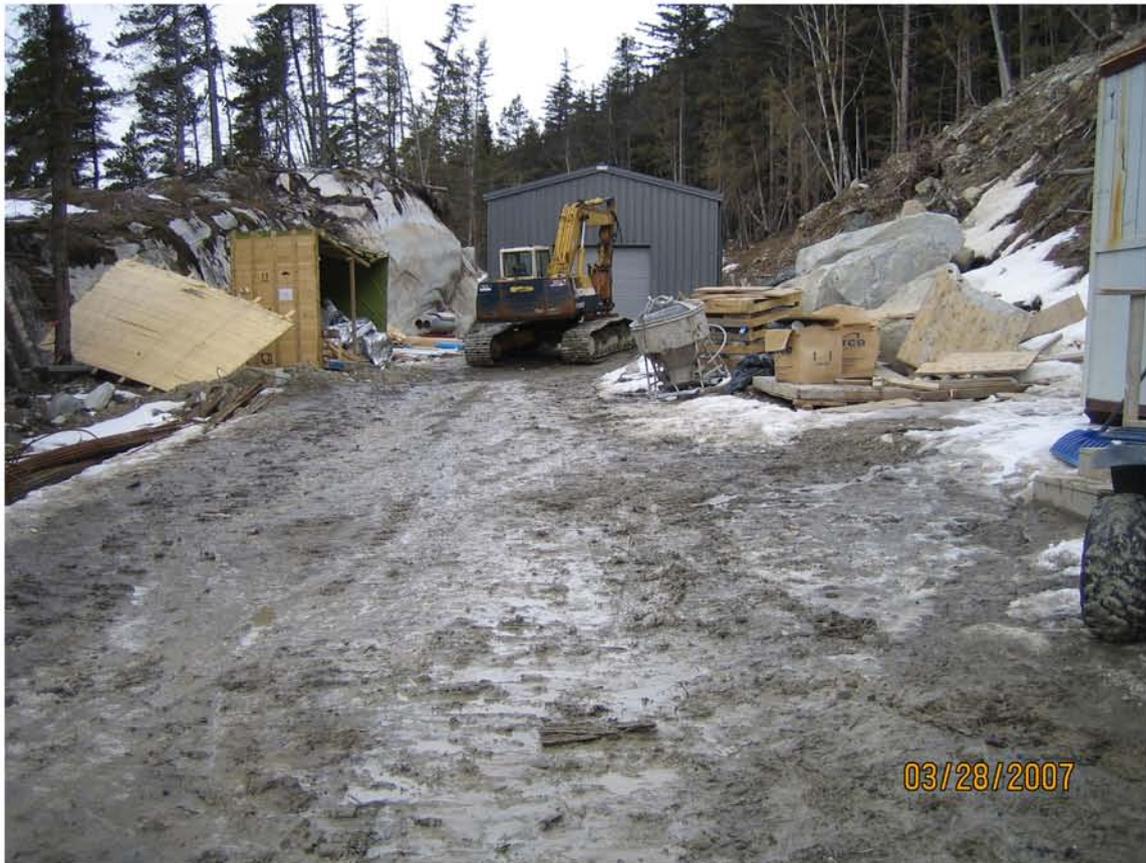
Photo 14

**WINTER BEGINS TO RECEDE FROM STAGING AREA**

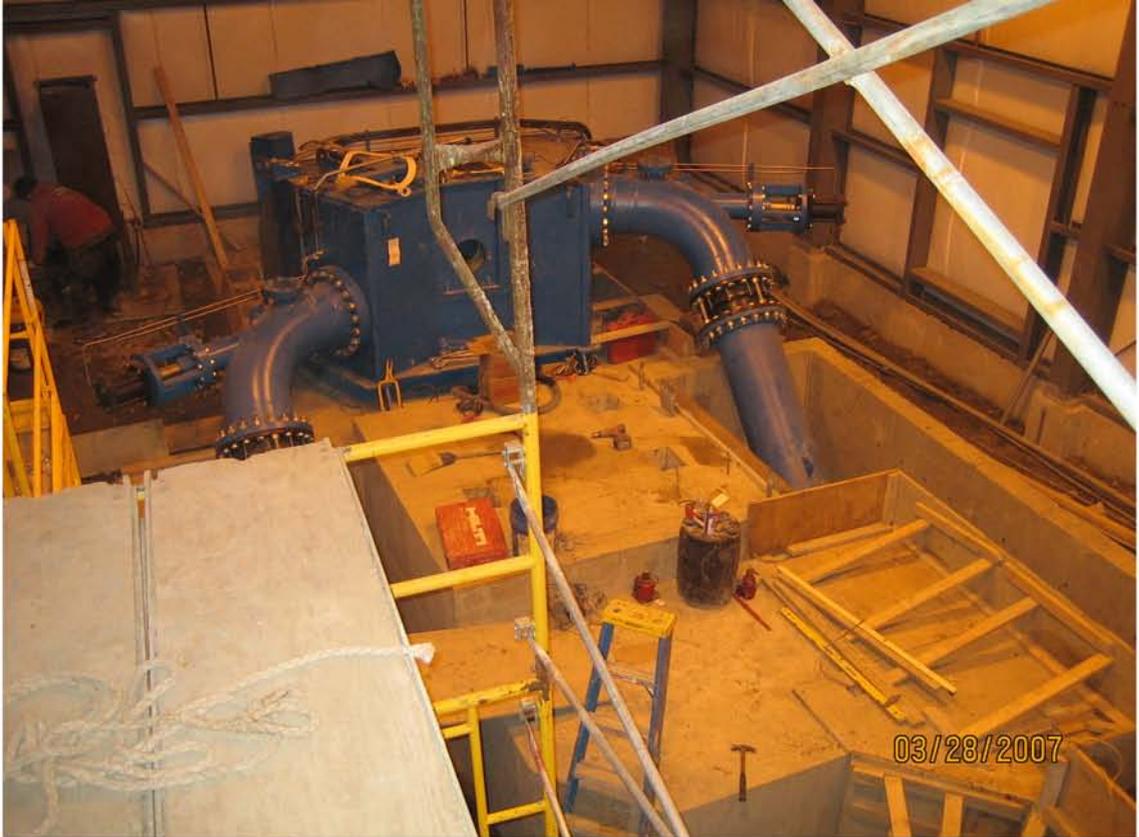
**Photo 15**

**TURBINE CASING WITH NEEDLE ASSEMBLY INSTALLED**

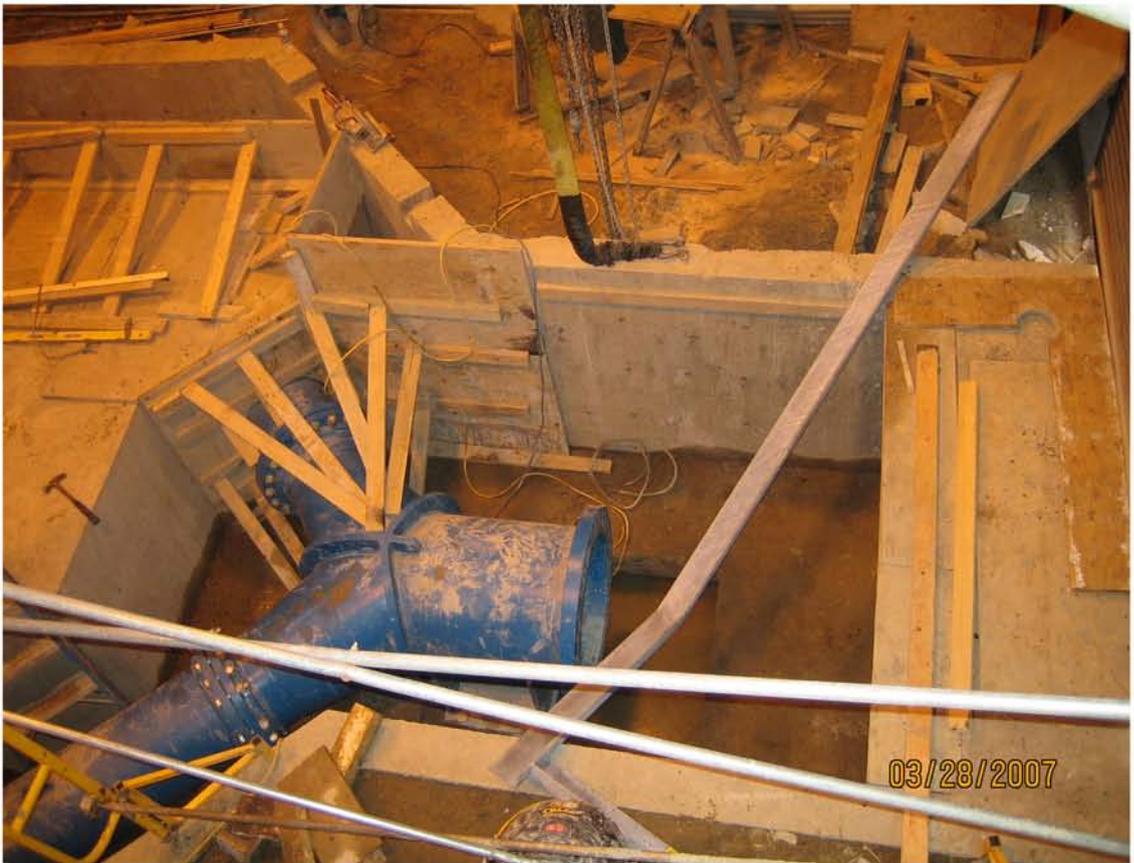
**Photo 16**

**PENSTOCK BIFURCATION CONCRETE WORK IN POWERHOUSE**

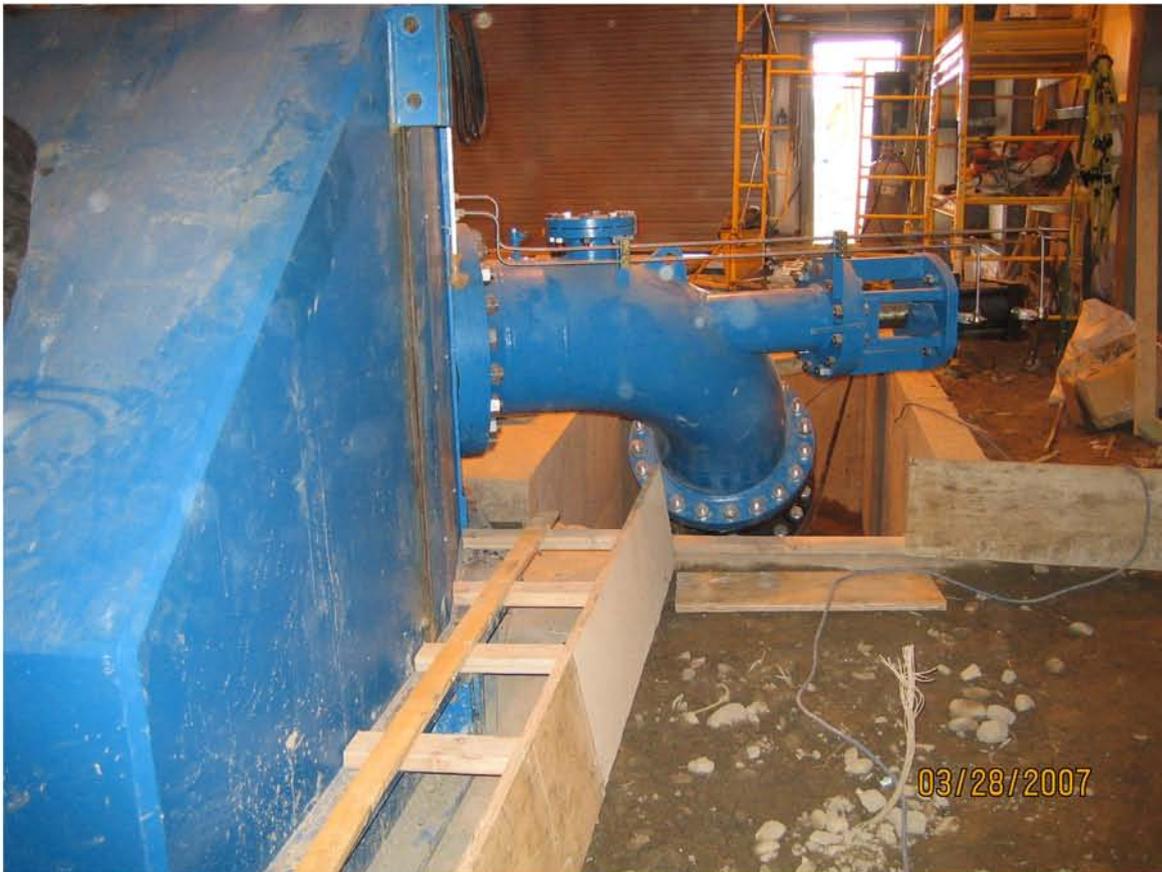
Photo 17

**TURBINE CASING AT LEFT WITH NEEDLE ASSEMBLY**

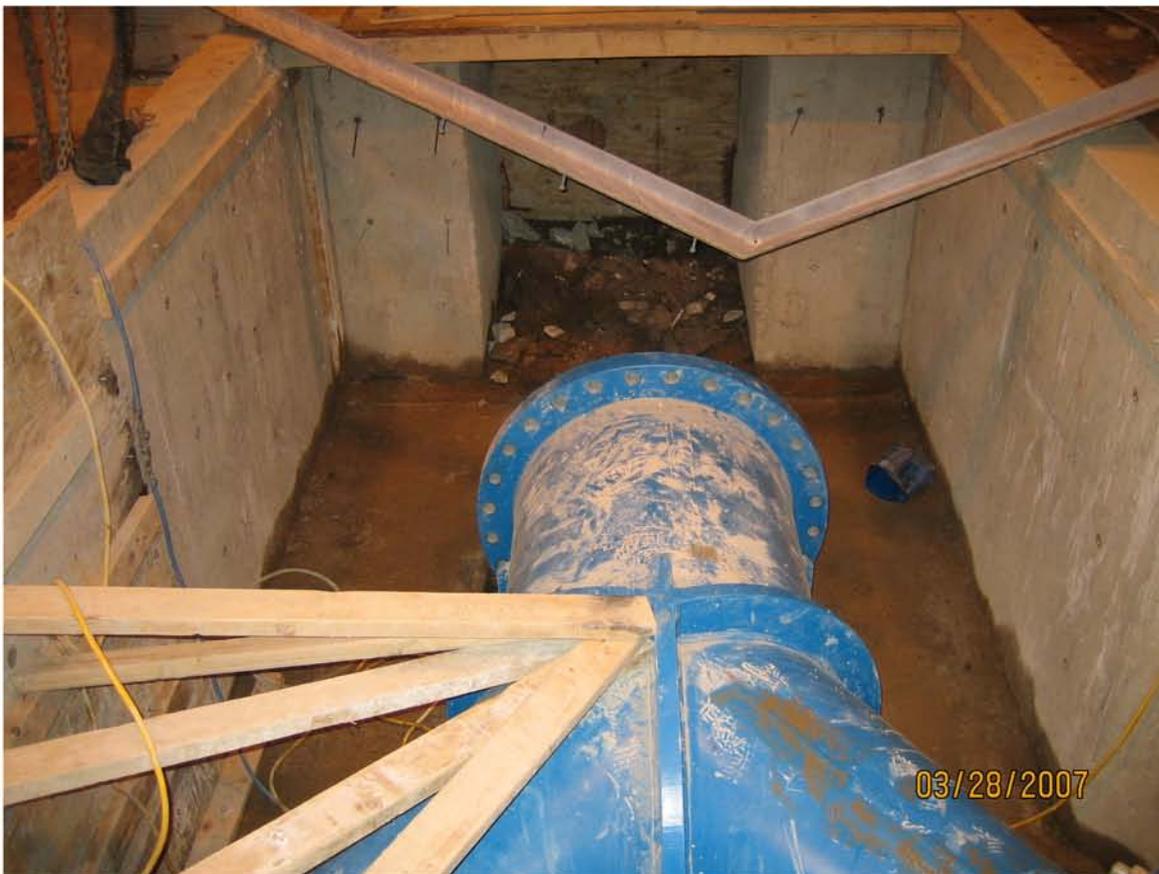
Photo 18

**POINT OF BIFURCATION IN POWERHOUSE FOR PENSTOCK**
