November Monthly Report for the Falls Creek Hydro-electric Project
FERC # P-11659

**Falls Creek Hydroelectric Project (P-11659)
MONTHLY CONSTRUCTION REPORT TO FERC
November 2006**

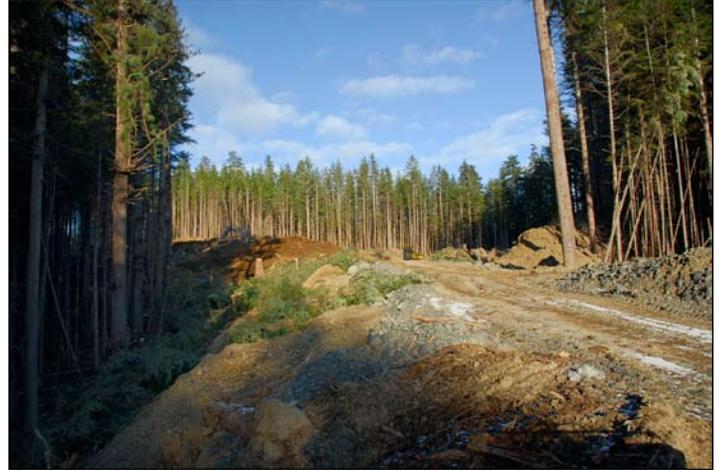
Newly stripped gravel pit area at left of road. Note large spruce trees at left may still be removed.

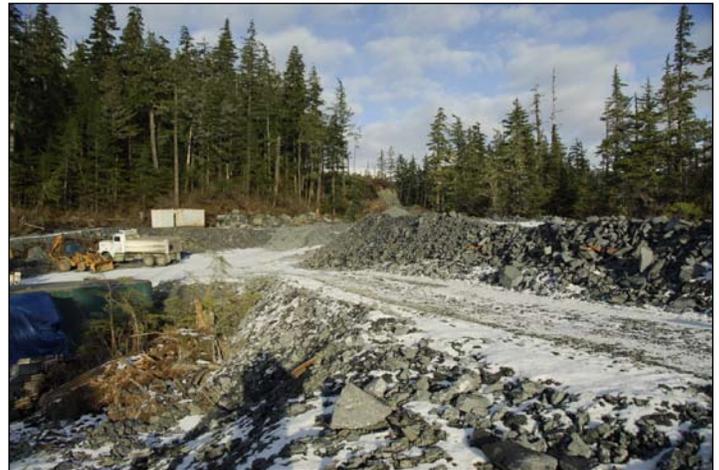
This is a picture of shot rock that has been stock-piled at the Strip Fen Y.

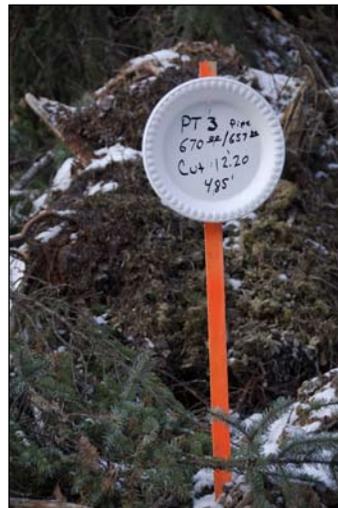
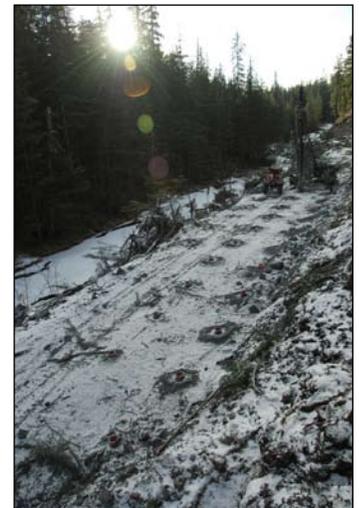
Some drilling and blasting was done along the intake service road this month.

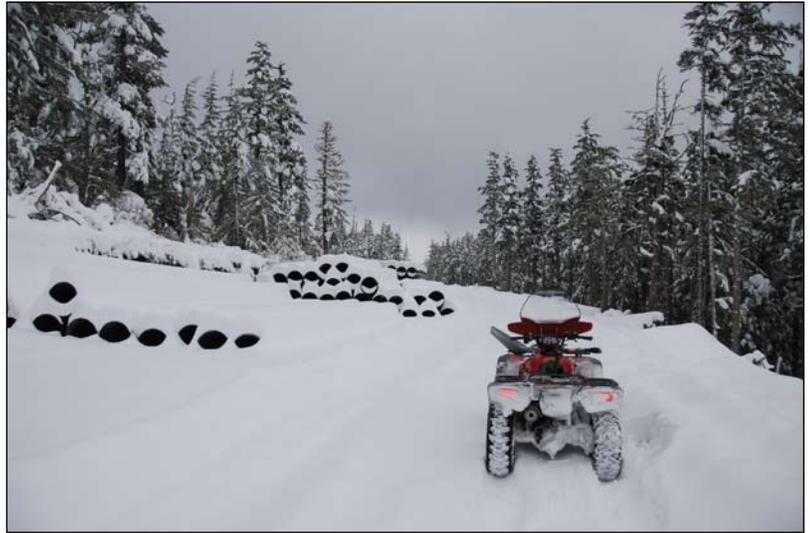
down from November 9th to the 21st, except for plowing. The month was also windy and cold, with three days down near -10F. The cold did not hinder progress, except diesel fuel that jelled had to be dealt with on a couple of occasions. Winds postponed the arrival of the penstock fusion machine such that training and welding work had to be postponed until at least January 2007.

Heavy snows for much of the month postponed construction activities, especially HDPE penstock welding.

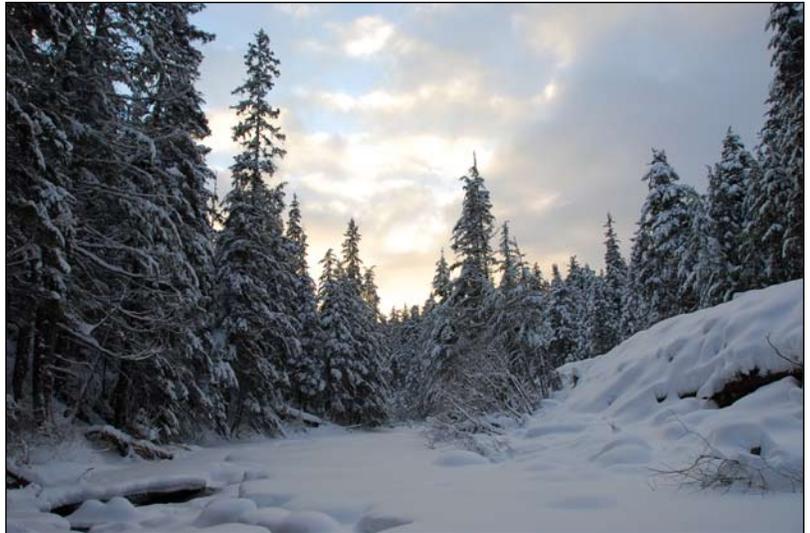
Ice and snow covered creek along intake service road.

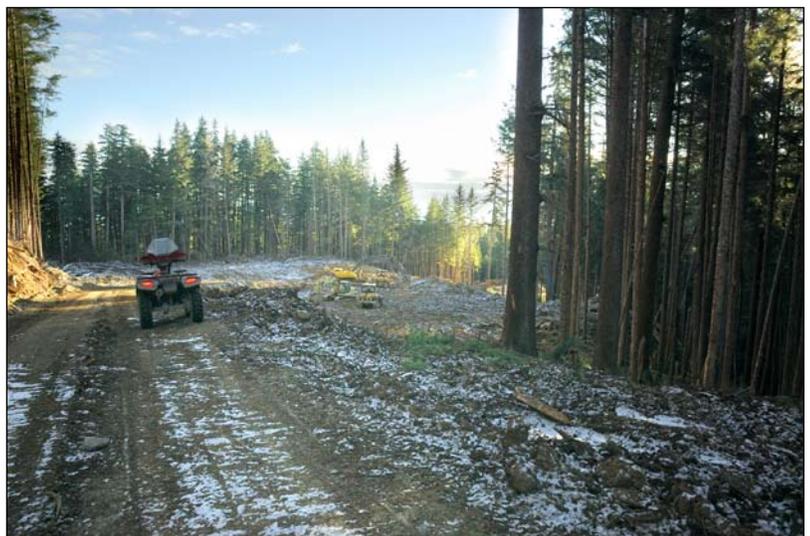
Expansion of the gravel pit area clearing has increased windthrow exposure to high quality forest habitat. In addition, it may be necessary to remove 1-4 "murrelet trees" to make way for the preferred penstock route. The ECM is working closely with the project manager on choosing a route that minimizes head loss and construction costs while keeping impacts to

Newly stripped gravel pit area at right of road. Note large spruce trees at right may be removed.

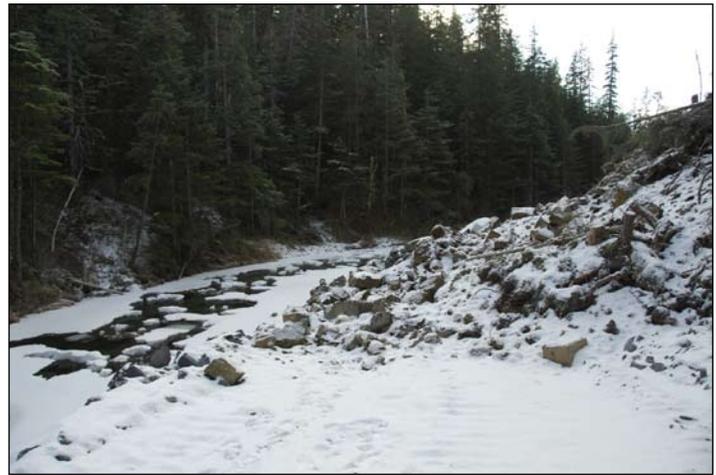
Blasting along the intake service road was conducted without causing landslides or otherwise contributing sediment to Falls Creek. Small shots and light loads have been used in this area with great success.

Blasting along the intake service road has gone very well this month - no slides or other impacts on fish habitat resources.

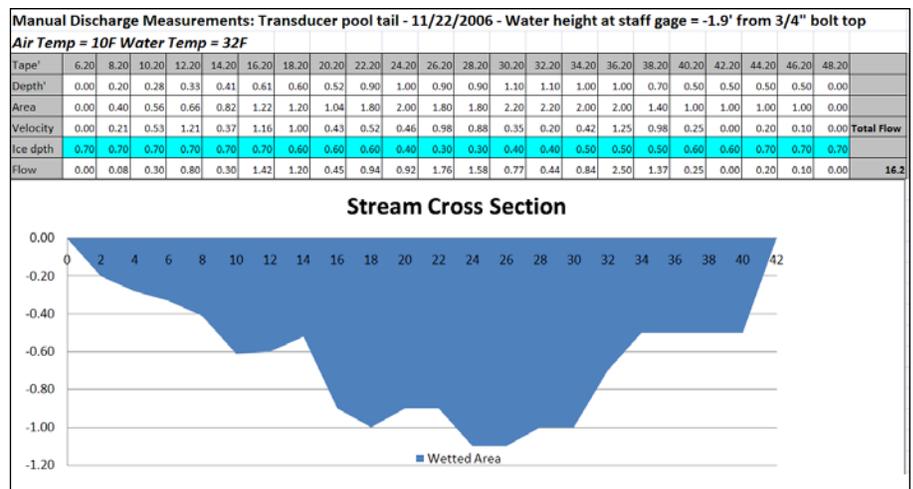
Example data from manual discharge measurements.

Manual discharge measurements will be conducted on a weekly basis until the transducer has been reinstalled. Roadwork near the transducer has been ongoing through November and has prohibited a timely reinstallation. We hope to have the instrument reinstalled by December. Once the transducer has been reinstalled, manual discharge measurements will be conducted once per month to improve the quality of the staff gage tables, and during cold and icy conditions for the frazzle ice model.
