# PLATINUM HEALTH CLINIC

## Alaska Rural Primary Care Facility Code and Condition Survey

April 23, 2003

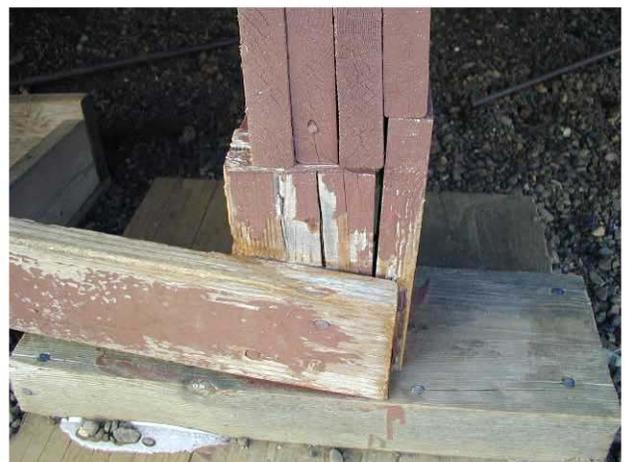
- a. Foundations  
The foundation is post and pad over gravel pad and is in poor structural condition. Posts have settled, walls are racked, and the building has floor level deviation and has substantial cracking on the interior. There not adequate hold down strapping and the bracing is loose or missing. In general the foundation needs substantial upgrade to new useful life or replacement.
- b. Walls and Roof:  
The walls and roof seem in relatively stable and adequate condition and do not meet code.
- c. Stairs, Landings, and Ramps  
These elements are in poor condition and in need of replacement with signs of rotting and deterioration of structural elements.

Foundation Failure

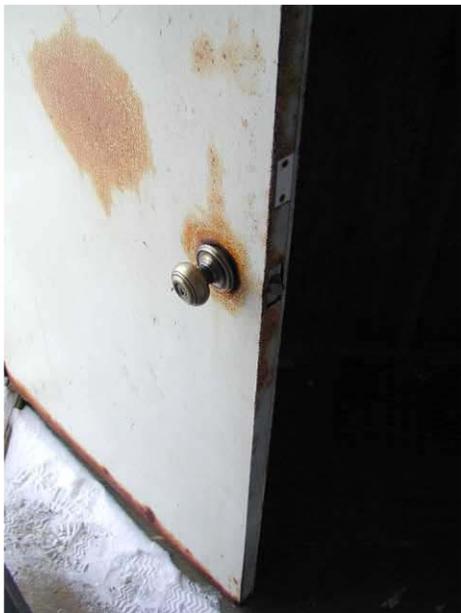
Entry Door

The exterior doors are residential metal and very deteriorated. They are in very poor shape and need replacement.

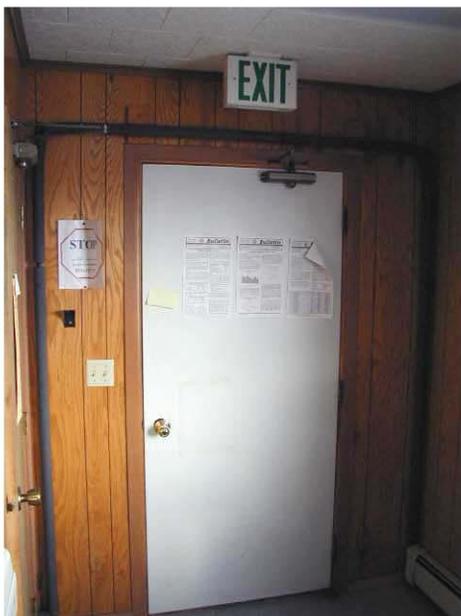
Waiting Room/ Entry

The front door of the clinic is through a non-compliant, unheated, vestibule, which is inadequate to defer the heat loss. There is no ADA access or proper gurney access. The exam rooms are cold every time the door is opened and the cold air migrates into the clinic where patients are being attended.

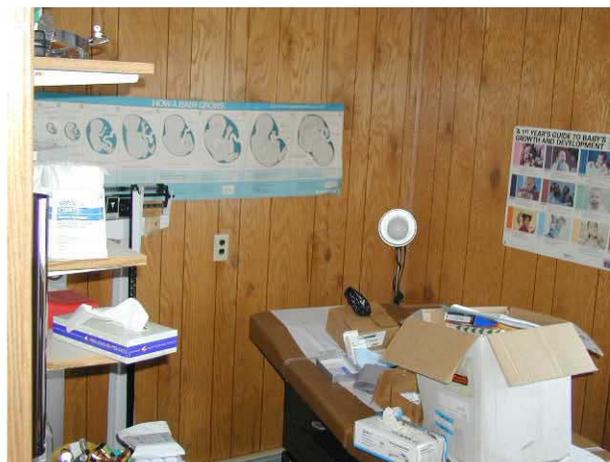
Exam Room

- d. Office / Exam – There is one exam room, which is crowded with equipment. There was no capability of putting a patient in a gurney in the exam rooms. There is no working sink in the room and therefore sanitation for patients was an issue. Privacy was very difficult. Note that electrical service is completely inadequate for the needs of the equipment.
