STEBBINS HEALTH CLINIC

Alaska Rural Primary Care Facility Assessment and Inventory Survey

Final
August 8, 2001

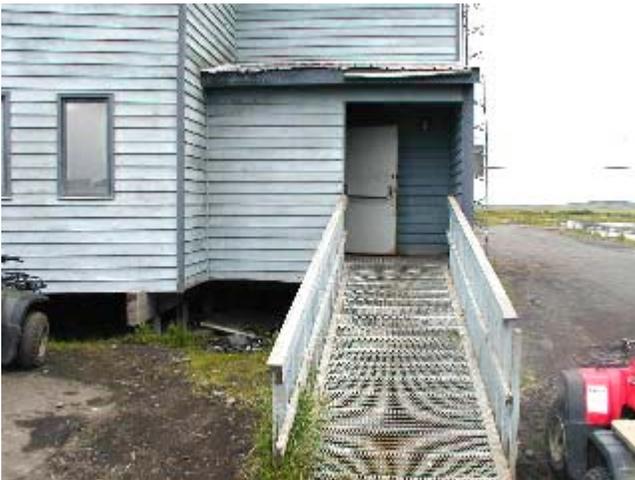
Front entry ramp, no stairs

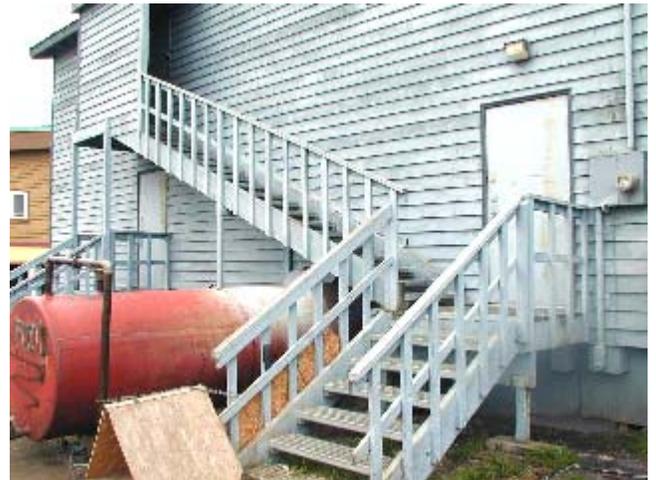
Rear steps

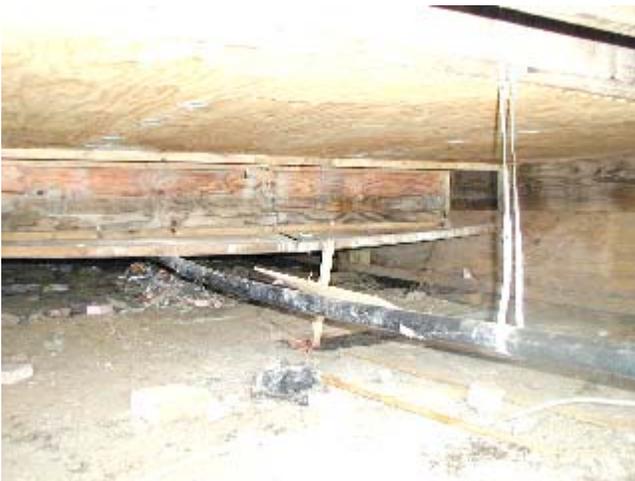
Foundation System

The foundation is beams and joists over post and pad floor system. The system seems adequate, however, it needs re-leveling and upgrading to keep the building from deteriorating further.

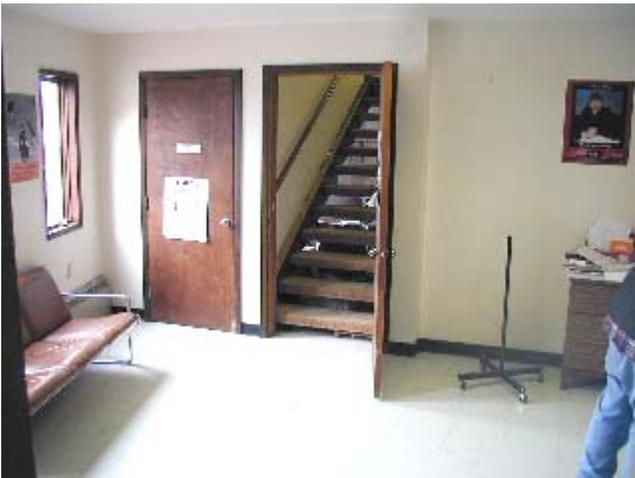
Main waiting room, stairs up, storage behind

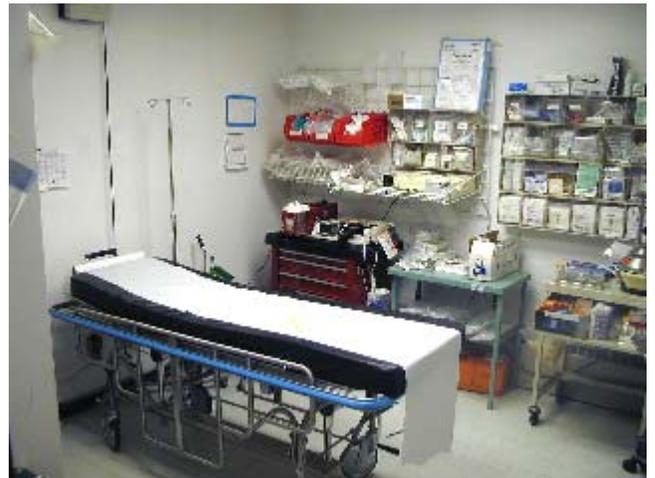
Trauma/exam, very small

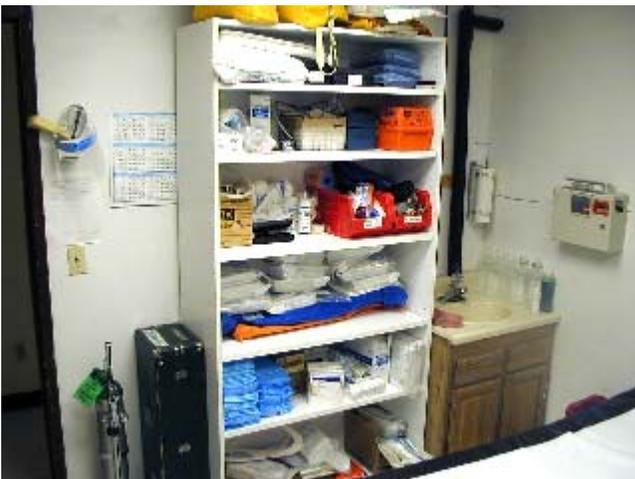
Trauma/exam room

- c. Exam / Trauma – There is one exam/trauma room available. The room is sized inadequately, is the first exam room but very difficult to access due to sharp corners. Additionally there is not door width for gurney access. The room is full of other clinic equipment and storage items. Privacy is an issue with hollow core doors.

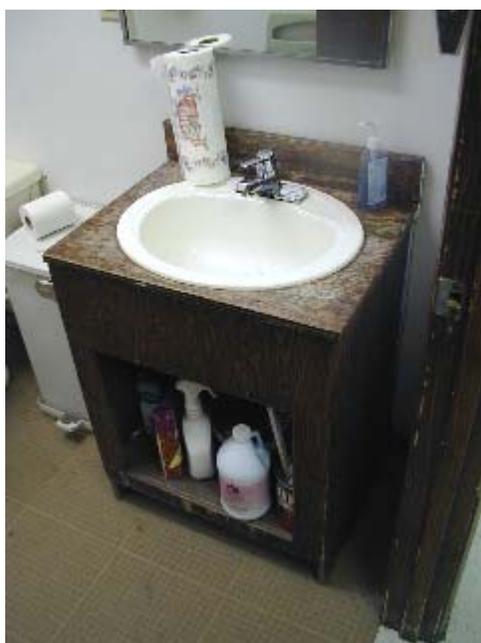
Toilet / Bath Sink, plywood

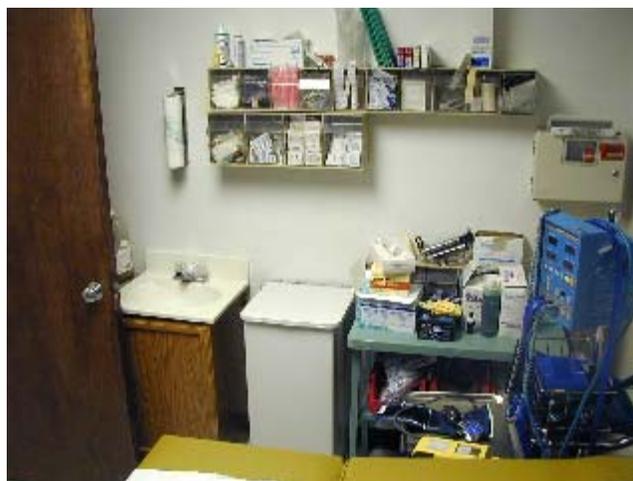
Exam Room 3

- d. Exam room – There is two smaller exam rooms, and one even smaller exam room with inadequate space for normal operation. Like the trauma room the exam room has considerable additional storage of items due to the lack of storage in the facility. Additionally, the sinks are not to code and sanitary conditions. One has a plywood cabinet, and none have ADA access. Sanitary concerns are also major in the floor, wall and ceiling materials in these rooms.

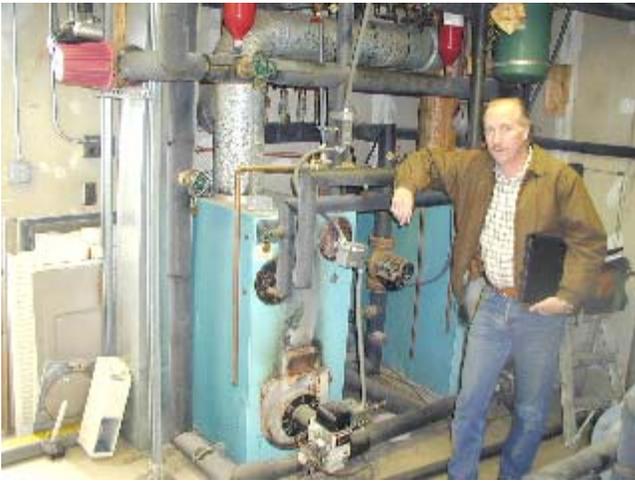
Boiler Room

Two commercial grade, oil-fired boilers provide heating for the clinic and the attached washeteria. The boilers are in good shape with all controls and systems needed to meet the needs of the clinic and washeteria. There is one inadequately sized combustion air opening for the boiler. There are no additional heaters in the clinic to assist with heating.
