TETLIN HEALTH CLINIC

Alaska Rural Primary Care Facility Code and Condition Survey

April 23, 2003

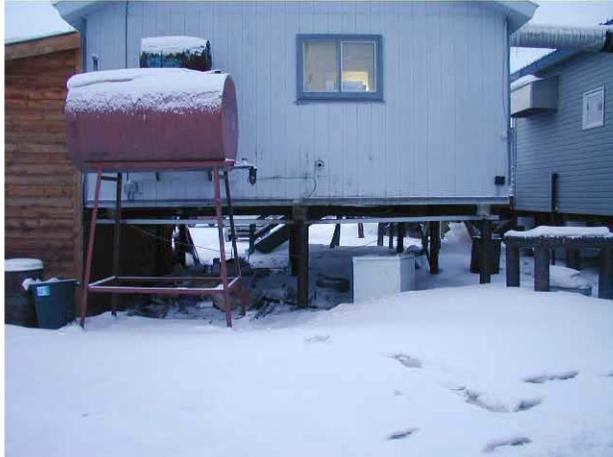
Foundation

- a. Foundations
The foundation is piling and metal frame and is in poor structural condition with some jacking of piling, probably due to inadequate depth of penetration into permafrost and deep active layer. Floors have settled, walls are racked, and the building has floor level deviation and has substantial cracking on the interior. There not adequate hold down strapping and the bracing is loose or missing. In general the foundation needs substantial upgrade to new useful life or replacement.
- b. Walls and Roof:
The walls and roof are adequate but should be upgraded to meet current codes. The roof system with no ventilation is prone to failure in the long term.
- c. Stairs, Landings, and Ramps
These elements are in poor condition and need of replacement with signs of rotting and deterioration of structural elements.

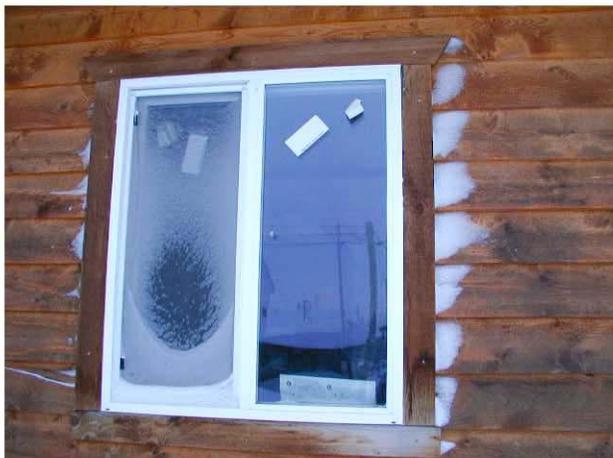
- d. Exterior Doors:
The exterior doors are residential metal and in poor shape and will not withstand the use required. They need replacement.
 - e. Exterior Windows:
Windows are thermo-pane windows; and need replacement due to age and deterioration.

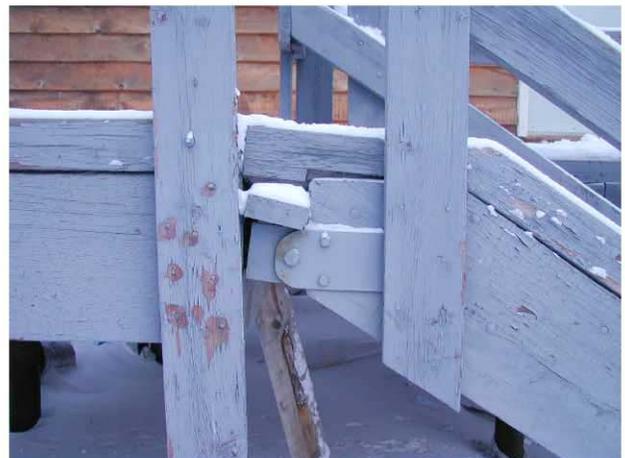
Exterior Stairs

- f. Exterior Decks, Stairs, and Ramps
There is only one entry on the front. It is 5 ft in elevated and the decks, stairs are deteriorating. There are also threshold problems that need corrections to allow for full ADA access. All new ramps, stairs, decks, and railings are required to meet code.

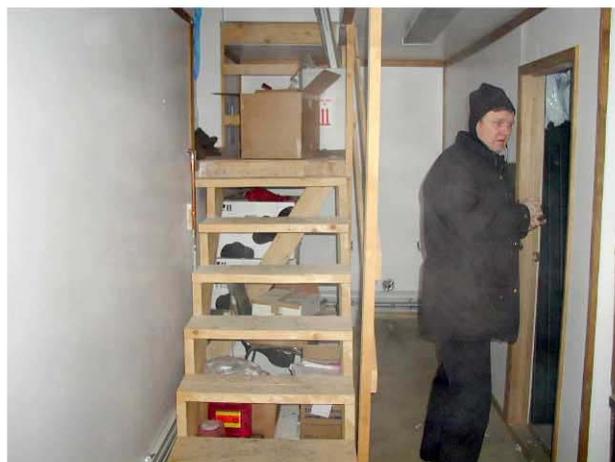
Addition Area Unheated

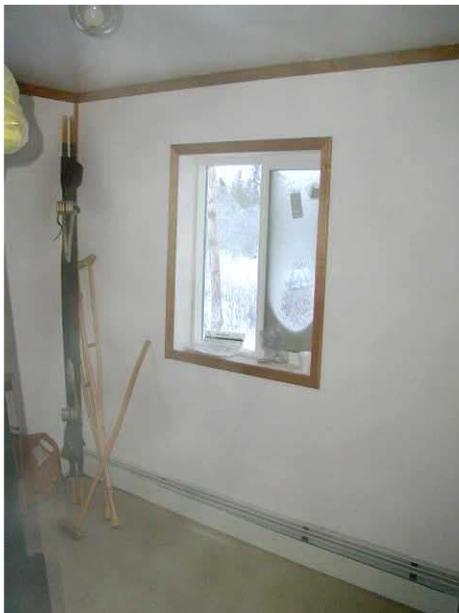
Addition Unheated

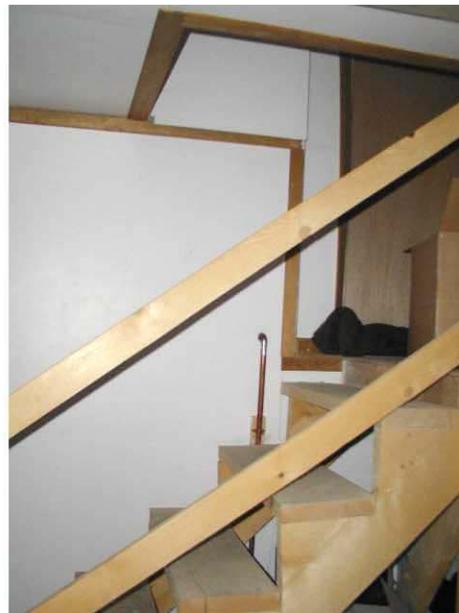
Stairs Not to Code

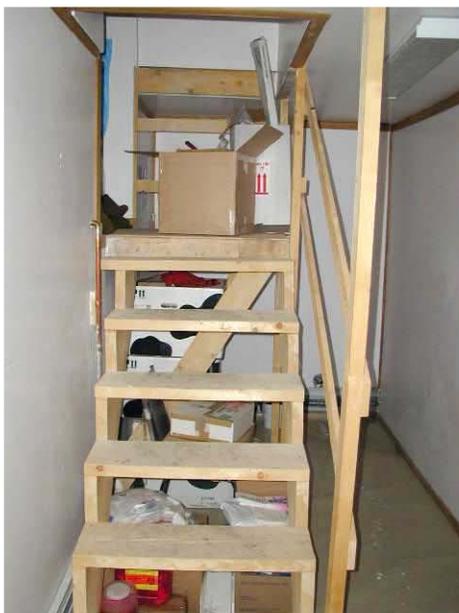
Stairs Not to Code

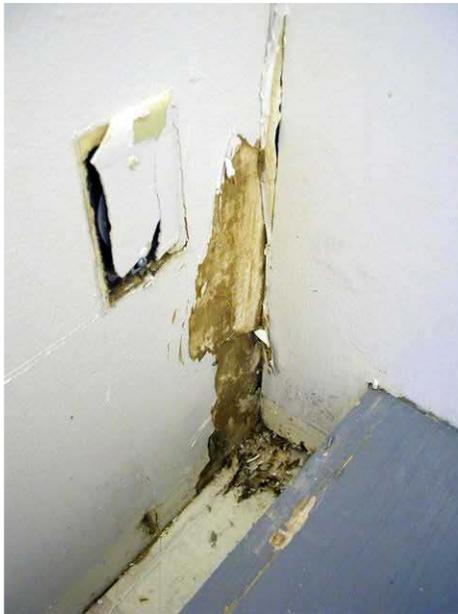
Rotting of Walls

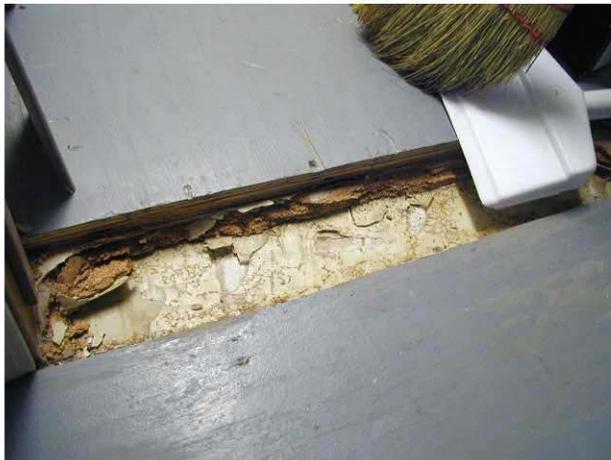
2. Interior Construction:
- a. Flooring:
The flooring is sheet vinyl over particle board. It has been replaced once and is in very poor shape. It is older, worn and patched and needs complete replacement for clean ability and infection control issue.

Floor Deterioration
