Yukon River Report

Visit to Eagle, AK

Time of visit September 10-14, 2007

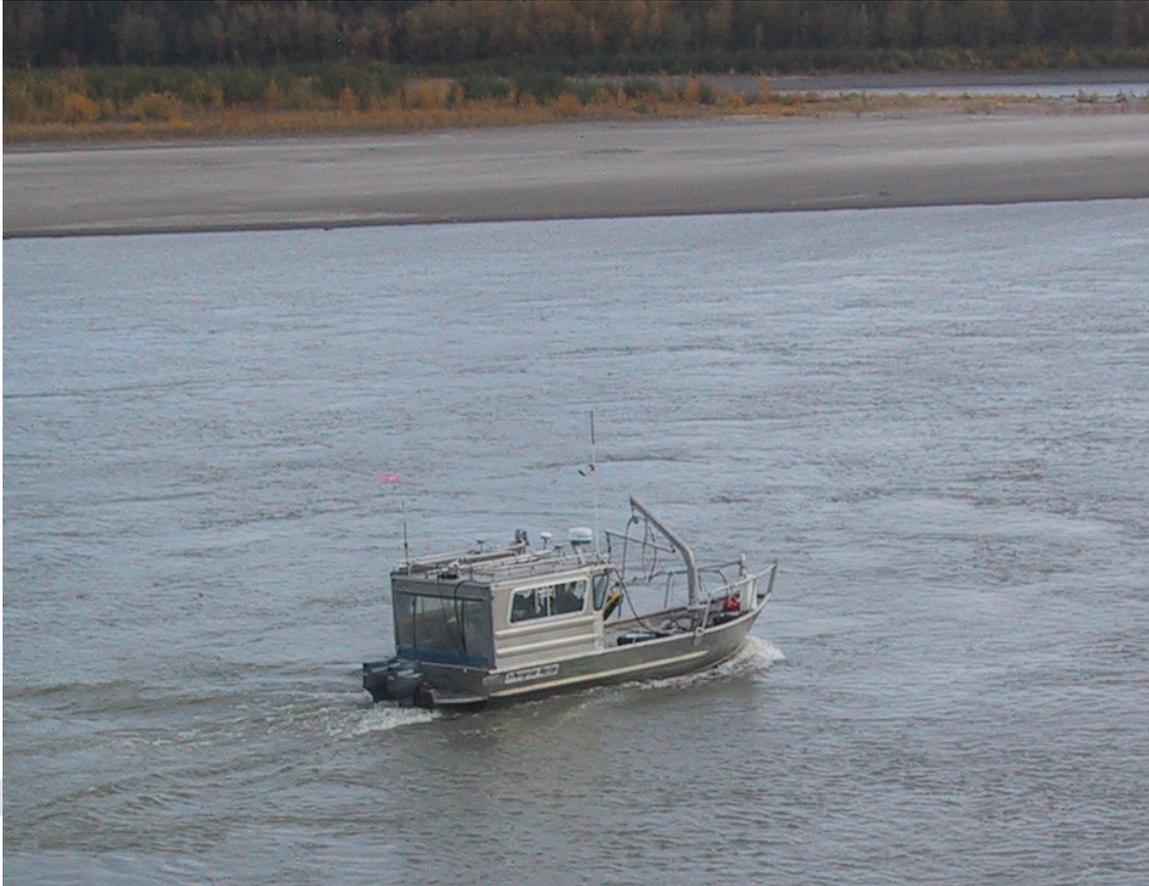
Photo 1 - TerraSond survey boat in river channel in front of Eagle

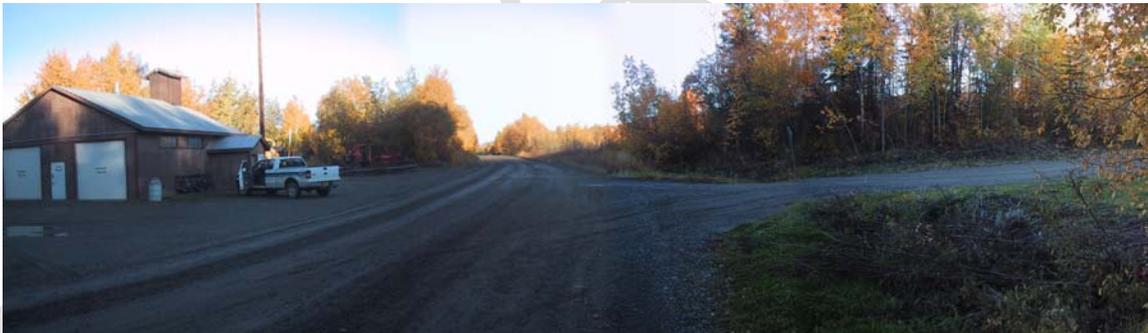
Photo 2 - Station would be located on the undeveloped property in the upper right corner of the picture. The building to the left is the city Fire Hall.

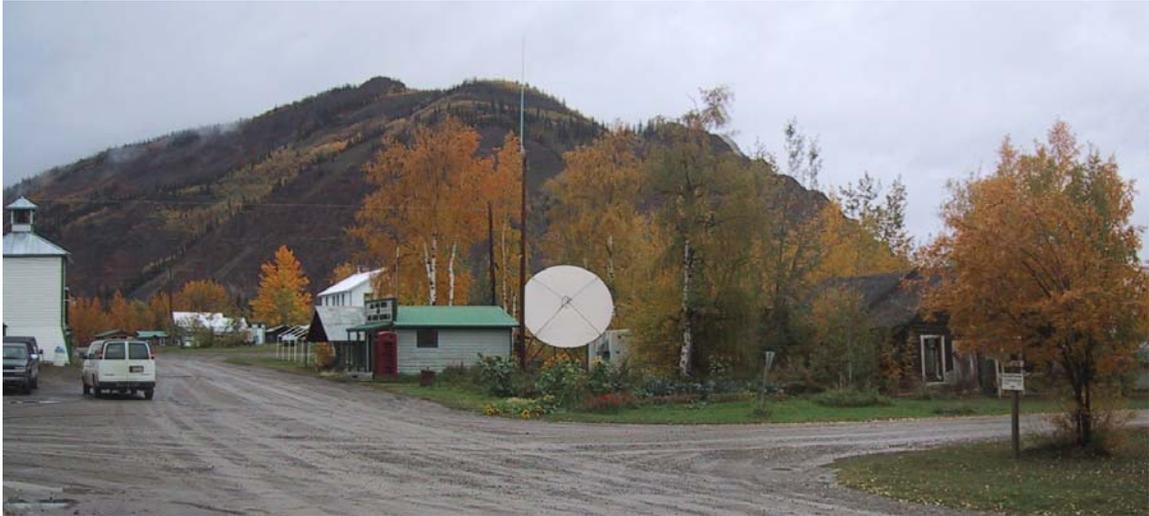
Photo 3 – View looking north up First Avenue, station would be on property in upper right hand corner of picture located behind the AP&T office [green roof] or next to the dish antenna, there is an alley on the far side of the AP&T office building

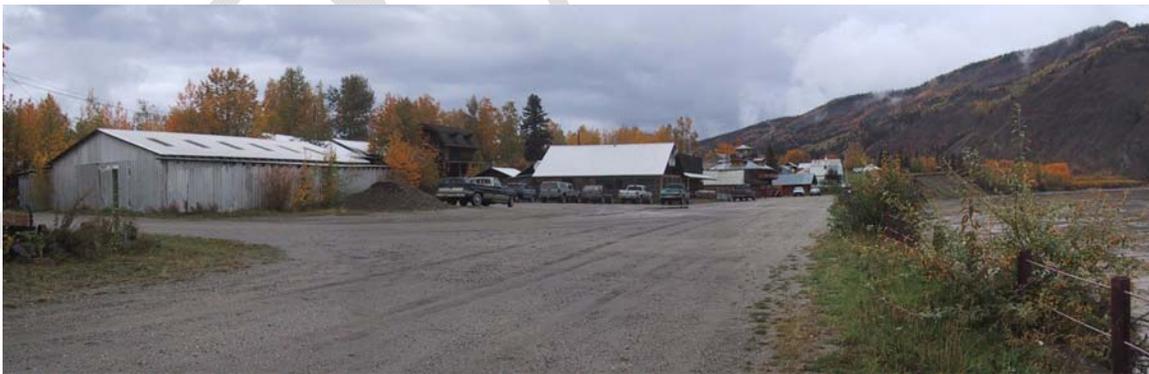
Photo 4 – View looking north on Front Street, station would be located adjacent to metal building in upper left hand corner of picture, the river bulkhead is on the right side of the picture

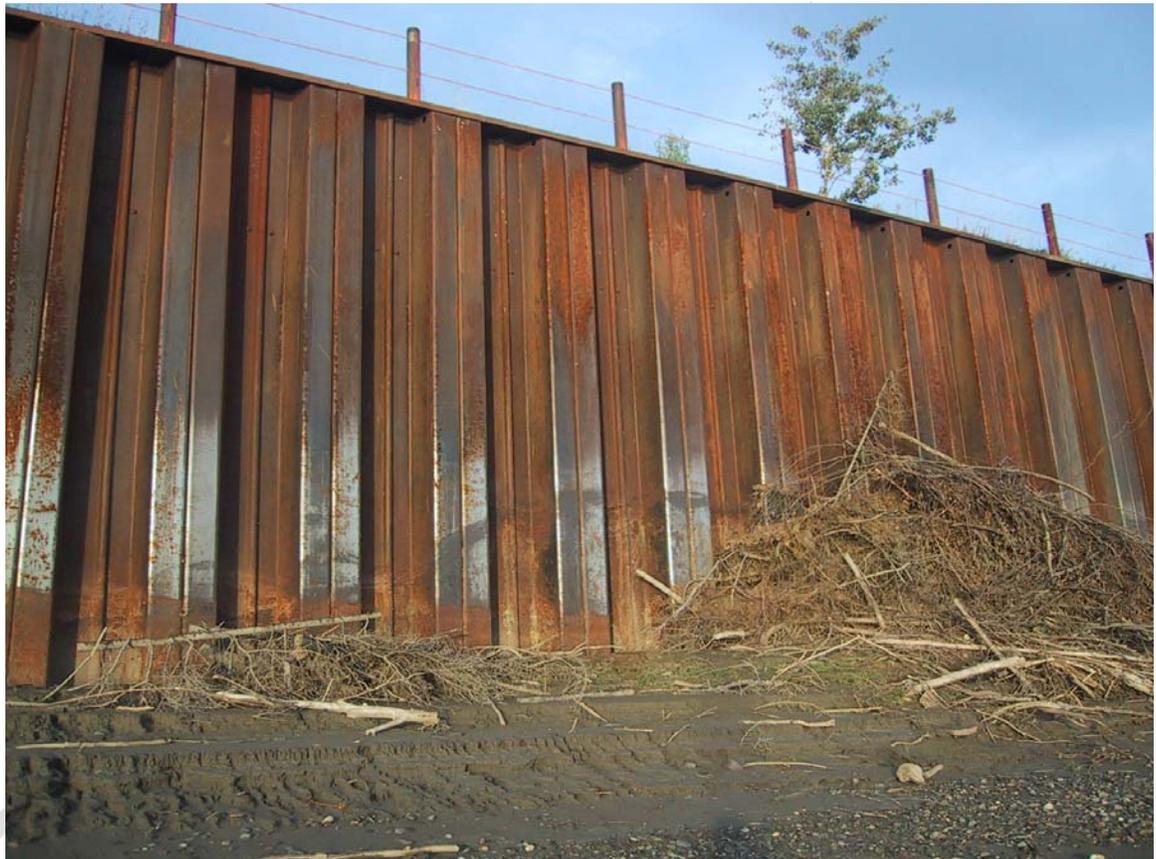
2.2.1.1. In front of town through the apex of the river bend there is a steel bulkhead that was built after the last major ice break-up/flood event that occurred in 1992 and caused severe erosion to the earth bank partially destroying the road in front of town. The bulkhead wall is built from 40' long interlocking Z section sheet piles driven roughly half their length.

Photo 5 - Steel bulkhead in front of town, brush is accumulation of debris dumped by residents.

2.2.1.2. A bulkhead conduit drop would include a traffic grade concrete vault installed below grade on the road side of the bulkhead, an opening would be cut through bulkhead for cables to pass through and cover plates installed to protect exposed the conduits. Conduits would be installed in the bulkhead depressions and would not protrude into the waterway.

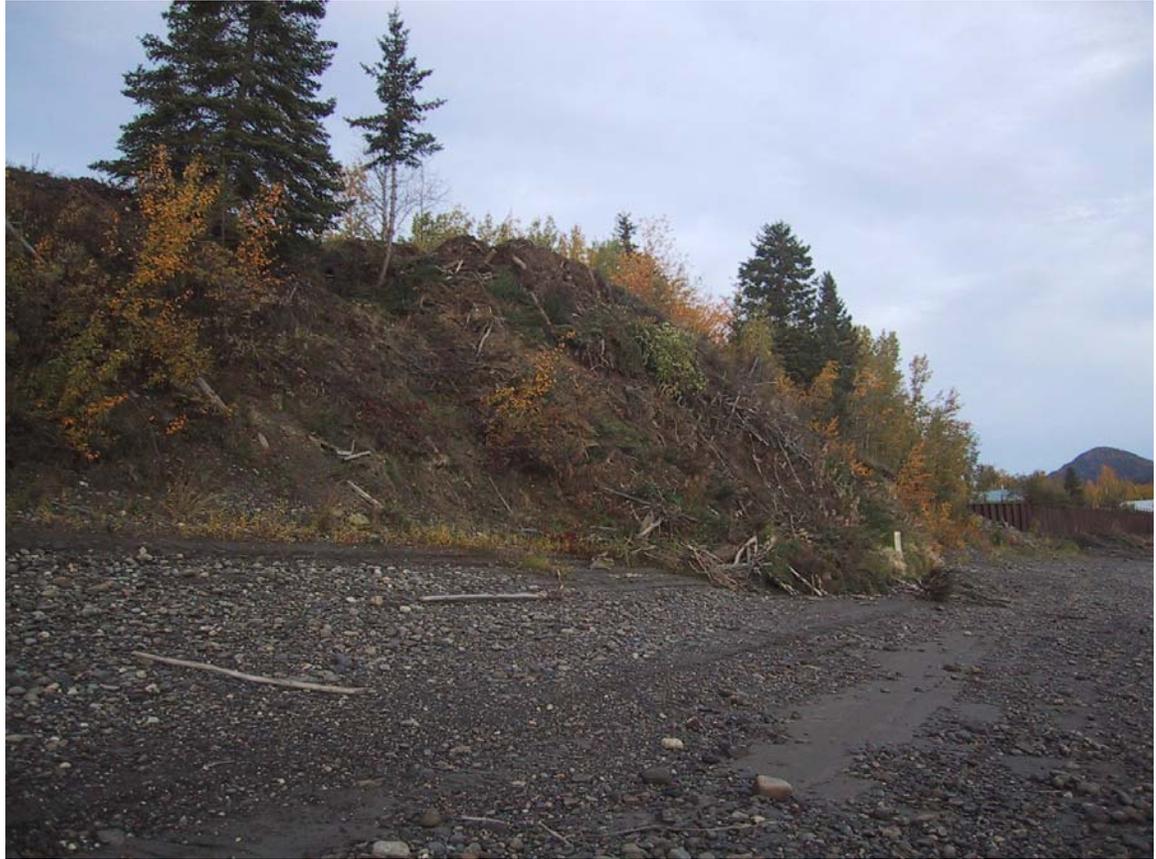
2.2.2.1. At the upstream end of the bulkhead the earth banks dips and then rises 15 to 20' above the top of the bulkhead. The end of Washington Street is located approximately 300' upstream from the bulkhead. The crest of the bank in this location is about 35 feet above the river beach. Presently the bank in this location is covered with three years accumulation of organic debris, dirt, brush, etc. creating a bulge about 40 feet wide and projecting 10 to 15 ' from the bank. The city allowed dumping here to keep the residents from dumping brush over the

bulkhead wall. In the eventual high water event this debris should be dragged downstream.

Photo 6 - Bank at foot of Washington Avenue, with debris accumulation from dumping by residents over the last three years.

2.2.2.2. Bank conduit drop will be accomplished with through a vertical or steeply inclined hole drilled [using conventional well drilling equipment?] from road surface down 5 to 6 feet below toe elevation [~40 feet] the toe of the bank and will require that a tunnel [20-30' long] be excavated into the base of the bank. The bank soil composition will require that the tunnel be shored along its entire length using culvert or pipe.
