CONSTRUCTION INSPECTION REPORT

Project: Birch St. Rehabilitation				Report No: 33		
File No : 092027.03				Date: December 16, 2011		
Consultant: PND Engineers				Day of the Week: Friday		
Weather:						
	Bright Sun	Clear	Overcast X	Rain X	Snow X	Other
Temperature:						
	Below 0	0-32	32-50 X	50-70	70-85	Over 85
Wind:						
	Still X	Mod	High	Comments: rain/snow mix at times		
Humidity:						
	Dry	Mod	Humid X	Comments:		
Contractor Information						
Name of Contractor		Non-Manual		Manual		Remarks
McGraw's Custom Construction		1		4		Zach Williams-Superintendent
VISITORS						
Name		Title		Phone No.		Remarks

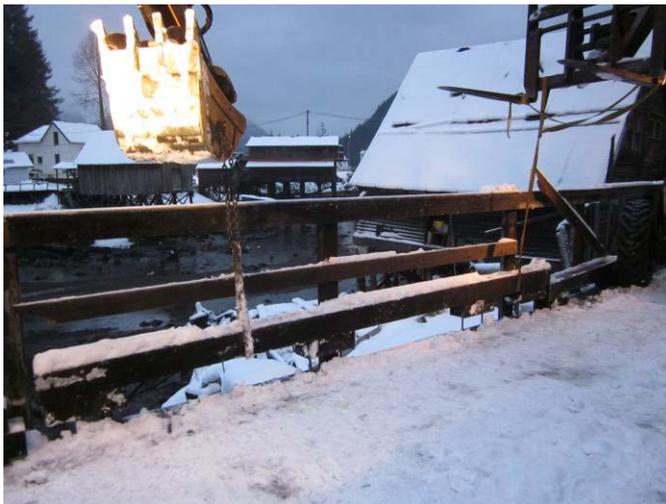
Excavator and IR reach forklift removed bullrail and scupper blocks. Note: Cloth straps were used so as to not damage the bullrail.

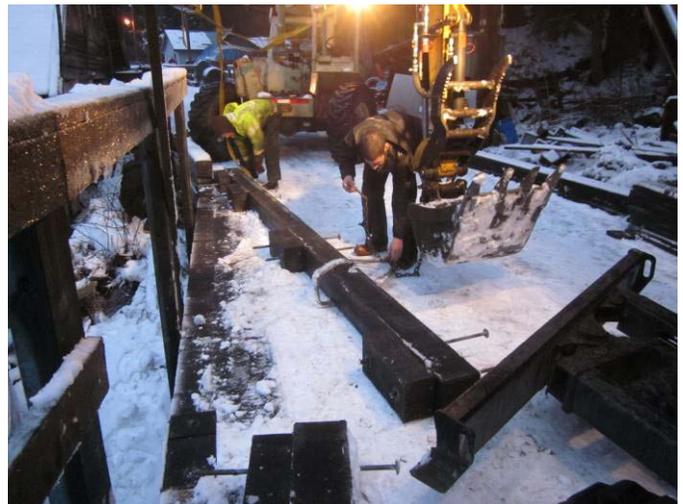
Excavator and IR reach forklift removed bullrail and scupper blocks. Note: cloth straps were used so as to not damage the bullrail.

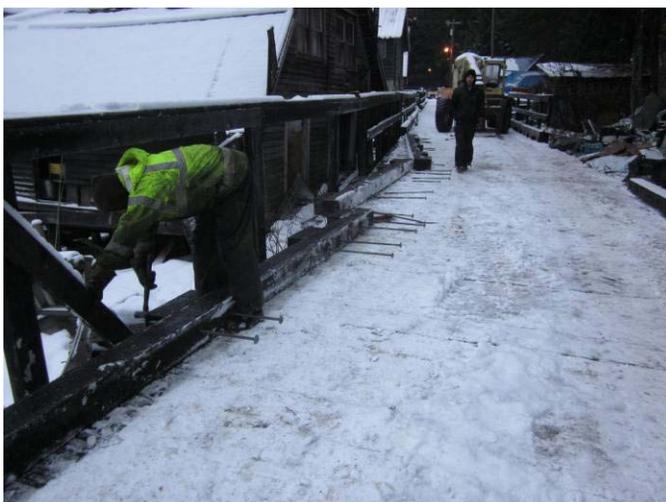
Workers removed bolts on bullrail.

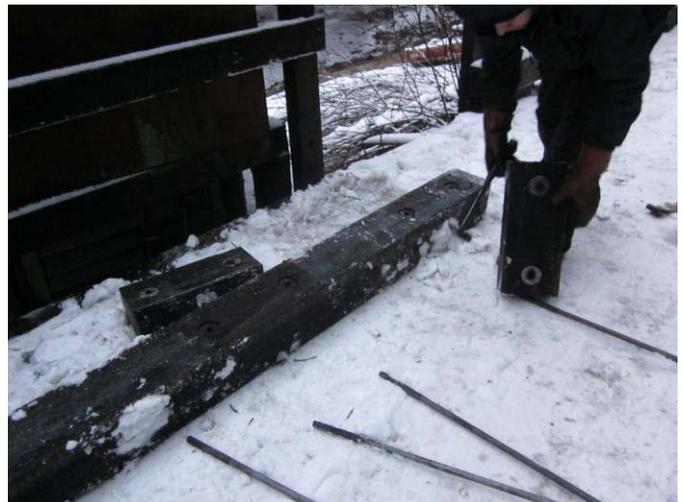
Workers removed scupper blocks that were toe nailed into bullrail.

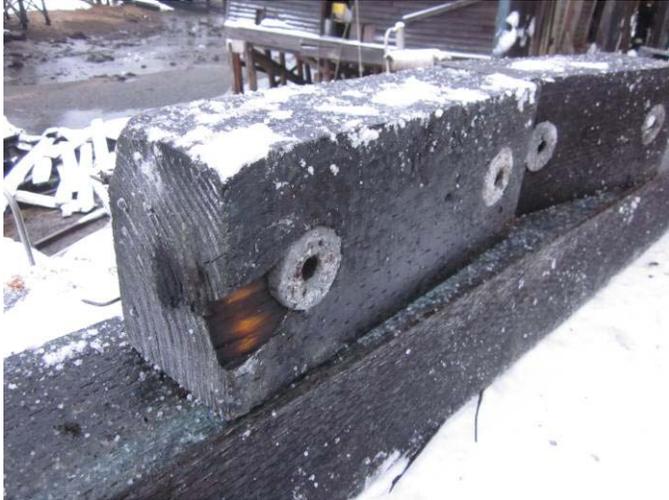
Damage on removed scupper block from mallet impact. Note: Scupper block was removed by mallet rather than pulling the toe nails. Notified Contractor of damage.

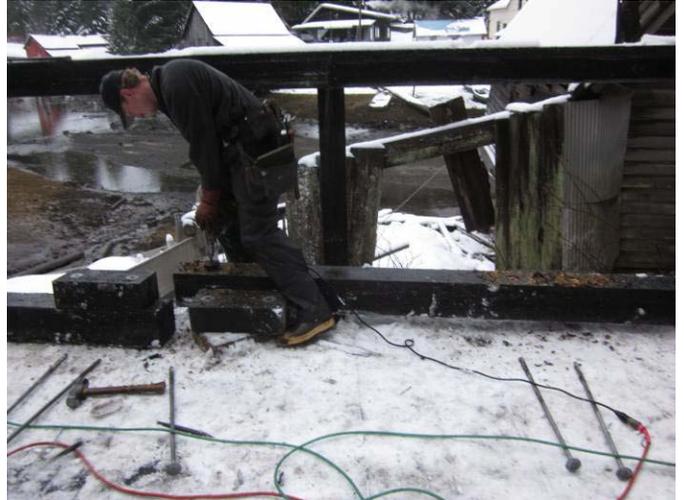
Drilling recesses into bullrail.

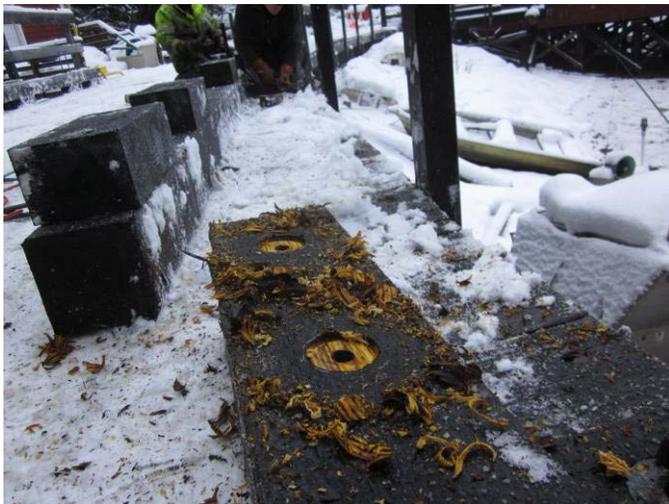
Drilling recesses into bullrail.

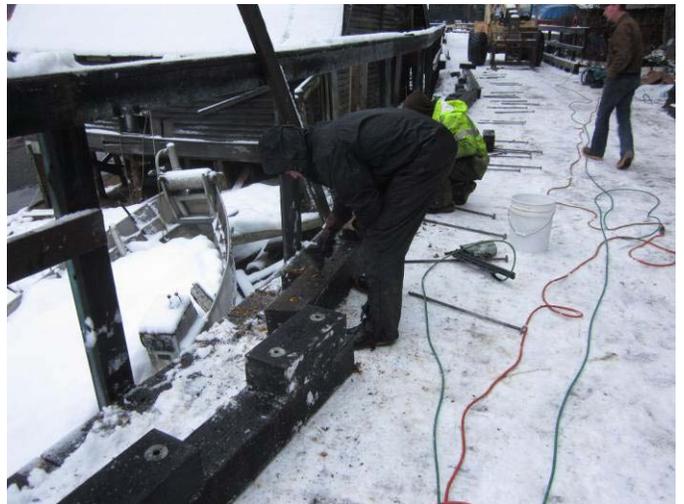
Recesses were treated with Bitumastic.

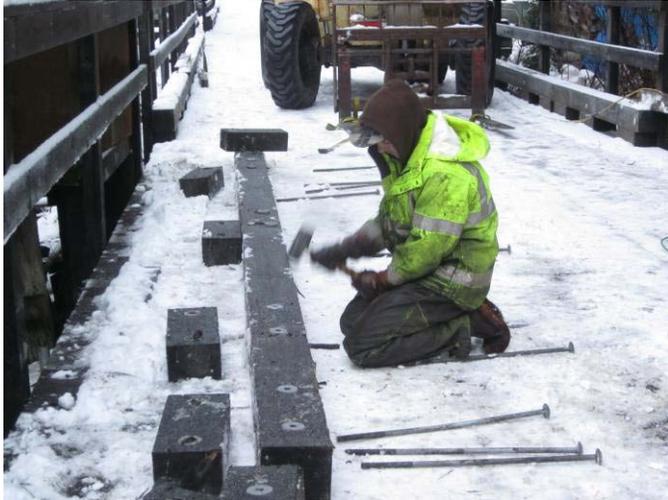
Shear plates were installed in bullrail.

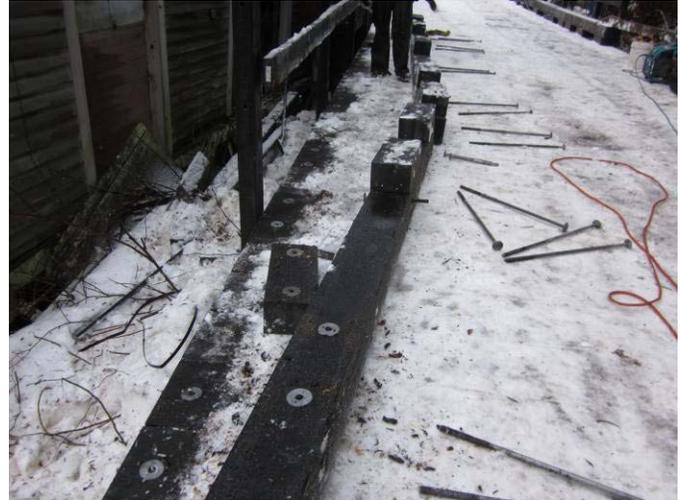
Shear plates were installed in bullrail and decking.

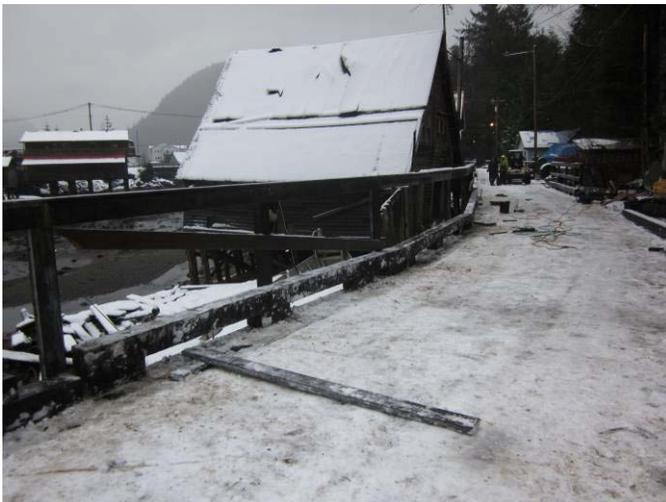
Section of bullrail reinstalled.

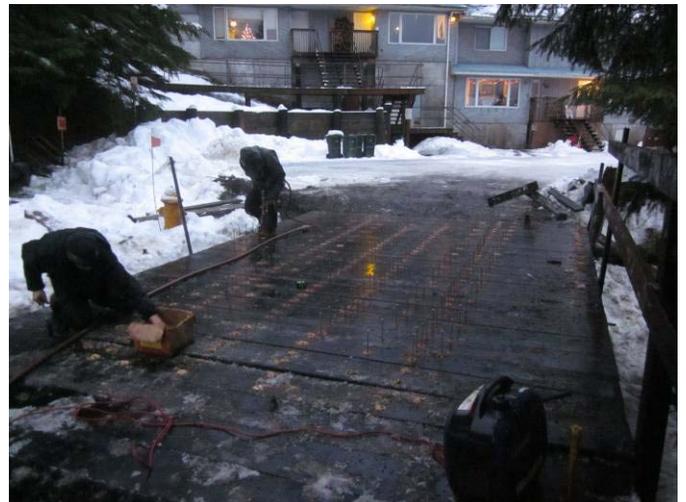
At end of Birch Street, decking was predrilled and treated and shank nails were installed.
