## Inspector's Field Report

**Project:** COMMUNITY HEALTHCARE FACILITY  
**Location:** Craig, Alaska  
**Contractor:** McGraw Custom Construction  
**Job Phone:** (907) 826-2582      **Job Fax:** (907) 826-2583  
**Project Manager** Chad McGraw - Cell: (907) 738-1410  
**Superintendent** Chris Blanc - Cell: (907) 401-0491  
**Inspector(s):**  
Gunther Erhmann: Phone (907) 826-2294  
Fax (907)225-3441, Cell: (206) 375-3562  
Mike McKimens: Phone/Fax (907) 826-3770  
Cell: (907) 401-0023

**Date(s):** Monday, June 22, 2009 to Friday, June 26, 2009

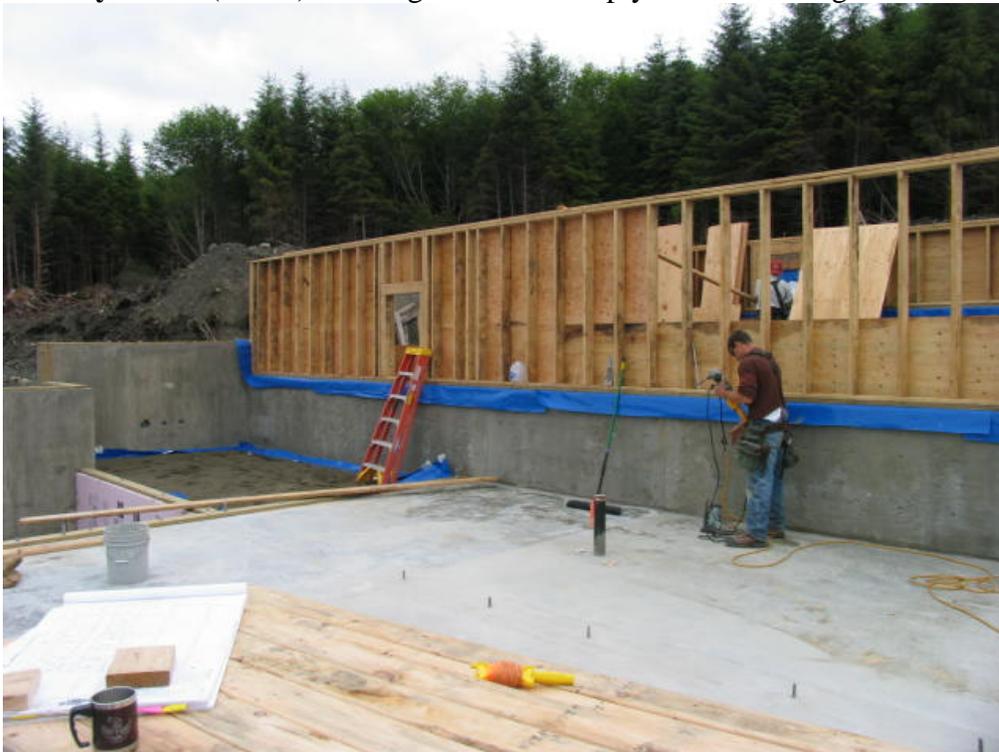
6/22/09 MCC, plywood sheathing - looking NE, E27'2

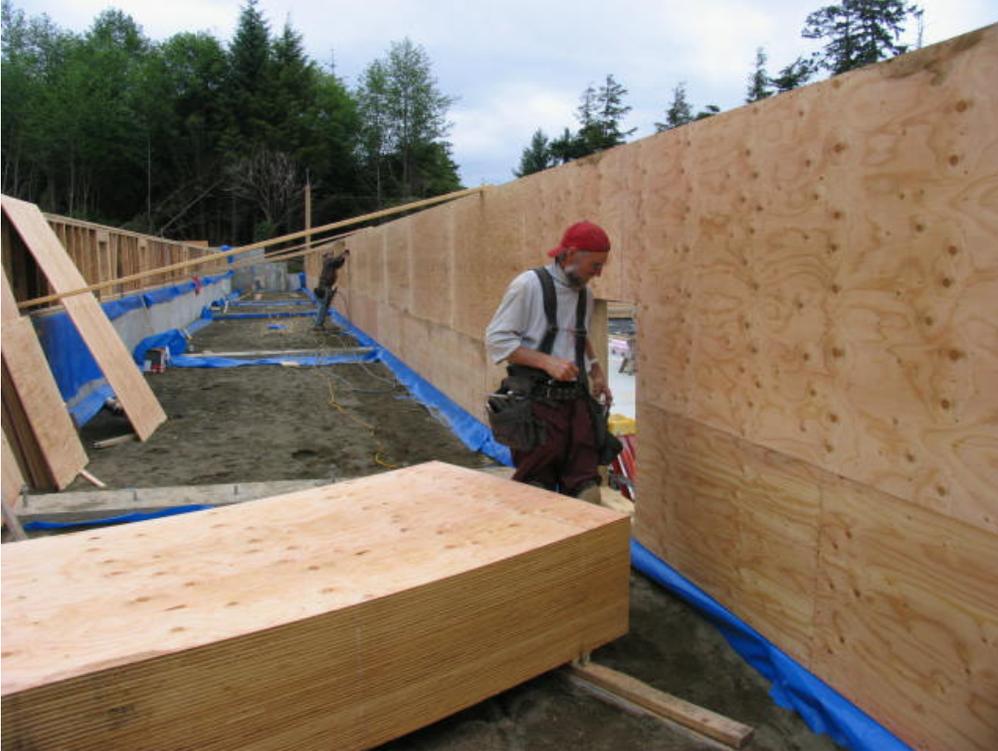
6/22/09 MCC, Tom M. and Tim M. plywood sheathing and bracing framed wall E27'2 - looking SW.

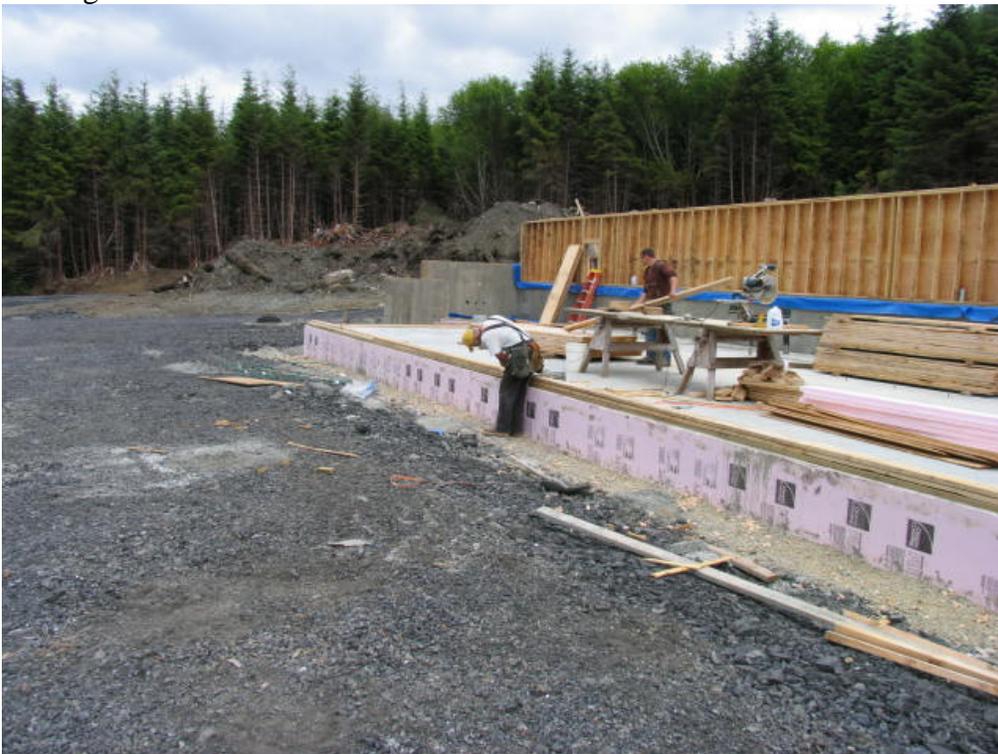
6/22/09 Chris B. started to mount 2x6 sill plates for exterior wall, E0'0 – looking NE

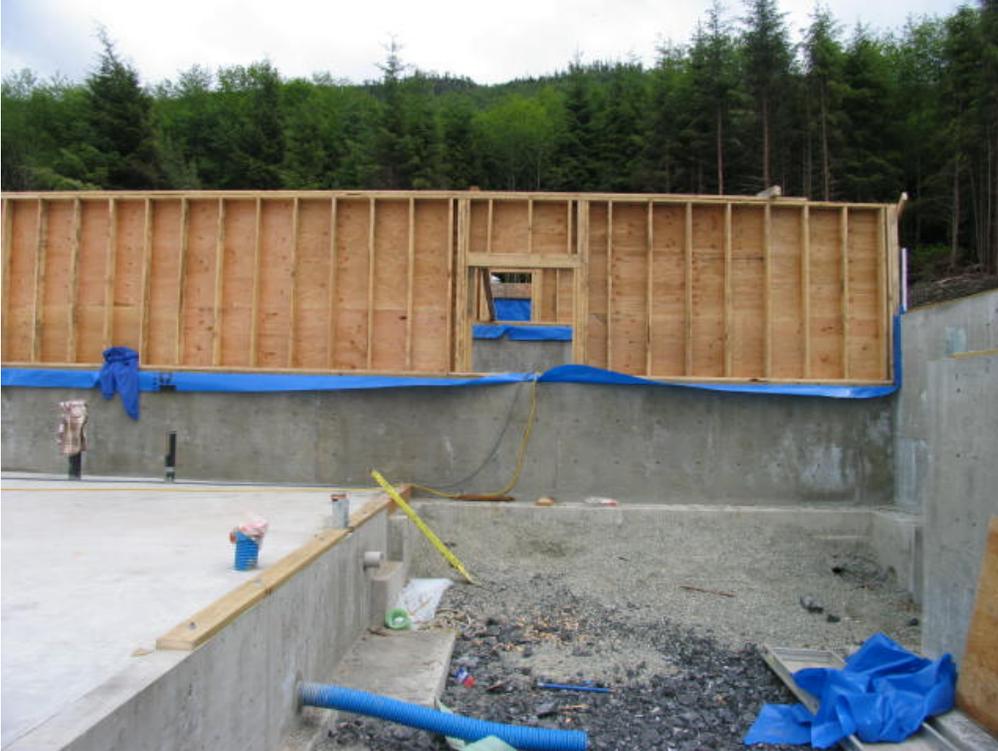
6/22/09 MCC, framed E27'2 with 36x36 crawl space access opening – looking East, between S135'0 and S151'8

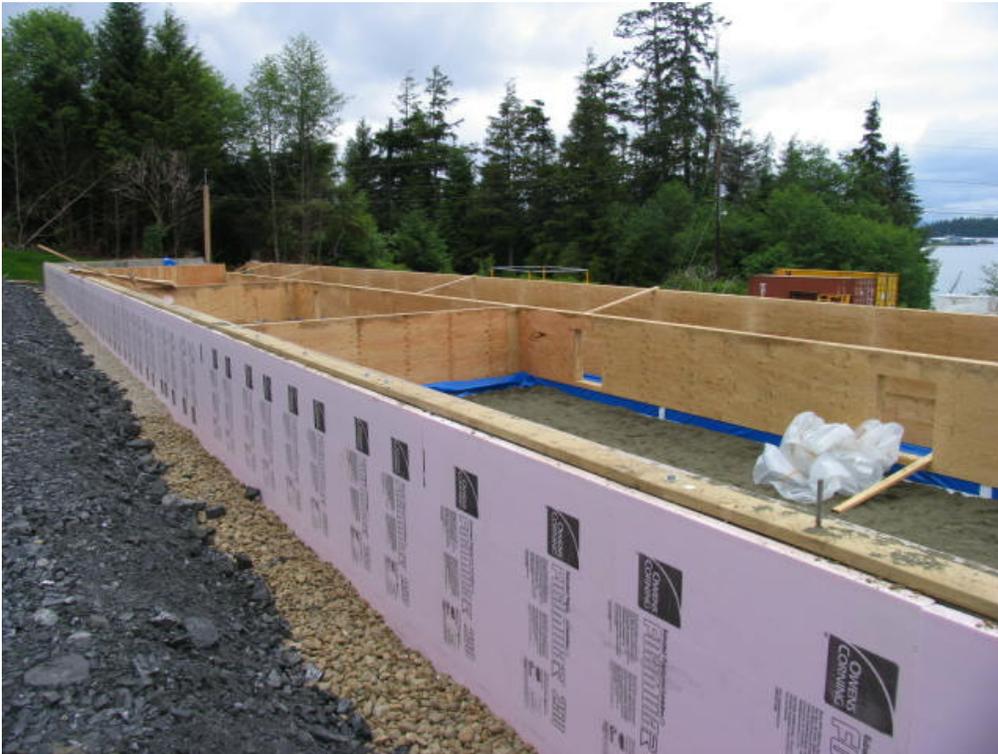
6/22/09 MCC, framed and sheathed crawl space walls – looking SW, from upper parking lot.

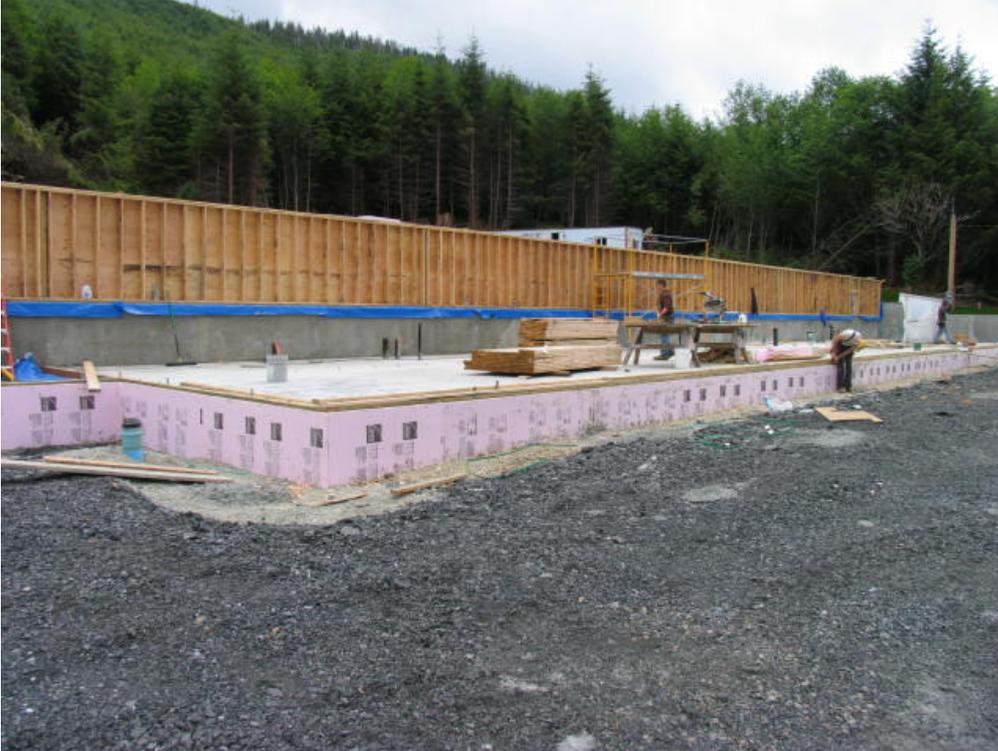
6/22/09 MCC, framed wall E27'2 – looking SE

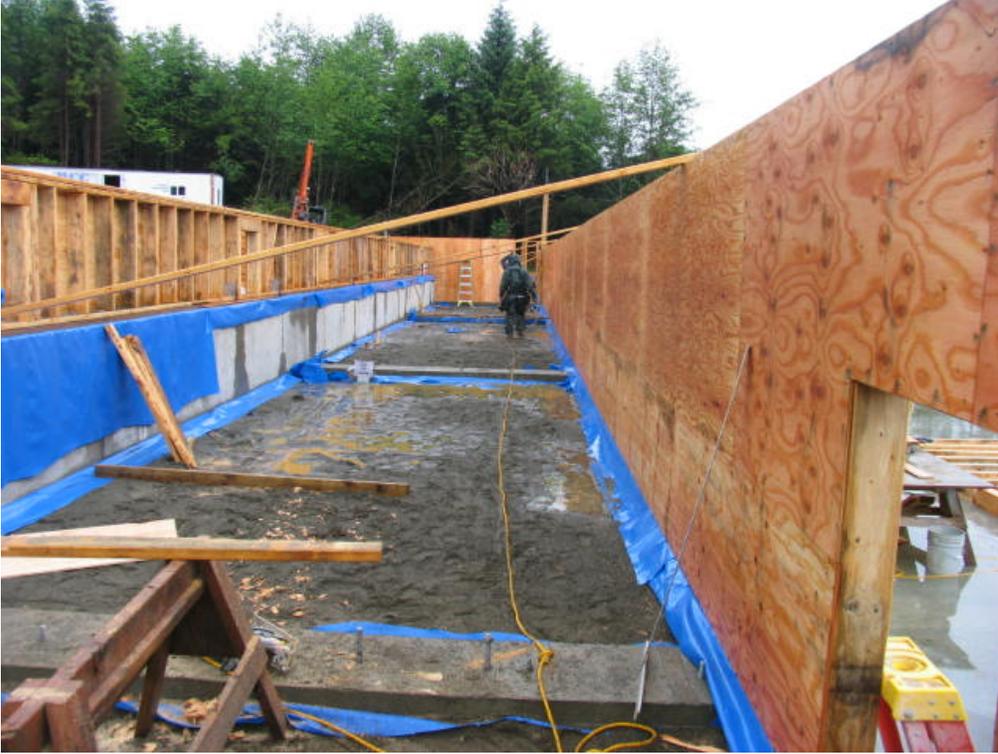
6/23/09 MCC, Framing shear walls, between E40'6 and E27'2 – looking South

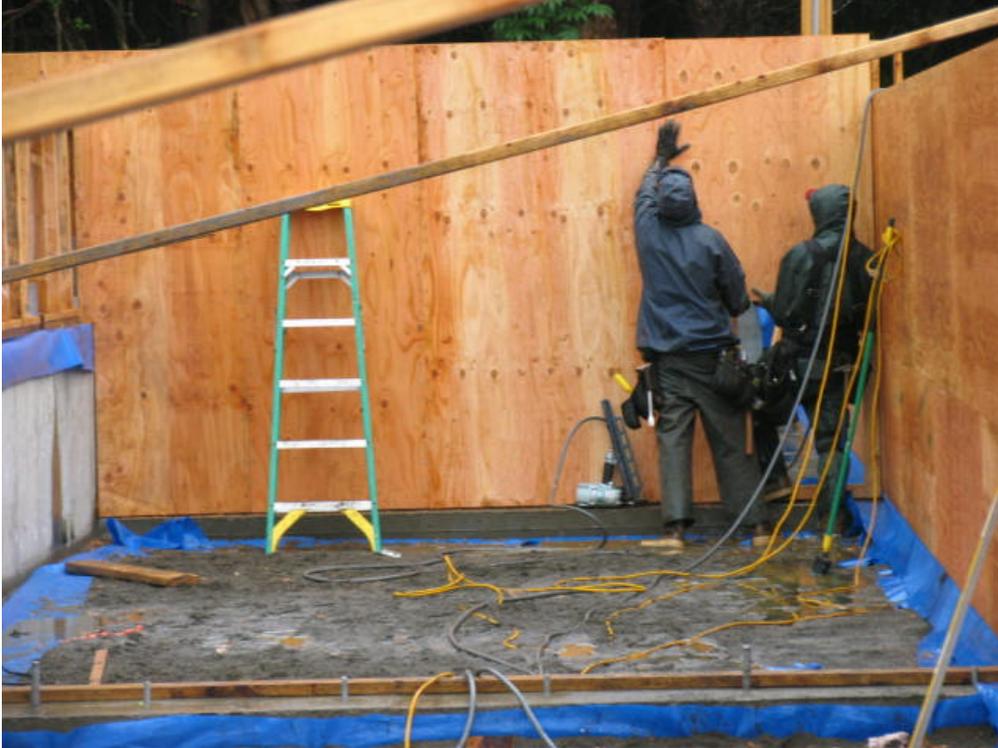
6/23/09 MCC, Tim M. and Tom M. are sheathing shear wall S108'8, between E40'6-  
E27'2 – looking South

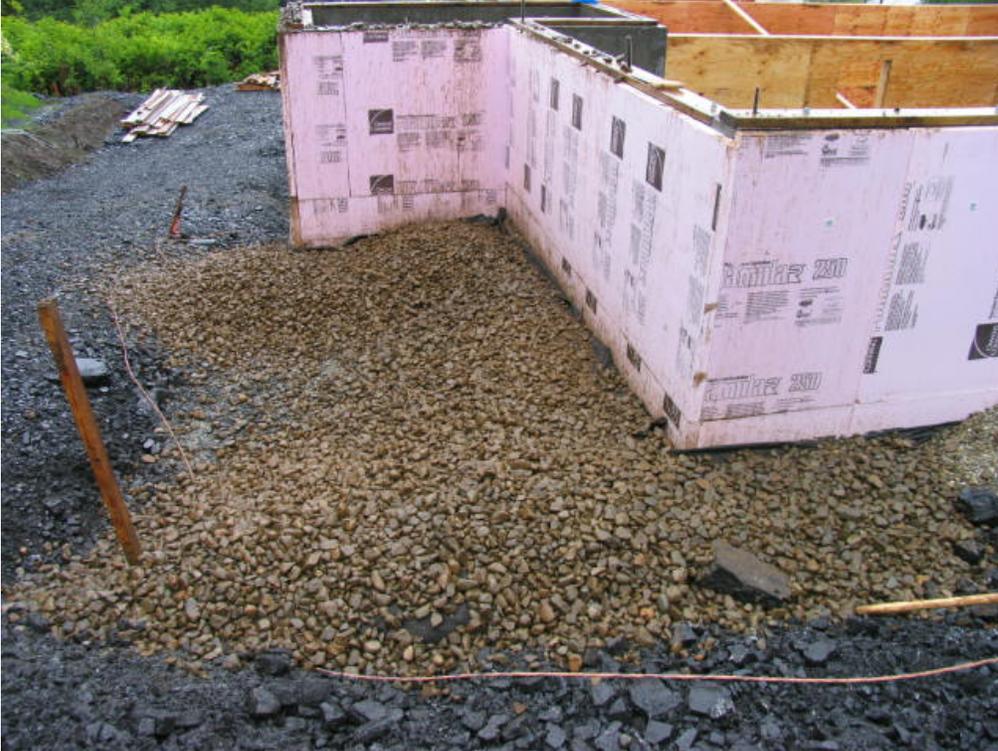
6/23/09 S&S laid out 6" drain pipe in drain rock and filter fabric, SE corner – looking NW, S151'8/E57'10

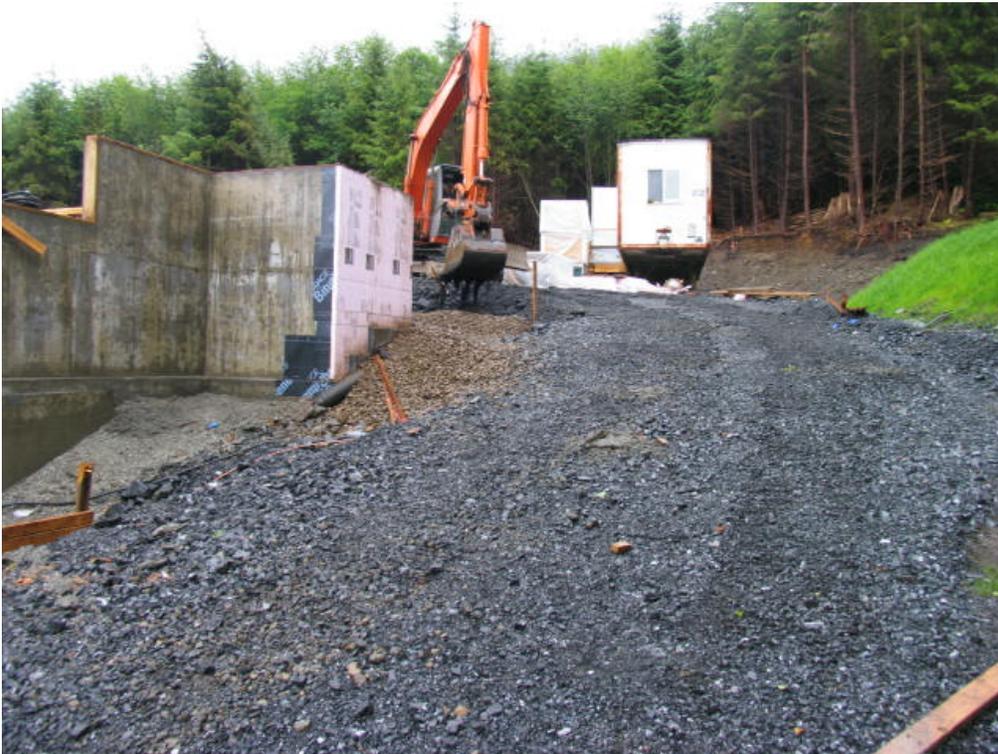
6/23/09 S&S, backfilling at SE, S151'8/E57'10 corner – looking East

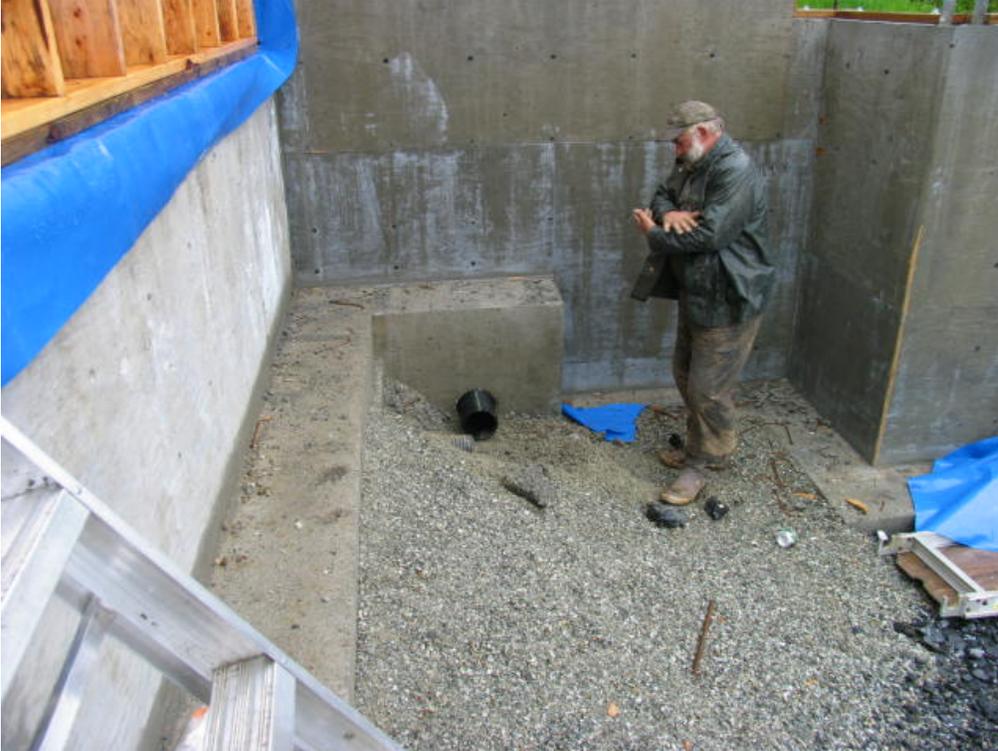
6/23/09 S&S, Doug M. is looking at the to be placed connector for exterior 6" drain pipe with interior 4" pipe S151'8/E27'2 – looking South

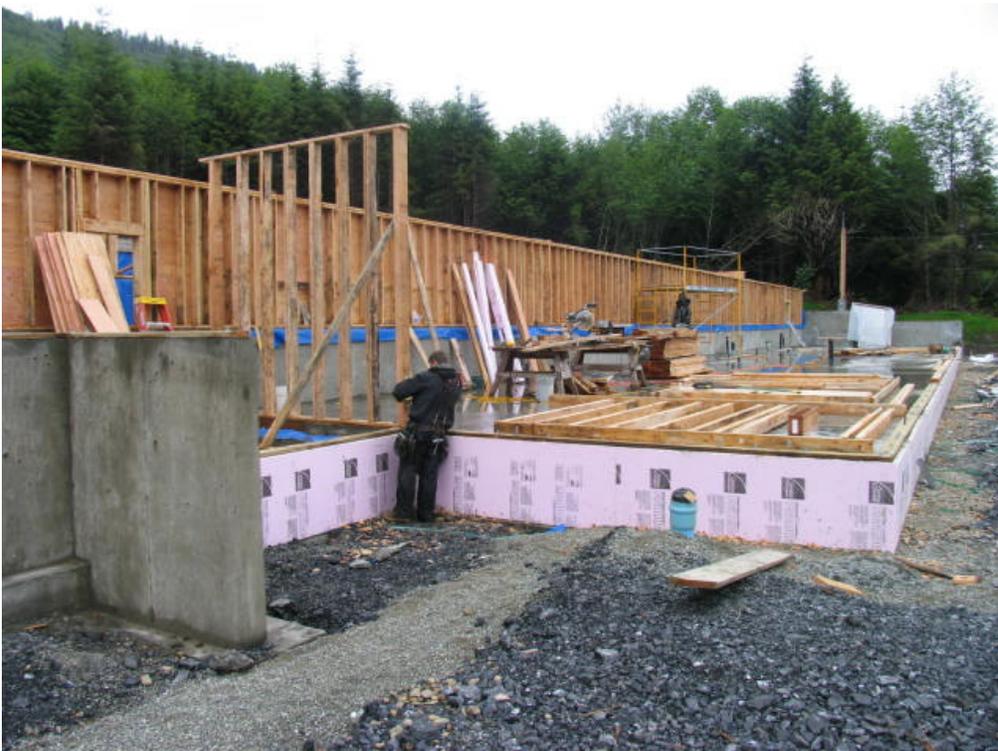
6/23/09 MCC, framing exterior 2x6 wall, S18'0 – looking SE from MH304

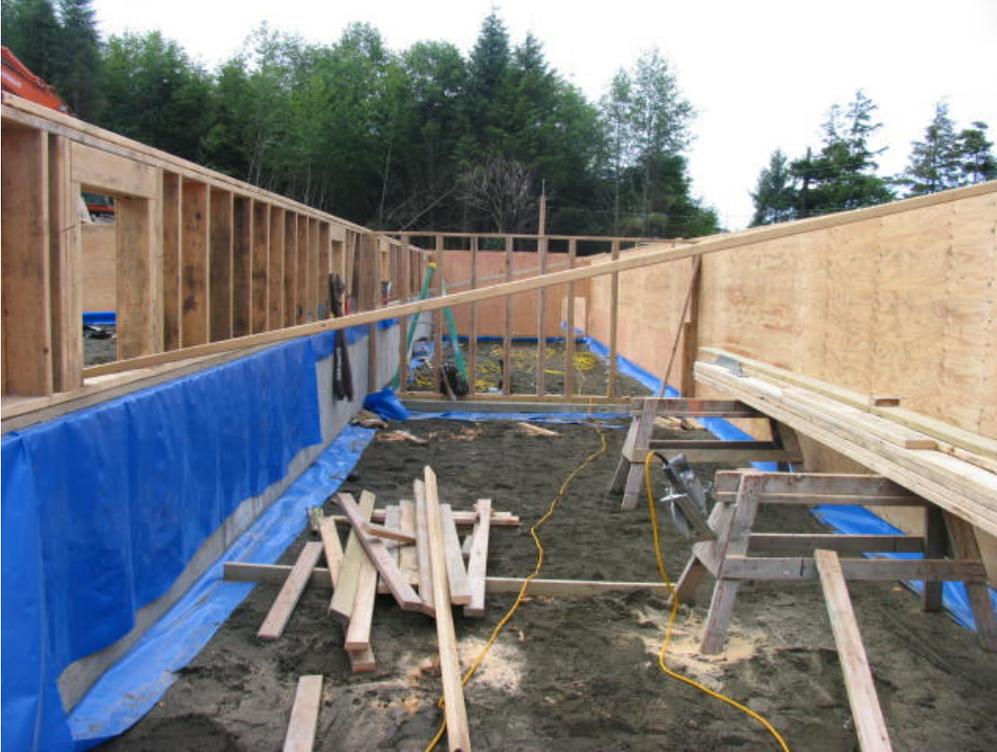
6/24/09 MCC, framing shear walls between E40'6-E27'2 – looking South

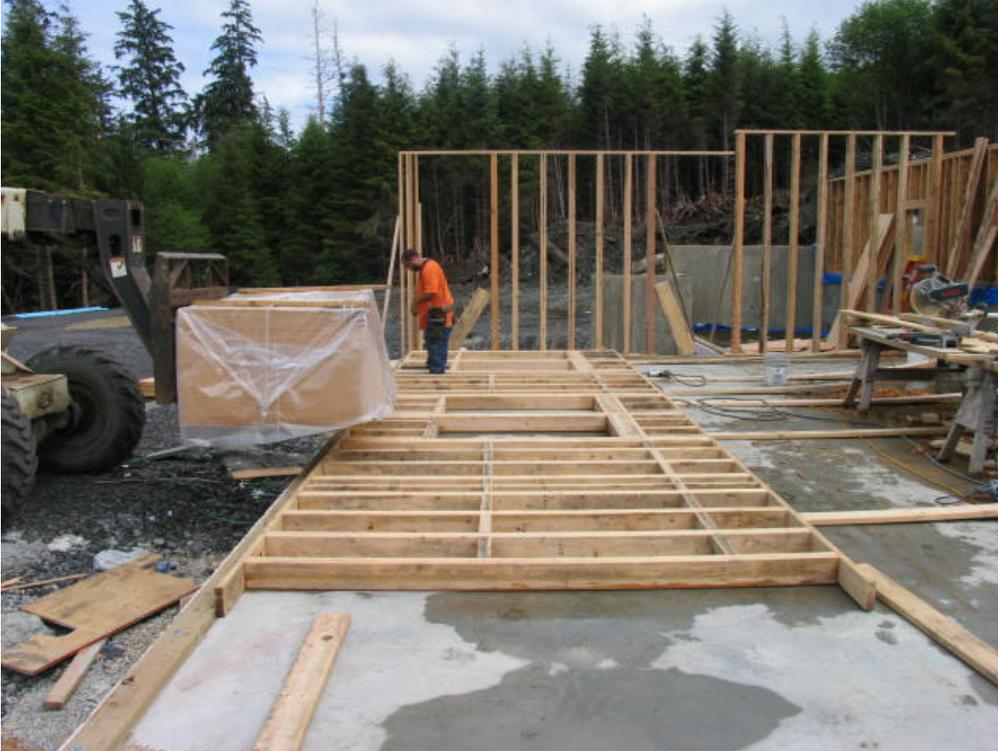
6/24/09 MCC, Chris S., framing exterior walls, S18'0 and E0'0 – looking North

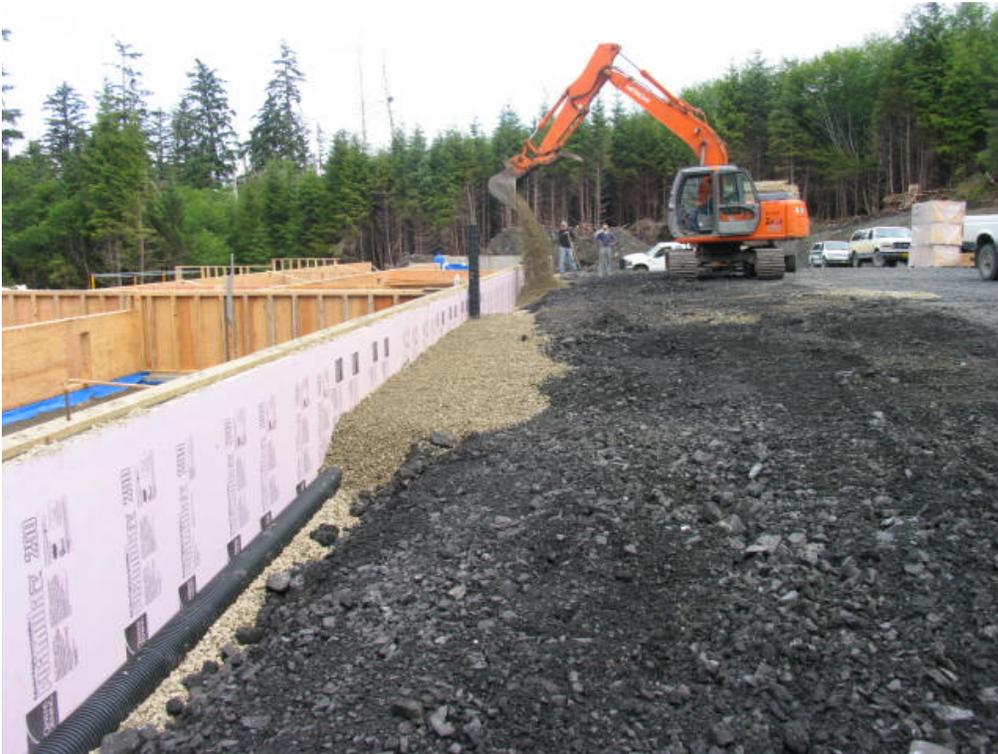
6/24/09 S&S, laying 6" rain drain pipe and backfilling, E57'10 – looking NW

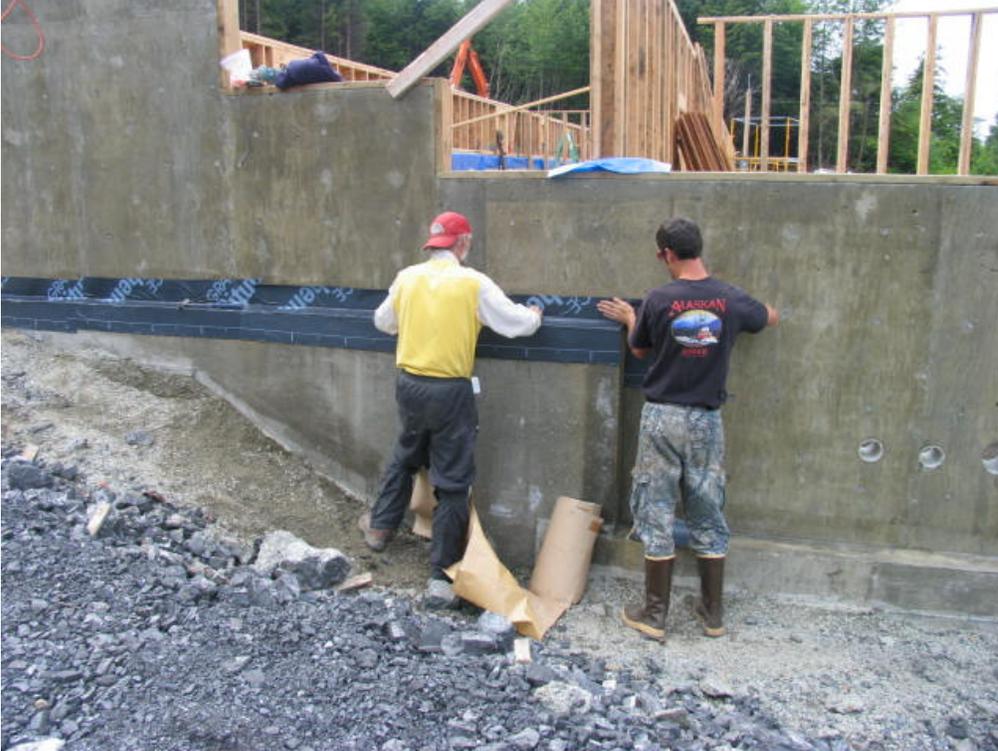
6/24/09 MCC, Tom M. and Tim M. applying sheet membrane waterproofing on foundation wall S0'0 – looking South

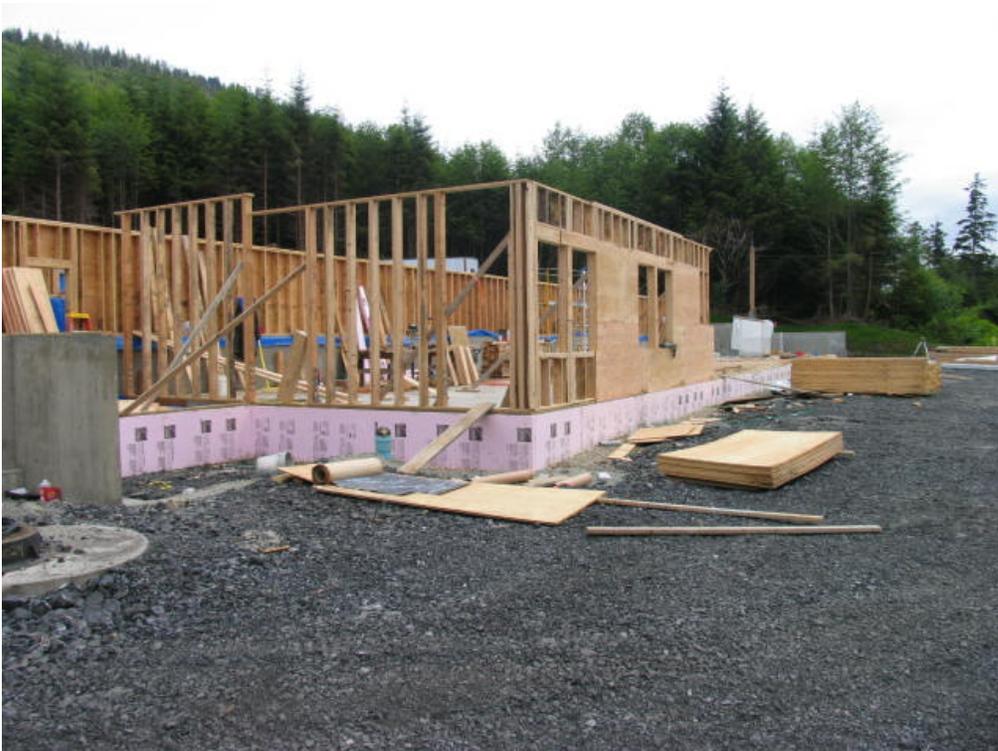
6/24/09 MCC, framing and sheathing lower level exterior walls – looking SE, S18'0 and E0'0

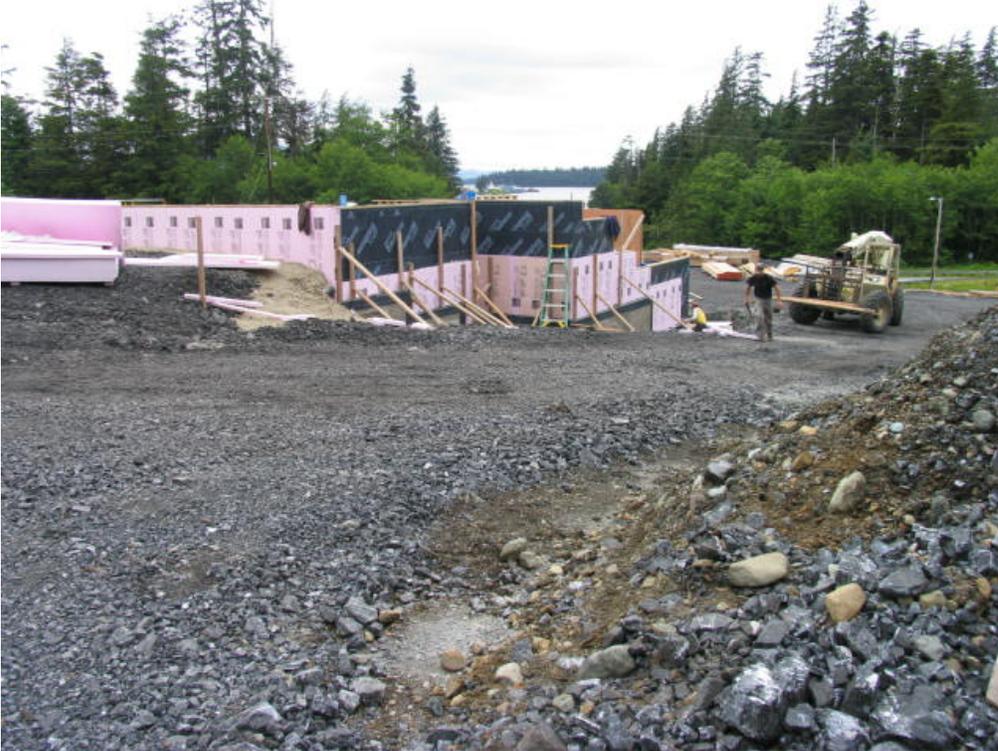
6/24/09 MCC, applying sheet membrane waterproofing and 2" foam insulation – looking SW, S5'2,S0'0

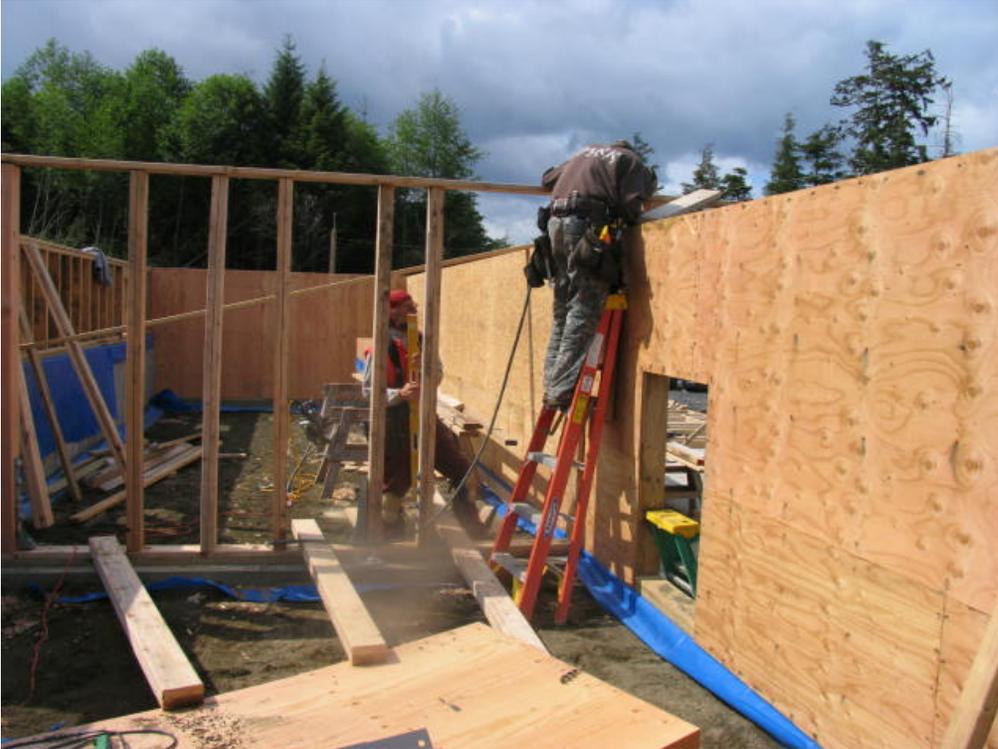
6/25/09 MCC, Tom M. and Tim M. are framing the last shear wall between E40'6 and E27'2 – looking South

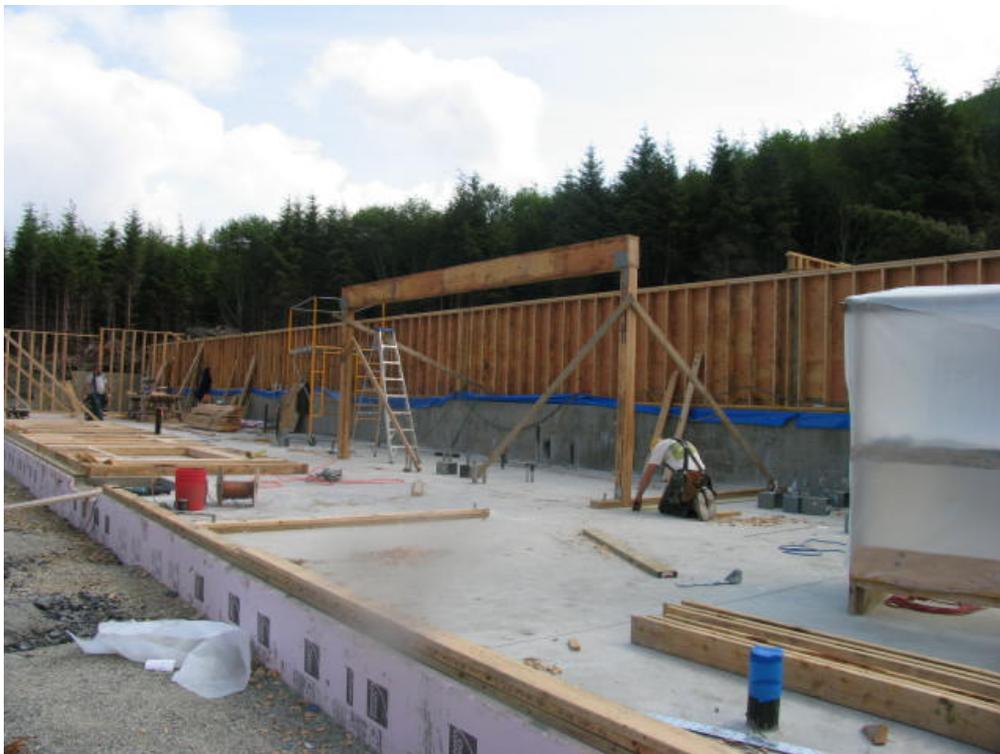
6/25/09 MCC, putting post's and beams in place. – looking NE, lower level, E15'10

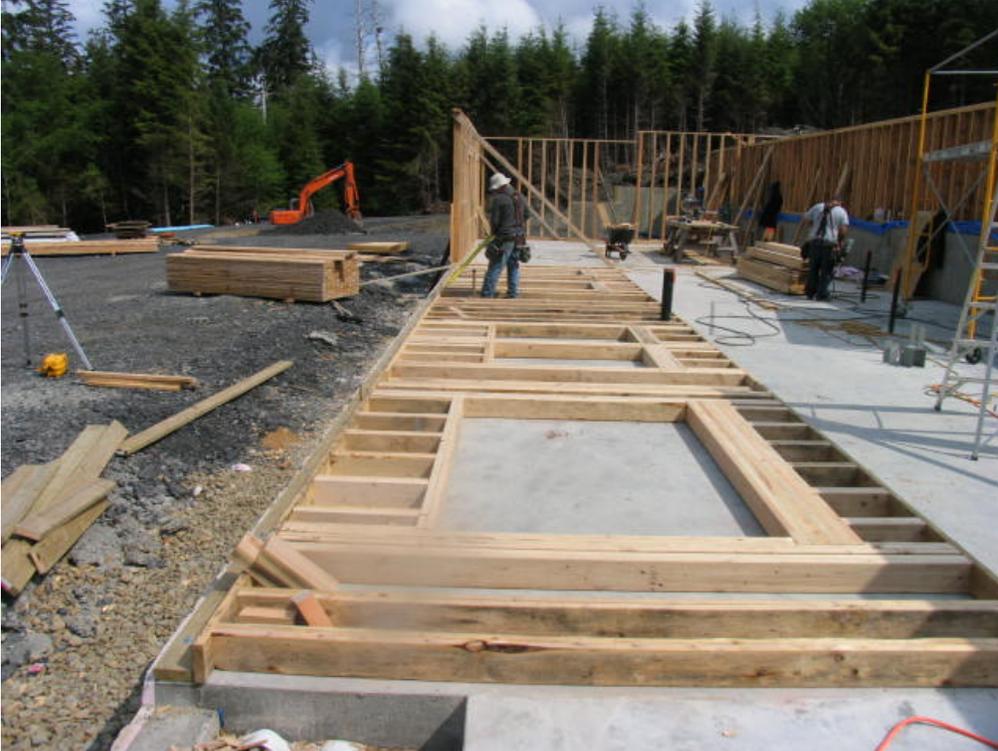
6/25/09MCC, framing exterior wall E0'0 – looking North

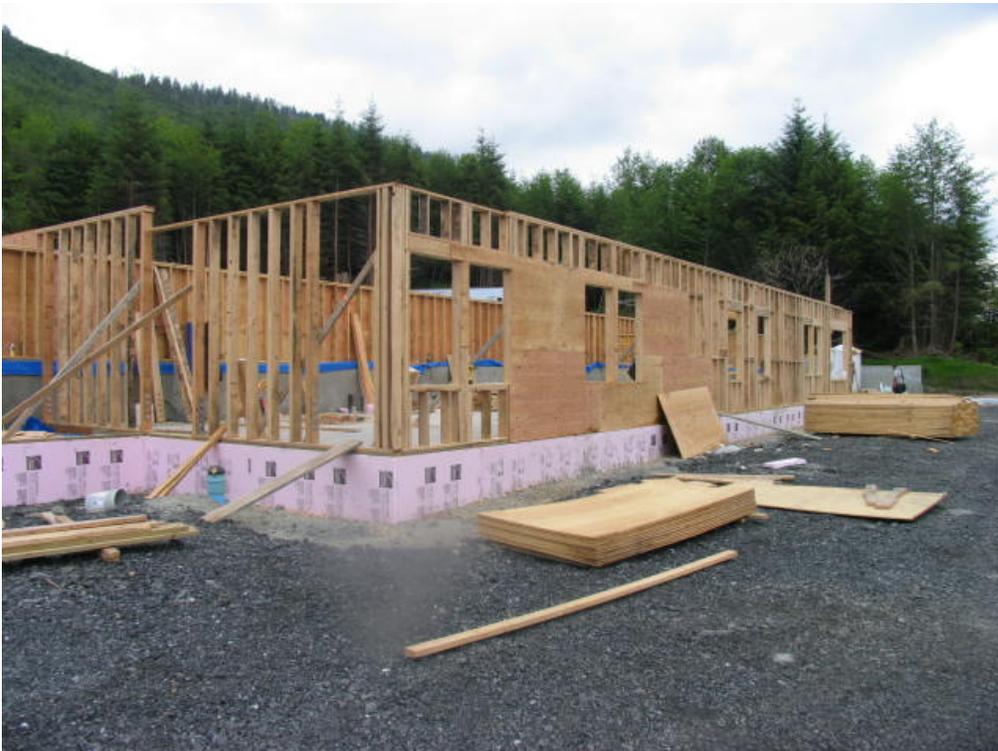
6/25/09 MCC, framed section of S18'0/ E0'0, S18'0 to S94'8 – looking SE

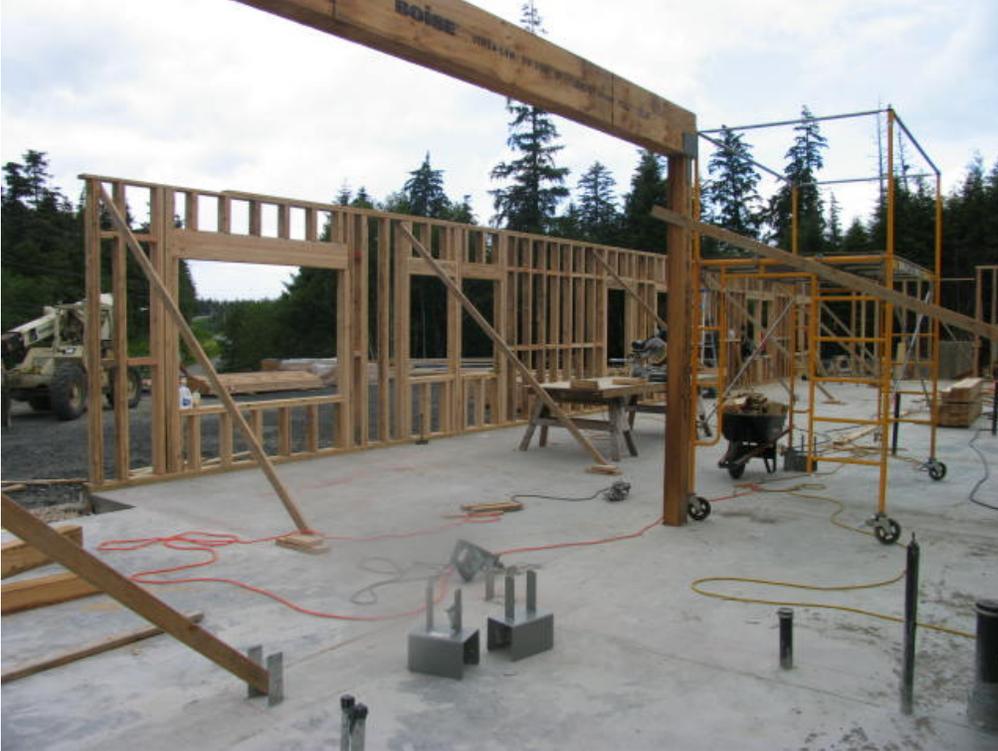
6/25/09 MCC, framed E0'0 wall section - looking NW from S108'8/E27'2

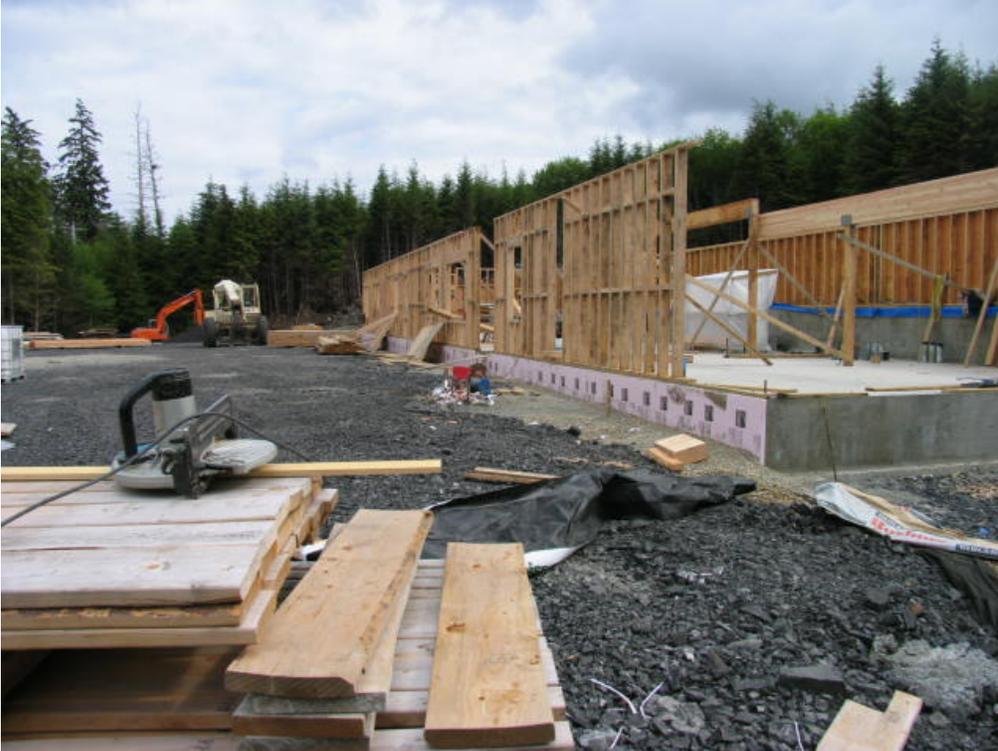
6/26/09 MCC, framing wall E0'0 - looking NE, E0'0/S135'0

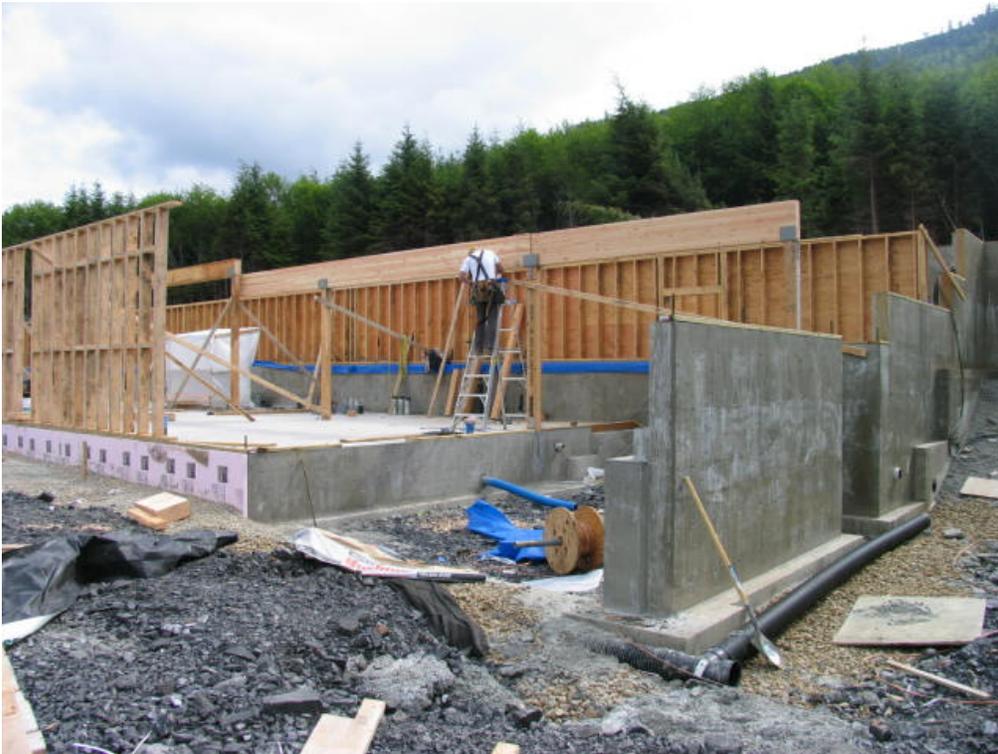
6/26/09 MCC, Chris B., mounting post's and beam's E16'8 – looking NE from SW corner.

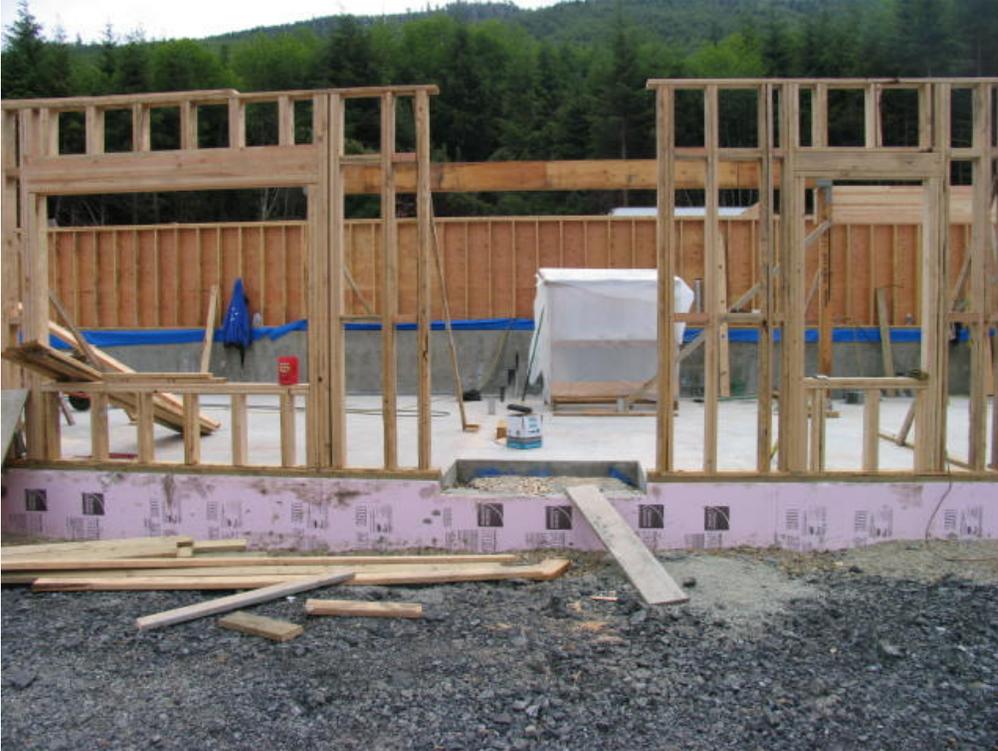
6/26/09 MCC, framing walls – looking at 101 entrance lower level, East

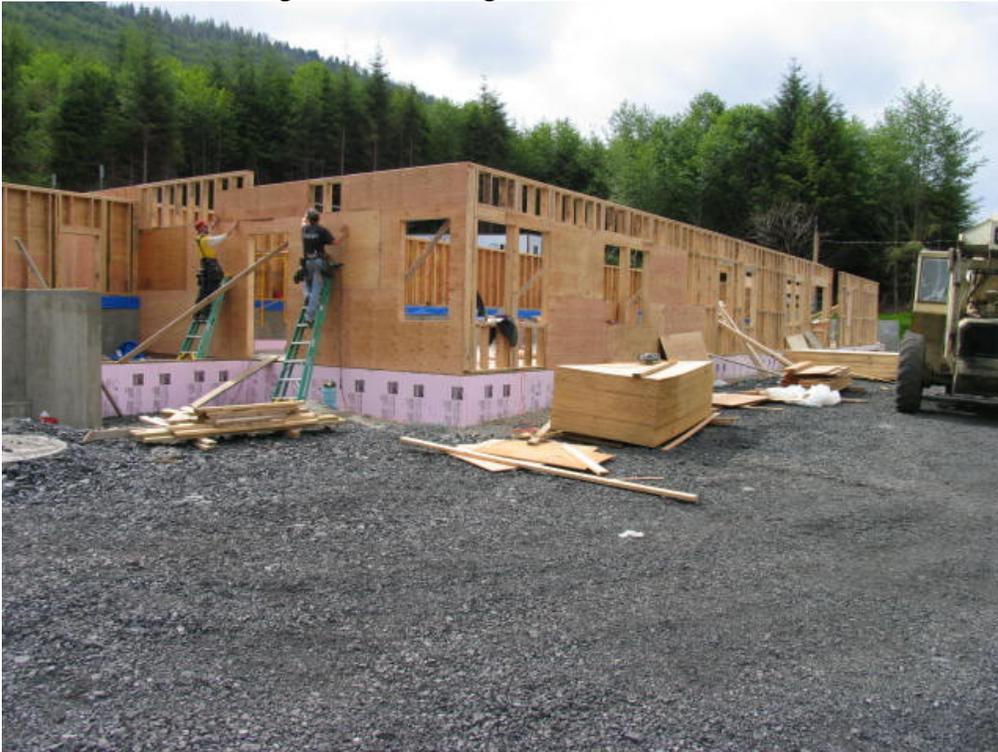
6/26/09 MCC, Tom M. and Tim M. are sheathing S18'0 – looking SE

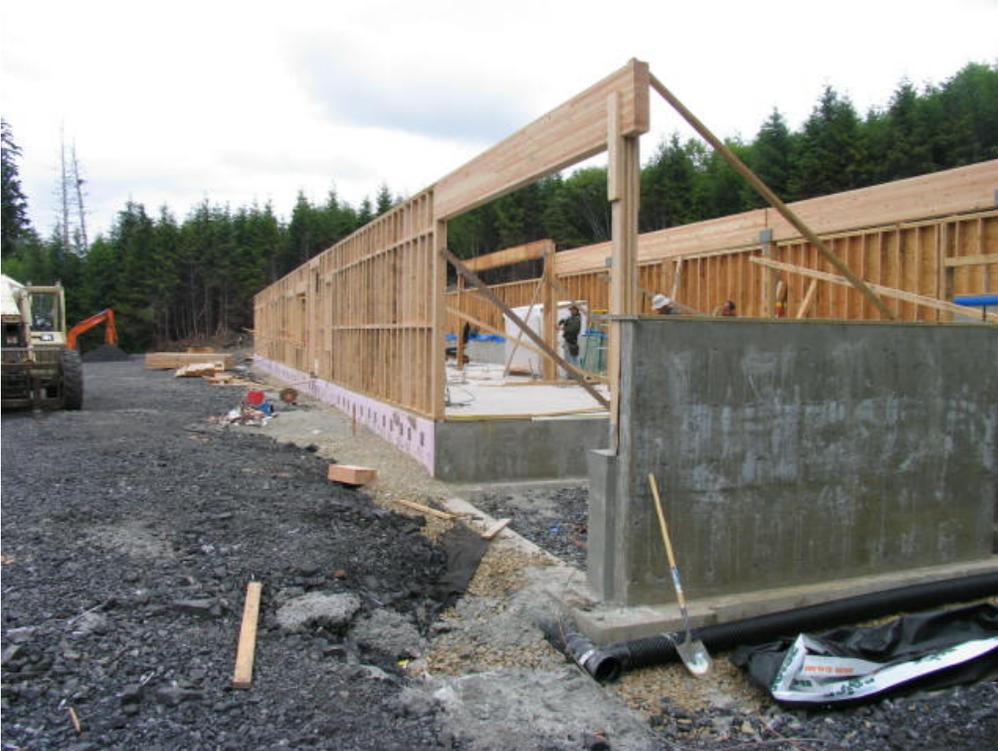
6/26/09 MCC, framed exterior wall E0'0 – looking NE from SW corner,S151'8/E0'0

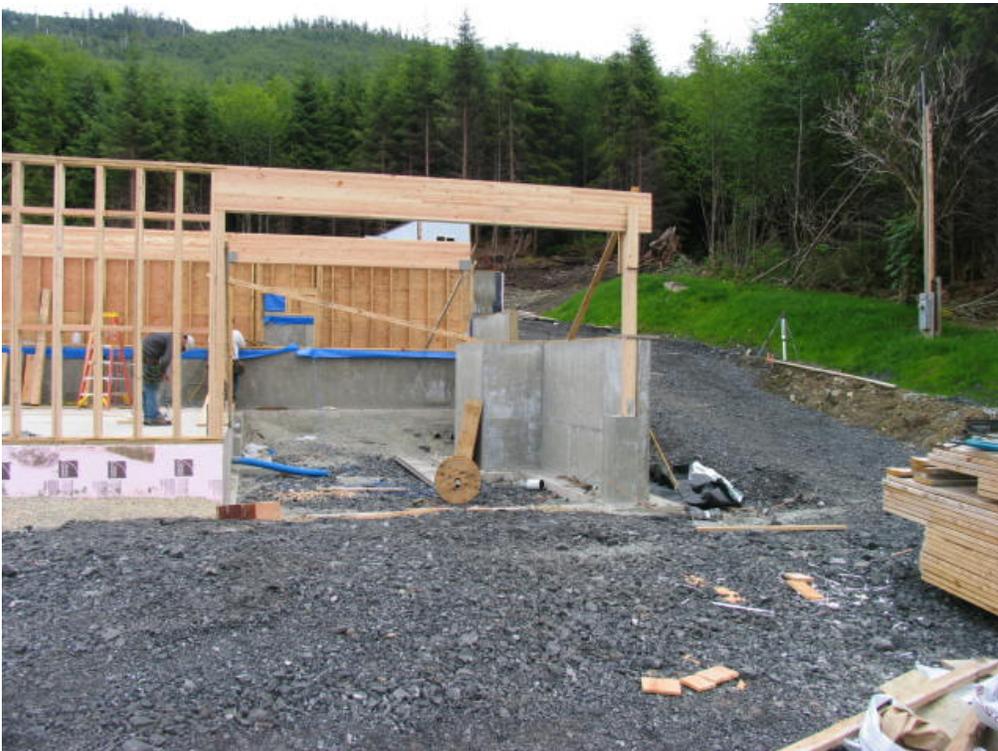
6/26/09 MCC, wood post w/ beam on conc. pilaster – looking SE at the SW corner.
