December Monthly Report for the Falls Creek Hydro-electric Project
FERC # P-11659

Falls Creek Hydroelectric Project (P-11659)
MONTHLY CONSTRUCTION REPORT TO FERC
December 2006

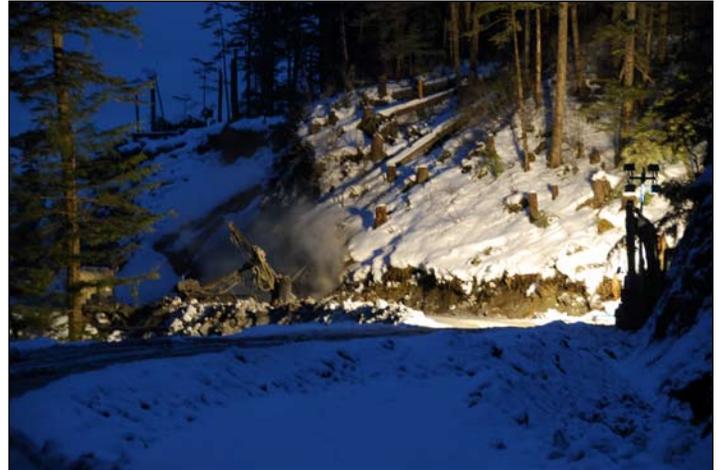
Drilling at the Blueberry Hill road cut during the short days of mid-winter.

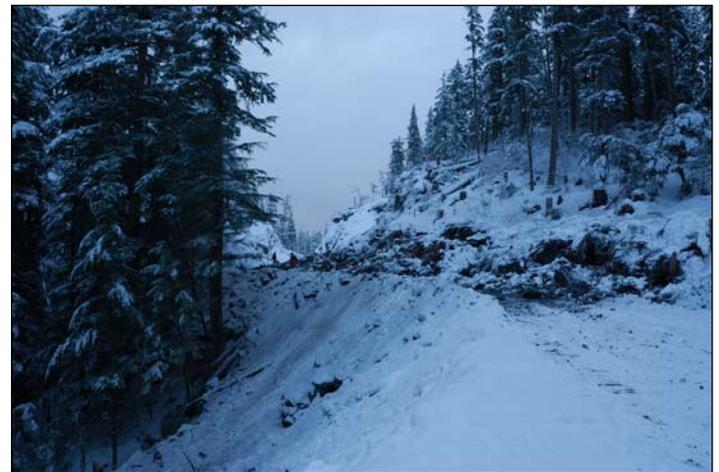
December 14th shot at Blueberry Hill road cut.

Additional blasting along the intake service road was conducted this month without causing landslides or otherwise contributing sediment to Falls Creek. Small shots and light loads have continued to be used in this area with great success. Of note - a successful shot in the Blueberry Hill road cut (see photos on previous page). Slides are of high concern in this area so it was considered exemplary that this shot did not result in further mass wasting.

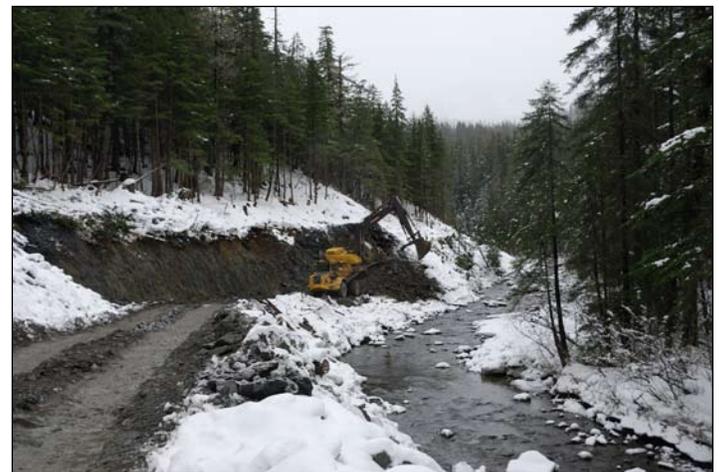
Intake service road and penstock grading. In this picture the equipment is approximately 500 feet from the impoundment site.

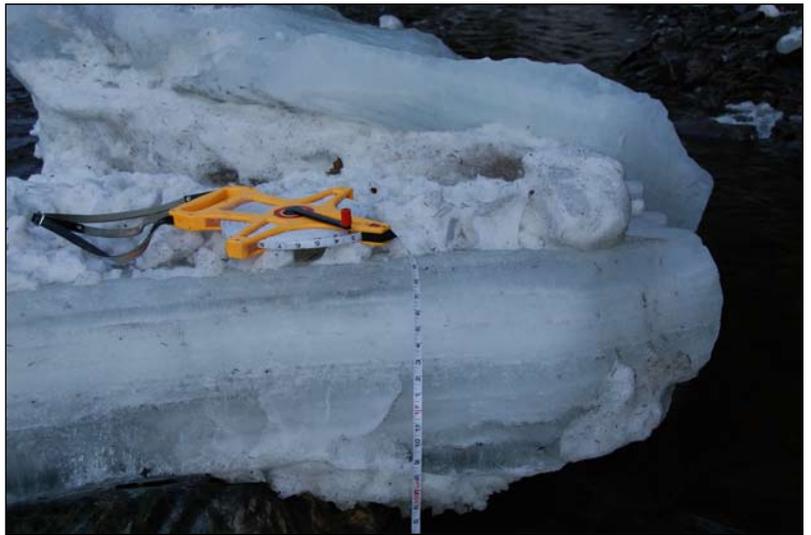
Ice thickness after the unusually cold month of November was over 1 foot along the intake service road. Flood conditions in early December flushed most of this ice.

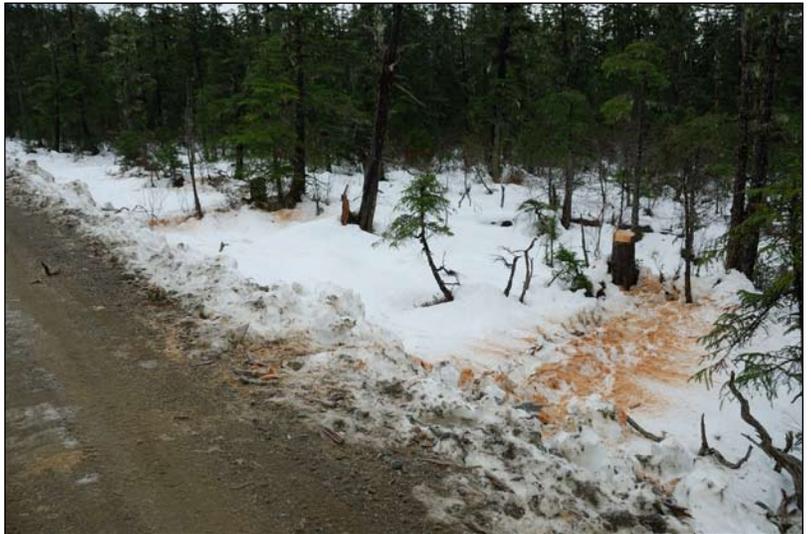
For part of December, public motorized access was provided to community members interested in collecting firewood. This access proved difficult to manage and resulted in the unfortunate loss of several wildlife snags from a wetlands area. Immediately following this action it was decided to restrict motorized access to the work crew only and to postpone public firewood access for the time being.

Evidence of wildlife snag removed from wetlands area.

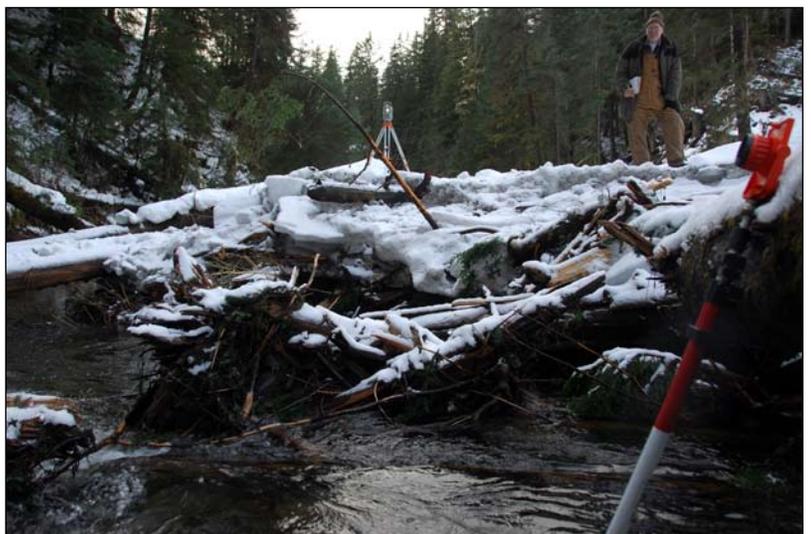
This is a picture of the project manager working with the ECM to survey stream gradient near the powerhouse.

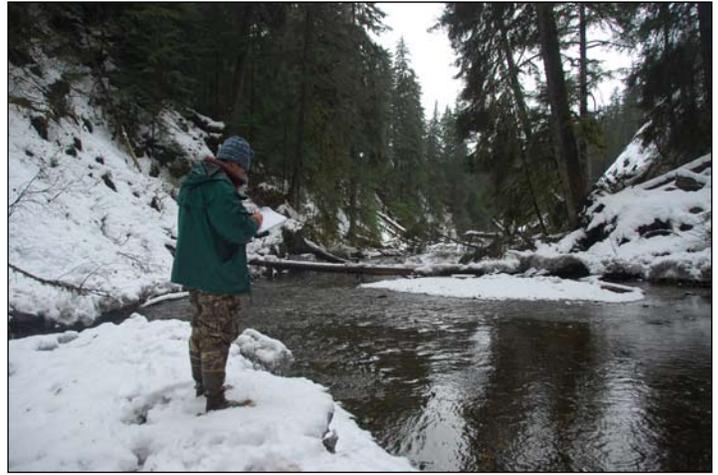
Tim Abbe of Herrera Environmental Consulting shown taking notes for modified tailrace design, mitigation and restoration of fish habitat.

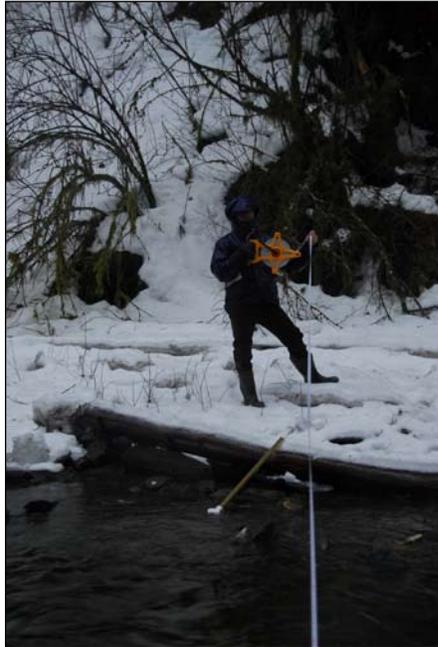
Stream width and substrate data were collected along several transects across the creek.

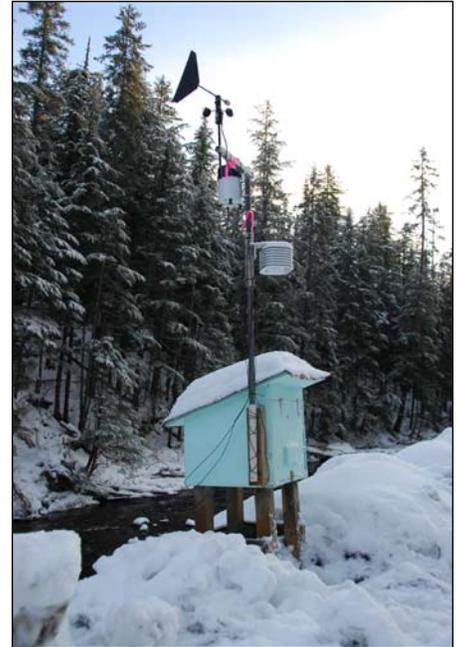
Weather station installed near transducer pool. This station collects air temp, wind direction, wind speed & precip data.

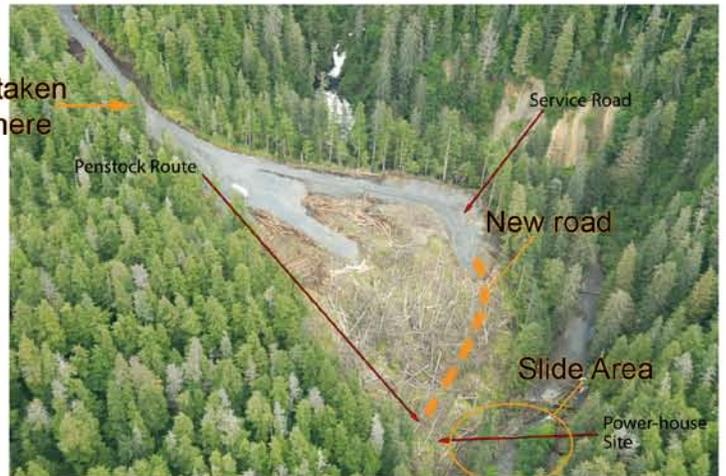
Current report photo (10). Photo above indicating photo 10 location.
