Gustavus Electric Company

September Monthly Report for the Falls Creek Hydro-electric Project
FERC # P-11659

Falls Creek Hydroelectric Project (P-11659)
MONTHLY CONSTRUCTION REPORT TO FERC
September 2006

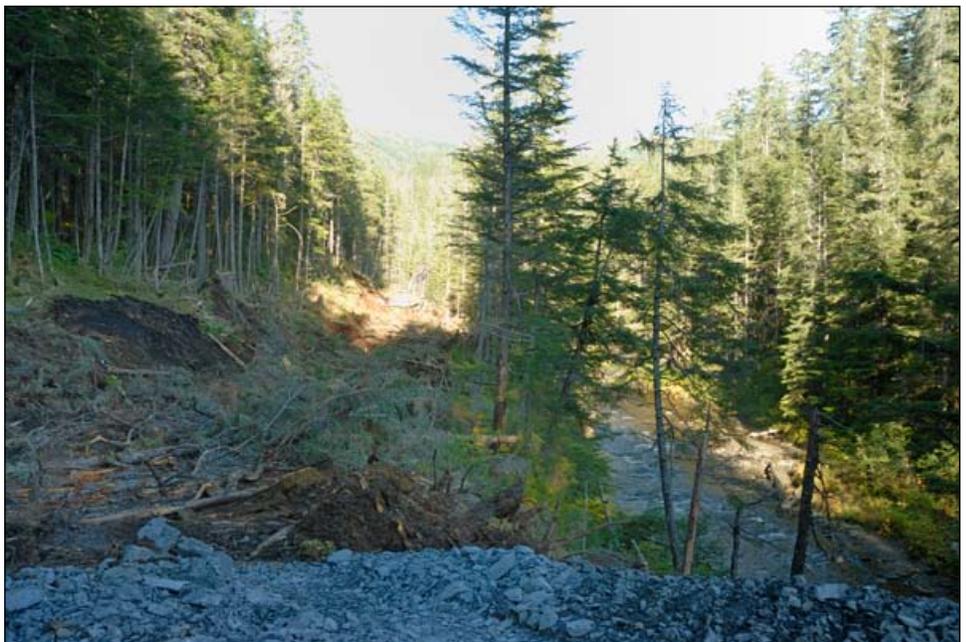
This is a picture of the initial stretch of intake service road right-of-way just upstream of the Horse Shoe Ridge cut. From this point up to the impoundment site the road is situated just above or along the creek bank and generally follows existing contours to avoid the need for intensive stripping/backhauling of overburden and blasting of bedrock.

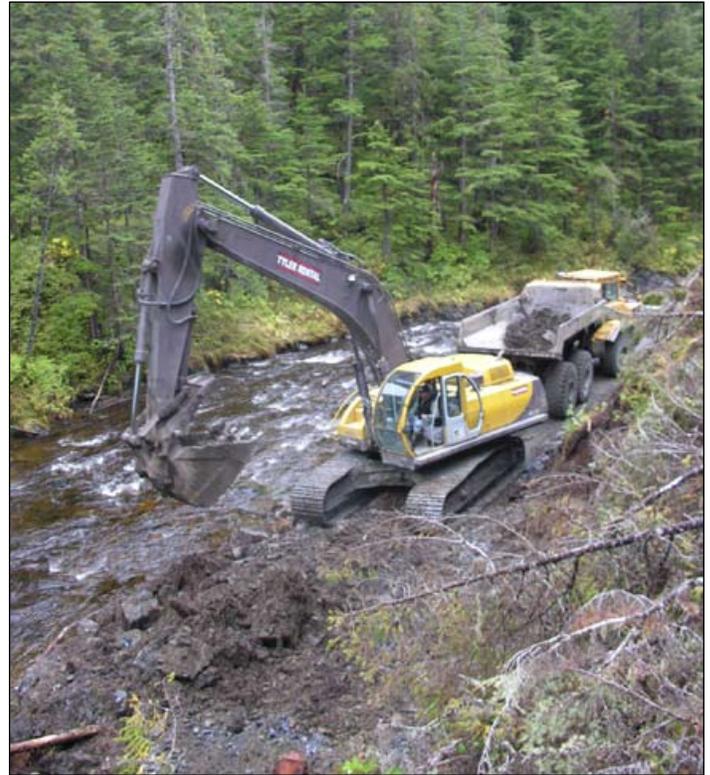
Road construction near the impoundment site.

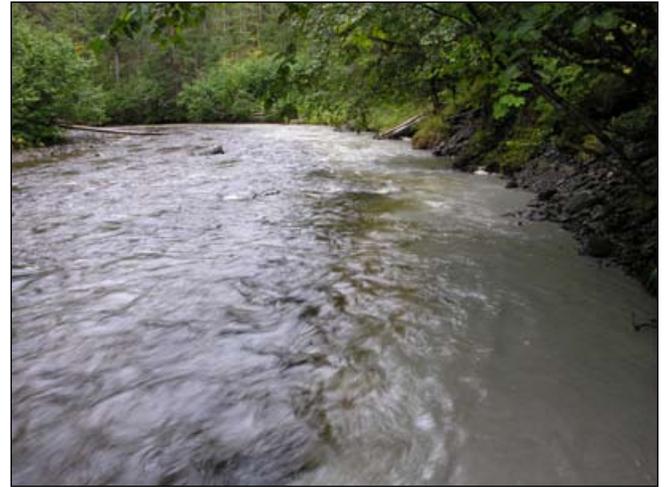
Sediments released to Falls Creek from the installation of a culvert at Greg's Creek.

Higher turbidity readings (above 10) have been the result of road surface sediments carried by runoff from the intake service road to the nearby creek. Most of these sources have been easily controlled by channeling hillside runoff and springs below the surface of the road but these sites will need to be properly ditched and culverted for long-term erosion control.

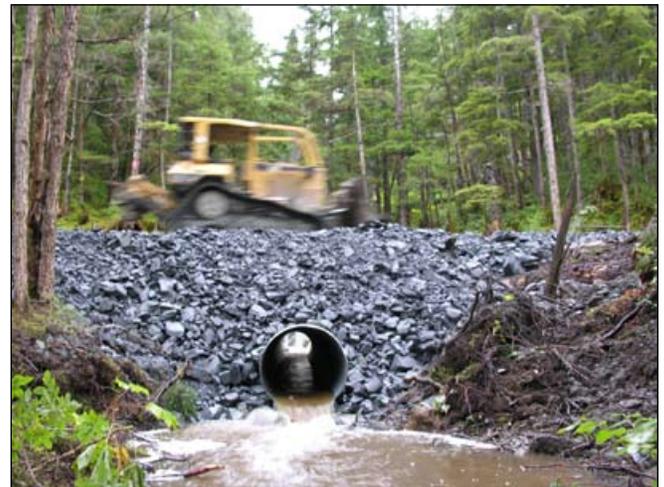
The finished culvert at Greg's Creek.

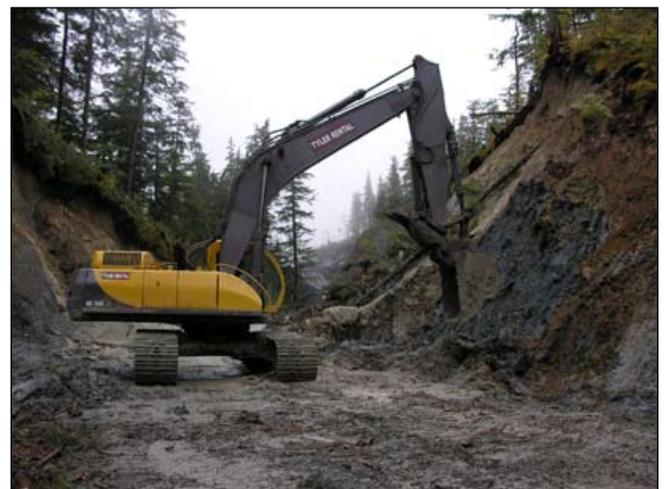
The most problematic sediment and erosion control area has been the deep cut at the Horse Shoe Ridge. The slopes have continued to weep and slough fine sediments to the road, sometimes in very large quantities (10-100 yards). Very wet periods result in the need for clearing of the road before truck traffic can resume. The construction superintendent and project manager are aware of the need for a permanent solution to sediment and erosion control at this location but are waiting for the final approval of the penstock plan before finishing this section of the intake service road.

Maintenance of the sloughing slopes at the Horse Shoe Ridge. These slopes will likely remain highly erodible without fairly aggressive mechanical and/or vegetative stabilization efforts.

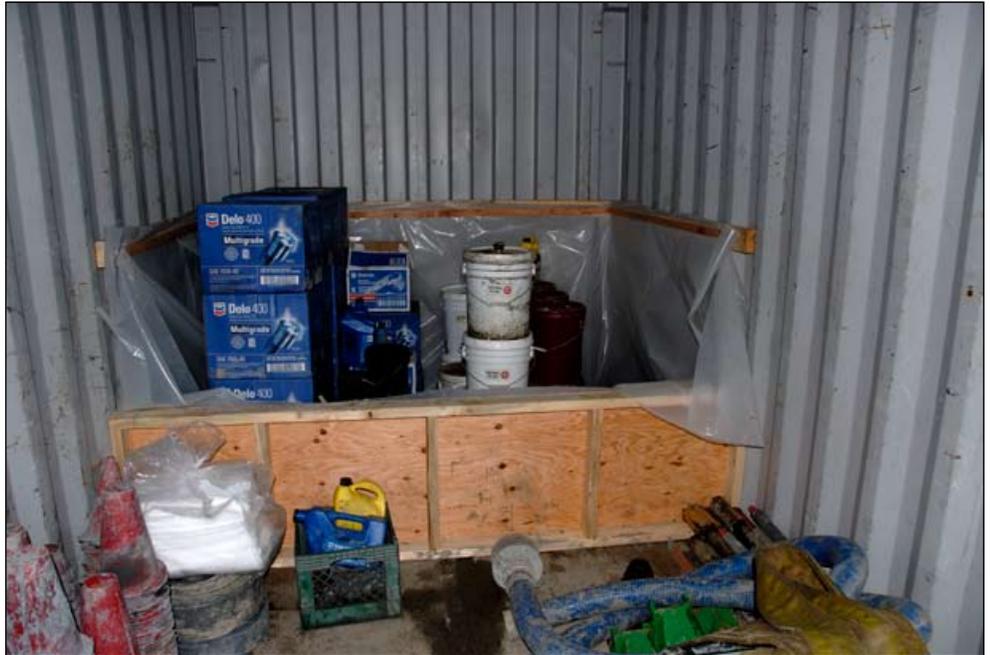
The construction site was visited by a FERC representative during the first week of September. During this visit it was brought to our attention that secondary containment of fuel and hazardous substances was necessary for compliance with Article 412. Construction of secondary containment facilities began immediately following the FERC representative visit and were completed a few days later.

Two storage areas were created using plywood and 2x4 construction lined with 12mm of plastic: 1) a lubricant storage area; 2) a fueling station. A tanker truck is used for all other fueling needs.

Lubricant storage area inside Conex container at the Strip Fen Y.

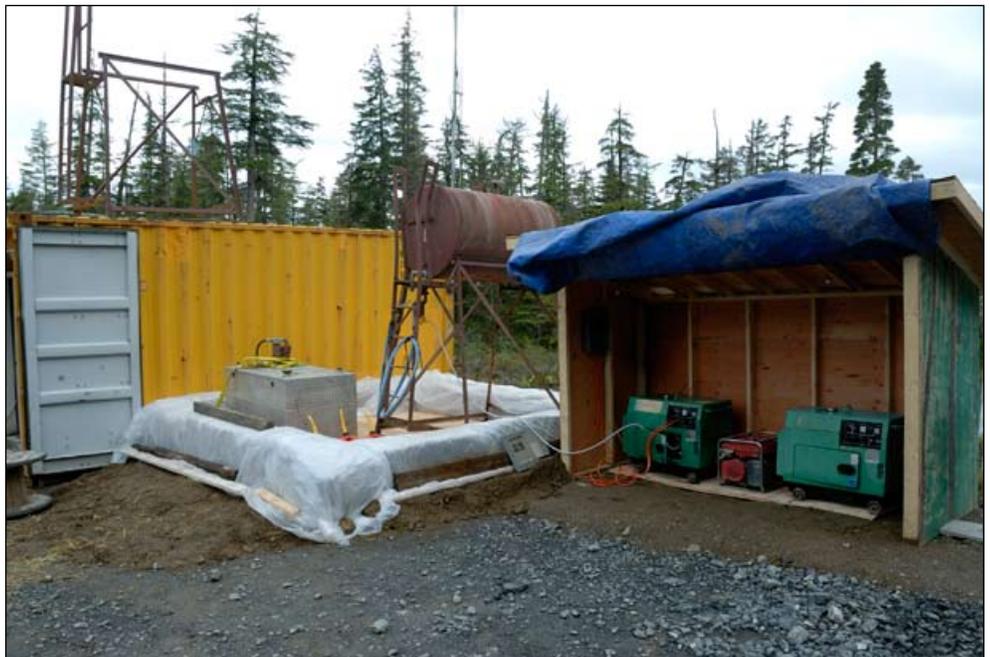
Fueling station and generator shack at the Strip Fen Y.

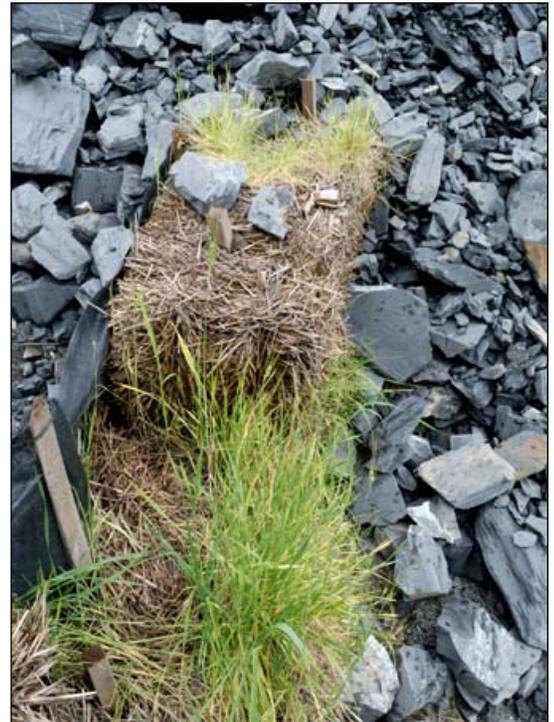
A few of the straw bales used for erosion and sediment control sprouted non-native grass. The species is likely the straw that is used to make the bales. The sprouted plants will be removed and monitoring of these areas will continue.

Non-native grass growing out of the "weed-free" bales used for erosion and sediment control. Seeds were produced in a few plants and were removed. All of these grasses will be removed before winter and monitoring of these areas will continue.
