DISTRICT TRIP REPORT

Project: Denali Commission Moorings Points Phase 4 – Yukon River

Description: Tanana Trip Report

Date: 7 June 2011

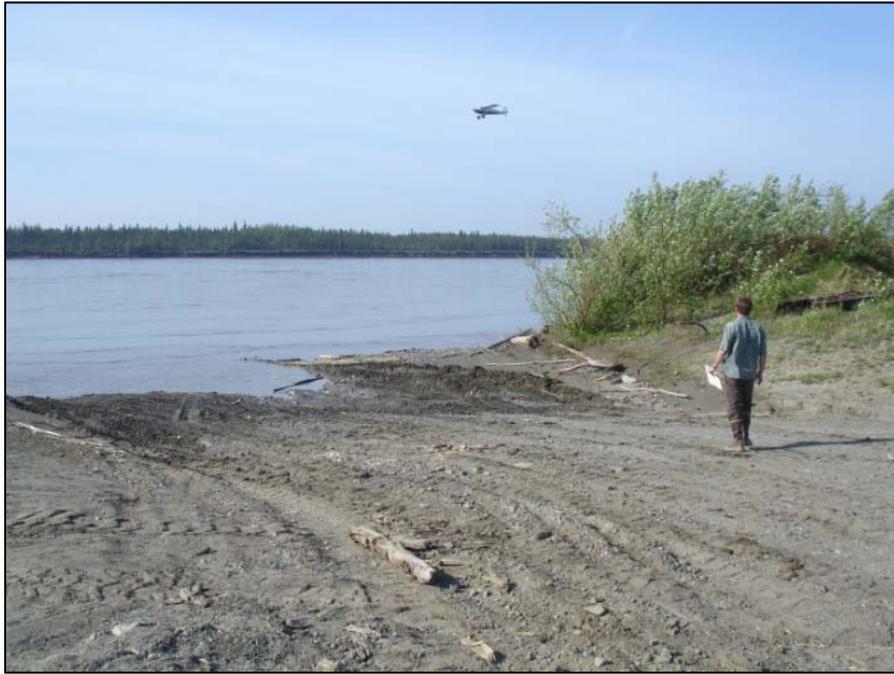
The freight landing is the downstream landing in Tanana located adjacent to the airstrip (Figure 1). It consists of an unimproved ramp with minimal gravel perpendicular to the river (Photos 1 - 3). No fuel header was observed at this landing, it appears to be used solely for freight.

Photo 1. Tanana Freight Landing Site. The Yukon River flows left to right in the photo.

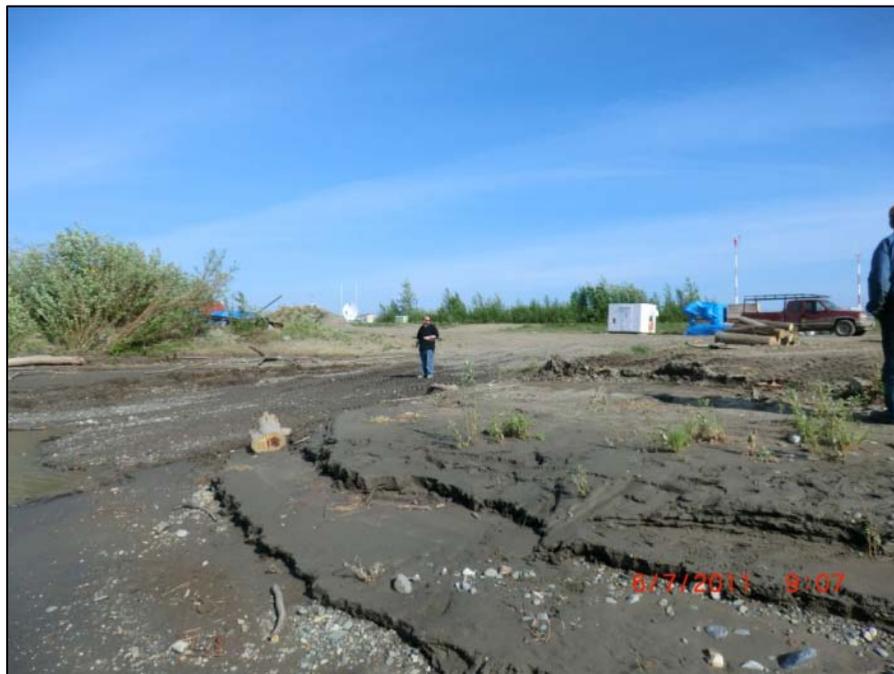
There is a large, unimproved staging area both upstream and downstream of the ramp (Photos 2 – 3). Various items, including two dilapidated cranes, old storage tanks, a partially collapsed three-sided covered storage shed, modular buildings, and logs, were found scattered about the staging area.

Photo 2. Tanana Freight Landing Site looking inland and slightly downstream. The staging area is both upstream and downstream of the top of the ramp. Note the small white building and pile of logs. The red and white antennas are affiliated with the airport located across the street.

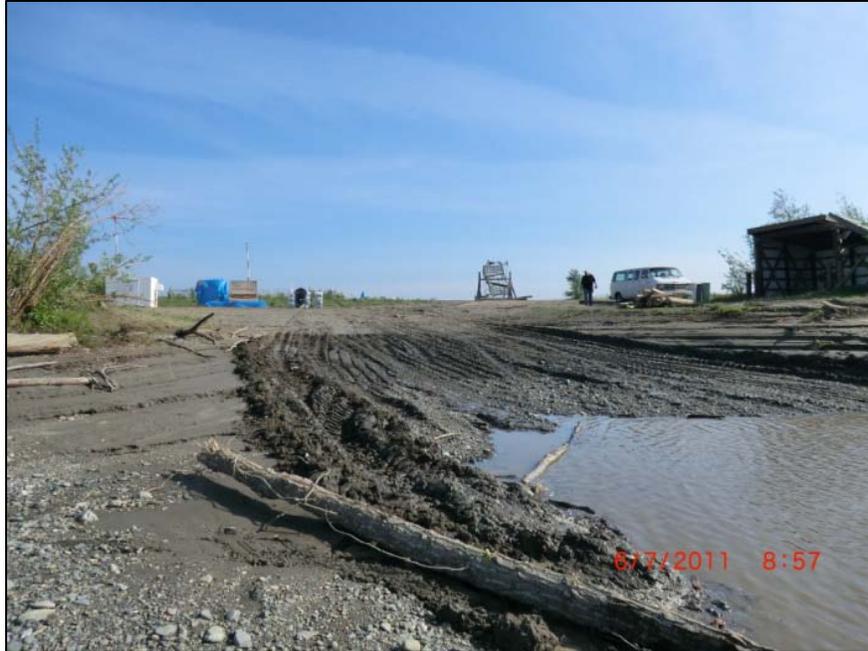
Photo 3. Tanana Freight Landing Site looking inland and slightly upstream. The staging area is both upstream and downstream of the top of the ramp. Note the small white building, fish wheel, pile of logs, and covered storage area. The red and white antennas are affiliated with the airport located across the street.

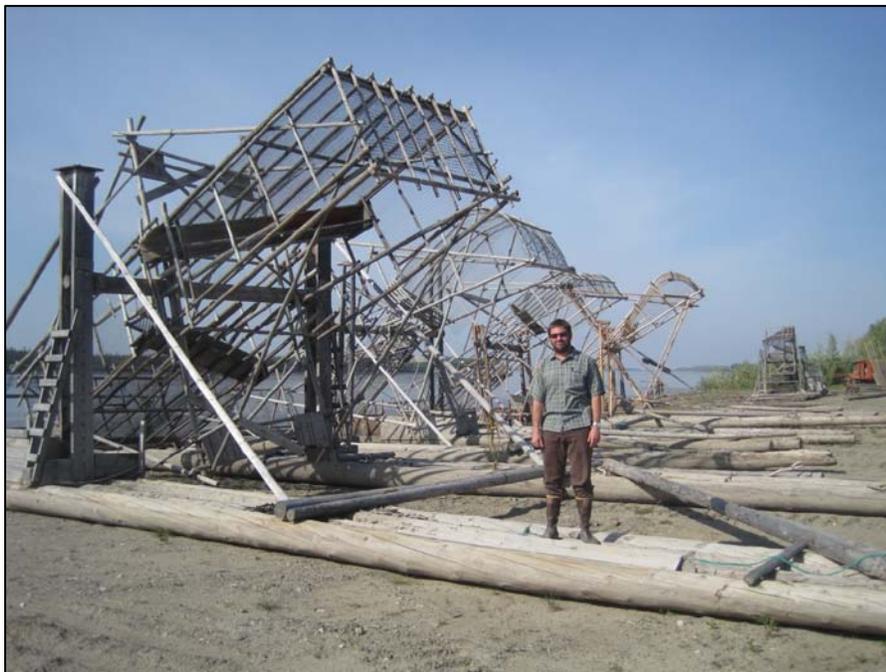
Upstream of the landing area and beyond the immediate vicinity of the staging area there were approximately 10 fish wheels being stored along the floodplain of the river (Photo 4).

Pat also informed us that the area upstream adjacent to the fish wheels has silted in over recent years. The fish wheels must now access the river in vicinity of the landing ramp. Pat expressed a concern regarding impacts that any mooring points could have upon access to the river by the fish wheels.

Photo 4. Fish wheels stored along the river upstream of the Tanana freight barge landing ramp. The location of the proposed upstream mooring point is to the left of the orange crane visible in the distance.

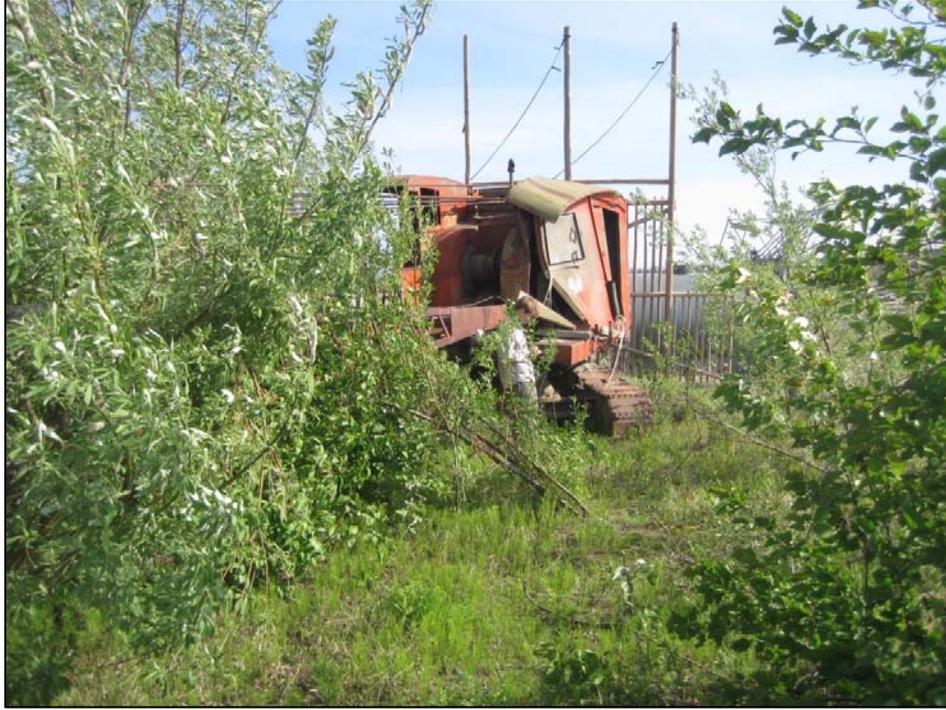
Photo 5. Corps employee standing in front of abandoned crane at location of proposed upstream mooring point.

The proposed upstream mooring point for this landing site is located 125 feet upstream of the center of the ramp and 55 feet inland from the top of bank. This location is located directly in front of the river side of a crane that we were told has been used as a mooring point (Photo 5). An existing deadman was located near the base of the crane. GPS coordinates for this location are 65°10'20.46"N and 152° 6'22.08"W. A below grade installation is recommended in order to avoid conflicts with fish wheels and potential future removal of the crane.

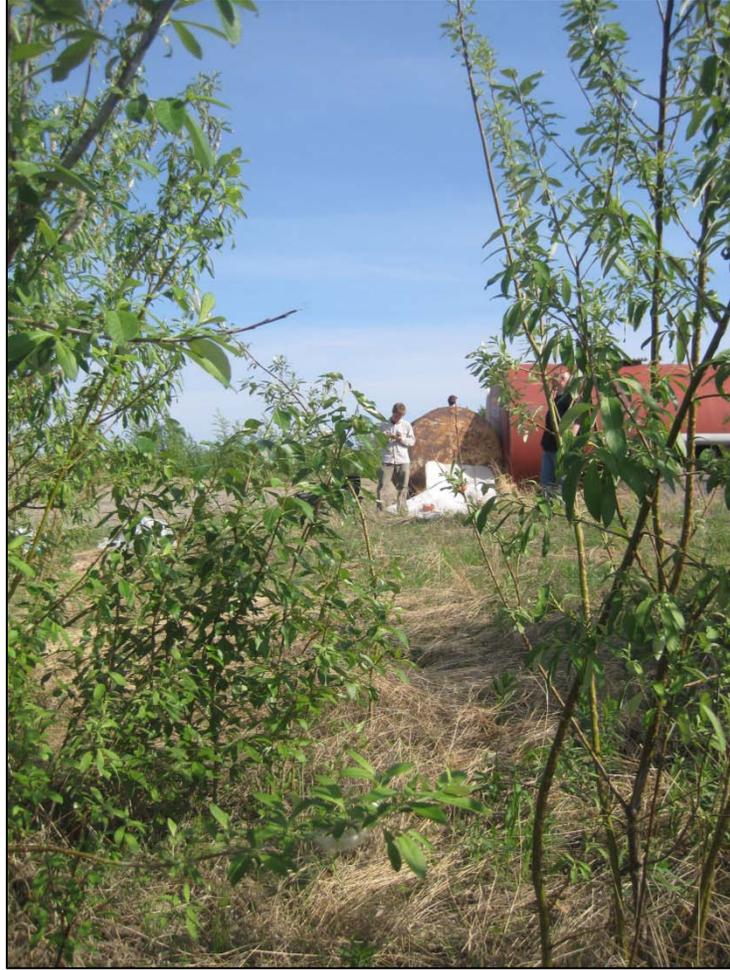
Photo 6. Corps employee standing in front of abandoned fuel tank at location of proposed downstream mooring point.

The proposed downstream mooring point for this landing site is located 125 feet downstream of the center of the ramp and 50 feet inland from the top of bank. This location is located approximately 25 feet downstream of another dilapidated crane and in front of the downstream end of abandoned fuel tanks (Photo 6). GPS coordinates for this location are 65°10'20.58"N and 152° 6'27.66"W. A below grade installation is recommended in order to avoid conflicts with potential future removal of the tanks and crane.

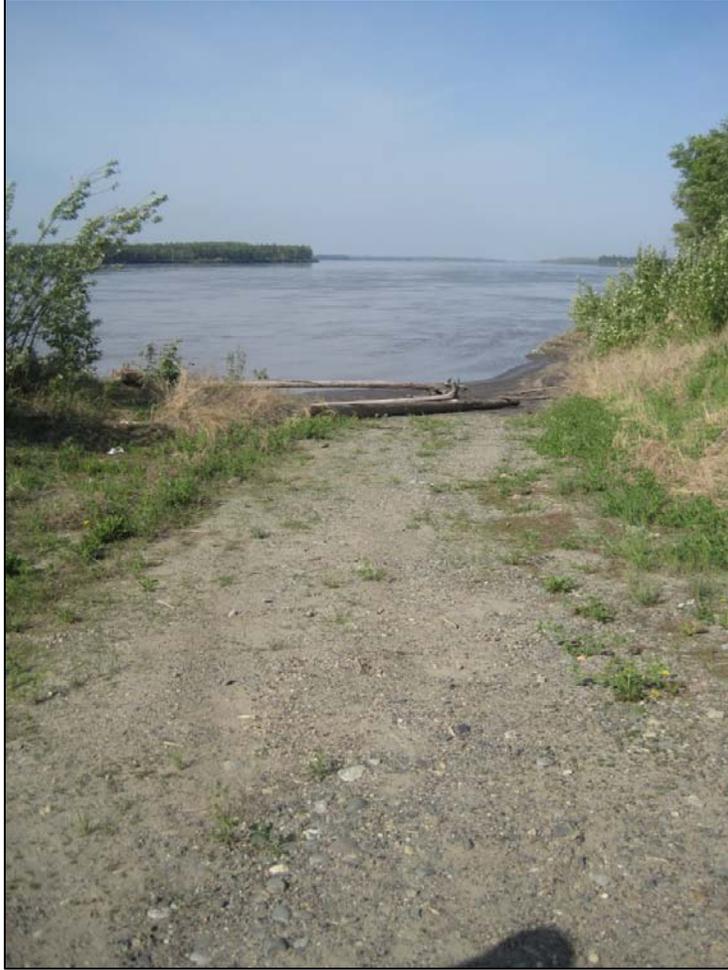
There is an additional unimproved ramp accessing the river from the downstream end of the staging area (Photo 7). During previous discussions with barge operators, we learned that this was previously a concrete ramp that eroded into the river. Use of this ramp has discontinued due to the presence of dangerous pieces of concrete scattered about the approach area. During a walk approximately 300 feet downstream from this abandoned ramp along the river, we observed various metal industrial waste such as pipes and machinery parts, as well as concrete (Photo 8). Mooring points are not recommended at this site.

Photo 7. Abandoned ramp located downstream of current freight barge landing.

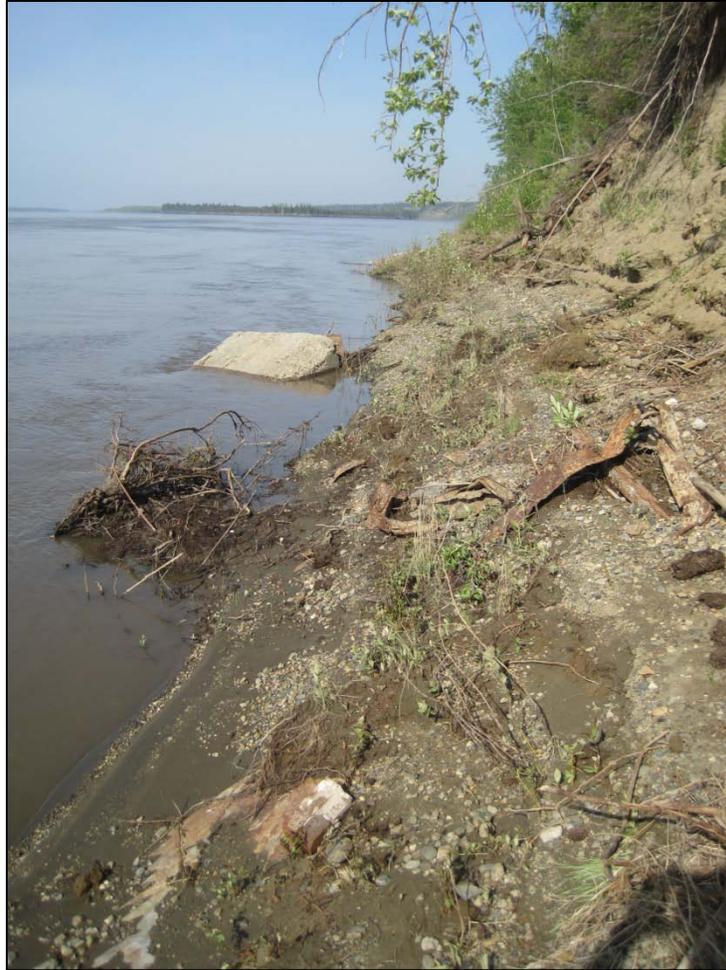
Photo 8. Industrial waste and concrete block found downstream of abandoned barge ramp.

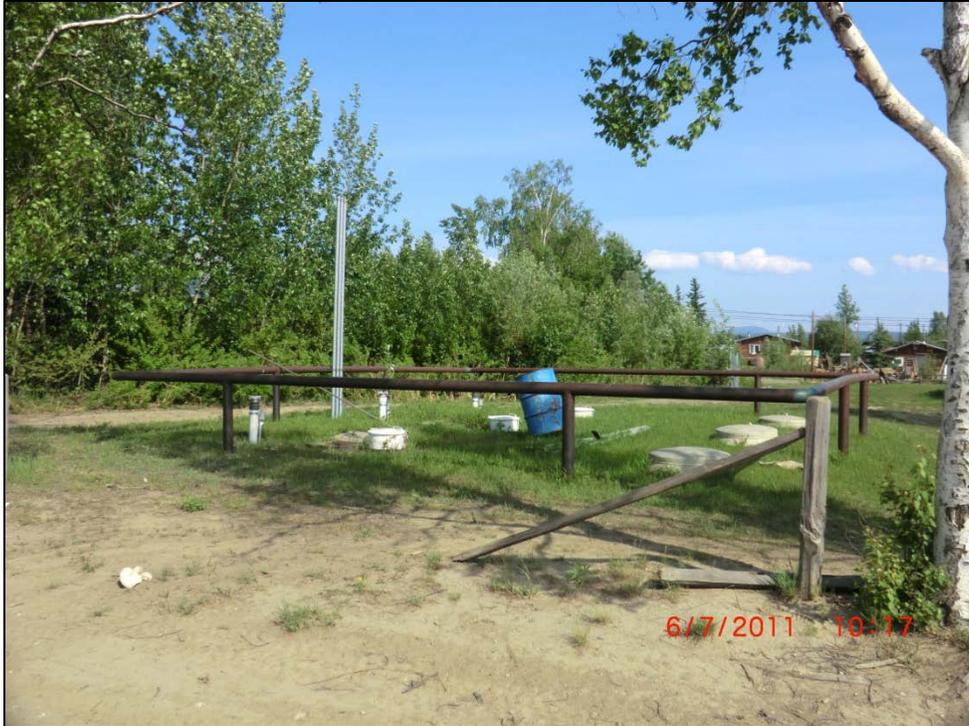
There are three underground fuel tanks across First Avenue from the Yukon River. Each tank has its own header (Photo 9).

Photo 9. Middle fuel landing tanks and headers.

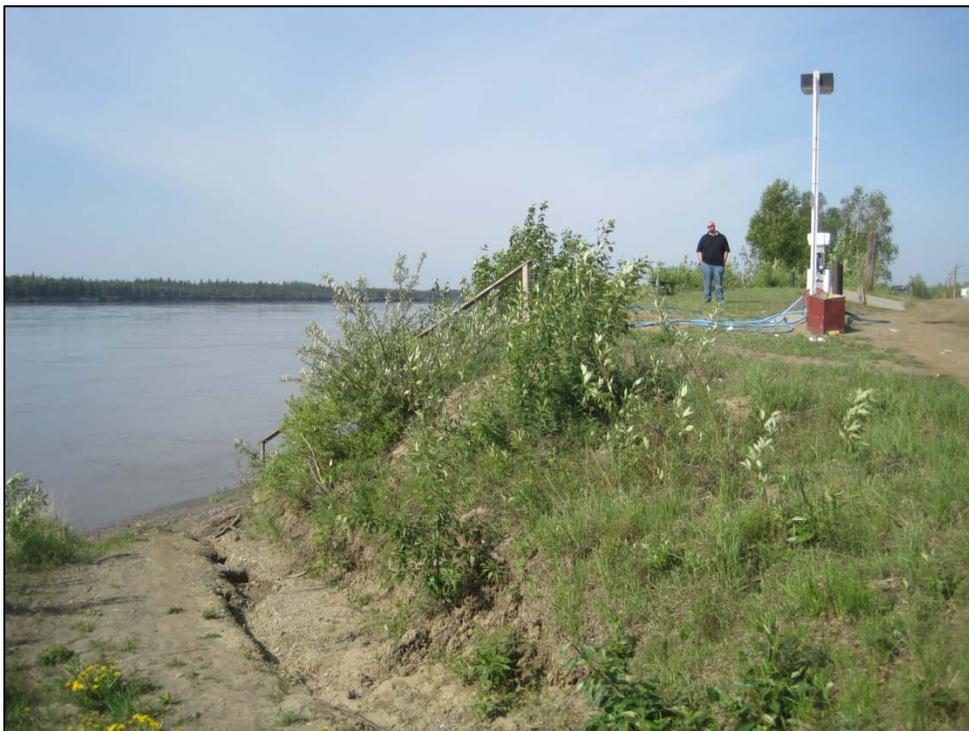
There is a fuel dispenser pump on the river side of First Avenue. There is small ramp angled down to the river just upstream of the pump (Photo 10).

Photo 10. Fuel pump and upstream ramp. Corps employee standing at the proposed location of the second most upstream mooring point.

The next downstream potential mooring point location is located 75' downstream on the downstream side of the fuel pump at $65^{\circ}10'14.58''N$, $152^{\circ}5'8.40''W$ (Photo 10).

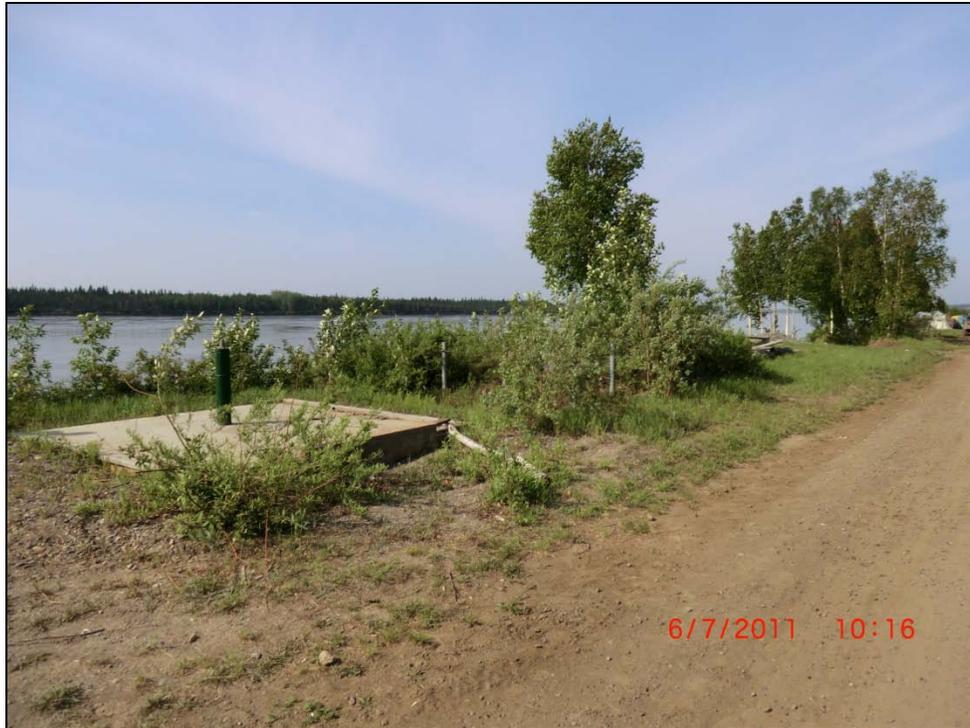
Downstream of the fuel pump and between the river and First Avenue there is a concrete slab with a protruding pipe (Photo 11). This could be a septic tank vent. During the public meeting we were informed that it is an old well house.

Downstream of the old well house there is a fenced off area (Photo 11). Inside the fenced area some geotextile fabric was evident. During the public meeting we were told that this may have been the site of a former above ground tank and is now a site of contaminated soil with a geotextile covering.

Photo 11. Old well house slab and green pipe with fenced off area adjacent to it. Beyond the fenced off area there is a ramp to the river along the row of trees.

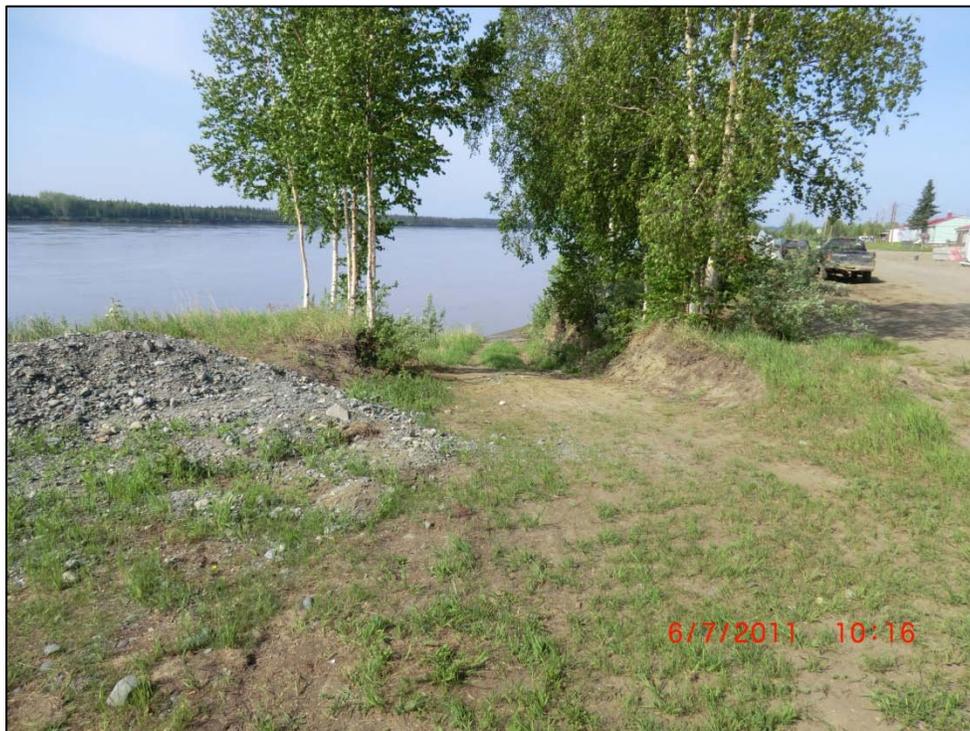
Downstream of the fenced off area there is another small ramp angling down to the river (Photos 11 – 12). There is a pole barn structure located near rivers edge at the toe of the bank just upstream of the bottom of the ramp (Photo 13).

Photo 12. Downstream boat ramp at the middle fuel landing site.

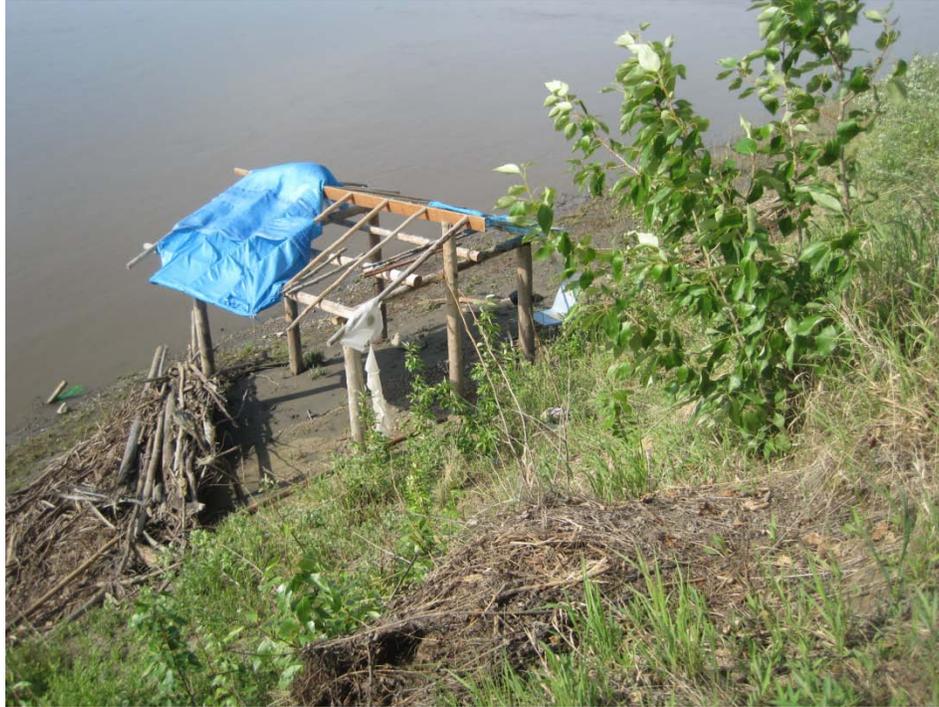
Photo 13. Pole barn structure located at the toe of bank just upstream of middle fuel landing site.

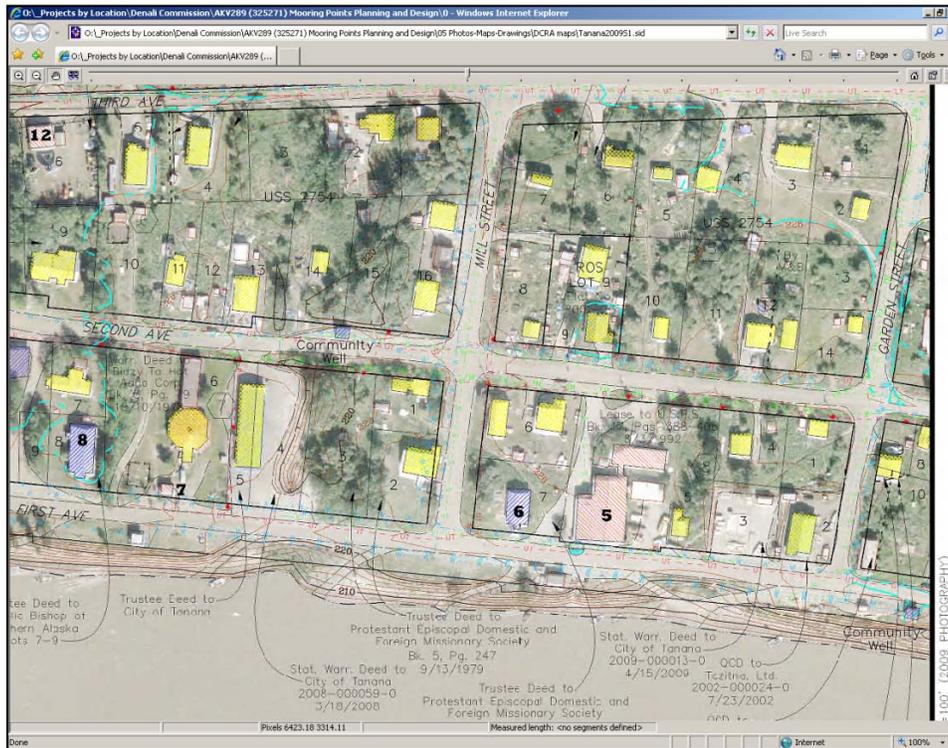
A community map of Tanana (Figure 2) indicates that there are buried water lines running along near the river side edge of First Avenue. Despite the fact that these water lines were thought to be out of use by those at the public meeting, a utility locate may be needed to avoid impacting any buried utilities at this location.

Figure 2. Screen capture of Tanana Community Map. The blue lines running along First Avenue indicate water lines in the vicinity of both the Middle and Upper Fuel Landing Sites.

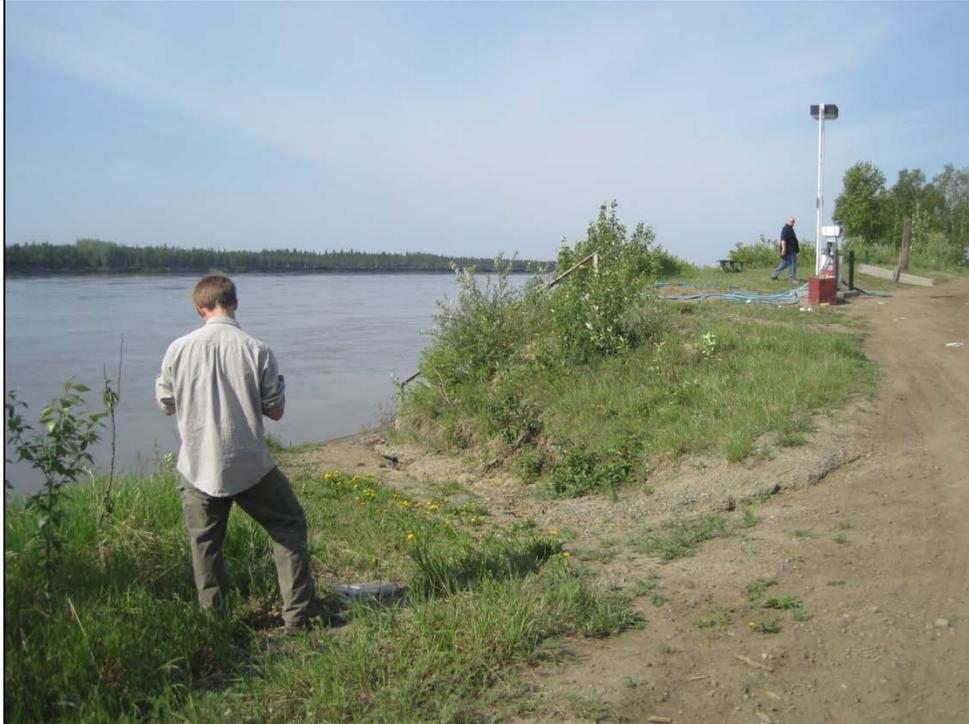
Photo 14. Corps employee standing at proposed upstream mooring point location.

The upstream most potential mooring point location is at the top of the upstream side of the upper ramp at $65^{\circ}10'14.52''N$, $152^{\circ}5'6.54''W$ (Photo 14). The remaining three potential mooring points are spaced 75, 150, and 225 feet downstream from this mooring point.

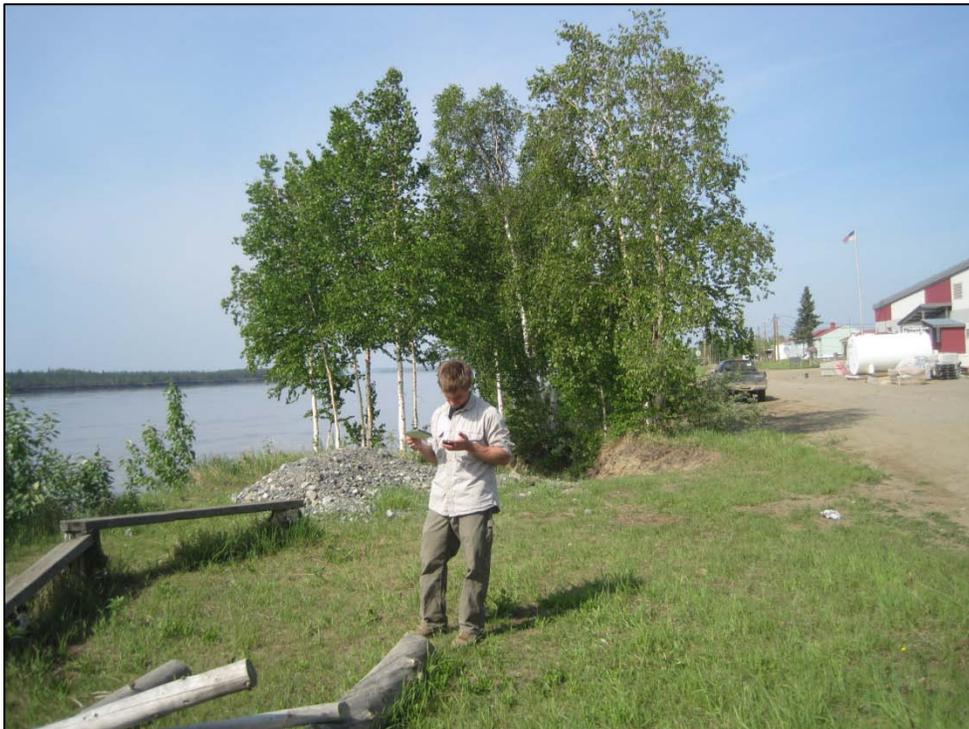
Photo 15. Corps employee standing at proposed downstream mooring point location.

The final mooring point is located a further 75' down on the downstream side of the fenced off area and toward the downstream boat ramp at $65^{\circ}10'14.76''N$, $152^{\circ}5'11.82''W$ (Photo 15).

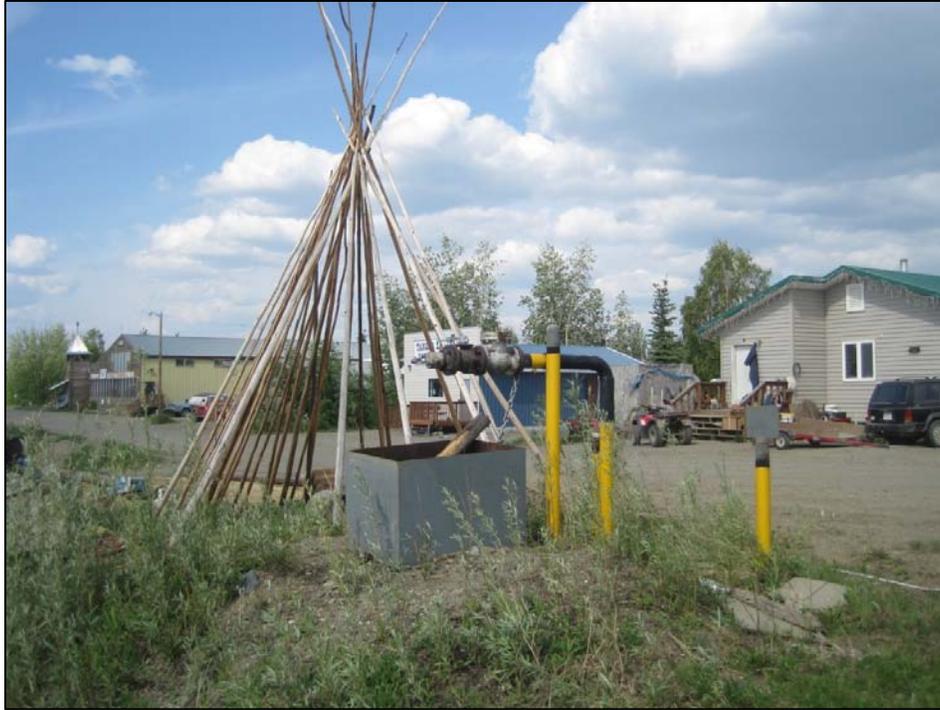
This site services a fuel header located between the river and First Avenue (Photo 16). There is a small ramp angling down to the river approximately 100 feet downstream of the header (Photo 18).

Photo 16. Upper Fuel Landing fuel header

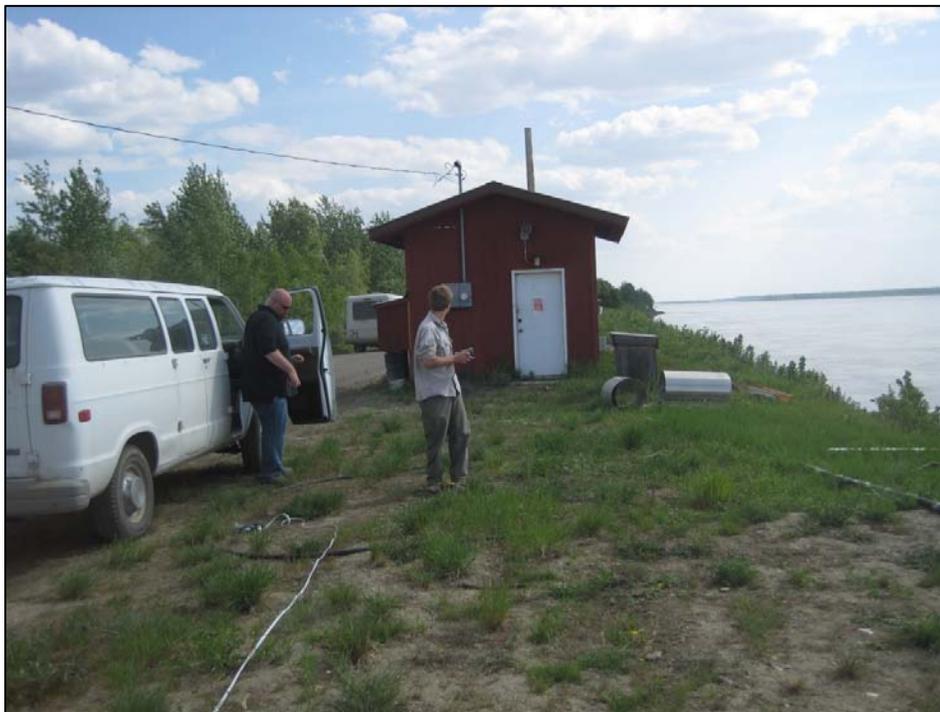
Photo 17. Corps employee standing at proposed location of upstream mooring point at upstream fuel landing.

The proposed upstream mooring point is located 75' upstream of the fuel header and 19' in from the top of bank near the water treatment plant at $65^{\circ}10'13.56''\text{N}$, $152^{\circ}4'47.52''\text{W}$ (Photo 17).

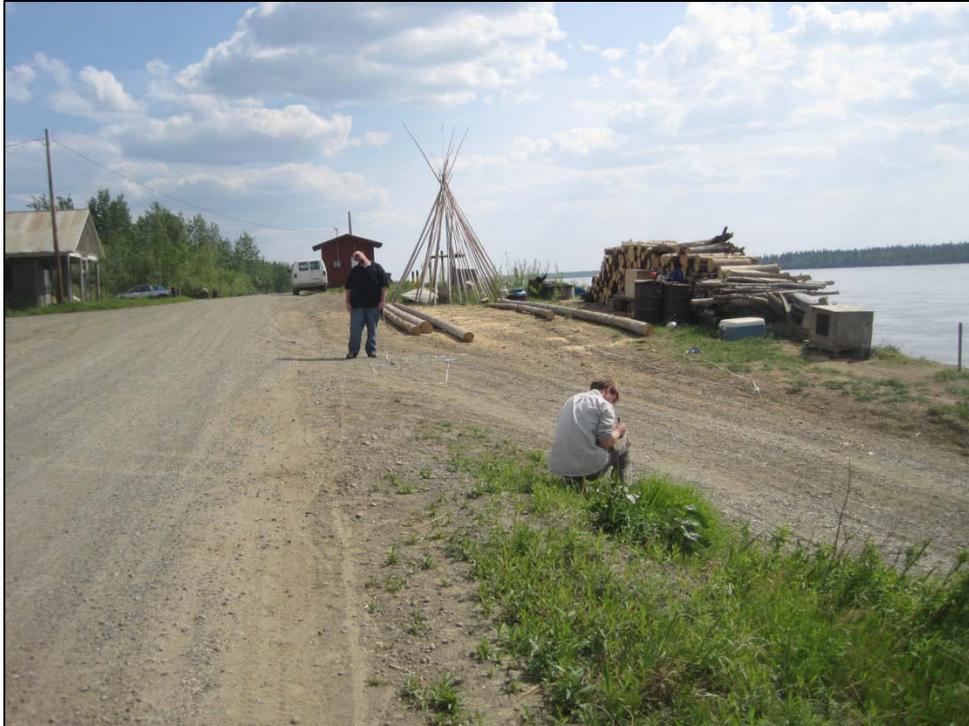
Photo 18. Corps employee crouching at proposed location of the middle mooring point for the upstream fuel landing. Note the small work area, log stash, and dog house on the opposite side of the ramp.

The proposed middle mooring point is located 85' downstream of the fuel header on the downstream side of where the ramp meets First Avenue at $65^{\circ}10'13.86''\text{N}$, $152^{\circ}4'51.24''\text{W}$ (Photo 18). Placement of a mooring point on the downstream side of the ramp could cause mooring cables to block the ramp. The opposite side of the ramp, however, was occupied by a small work area, woodpile, and dog house with dog during our visit. If barge operators indicate the potential blocking of the ramp as unacceptable, placement of this mooring point on the upstream side of the ramp should be considered.

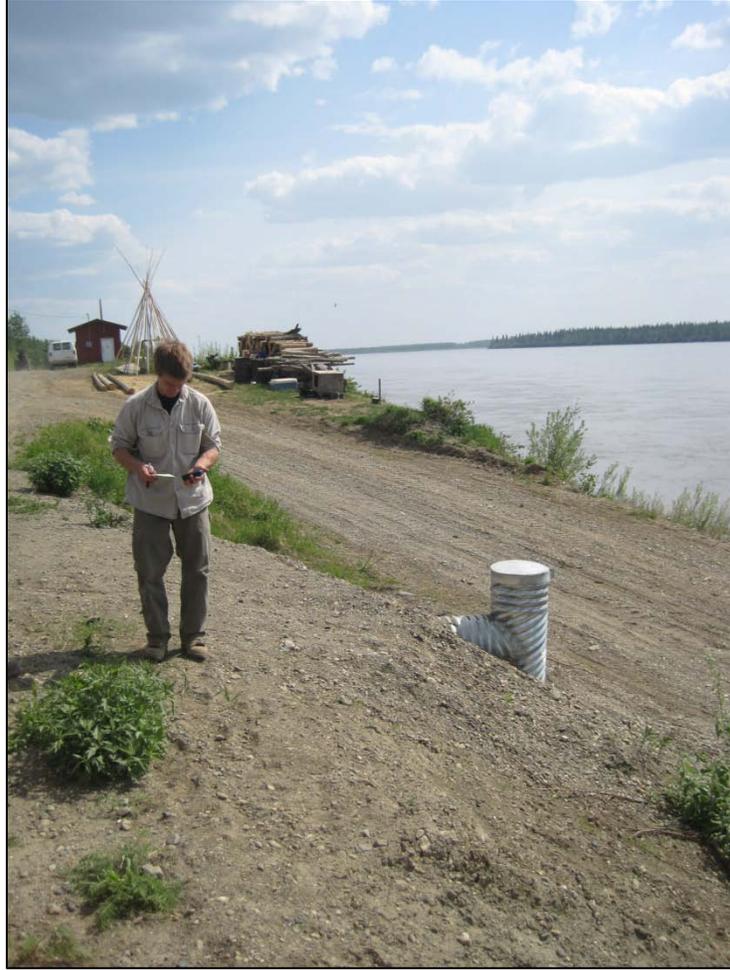
Photo 19. Corps employee standing at the proposed location of the downstream mooring point at the upper fuel landing.

The proposed downstream mooring point is located 65' downstream of the proposed middle mooring point and 6' downstream of a sewer cleanout along the shoulder of First Avenue at $65^{\circ}10'13.86''\text{N}$, $152^{\circ}4'52.68''\text{W}$ (Photo 19).
