GRAYLING HEALTH CLINIC

Alaska Rural Primary Care Facility Code and Condition Survey

Final
July 23, 2001

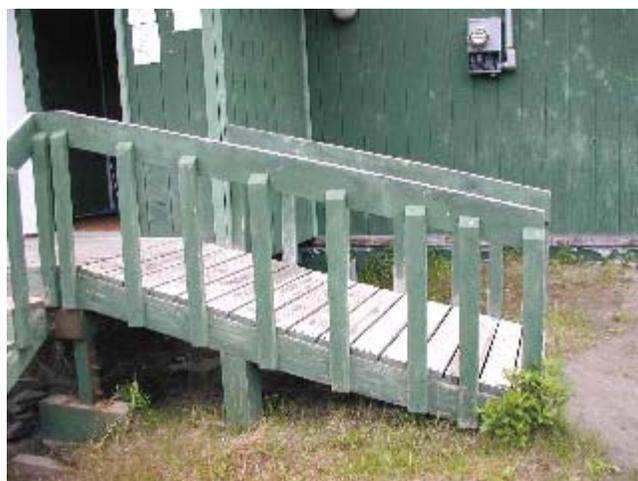
Front Ramp

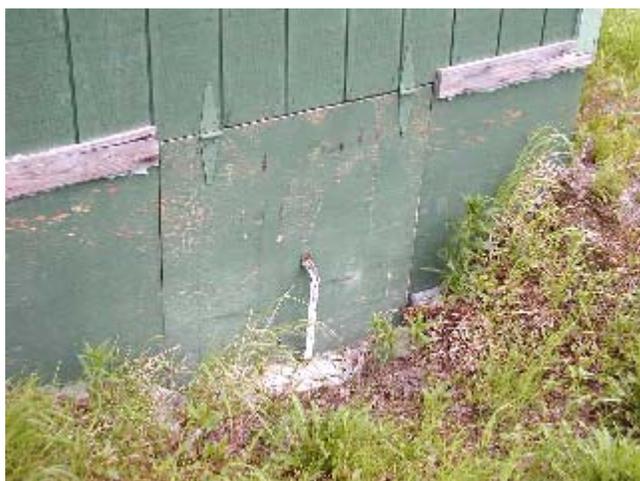
Crawlspace door and bermed earth

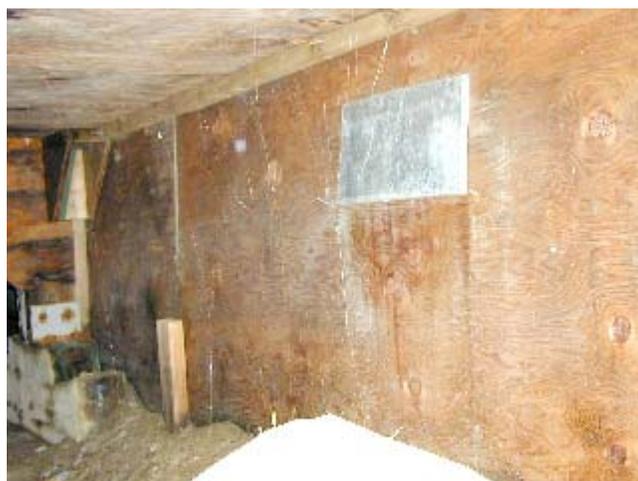
The foundation is treated 8 x 8 posts on 3 x 12 pads for support. There is a 2 x 4 untreated pony wall with 6 mil deteriorated plastic as protection of the plywood containing the crawlspace. The crawlspace has been backfilled to floor level. The system is over a silty, sandy dirt base and is in poor structural condition. Pads have settled, walls are racked, and the building has floor level deviation and has substantial cracking on the interior. There is no hold down strapping and the bracing is loose or missing. The addition of the crawlspace wall and exterior dirt has lead to foundation rotting. In general the foundation needs substantial upgrade work for a new useful lifetime or replacement.

Crawlspace

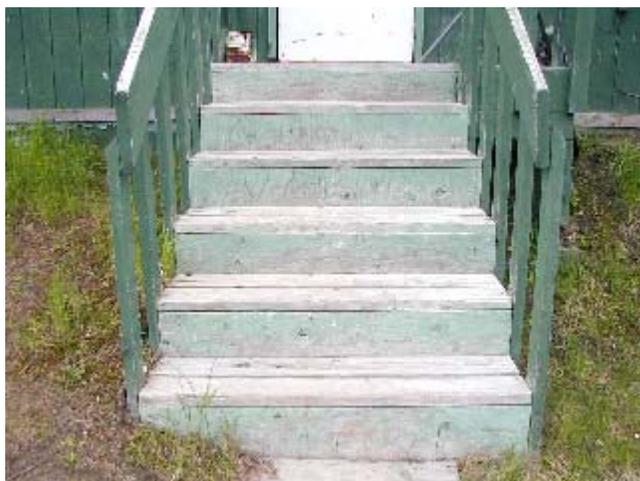
- f. Exterior Decks, Stairs, and Ramps
There are minimal Arctic entries. There is a landing at the front entrance outside the main door, and the rear door the stairs and ramp are deteriorating, and the stairs rise and run do not meet code. The ramp is very steep and does not meet ADA and the handrails and landings do not meet code.

Rear Stair

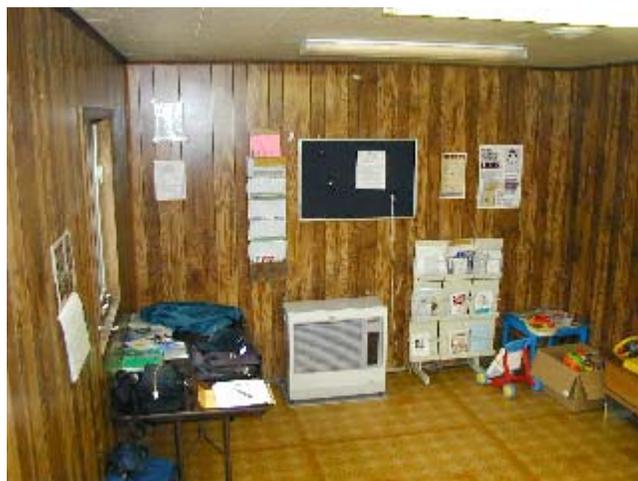
- b. Waiting / Reception –The waiting area contains a couch for secondary patient use and two chairs and has equipment and other items stored in the room.

Waiting Area

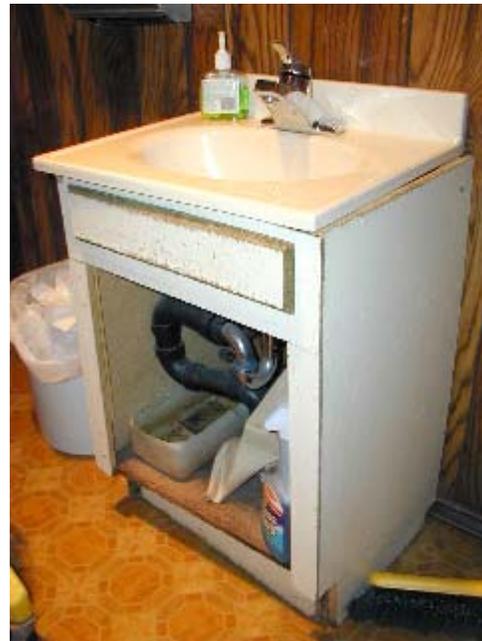
Sink in Toilet room

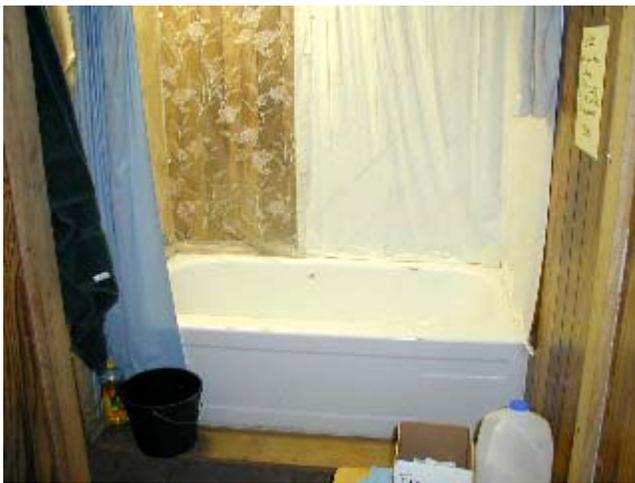
- j. HC Toilet Facilities – A single toilet room serves patients and clinic staff. The toilet room did not meet any of the ADA or UPC requirements. Entry door width was too narrow, and the toilet and sink lacked sufficient clearances and were of incorrect fixture type. There is no vacuum breaker on this sink as required by code. The tub is raised and is waterproofed with duct tape and plastic. All these areas are very unsanitary.

Bath tub not code compliant

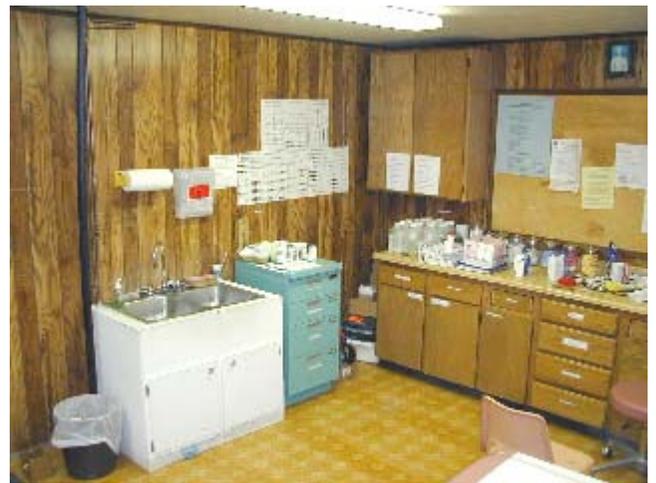
- c. Trauma/Telemed/Exam – There is a trauma exam/trauma room that is really the only exam room available. The room though sized adequately is full of other clinic equipment and storage items.

Exam/Trauma Room

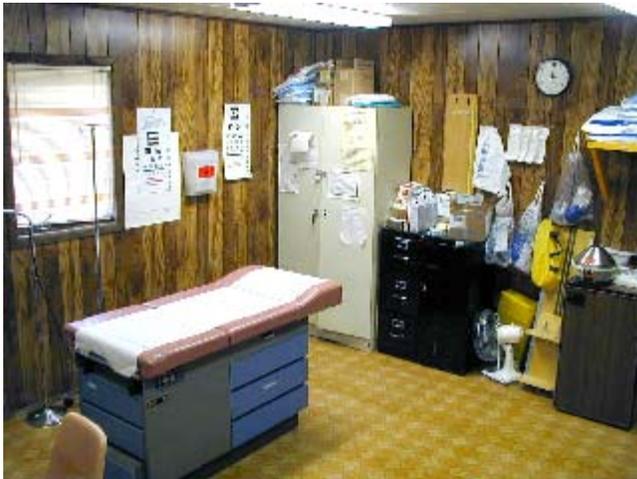
Exam / Trauma Room

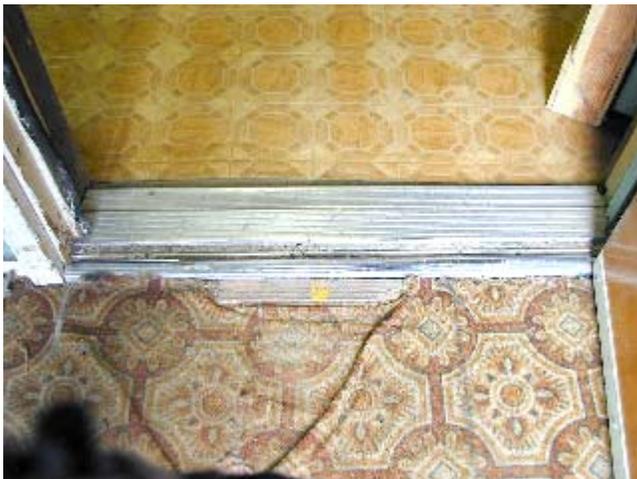
Floor and Threshold non-compliant

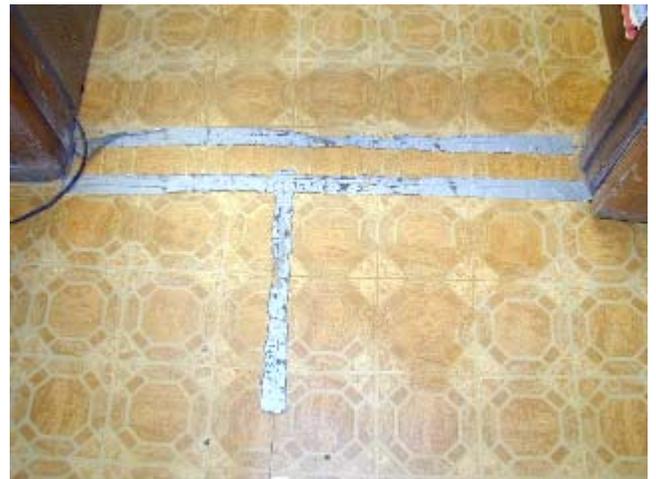
- a. Flooring:
The flooring is Sheet vinyl over plywood. It has been replaced in many area and is seriously deteriorated in most areas. Duct tape has been used to patch the flooring that is

worn out and covered with duct-tape in other areas. Entire replacement of sub-floor and finish is required to meet sanitary requirements.

Typical floor condition
