CONSTRUCTION INSPECTION REPORT

Project: Knudson Cove Harbor				Report No: Pool – 018			
File No: 062010.05 C-2				Date: February 23, 2009			
Consultant: PND Engineers, Inc.				Day of the Week: Monday			
WEATHER	Bright Sun	Clear X	Overcast	Rain	Snow	Other	
TEMP	Below 0	0-32	32-50 X	50-70	70-85	Over 85	
WIND	Still	Mod X	High	Comments:			
HUMIDITY	Dry	Mod X	Humid	Comments:			
<u>Name of Contractor</u>		<u>Non-Manual</u>		<u>Manual</u>		<u>Remarks</u>	
Pool Engineering		1		4			
CONTACTS							
<u>Name</u>		<u>Title</u>		<u>Phone No.</u>		<u>Remarks</u>	
John Pool		Project Manager		907-617-1615			
FIELD ACTIVITIES							
<p>At pile H8 Contractor placed drill casing in pile hoop to continue drilling were 3ft. of pile socket was still needed. They drilled at this location for 1hr., very little advancement was made. Due to high tide and a short drill casing, Contractor was forced to remove drill and casing before damage to the floats occurred. With the rising tide, light damage was done to the pile hoop galvanizing from the drill leads. Contractor will repair per specification.</p> <p>Contractor continued to drill at pile location H7. They drilled at this position for 5hrs were a total of

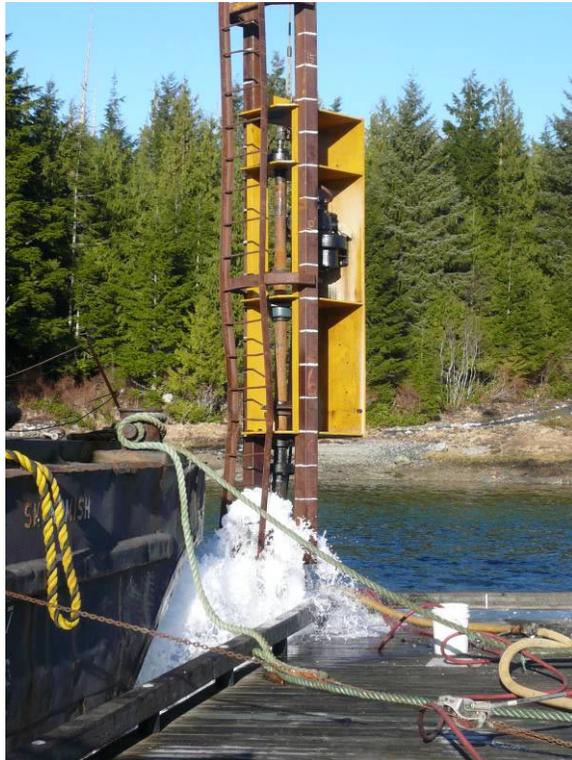
Photograph No. 1

Rock socket drilling for pile H8.

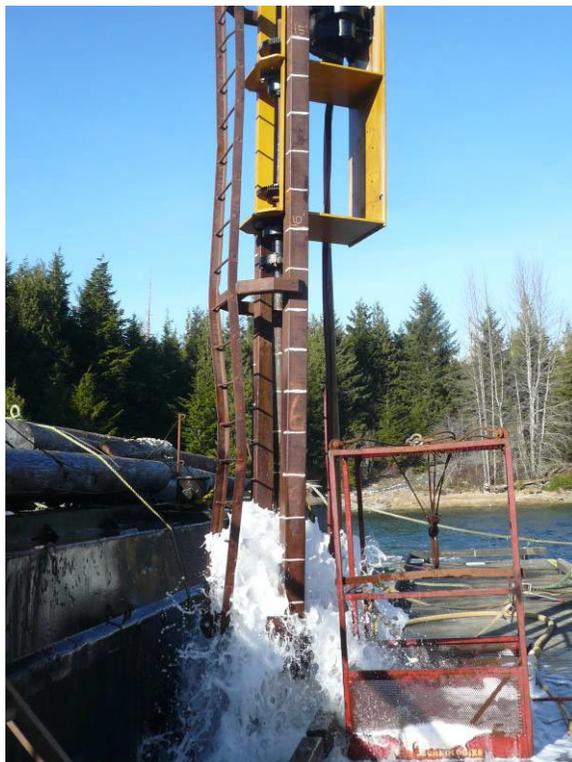
Photograph No. 2

Rock socket drilling for pile H7.
