CONSTRUCTION INSPECTION REPORT

Project: Knudson Cove Harbor				Report No: Pool – 032		
File No: 062010.05 C-2				Date: March 25, 2009		
Consultant: PND Engineers, Inc.				Day of the Week: Wednesday		
WEATHER	Bright Sun	Clear	Overcast X	Rain	Snow	Other
TEMP	Below 0	0-32	32-50 X	50-70	70-85	Over 85
WIND	Still X	Mod	High	Comments:		
HUMIDITY	Dry	Mod X	Humid	Comments:		
Name of Contractor		Non-Manual		Manual		Remarks
Pool Engineering		1		4		
CONTACTS						
Name		Title		Phone No.		Remarks
John Pool		Project Manager		907-617-1615		
FIELD ACTIVITIES						
<p>2 weeks later, after equipment repairs, the Contractor was able to continue drilling at pile location M6. The required 8-ft rock socket was achieved and approx. 1 yard of aggregate was placed in the hole, through the casing. The supplied 80-ft pile was placed into position and driven to approx. 5' of penetration with the vibratory hammer. This was the entire penetration achieved today do to damage to the vibratory hammer. Contractor will continue driving after repairs are made.</p> <p>Float section M2 was put in position, and the hinge assembly was installed. Contractor placed the 60-ft drill casing through the pile frame of M7 and s

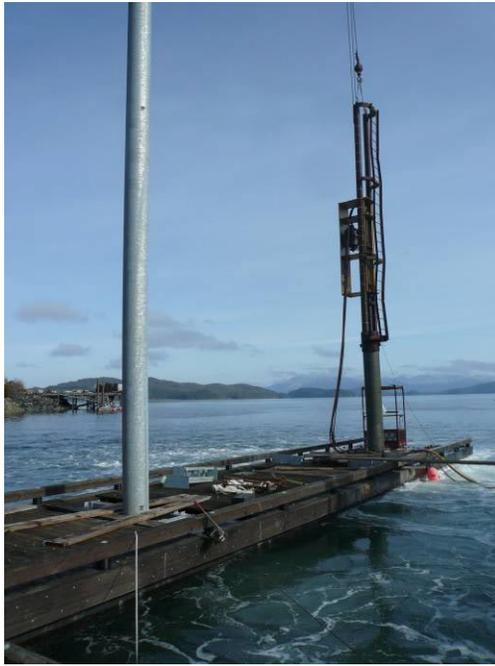
Photograph No. 1

Continued drilling socket at pile M6.

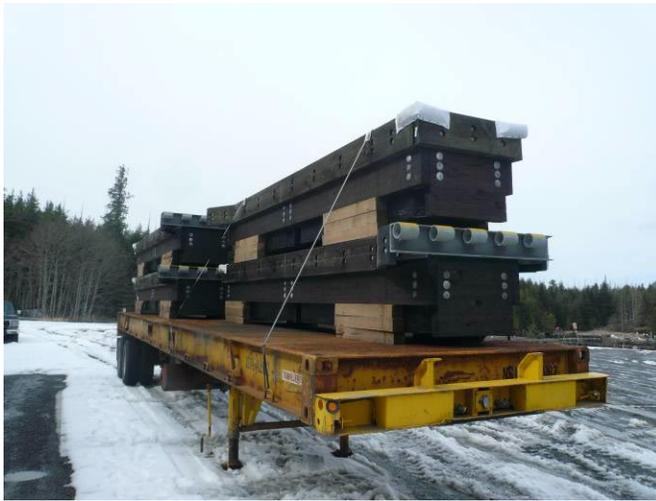
Photograph No. 2

(4) Finger floats arrived on site.

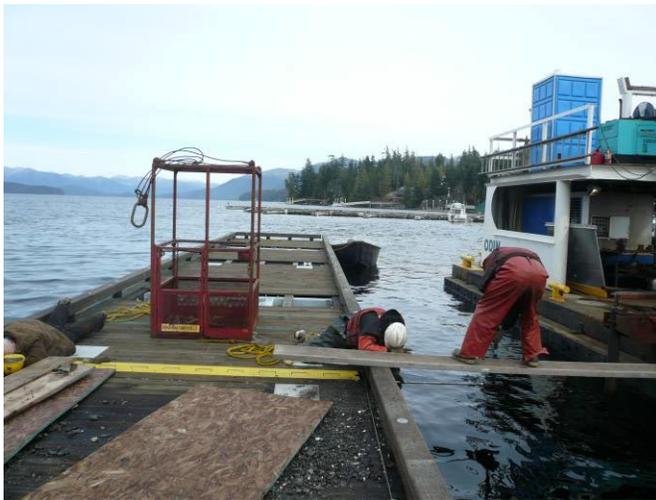
Photograph No. 3

Float section M2 in position.
Contractor installing hinge pin.
