DISTRICT TRIP REPORT

Project: Denali Commission Moorings Points Phase 3 – Kuskokwim River

Description: Kongiganak Trip Report

Date: 24 September 2010

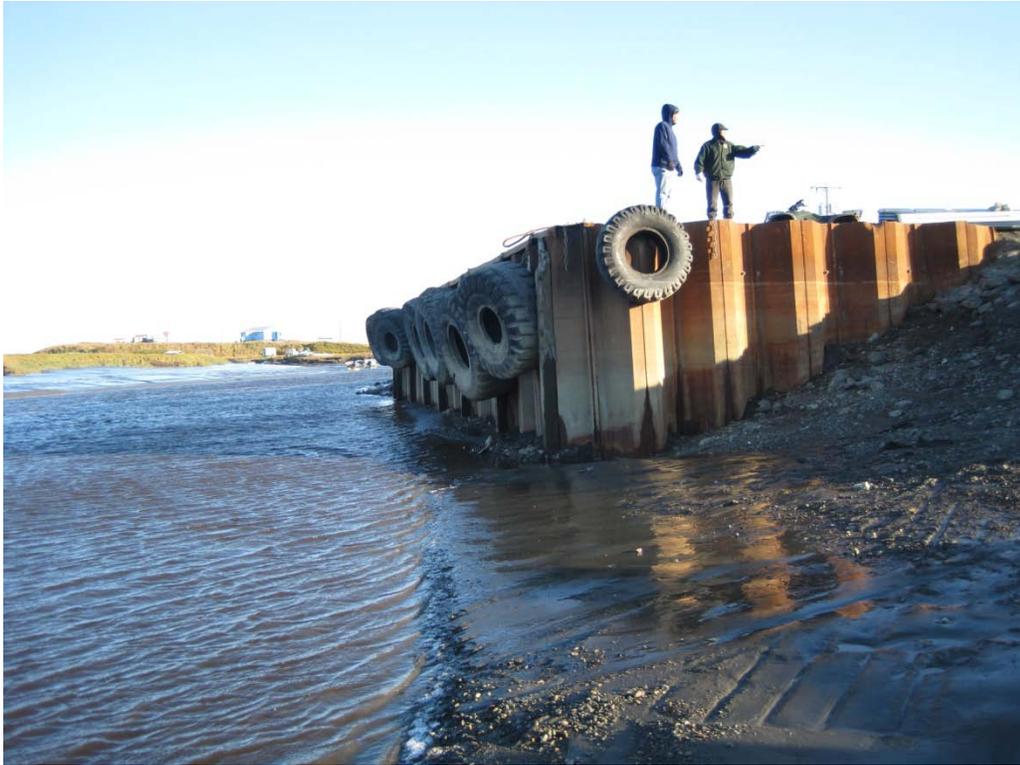
This is an improved landing site consisting of a rectangular, sheet pile, backfilled landing area running approximately 100 feet along the Kongiganak River (Photos 1 - 4). A gravel road leads away from the gravel staging area toward the airstrip where a school was being constructed.

Photo 1: Existing Barge Landing Site Looking Upstream

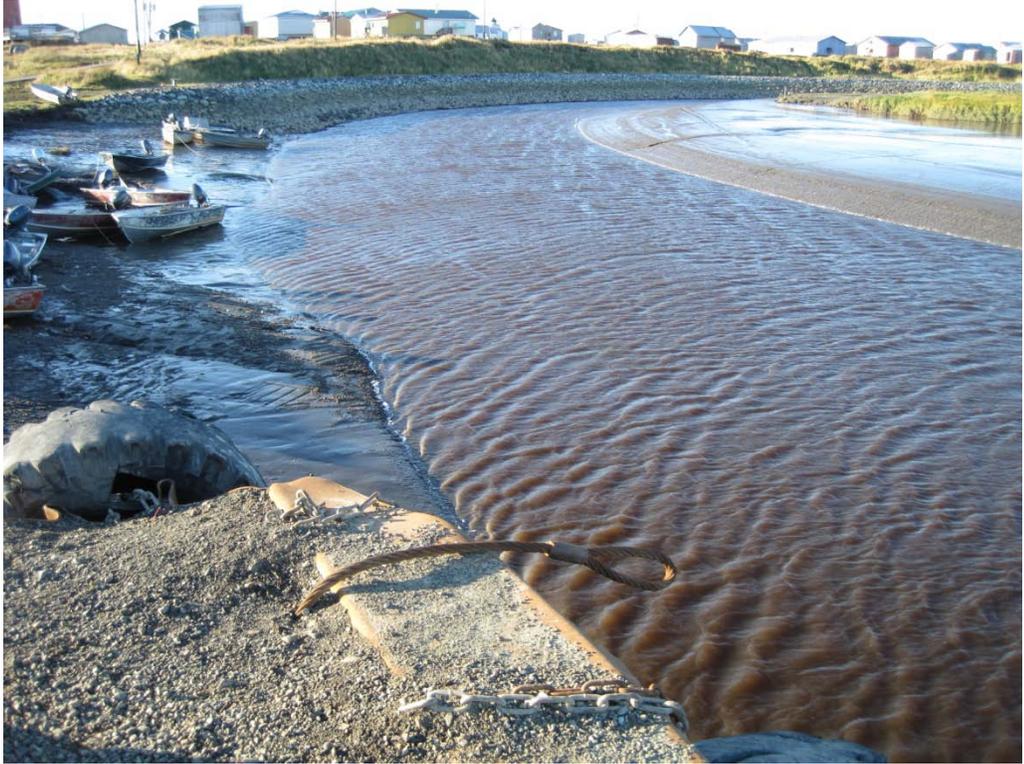
There are currently two cables protruding from the fill adjacent to the two corners of the structure that appear to serve as mooring points (Photos 2 – 3). The coordinates of the existing downstream mooring cable site are 59 57'41.71861" N, 162 53'17.09894" W while the coordinates of the existing upstream mooring cable site are 59 57'42.56531" N, 162 53'17.22383" W. Ascertaining the effectiveness of these mooring cables requires follow up with barge companies using this landing site.

Photo 2: Existing Downstream Mooring Cable

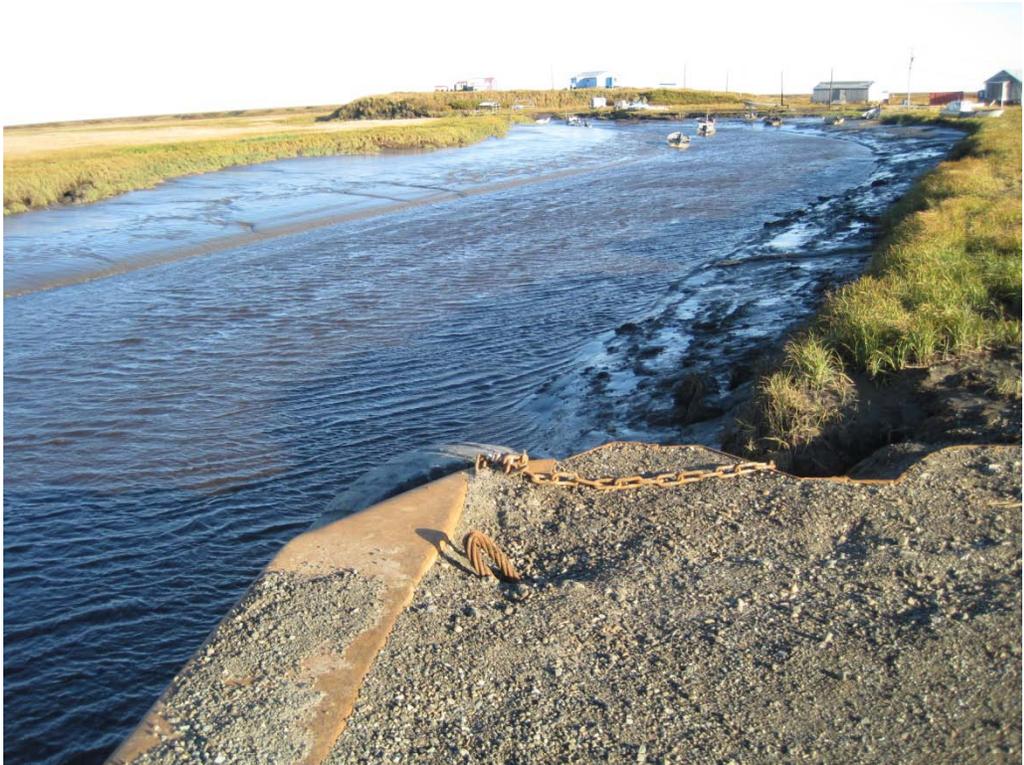
Photo 3: Existing Upstream Mooring Cable

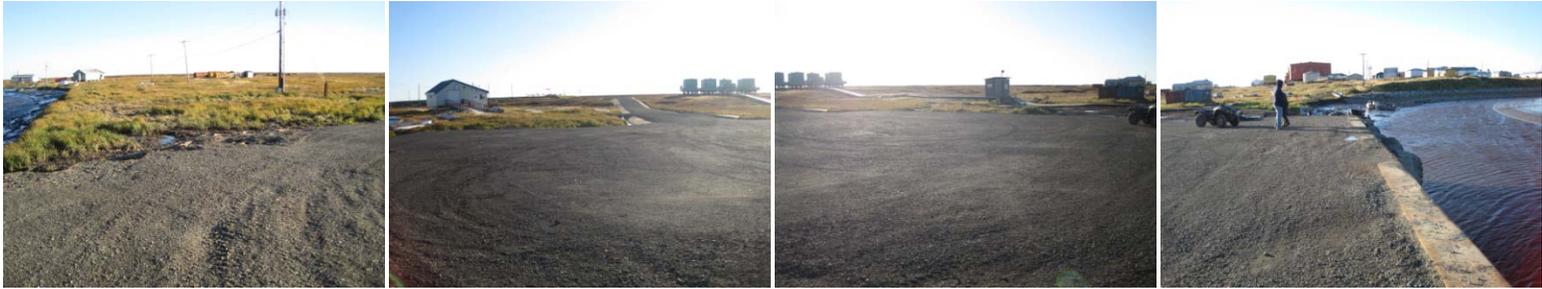
Photo 4: Panoramic View of Existing Freight Barge Landing Looking Upstream to Downstream Left to Right

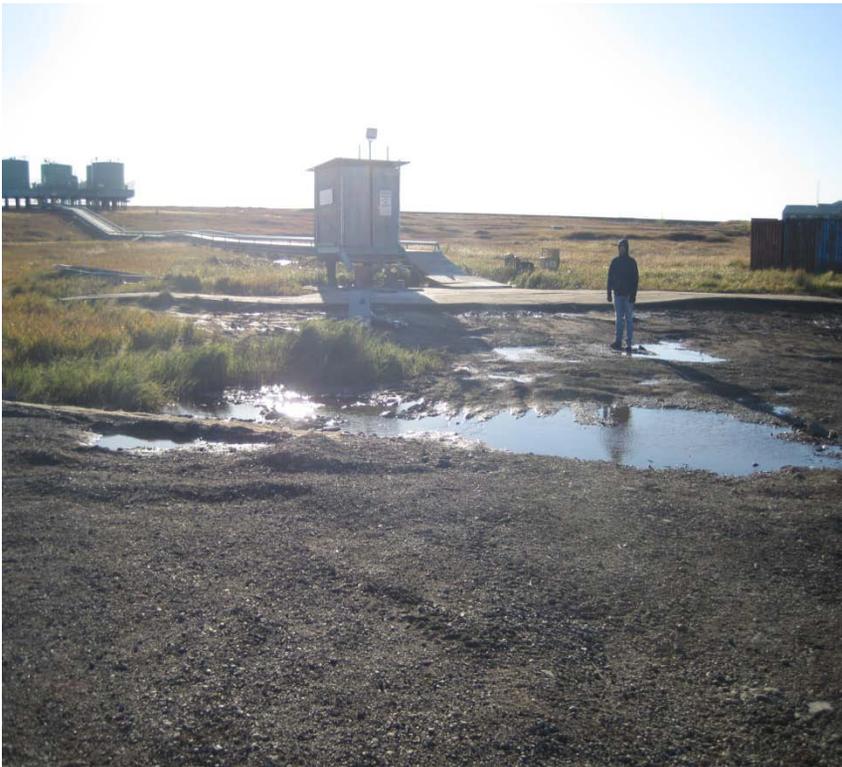
Photo 5: Coleman at Potential Downstream Mooring Point

If new mooring points were to be installed at this landing site they could be placed 50 feet upstream and downstream of the corresponding edges of the landing area and each 50 feet inland

from the river bank (Photos 5 – 6). The coordinates of the proposed downstream mooring point site are 59 57'41.21847" N, 162 53'15.61110" W while the coordinates of the proposed upstream mooring point site are 59 57'43.13831" N, 162 53'15.99739" W. The upstream mooring point should be an above grade installation to avoid the chain getting lost or frozen in the prevalent mud and standing water. The downstream mooring point should be a below grade installation to avoid conflicts with local staging and travel.

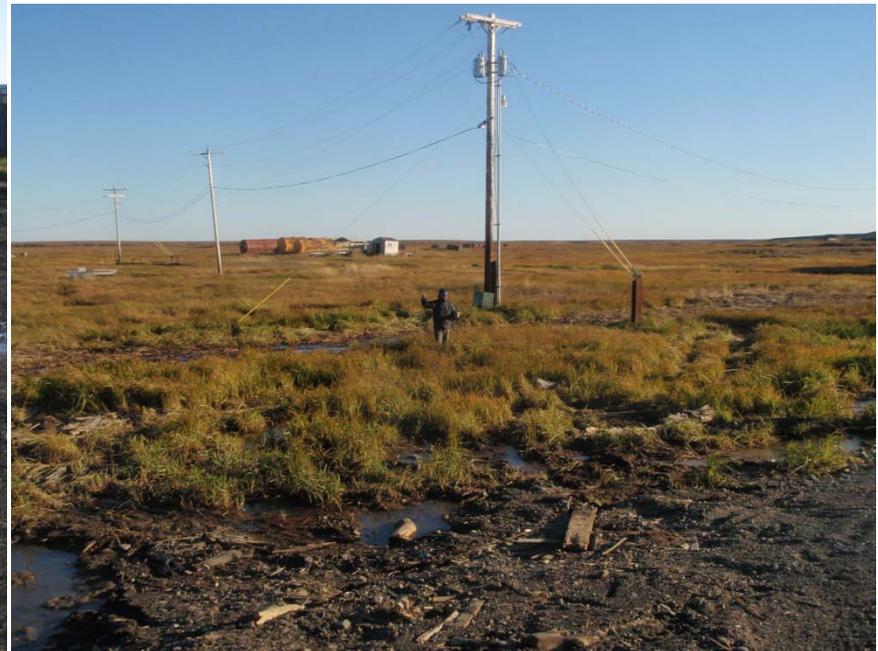
Photo 6: George at Potential Upstream Mooring Point.

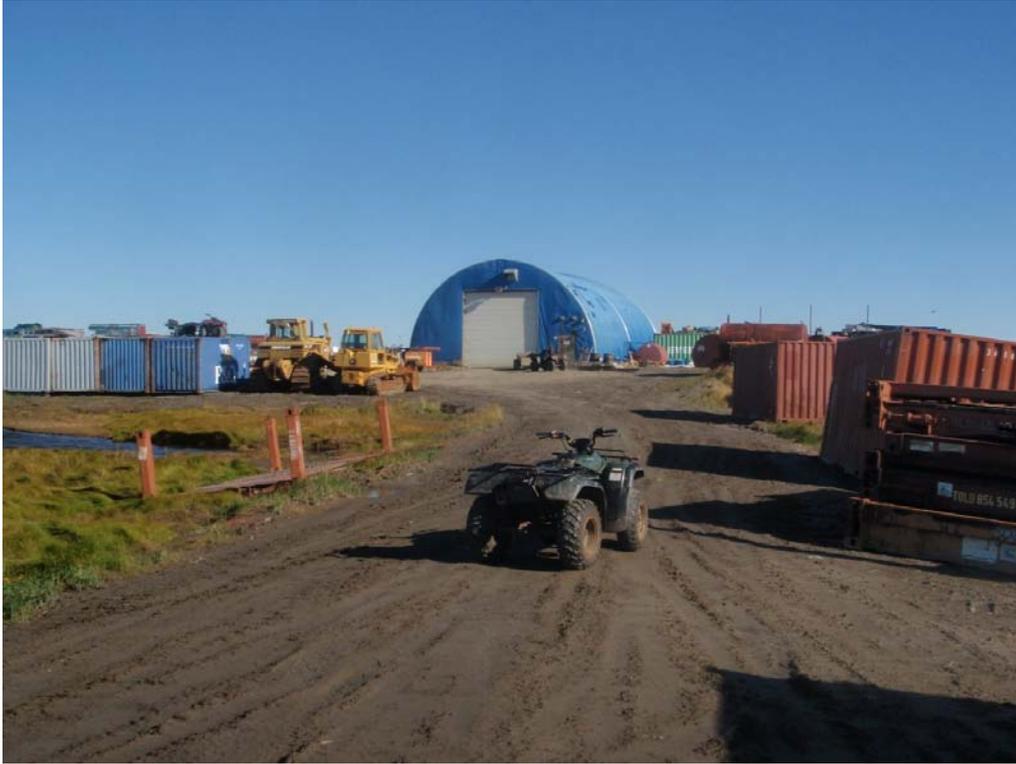
This freight landing site is located to the west of the community sewage lagoon. It is downstream of the freight barge landing site described above and upstream of the fuel barge landing site. There is a good, gravel access road to the site and a small staging area (Photos 7 – 8). It is referred to as the Village Safe Water Freight Landing Site since it apparently was built specifically in support of the ongoing water and sewer installation project in the village. There is a fair bit of equipment and supplies stored about the site.

Photo 7: Village Safe Water Freight Landing Site Looking Inland

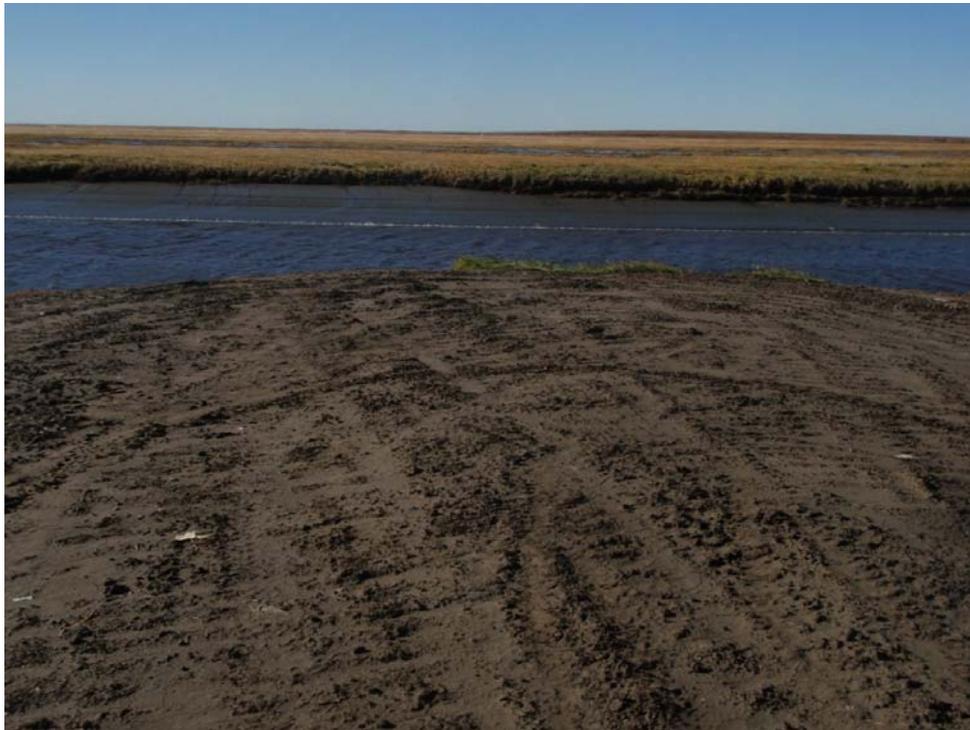
Photo 8: Village Safe Water Freight Landing Site

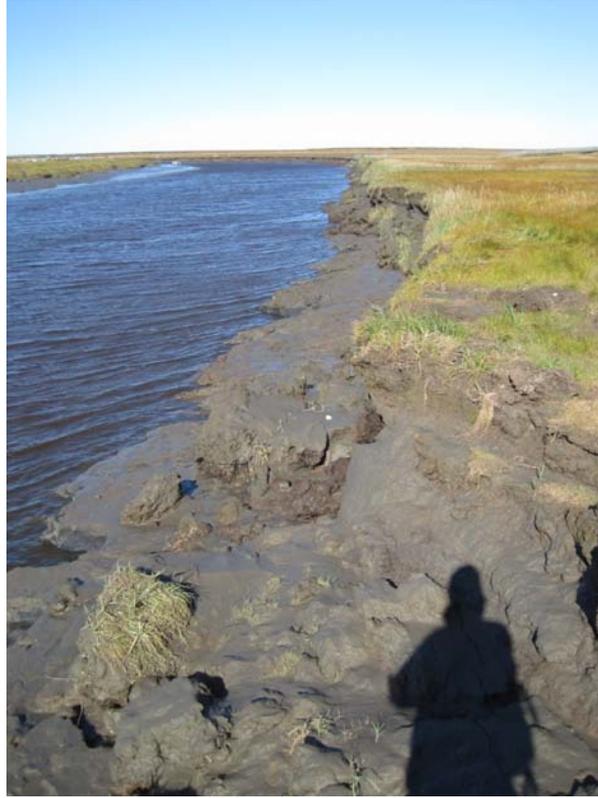
Although this landing site is located along a straight stretch of river, active erosion is still evident (Photo 9). Some small diameter pipes are daylighting out of the eroding bank downstream of the landing area.

Photo 9: Active Erosion Along Village Safe Water Landing Site

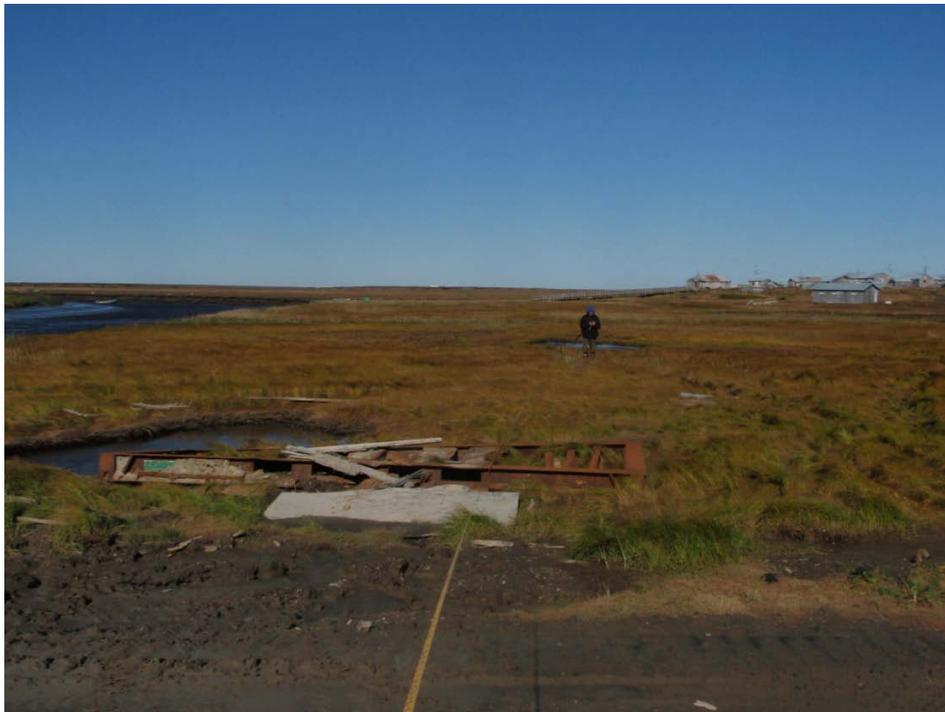
Photo 10: George at Potential Upstream Mooring Point for Village Safe Water Freight Barge Landing Site

If mooring points were to be installed here they could be placed one each 100 feet upstream and downstream from the centerline of the barge landing access road and 50 feet in from the river (Photos 10 – 11). Coordinates for the upstream mooring point at this location is 59 57'20.55551" N, 162 53'47.12396" W and for the downstream mooring point 59 57'18.62142" N, 162 53'47.03579"W. Both mooring points should be below grade installations since the area is wide open and likely an area of rapid snow machine travel in the winter.

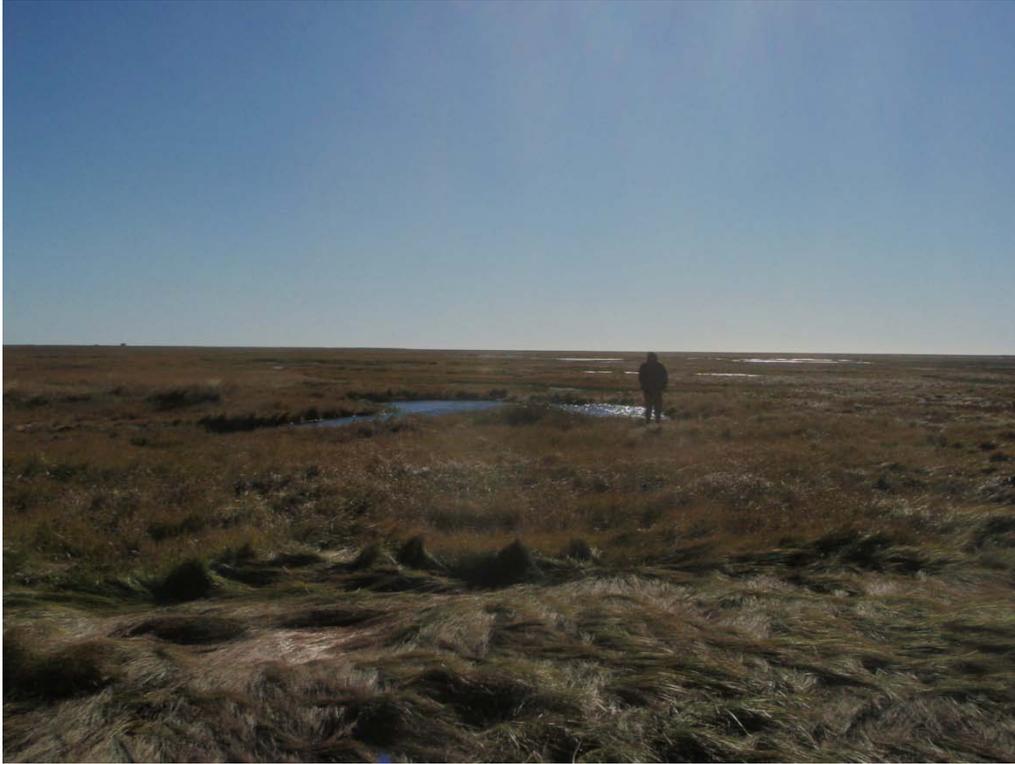
Photo 11: George at Potential Downstream Mooring Point for Village Safe Water Freight Barge Landing Site

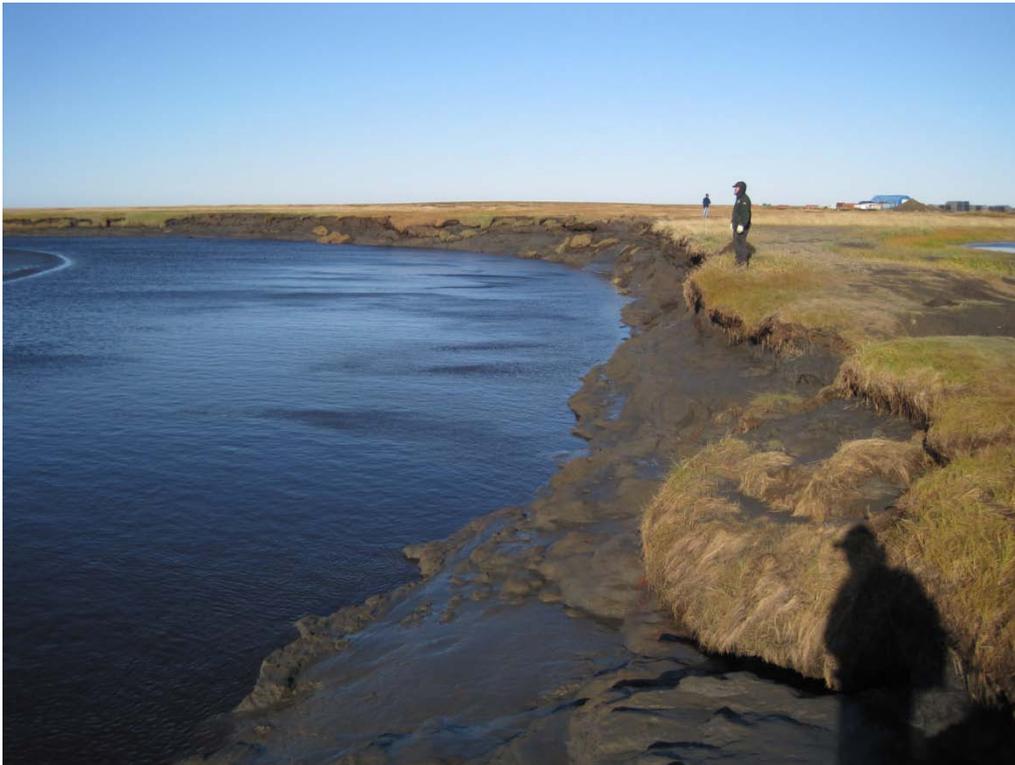
This river bank along the landing site is actively eroding (Photo 12). We were told during the public meeting that the fuel header has required relocation approximately 20 feet inland due to the erosion threat.

Photo 12: Active Erosion at the Fuel Barge Landing Site

Due to the erosion occurring at this site and the apparent instability of the existing deadman anchors, if new mooring points were installed they should be placed inland from the existing deadman anchors. The downstream mooring point should be placed 40 feet inland from the existing anchor across a small pond and adjacent to a faint 4-wheeler trail. The upstream mooring point should be installed 30 feet inland of the existing anchor just before a small rivulet. Both mooring points should be subgrade installations.

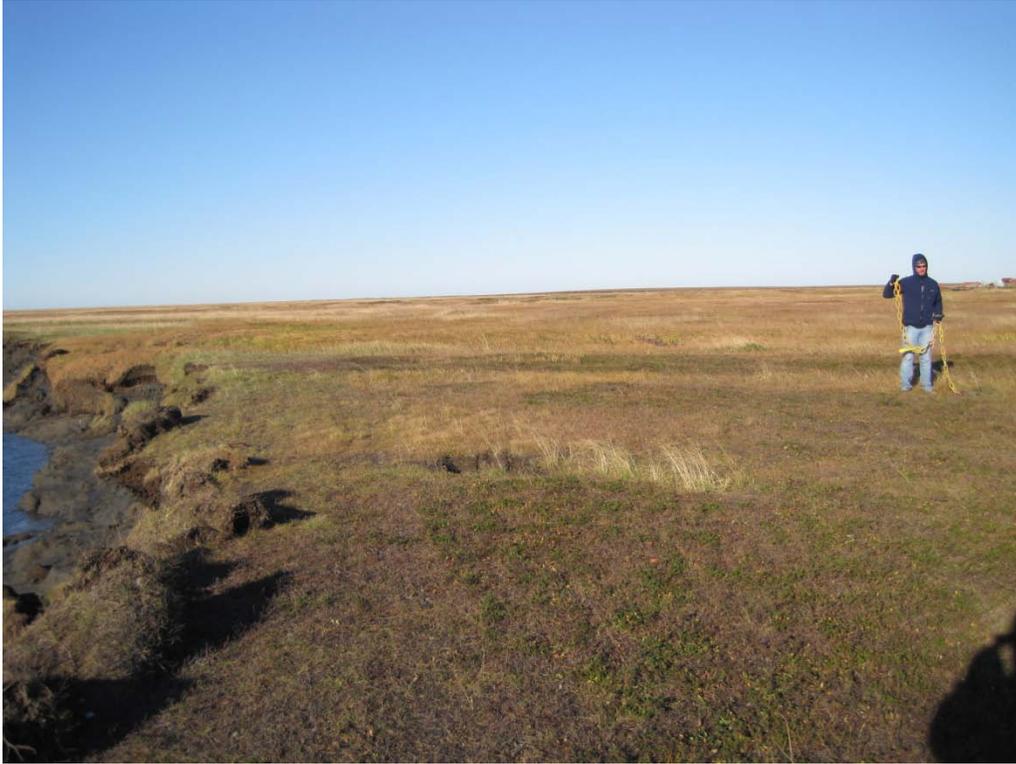
This fuel barging landing site has existing deadman anchors with chains protruding from the tundra. We were told during the public meeting that the anchors consist of 8 foot lengths of telephone pole buried 2 feet deep and were not intended to be permanent. There was evidence that the downstream anchor was beginning to become unburied and may not be capable of serving as an effective mooring point.

The existing upstream anchor was located 30 feet from the eroding top of bank and had the coordinates 59 57'11.17634" N, 162 53'18.60755" W (Photo 13). The existing downstream anchor was located 37 feet from the eroding top of bank and had the coordinates 59 57'10.48740" N, 162 53'14.24143" W (Photo 14). The coordinates of the fuel header are 59 57'11.82210" N, 162 53'17.44594" W.

Photo 13: Upstream Existing Fuel Barge Landing Mooring Point

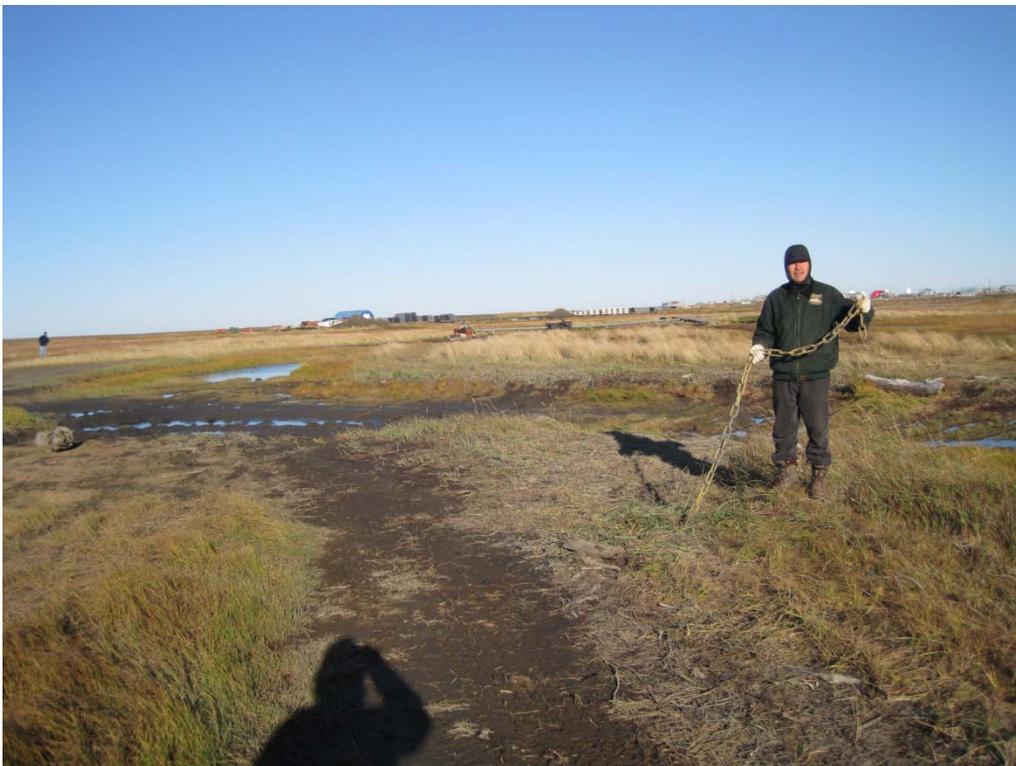
Photo 14: Downstream Existing Fuel Barge Landing Mooring Point
