# **KASIDAYA CREEK HYDROELECTRIC PROJECT**

**PROJECT NO. 11588**

## **MONTHLY CONSTRUCTION REPORT**

**APRIL 2007**

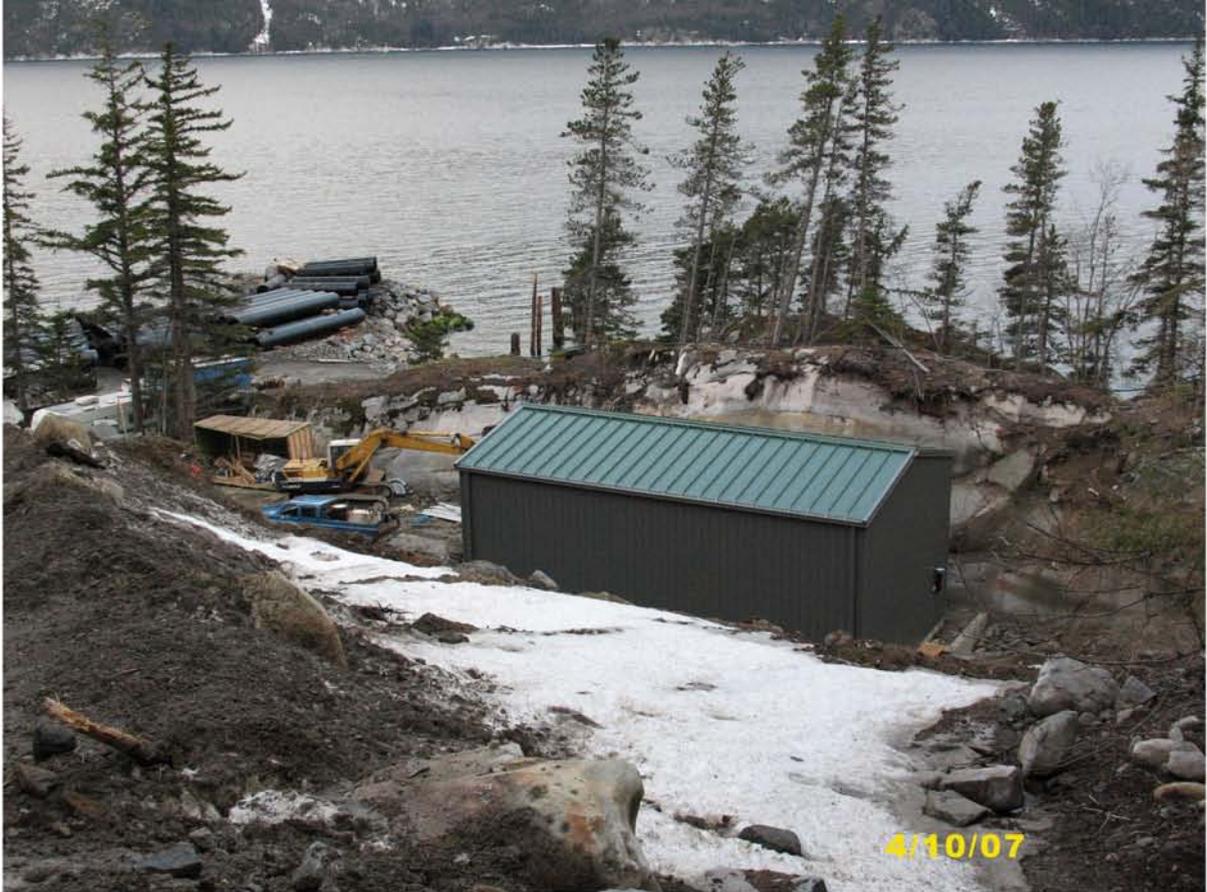
**Looking west from the Right of Way above the Powerhouse.**

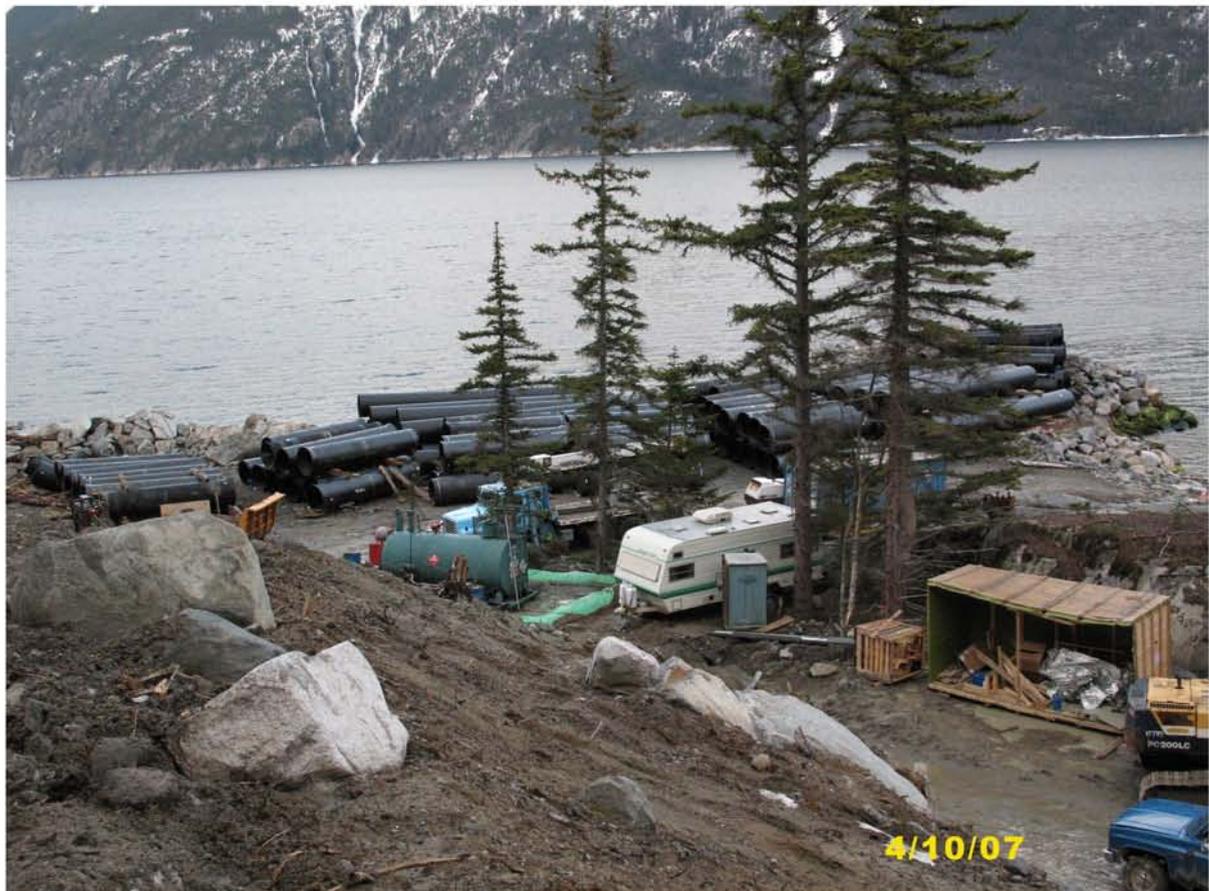
**Looking towards the Staging Area from the Right of Way above.**

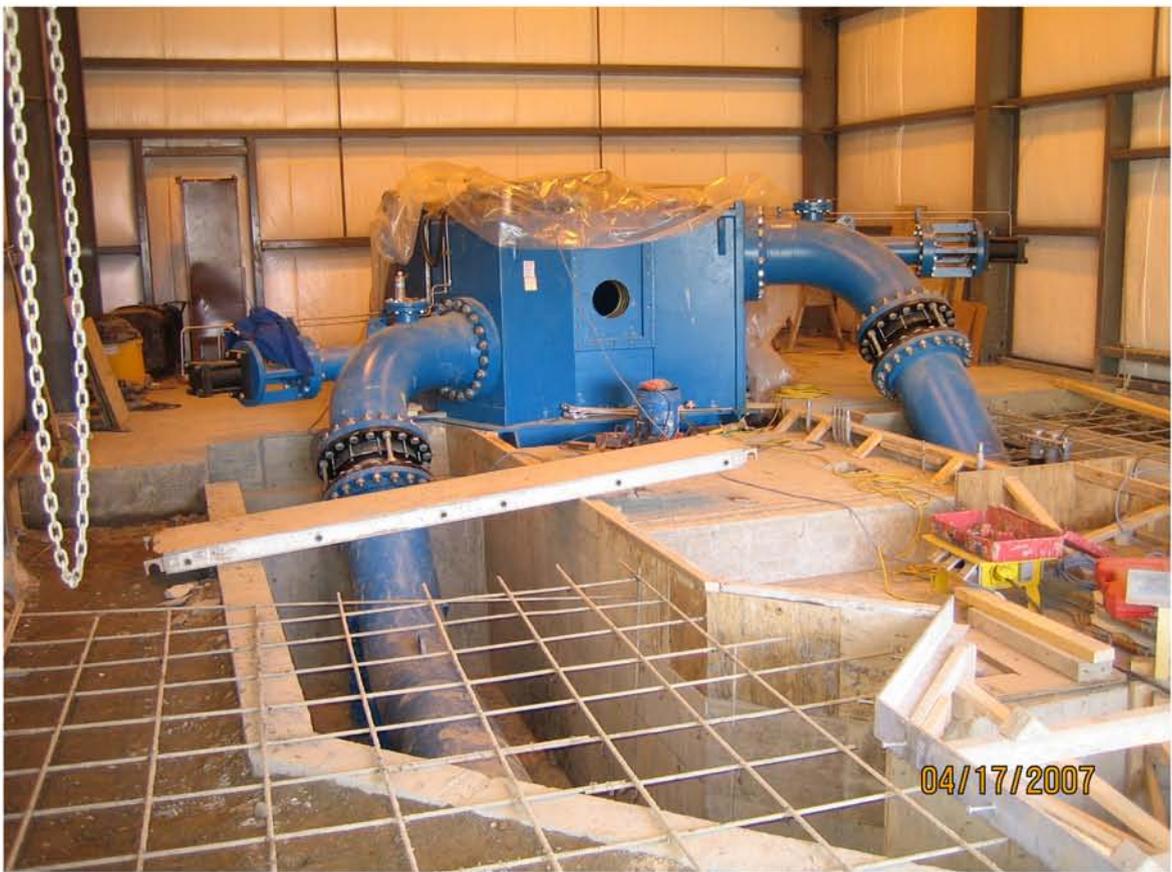
**FORMS BEING MADE AROUND THE BRANCH PIPES TO THE TURBINE**

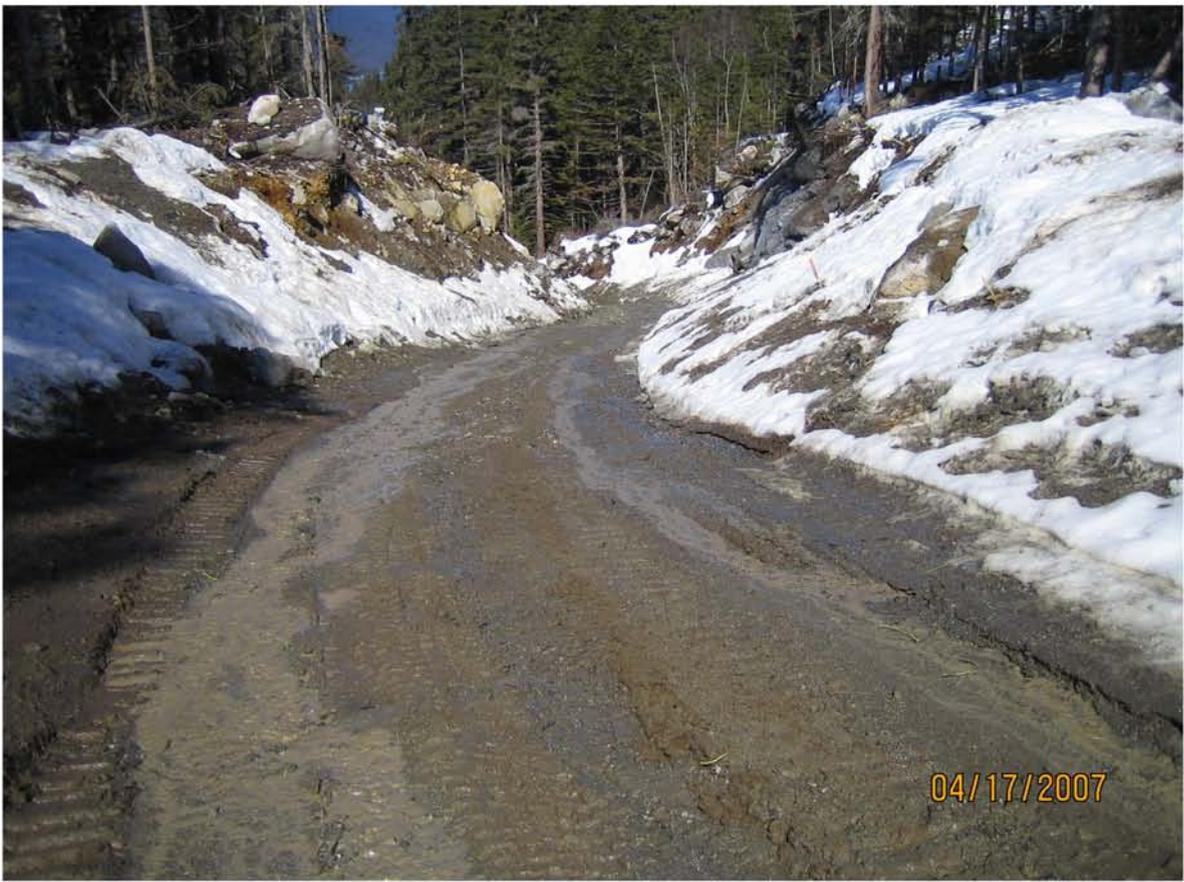
**ABOVE PHOTO: ACCESS ROAD FROM STA. 15+25  
BELOW IS VIEW OF POWERHOUSE WITH COMPLETED EXTERIOR SHELL**

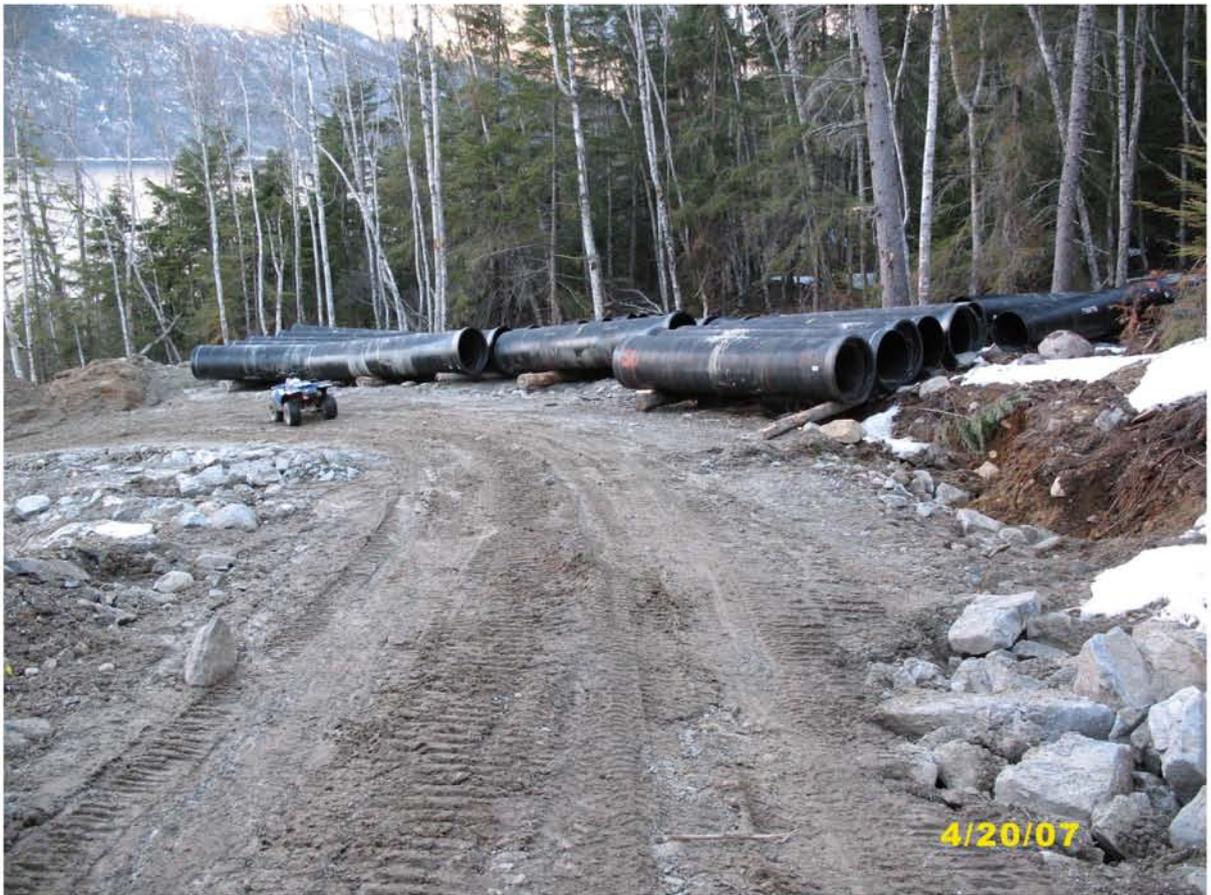
**Pipe being stored at Sta. 9+00.**

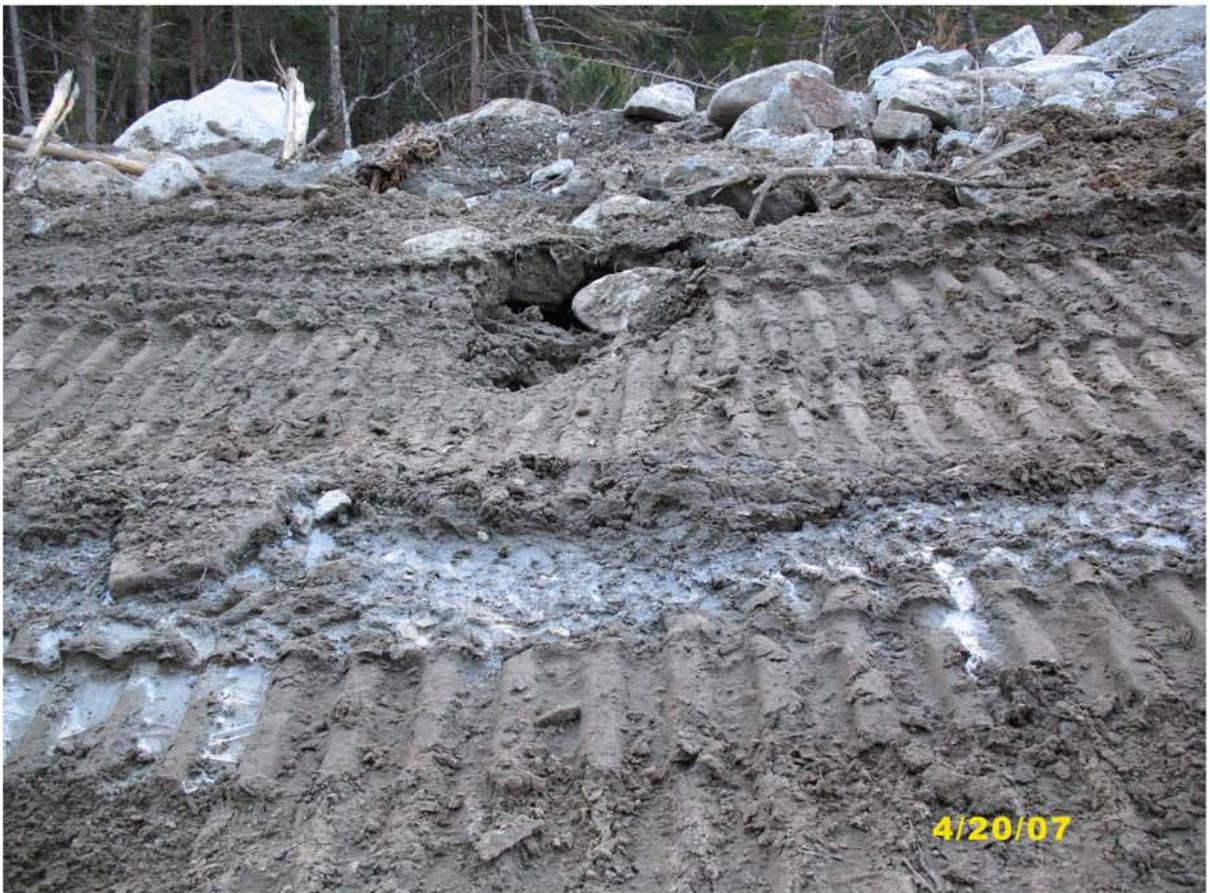
- The site is beginning to thaw out. Standing surface water and mud is found throughout the site.
- The crew is still primarily working in the staging area and around the powerhouse, therefore the work currently being done out at Kasidaya applies only a minimal threat of erosion.
- The right-of-way is beginning to thaw and the majority of the road is clear of ice to Station 9+00. The road is in decent condition with minimal water damage at this point.
- Water is currently flowing through the culvert by Station 7+31. It appears as if there was some sediment in the water earlier but now it is flowing clear.

**Hole in the Right of Way by Sta. 7+31.**

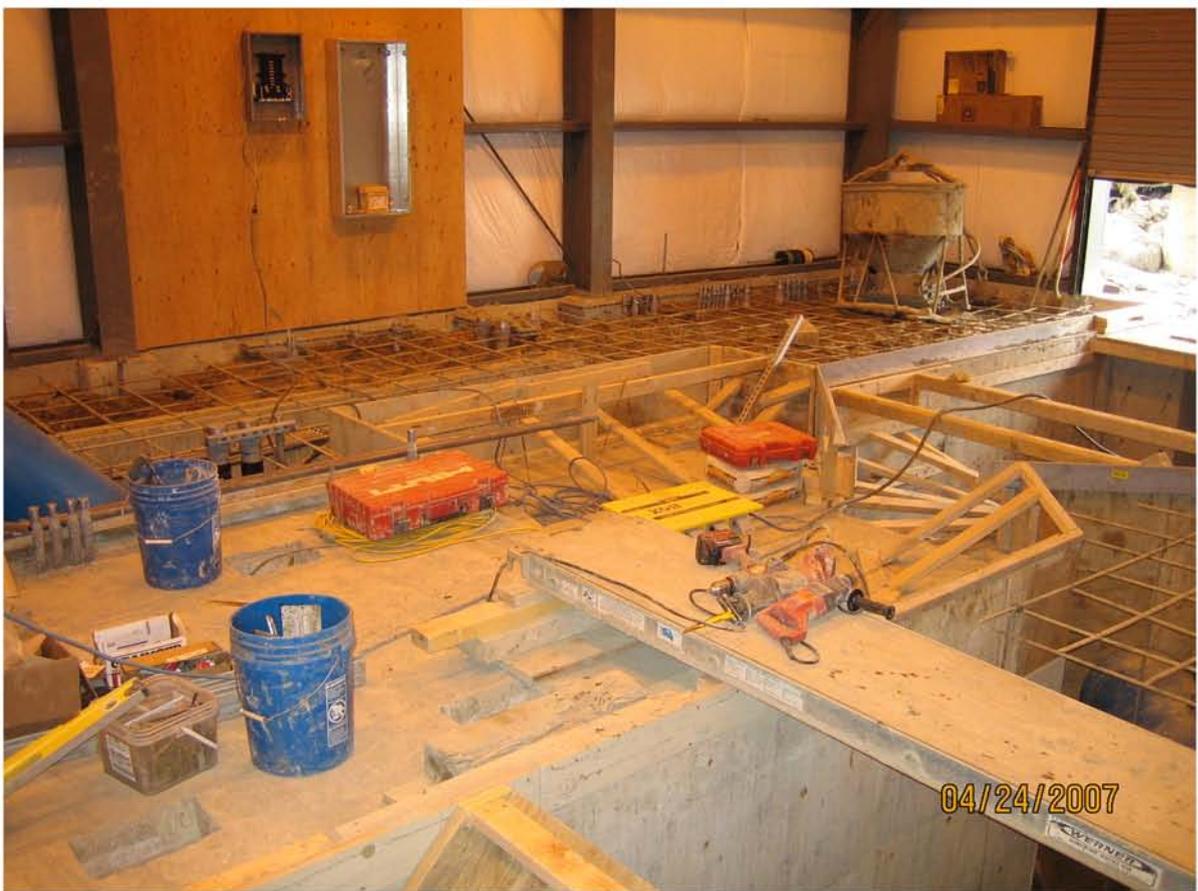
**ABOVE PHOTO: CONDUITS IN FORMS FOR BIFURCATED PIPE**

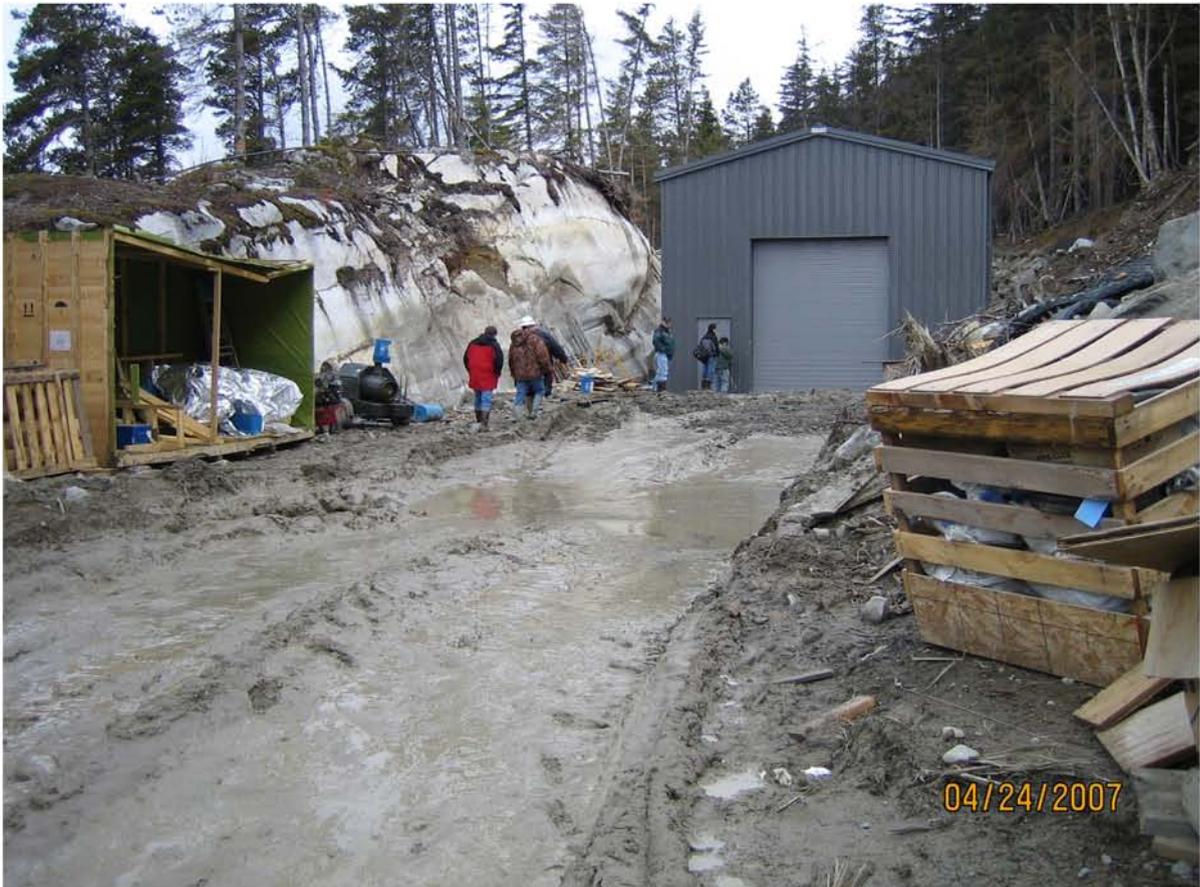
**SOUTH SIDE OF POWERHOUSE AFTER THAW**

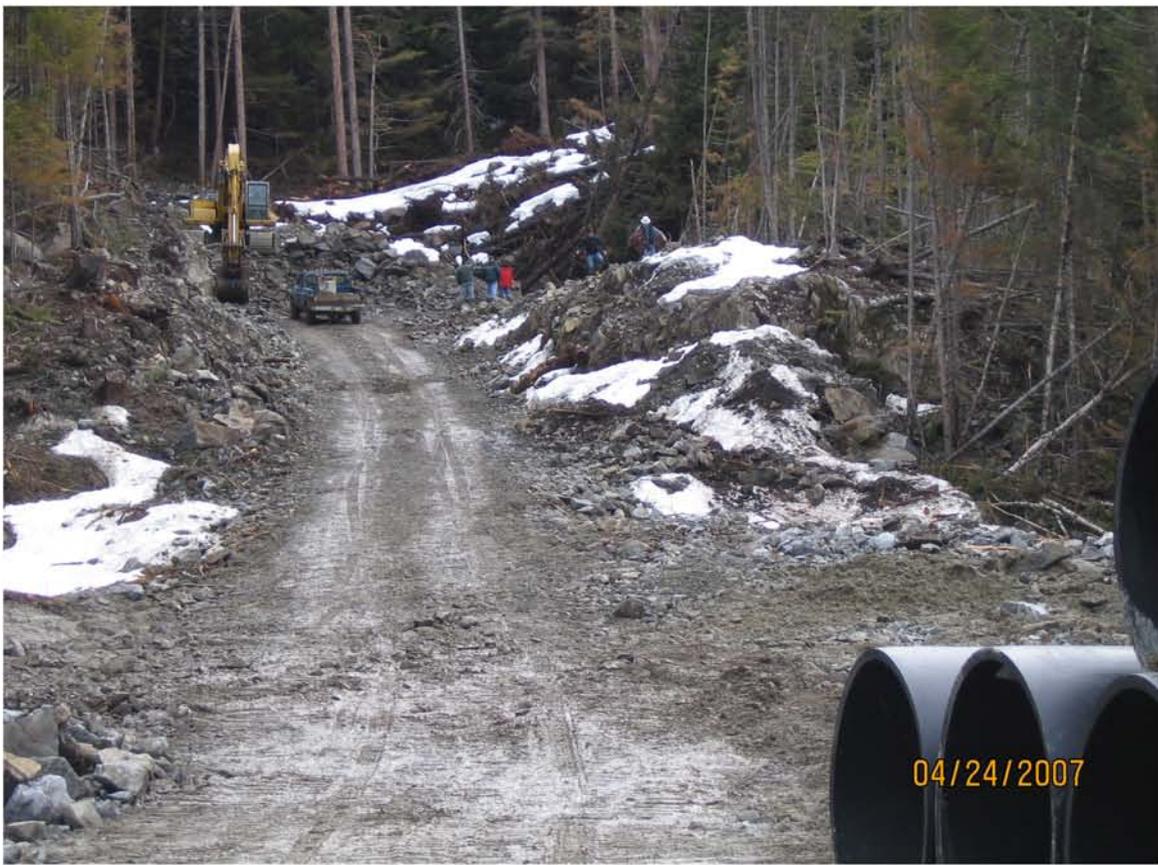
**ABOVE PHOTO: ACCESS ROAD GRADING AT 'NORTH TRIBUTARY'**
