KASIDAYA CREEK HYDROELECTRIC PROJECT

PROJECT NO. 11588

MONTLY CONSTRUCTION REPORT

JANUARY 2007

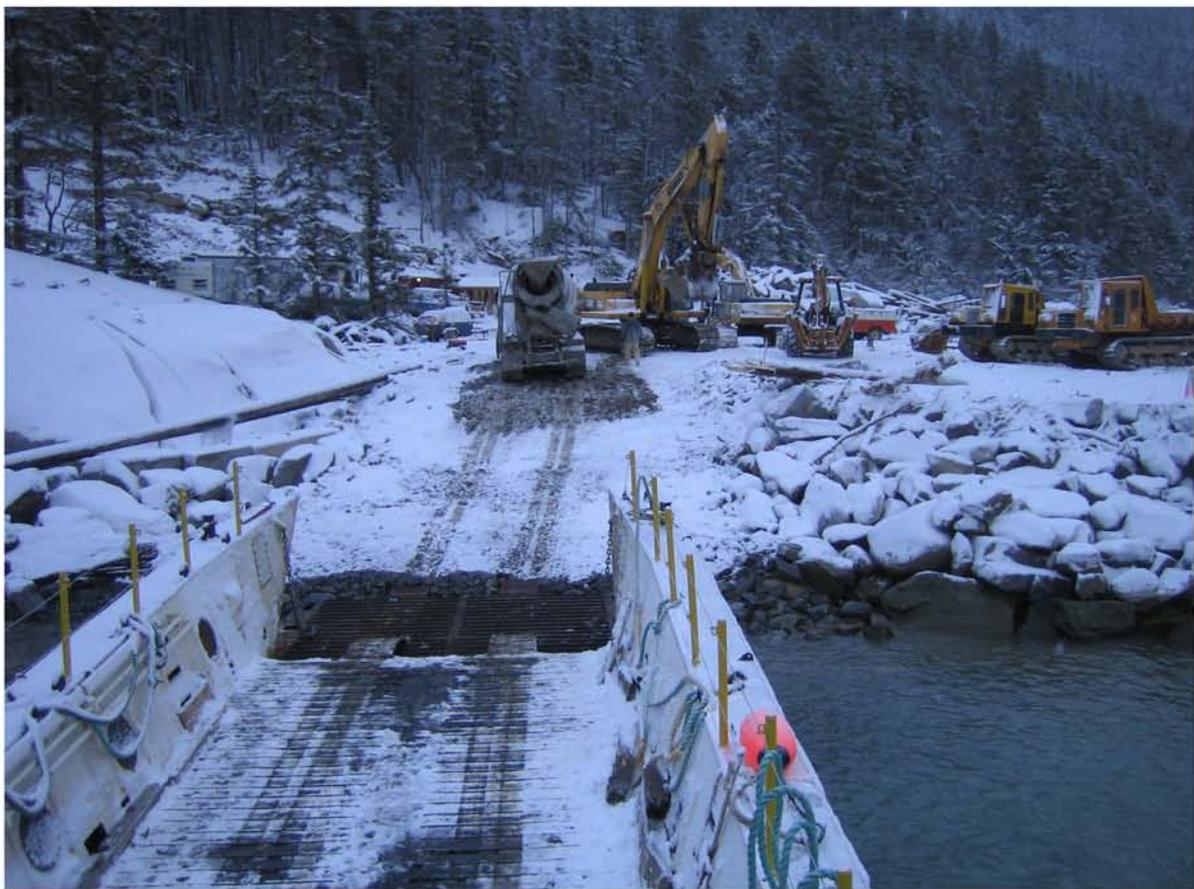
Photo 1

CONCRETE TRUCK ARRIVING VIA LANDING CRAFT JANUARY 5, 2007

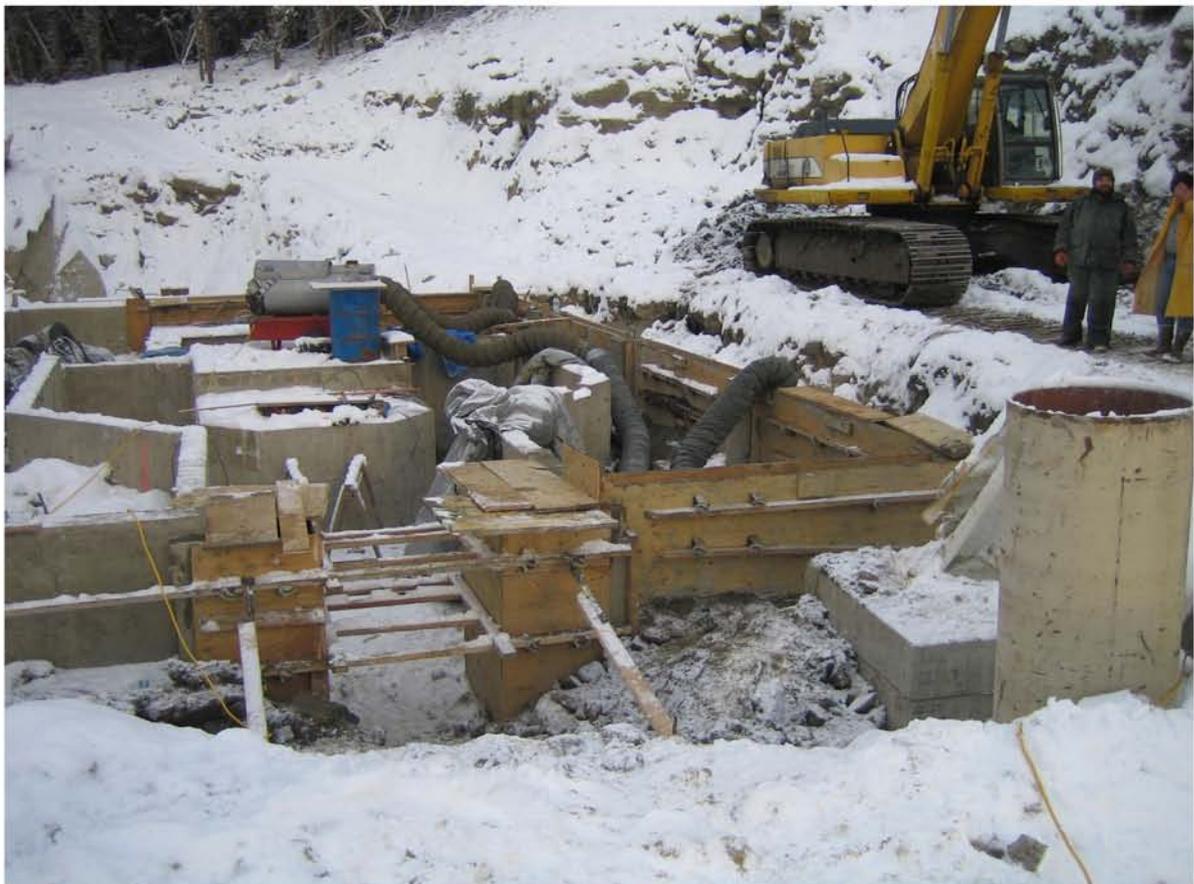
Photo 2

POWERHOUSE FOUNDATION AS VIEWED FROM THE SOUTH END, JANUARY 5, 2007

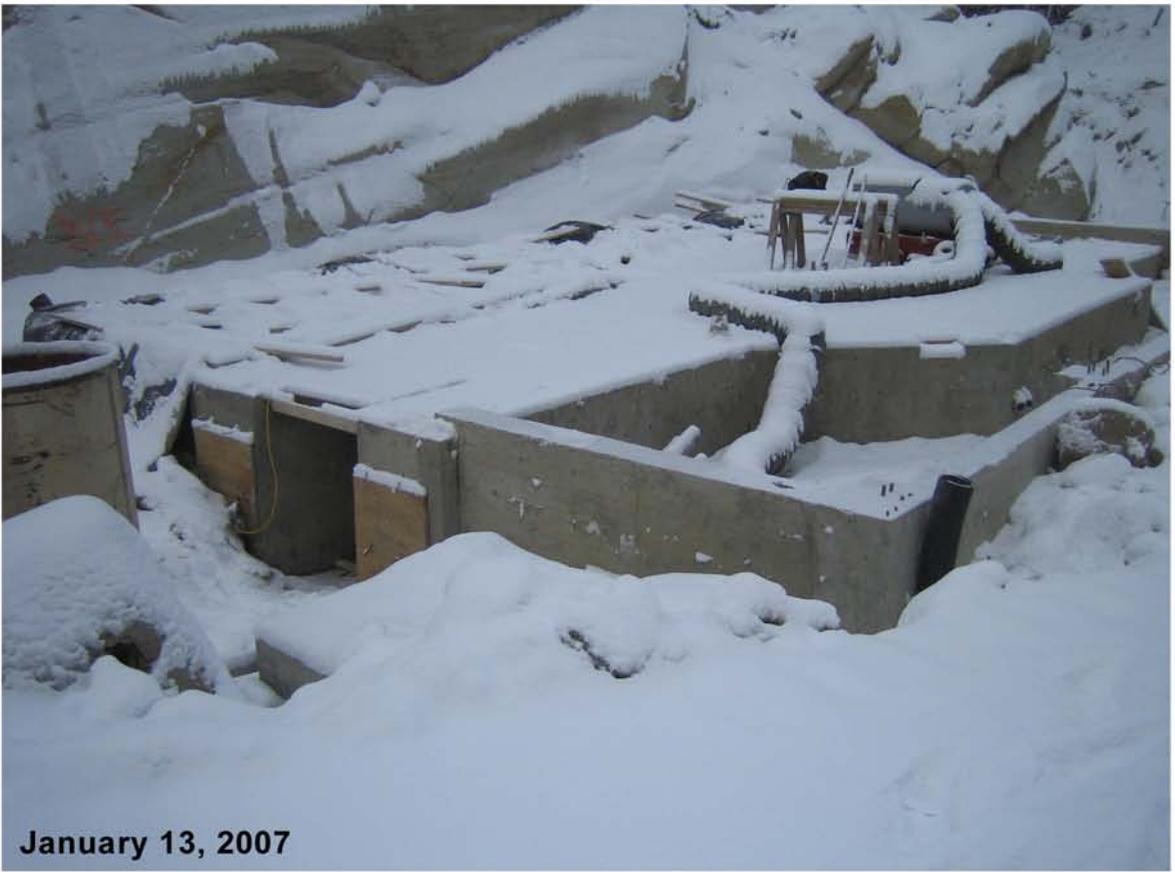
Photo 3

POWERHOUSE FOUNDATION FROM THE SOUTHEAST CORNER

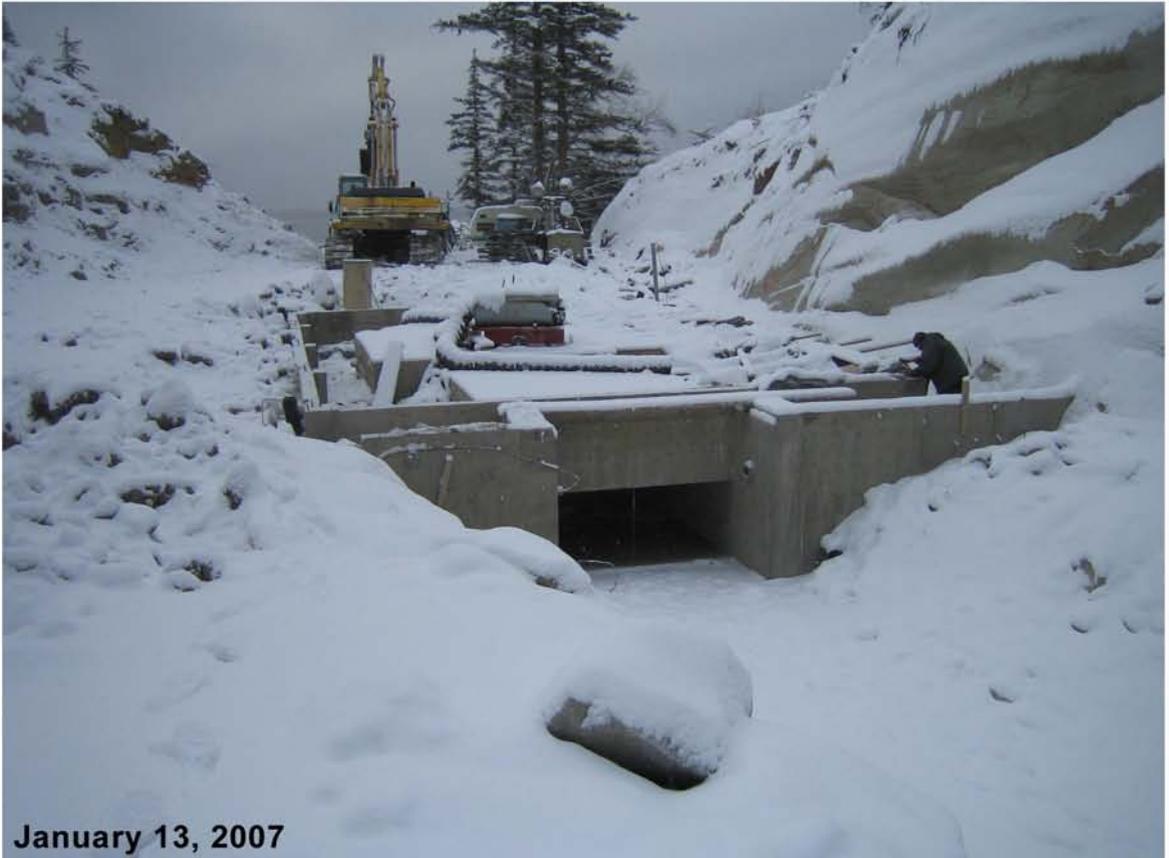
Photo 4

POWERHOUSE FOUNDATION FROM THE NORTH WITH TAILRACE PORTAL VISIBLE

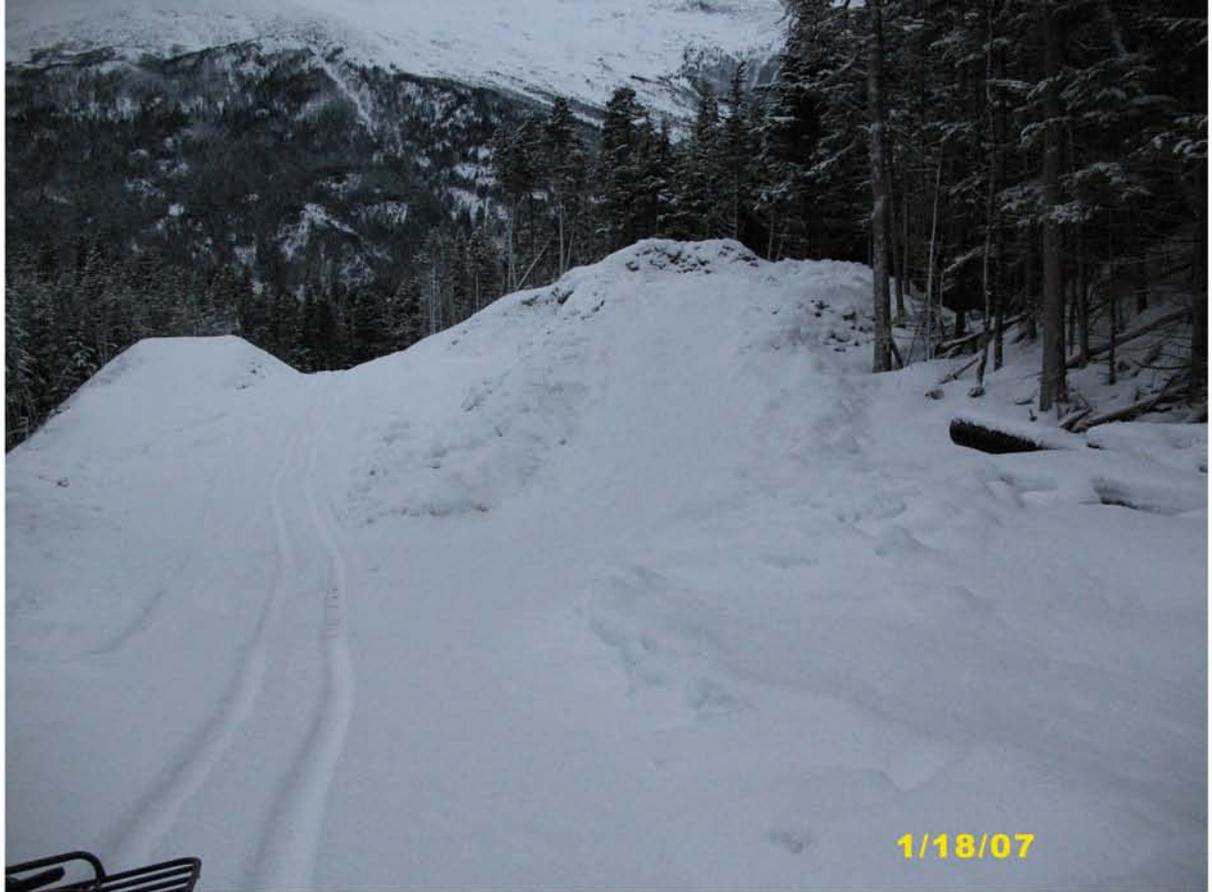
Photo 5

- Since the first of the year, it has snowed almost every day which is keeping the temperatures around freezing. There has been a lot of thawing and freezing which has caused surface ice to form everywhere.
- The right-of-way up to the Upper Spoils Area has large frozen ruts throughout.
- The only flowing water that was seen was through the culvert at Sta. 7+31. The water is free of sediment and the culvert is working.

Looking towards the Upper Spoils Area from Sta. 23+00

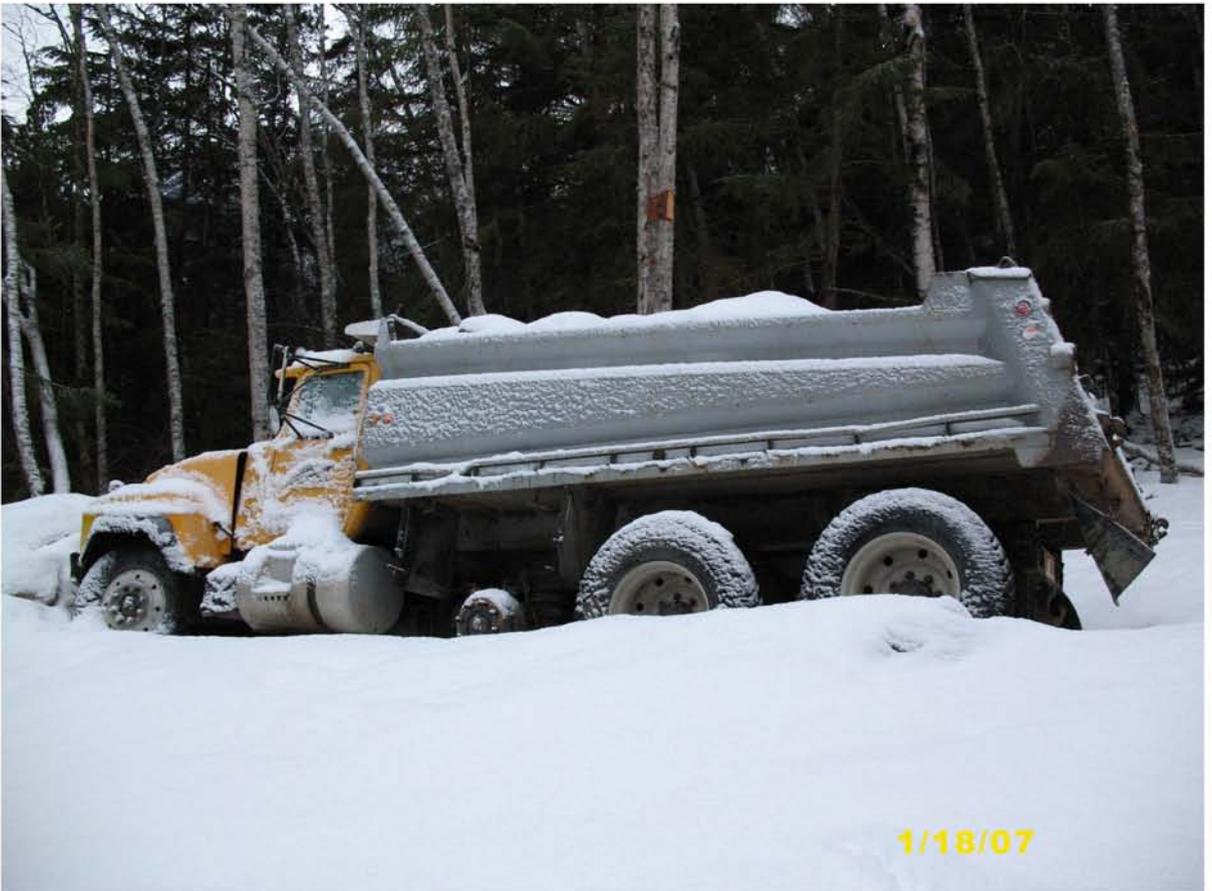
Photo 6

- No fuel spills or sheens were observed at the property, including around the truck that slipped off the right of way by Station 9+00. I inspected the perimeter of the truck and saw no visible leakage.
- All hazardous substances are being held in appropriate containers.
- The petroleum shed continues to be used as intended.
- There are adequate numbers of hazardous substance cleanup supplies on site.
- Fire hazard remains low due to wet and freezing conditions.

Truck slid off the side of the right of way near Sta. 9+00.

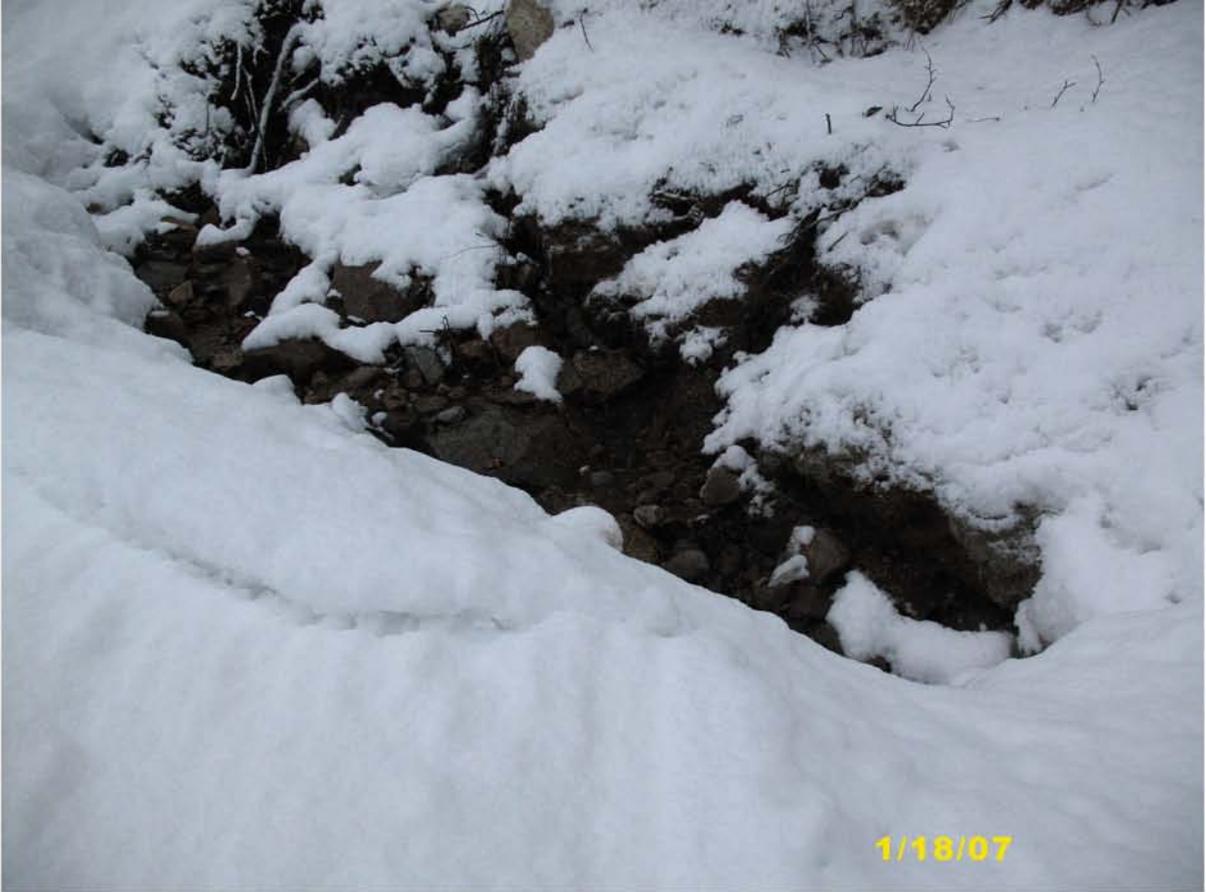
Photo 7

Water flowing through the culvert at Sta. 7+31.

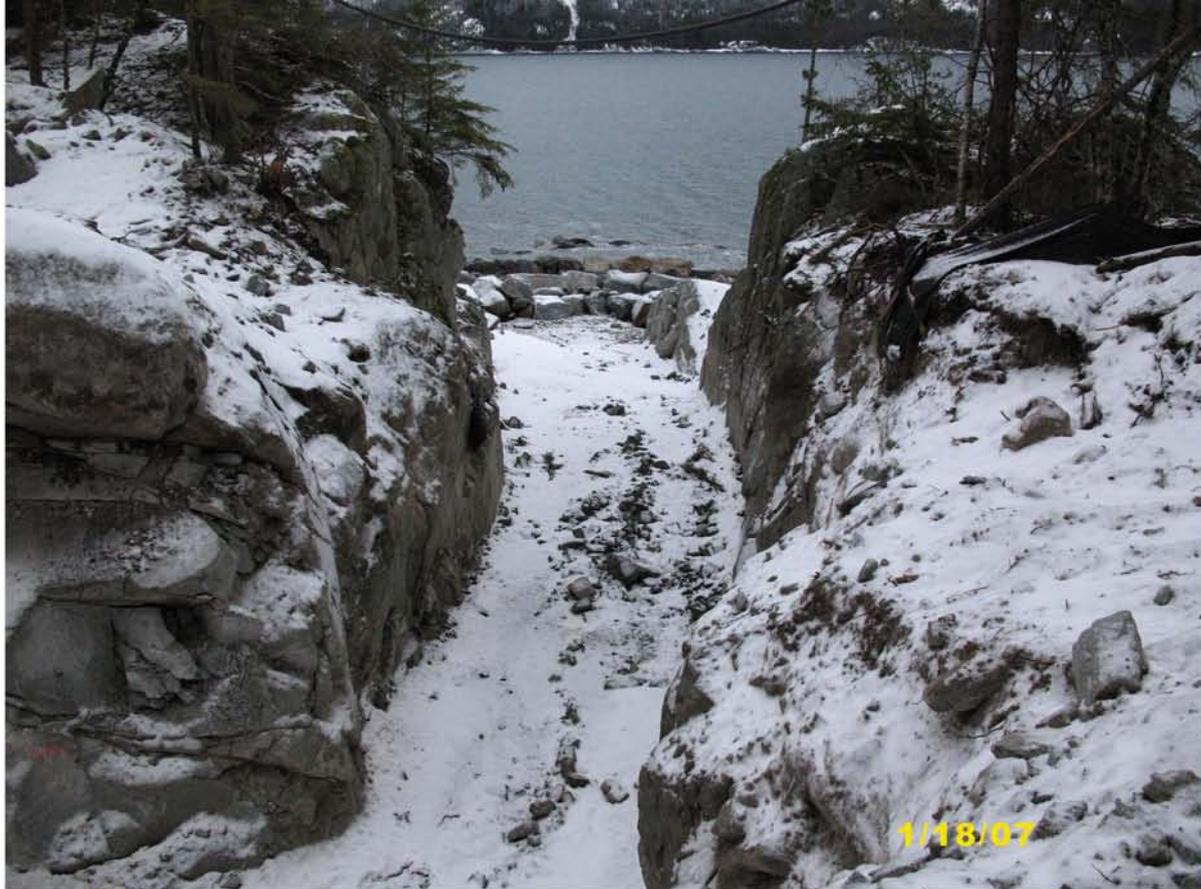
Photo 15

- Five of the six Tailrace Weirs were installed. Roger Barger, project Superintendent, was worried that the sixth weir would block boat access to the beach so he said that he would install it later in the project.

Looking west down the tailrace towards the weirs.

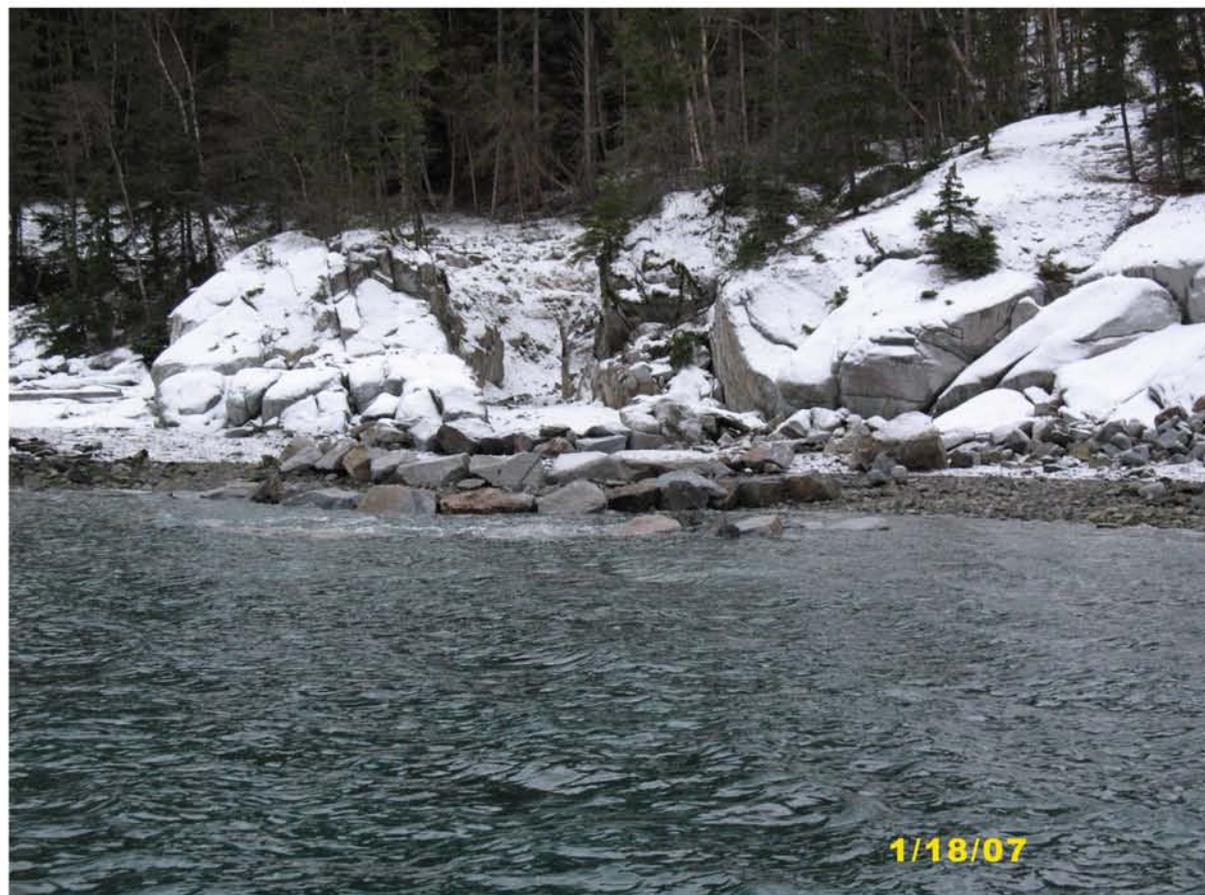
Photo 16

Looking east towards the weirs from the water.

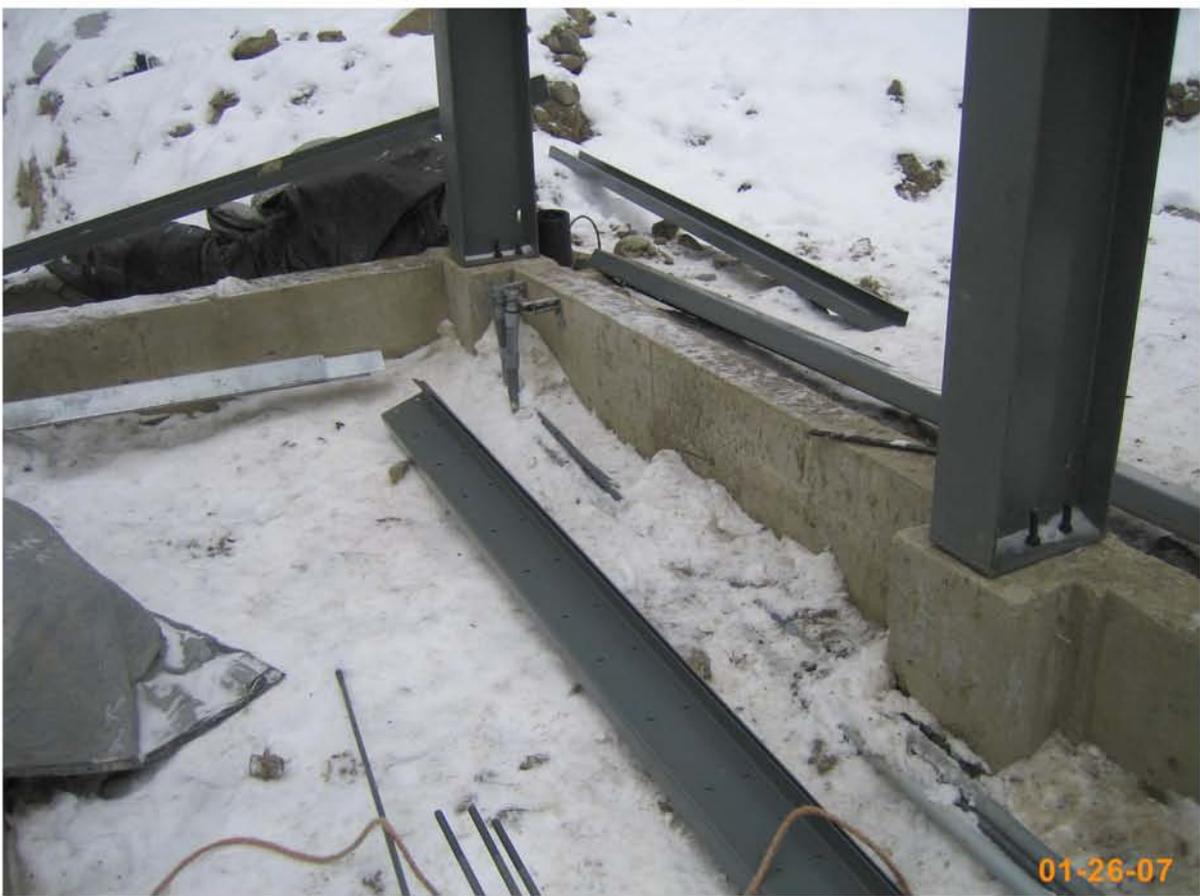
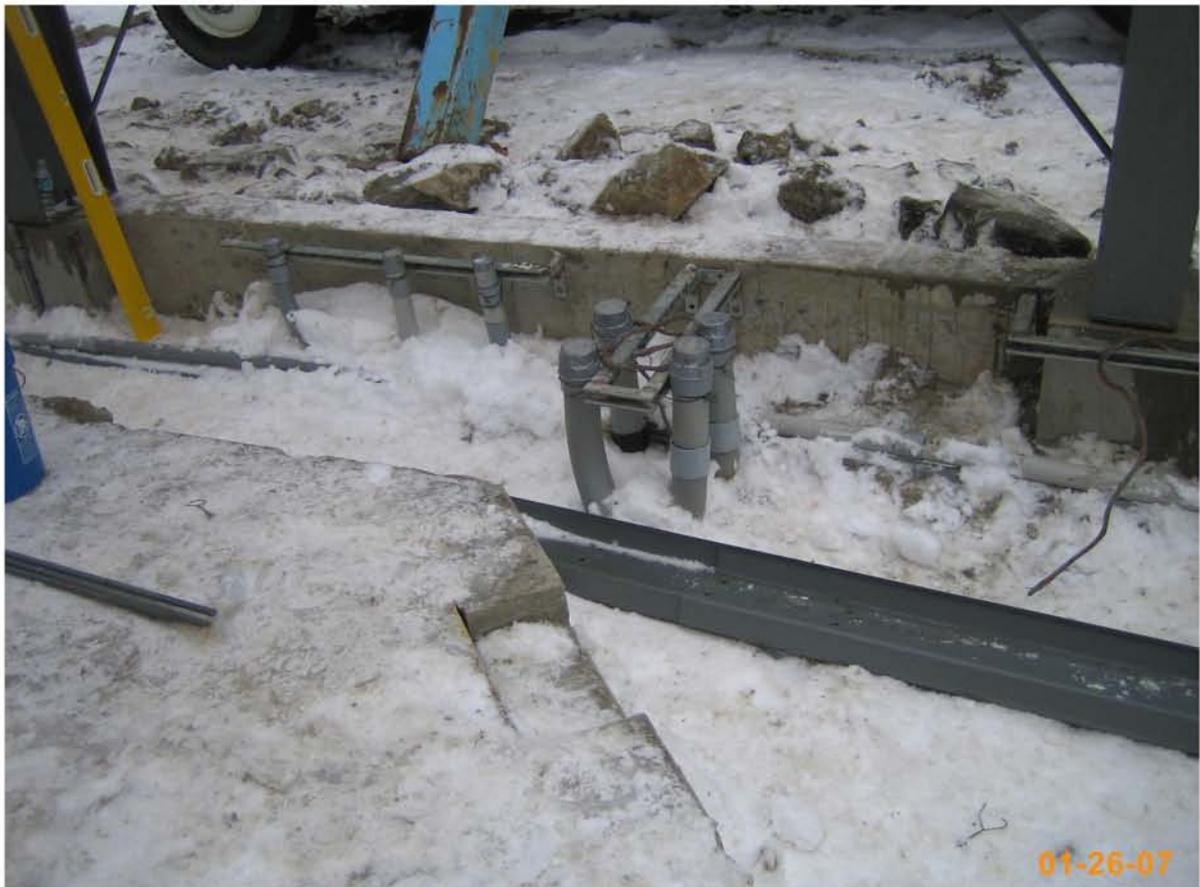
CONDUIT RUNS BEING INSTALLED ALONG POWERHOUSE FOUNDATION FOR VARIOUS PIECES OF EQUIPMENT

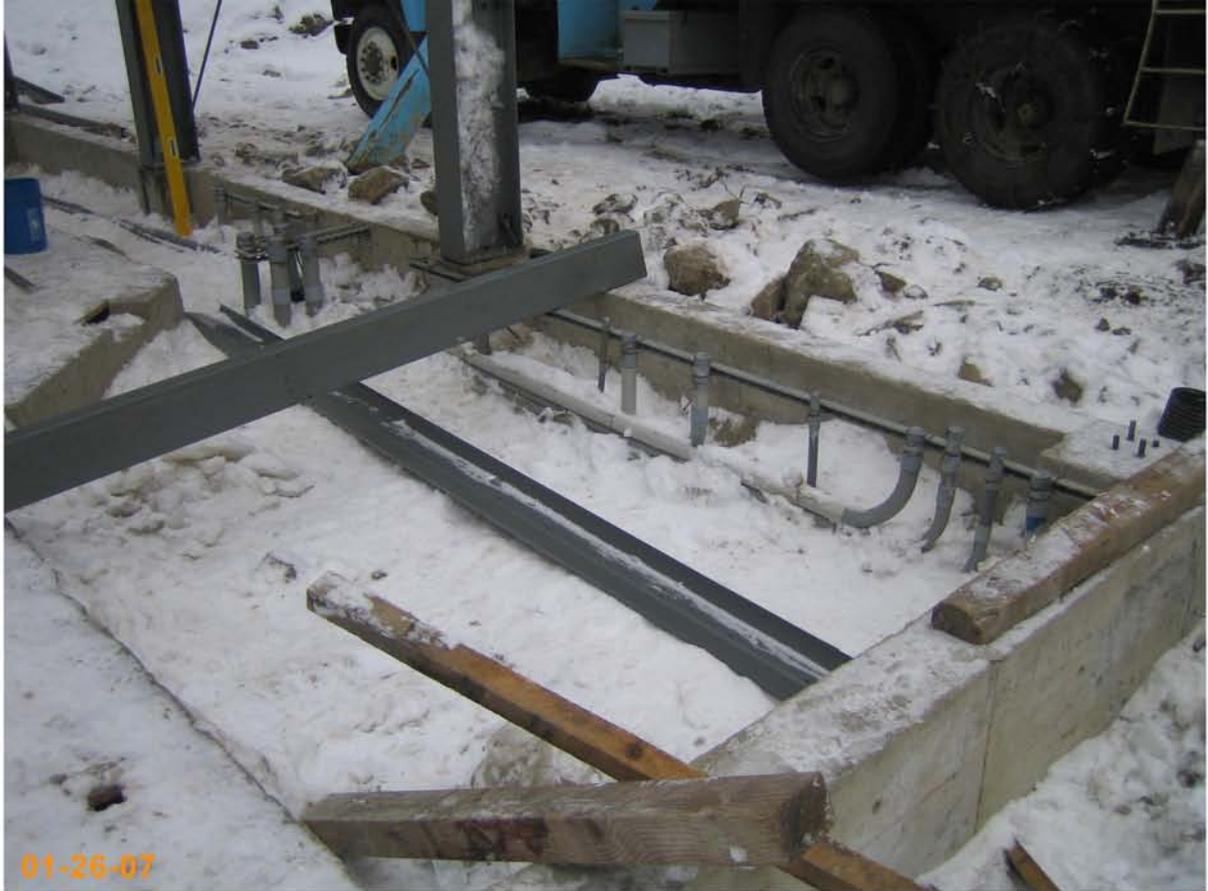
Photo 23

CONDUIT RUNS ALONG POWERHOUSE FOUNDATION FOR VARIOUS EQUIPMENT

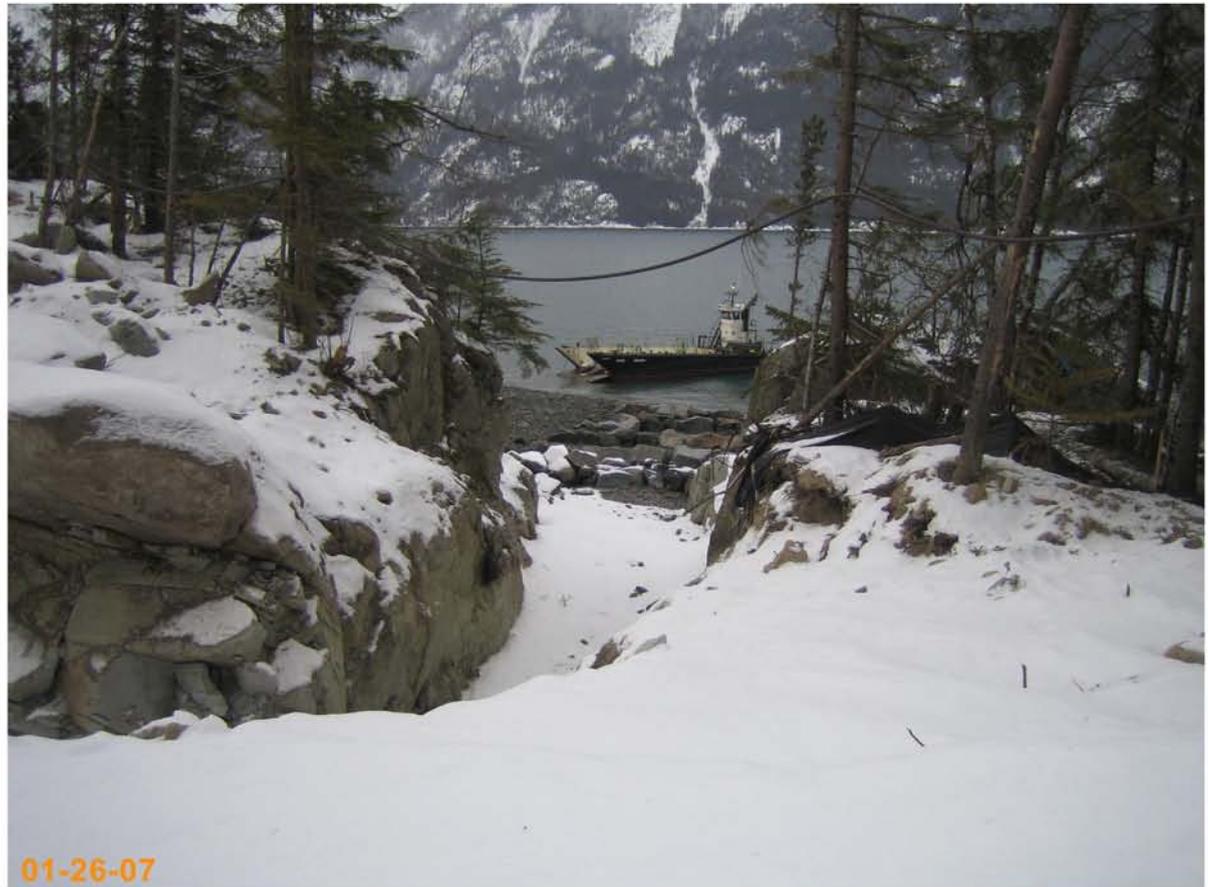
Photo 24

Five of six tailrace weirs (energy dissipaters) were installed on the beach below the tailrace. The sixth weir was not installed at this time because it may interfere with beach landings by the personnel boat and landing craft.

LOOKING OUT THE TAILRACE WITH WEIRS INSTALLED ON BEACH
