ALASKA DISTRICT TRIP REPORT

Project: Napakiak Mooring Points Evaluation for the Denali Commission

Description: Napakiak Trip Report

Date: 16 August 2011

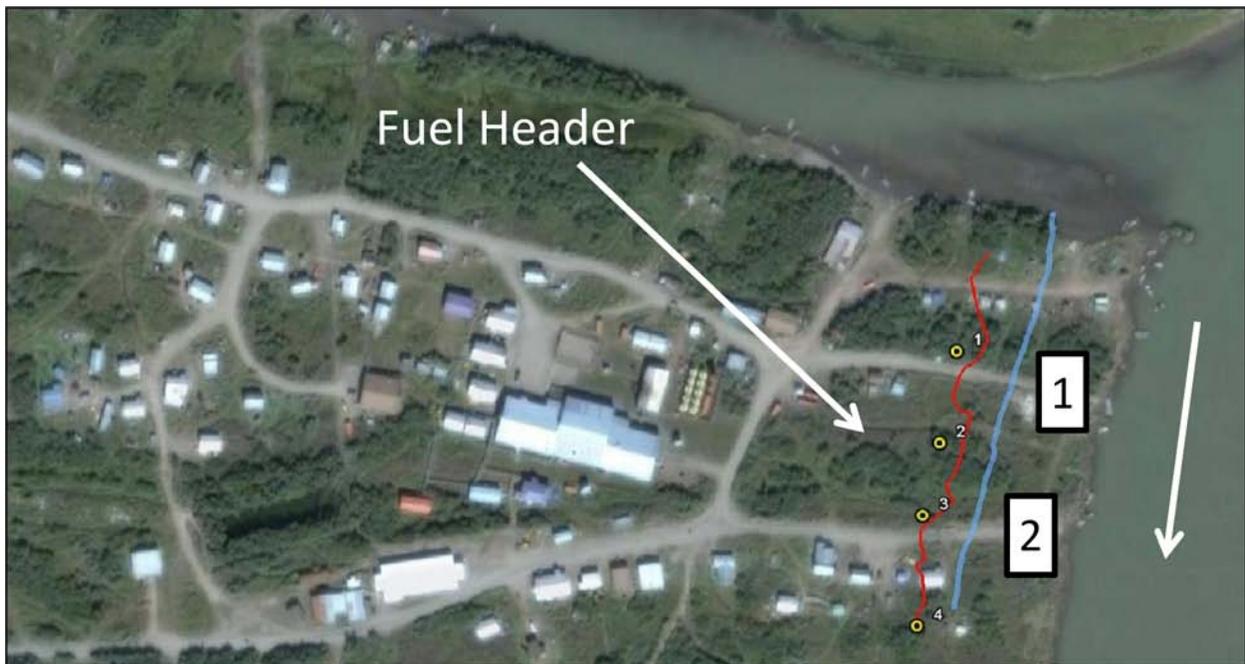
Figure 1. Overview of Napakiak proposed mooring point locations. The Kuskokwim River flows top to bottom. GPS points (numbered yellow dots) are at the top of the current river bank. Underlying imagery is from 2005. Riverbank erosion has shifted the top of bank approximately 225 feet to the west since the photo was taken. Red line: top of bank. Blue line: low tide line. Boxed number 1: Upstream Landing. Boxed number 2: Downstream landing. White arrow indicates flow.

Site Description: Napakiak is on the west bank of the Kuskokwim River approximately 14 river miles downstream of Bethel. Johnson Slough forms the northern extent of the community. Since the last site visit in 2007, it was observed that the top of bank of the Kuskokwim River has shifted approximately 160 feet from its previously measured position at an average of 40 feet per year. The banks of the Kuskokwim River are composed of fine sand and silt, which is highly erodible. Erosion of the top of the bank is episodic, typically occurring during the fall storm season when waves in the river can reach as high as 8 feet under special conditions. The main channel of the Kuskokwim appears to be eroding due to tractive forces of the current against the bank. The river makes a sharp turn to the south at Johnson Slough and the thalweg is hard against the west bank of the river throughout this reach.

Recommendations: Based on community input and barge operator comments, installation of mooring points at the locations examined in this report are not recommended due to continued erosion of the riverbank and tidal fluctuations.

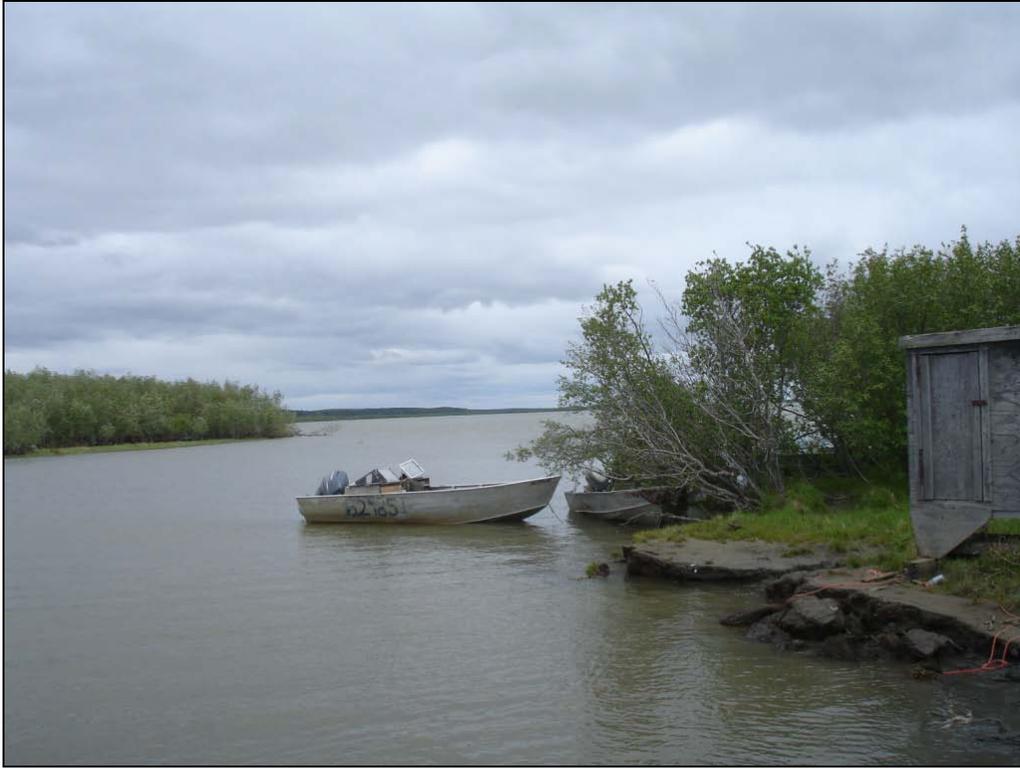
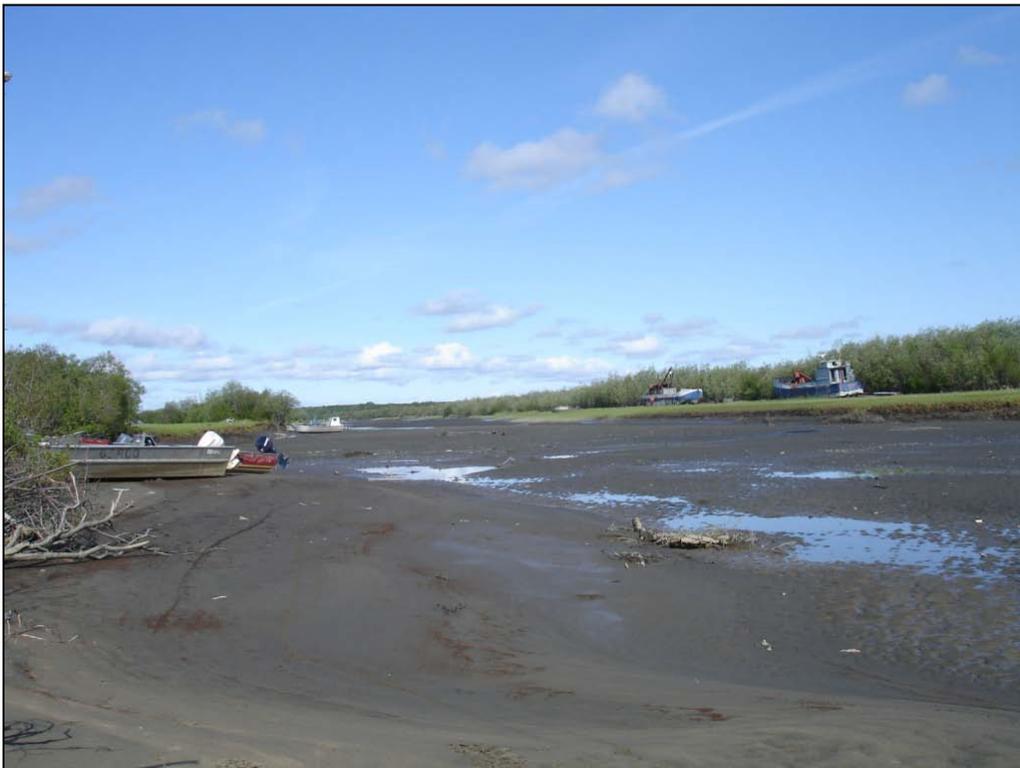
Johnson Slough provides boat storage for the community. The slough is very shallow and goes completely dry at low tide. At high tide, there is sufficient water to navigate the slough (figure 2). The primary boat launch is south of Johnson Slough's outlet (figure 3).

Figure 2. Looking downstream near the outlet of Johnson Slough at high tide (top) and looking upstream from the outlet at low Tide (bottom)

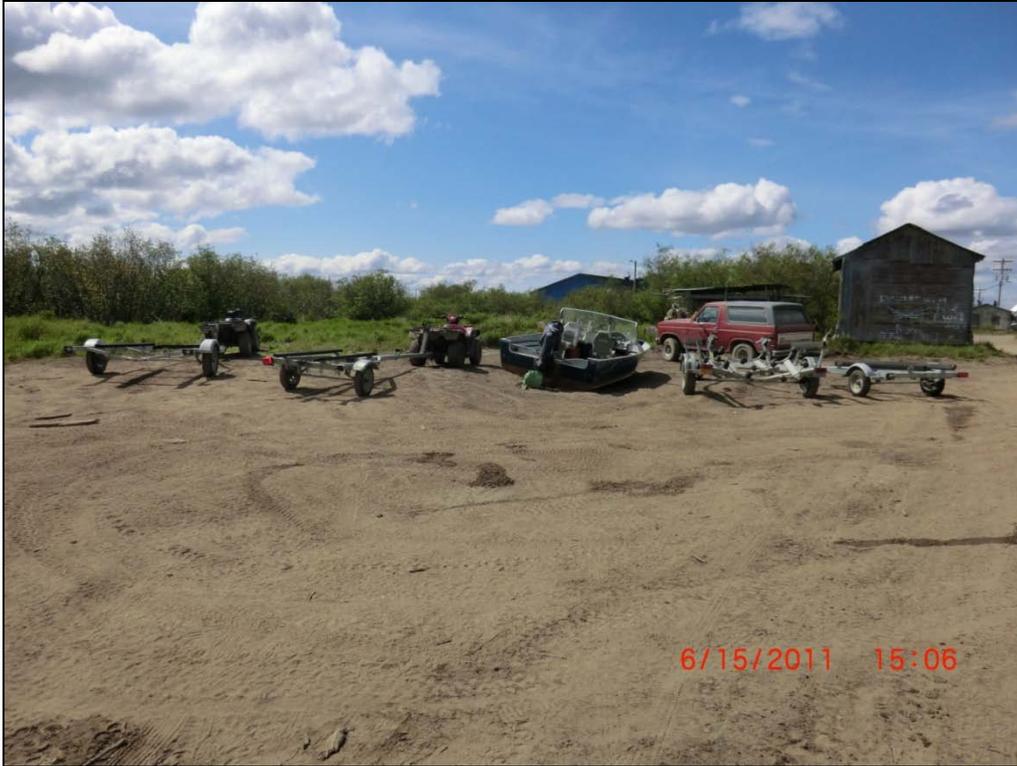
Figure 3: Boat trailers staged at the boat launch site. River is off frame to the left.

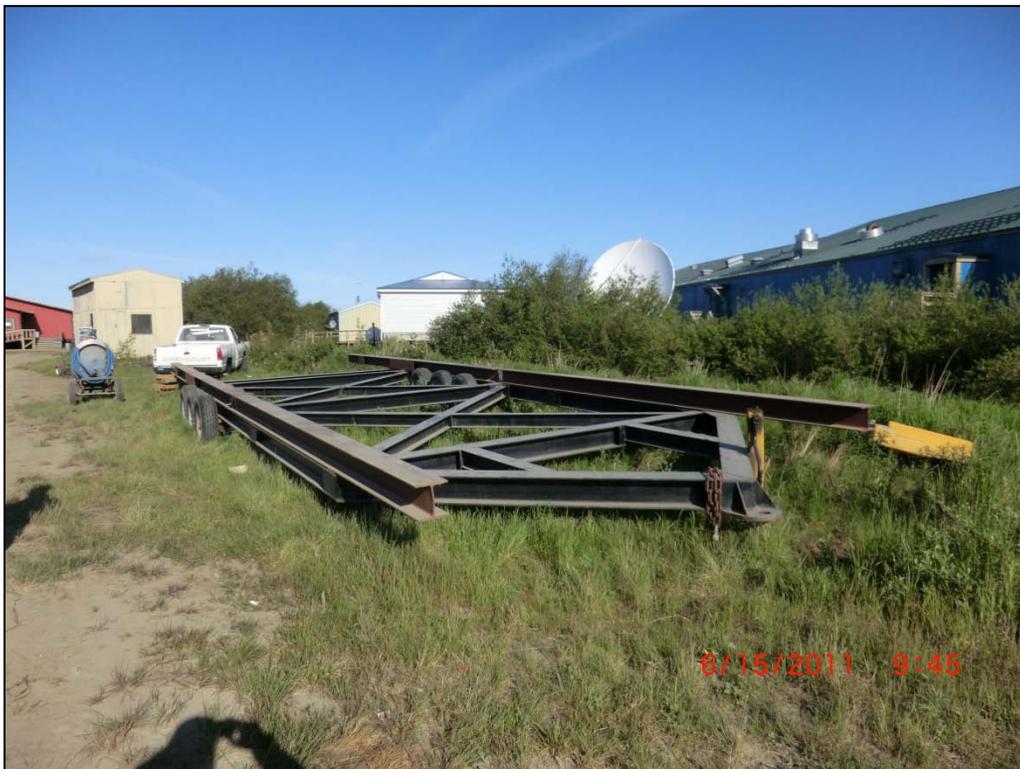
The community manages the erosion issue by moving structures at risk to the far west side of the community, currently around 4,500 feet from the top of the bank. Two structures used as reference points to monitor erosion in 2007 were relocated in the last 4 years. The community owns a large trailer for moving structures and future moves are planned (figure 4).

Figure 4: Trailer used to relocate structures threatened by erosion.

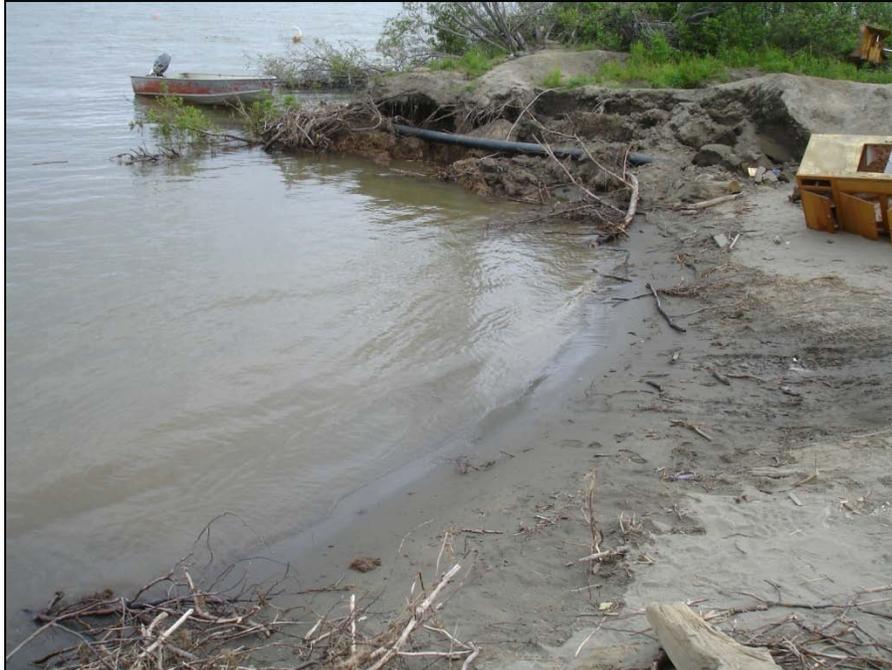
Figure 5. Upstream Landing

Upstream Landing Site: The upstream landing site (figure 5) is approximately 375 feet east of the upstream corner of the Napakiak School's fuel tanks. The school's fuel header is near this site (figure 7). This site has a fair amount of uplands (figure 8) for staging freight; however, like the rest of the riverbank at Napakiak, this site is experiencing active erosion (figure 9). GPS readings were taken 75 feet upstream and downstream of the center of the landing and approximately 10 to 20 feet inland. Due to bank conditions including brush, elevation changes, and bank profile, it would be difficult to install mooring points at this site.

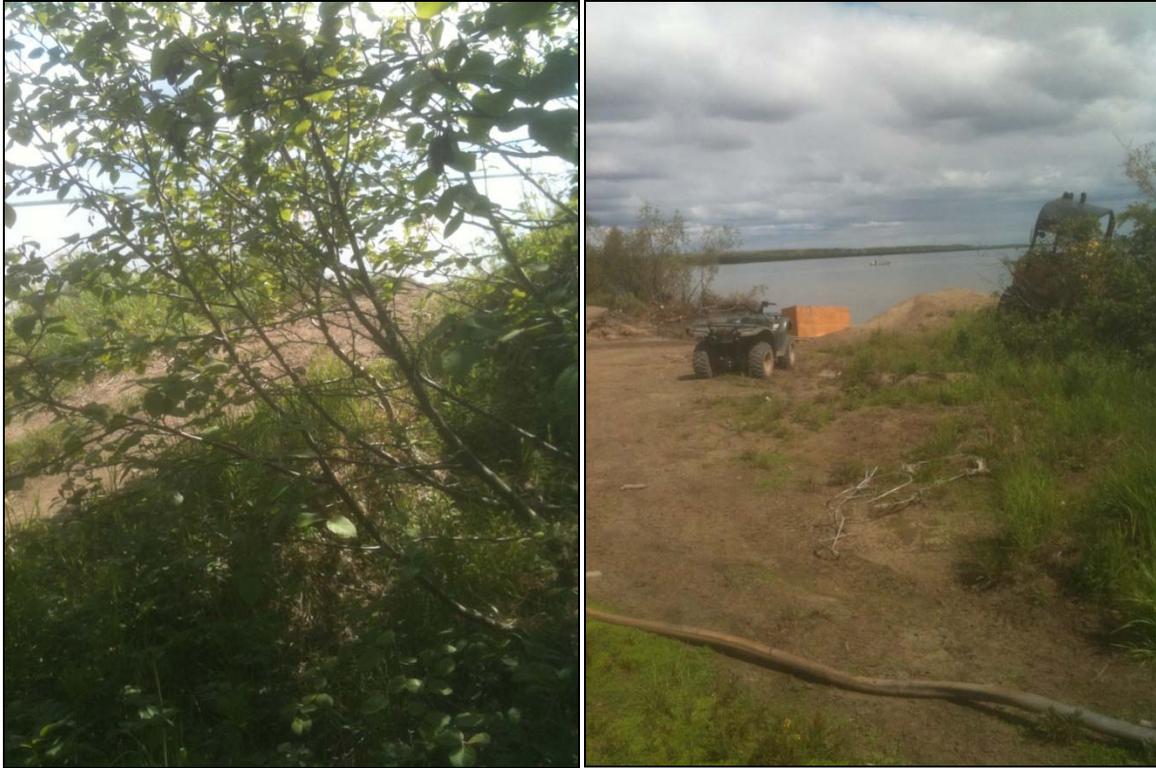
Figure 6. Upstream Landing, Upstream Point (left) and Downstream Point (right)

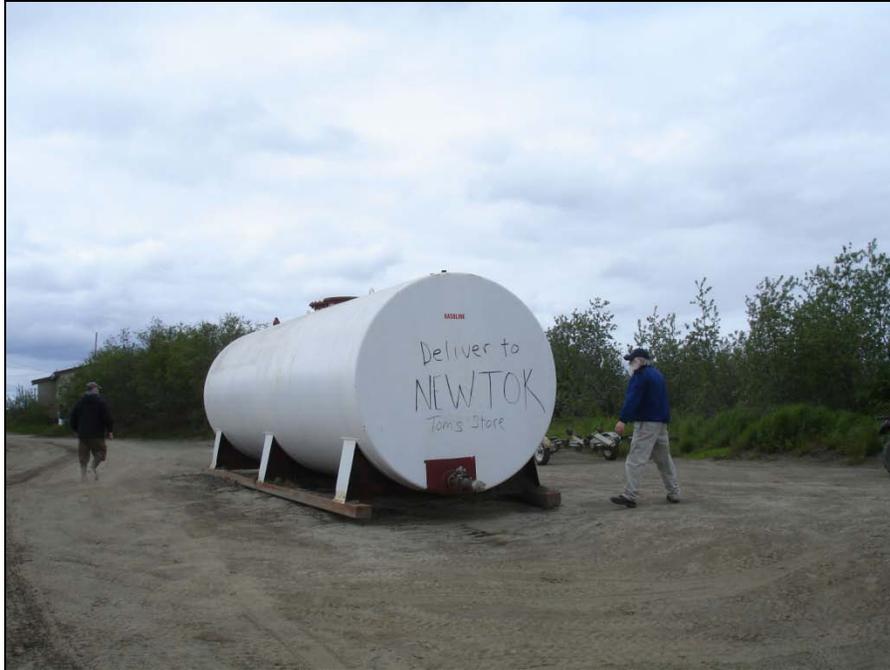
Figure 8. Fuel Tank Staged on Uplands at Upstream Landing

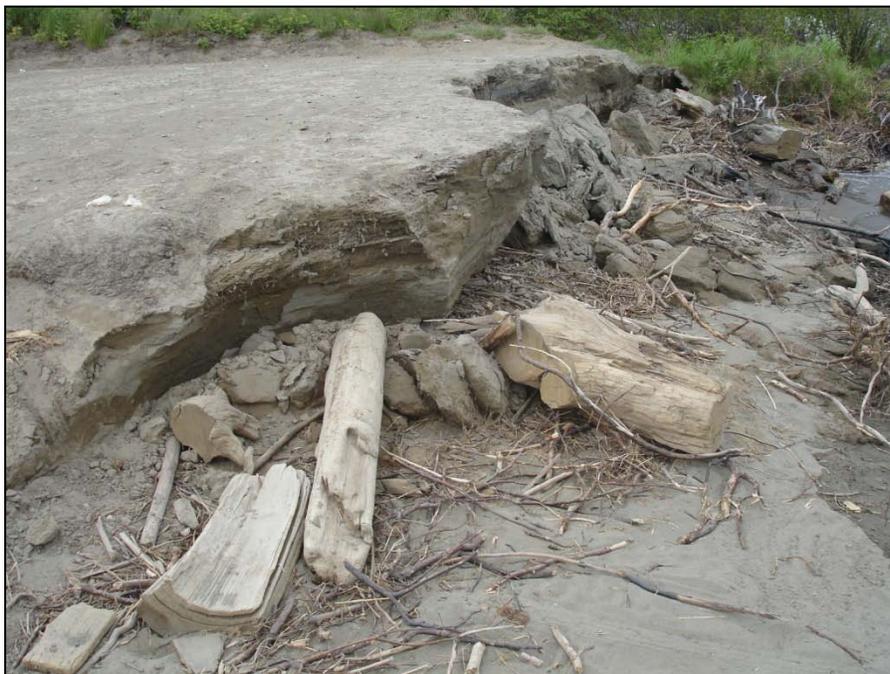
Figure 9. Erosion at Upstream Landing

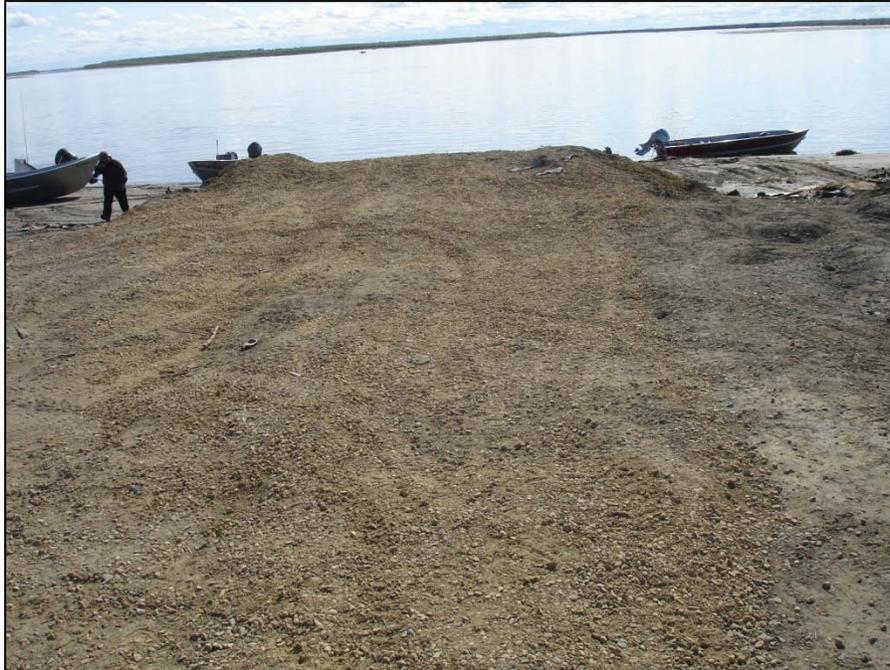
Figure 10. Downstream Landing Site

Downstream Landing Site: The downstream landing site (figure 10) is approximately 250 feet downriver of the upstream landing. View of the downstream landing from the proposed location of the upstream point (left photo) and downstream point (right photo) is shown in figure 11. A fuel header (figure 12) for the Bulk Fuel Storage Facility is approximately 650 feet inland from the landing site. A stockpile of gravel (figure 13) is used to reshape this landing as it is eroded.

While on site we were able to witness a hovercraft delivering goods to this landing (figure 14). The main building at the Napakiak School (figure 15) is approximately 450 feet inland of the landing. GPS readings were taken 75 feet upstream and downstream of the center of the landing and approximately 10 to 20 feet inland. The bulk fuel storage facility is shown figure 16. Due to bank conditions including brush, elevation changes, and bank profile, it would be difficult to install an effective mooring point more than 75 feet upstream of this landing. A mooring point could possibly be installed more than 75 feet downstream of this landing; however, it appears that property ownership could become an issue.

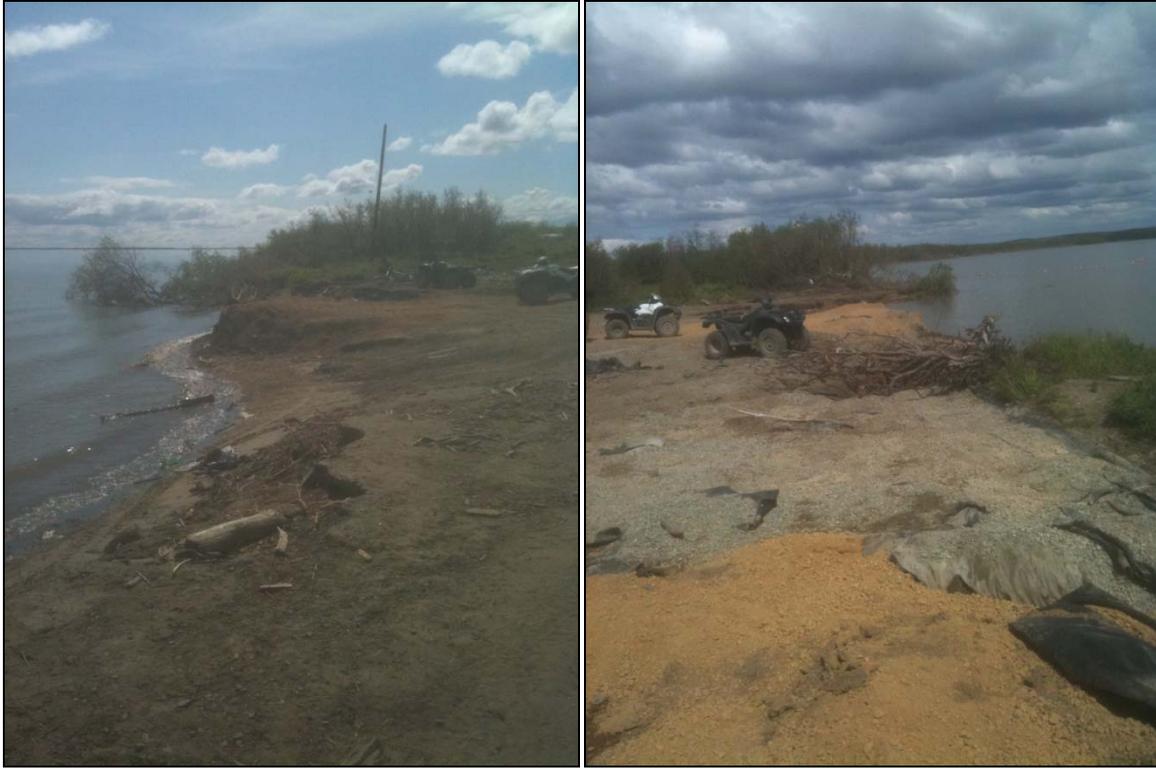
Figure 11. Downstream Landing View from Proposed Location of Upstream Point (left) and Downstream Point (right)

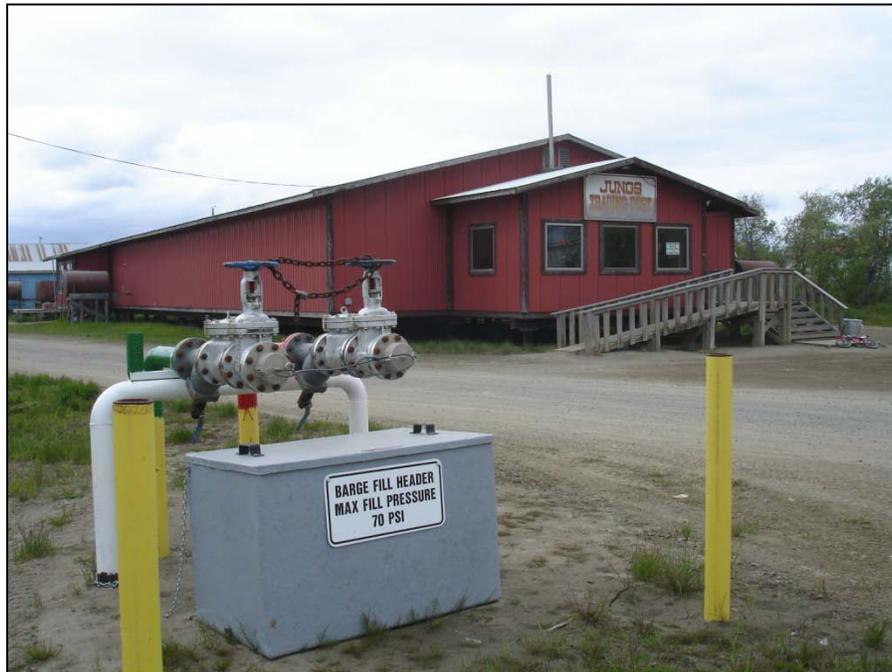
Figure 12. Fuel Header for Bulk Fuel Storage Facility near Downstream Landing

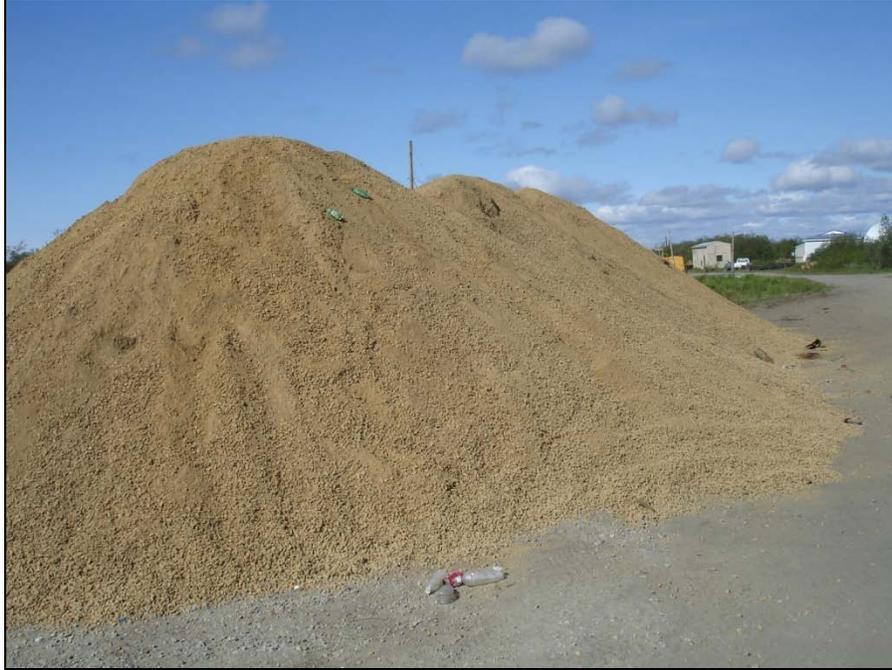
Figure 13. Gravel Stockpile at Downstream Landing

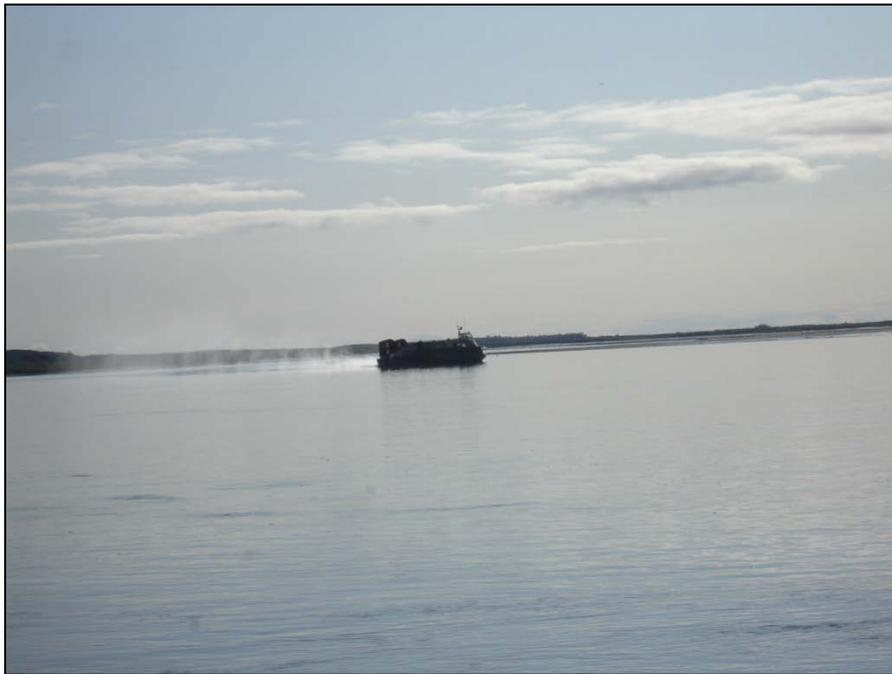
Figure 14. Hovercraft on Kuskokwim River

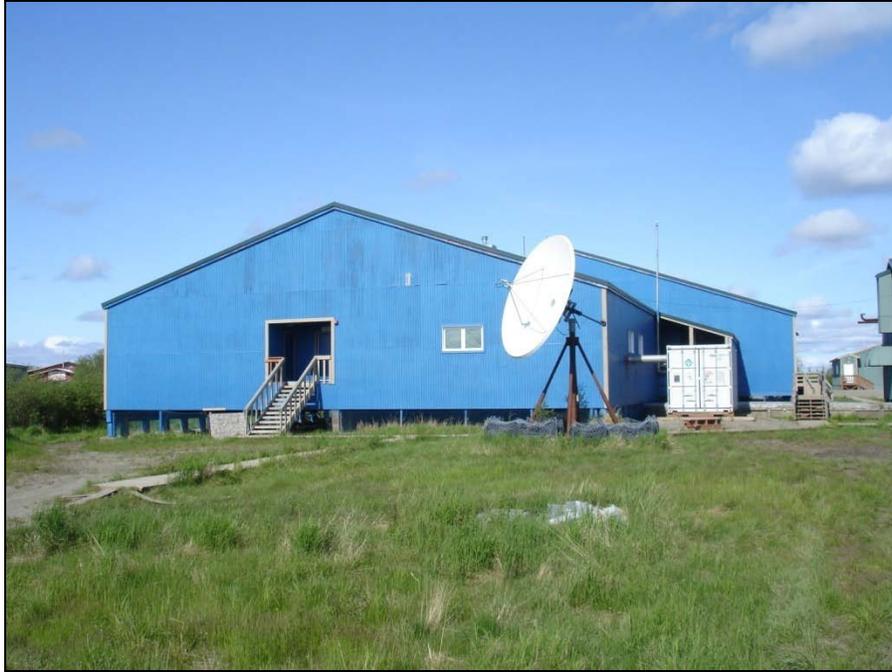
Figure 15. Napakiak School, side facing river
