ALASKA DISTRICT TRIP REPORT

Project: Denali Commission Mooring Points Phase 4

Description: Pilot Point Trip Report

Dates: 4 - 5 August 2011

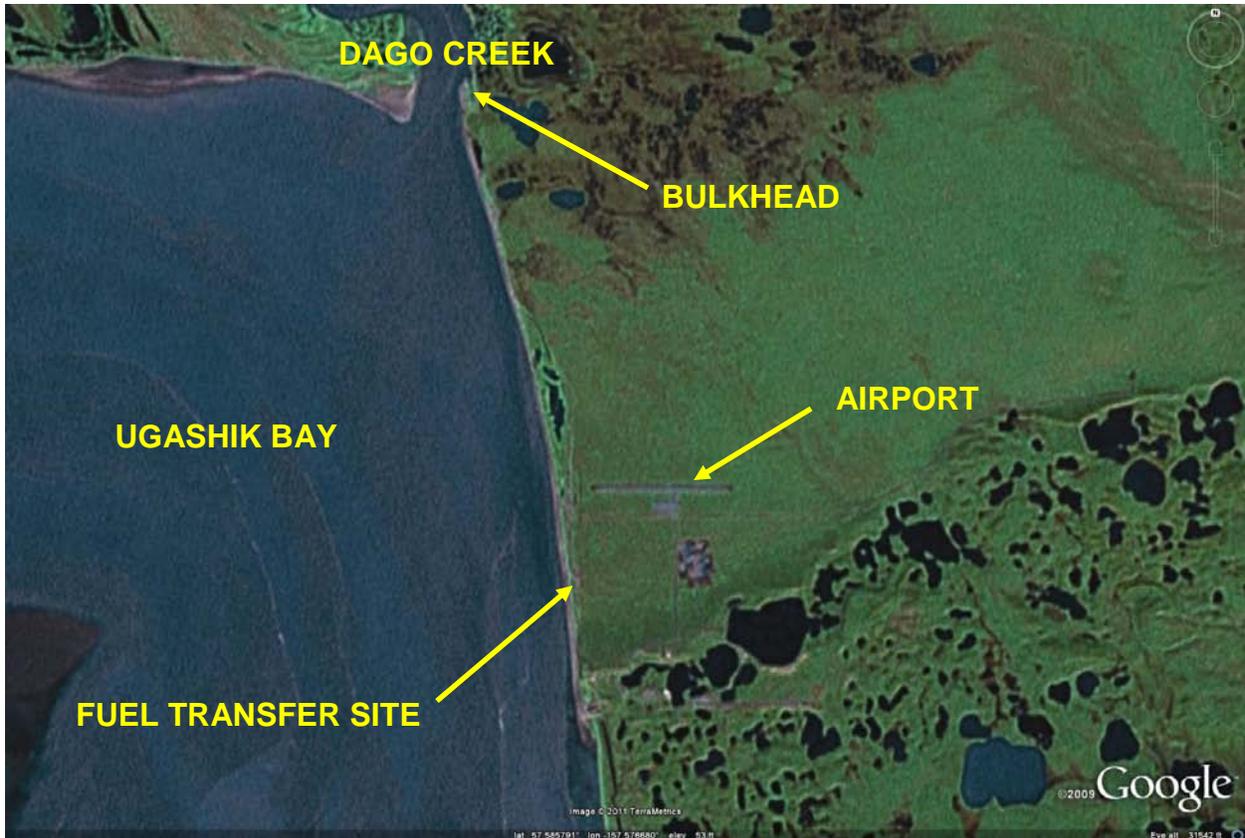
Figure 1: Pilot Point barge landing locations

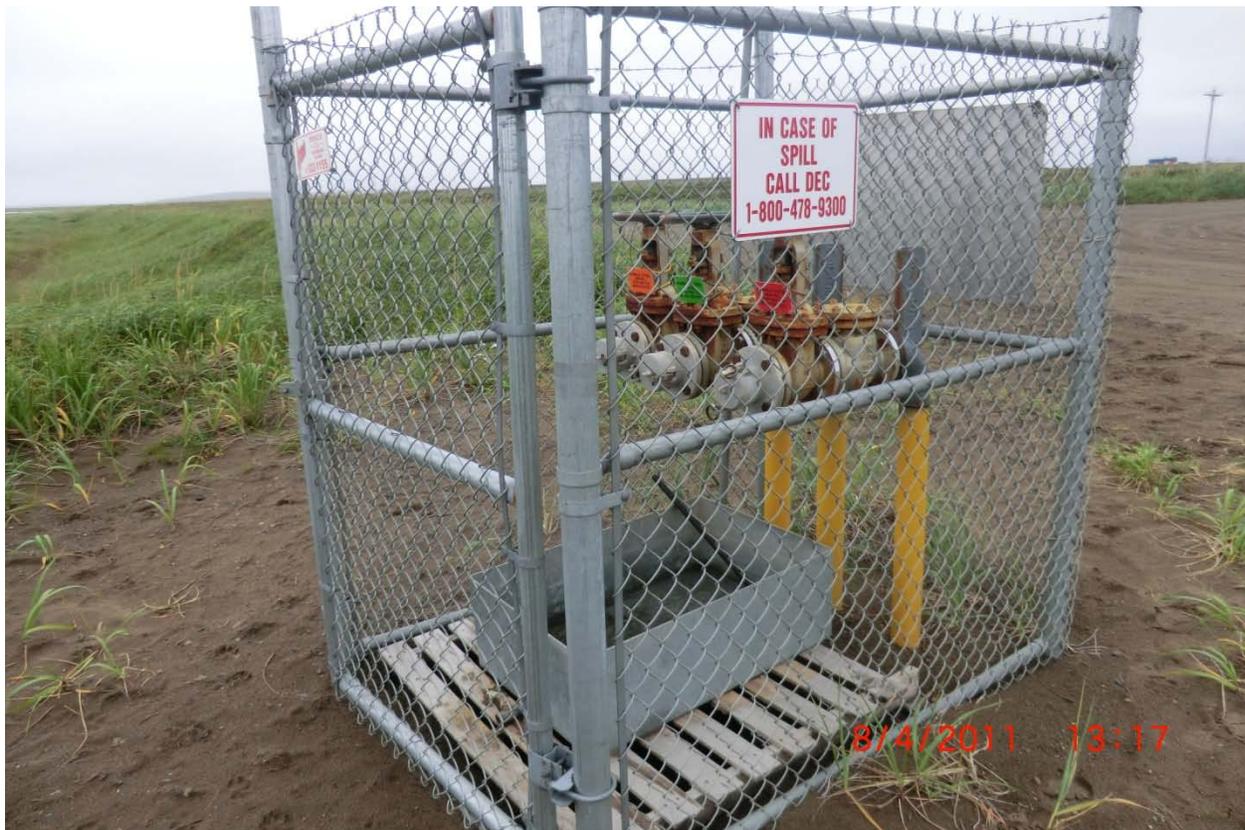
Typically, the fuel delivery barge will approach the beach at mid tide as the tide is going out and ground on the beach. The beach material is a mix of fine sand and clay that provides a soft surface for the hull to rest on. Fuel hoses are dragged up the beach and connected to fuel headers behind the first line of dunes at the top of the beach (Figure 2).

Figure 2: Fuel headers

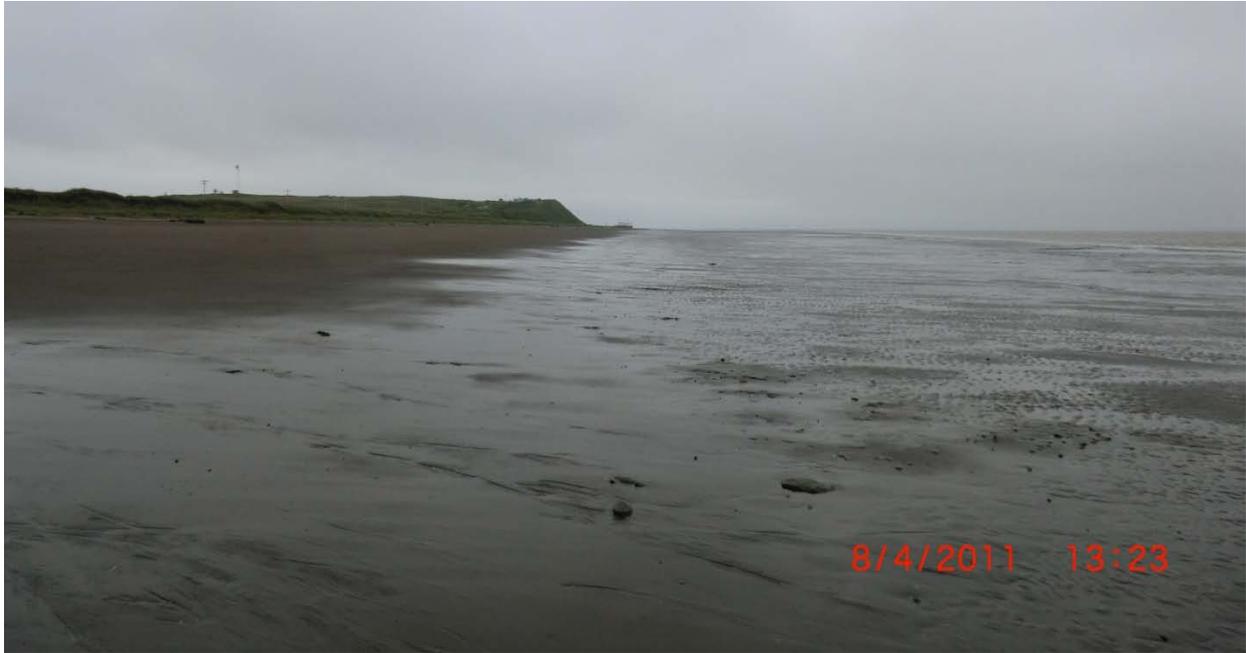
The beach at Ugashik bay is very shallow and is composed of fine sand and clay. The upper portions of the beach are predominantly sandy with more clay present in deeper water (Figure 3).

Figure 3: Beach landing site for fuel barges. The slope is very shallow and the lower portion of the beach appears to have more clay than the upper portion.

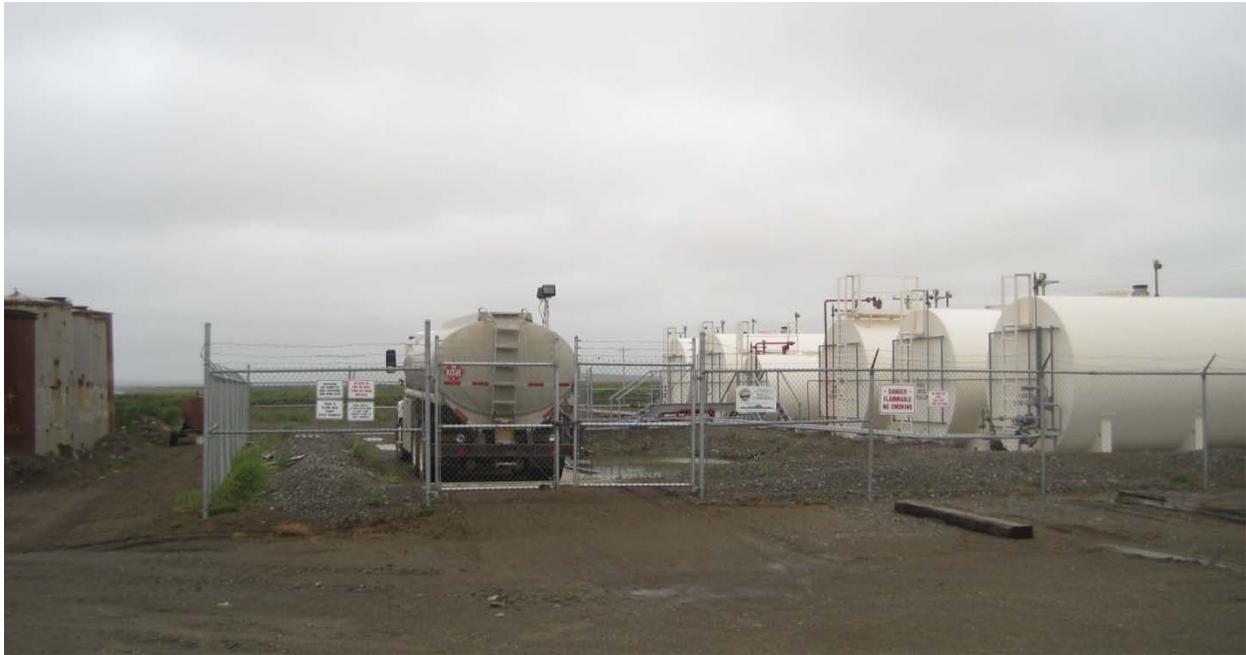
The community's fuel dispenser facility (**Figure 4**) is about halfway between the community and the airport. Fuel is transferred between the tank farm and dispenser tanks via the truck shown in Figure 4. The fuel dispenser facility was constructed in 2009 with funding from the Denali Commission.

Figure 4: Fuel dispenser facility

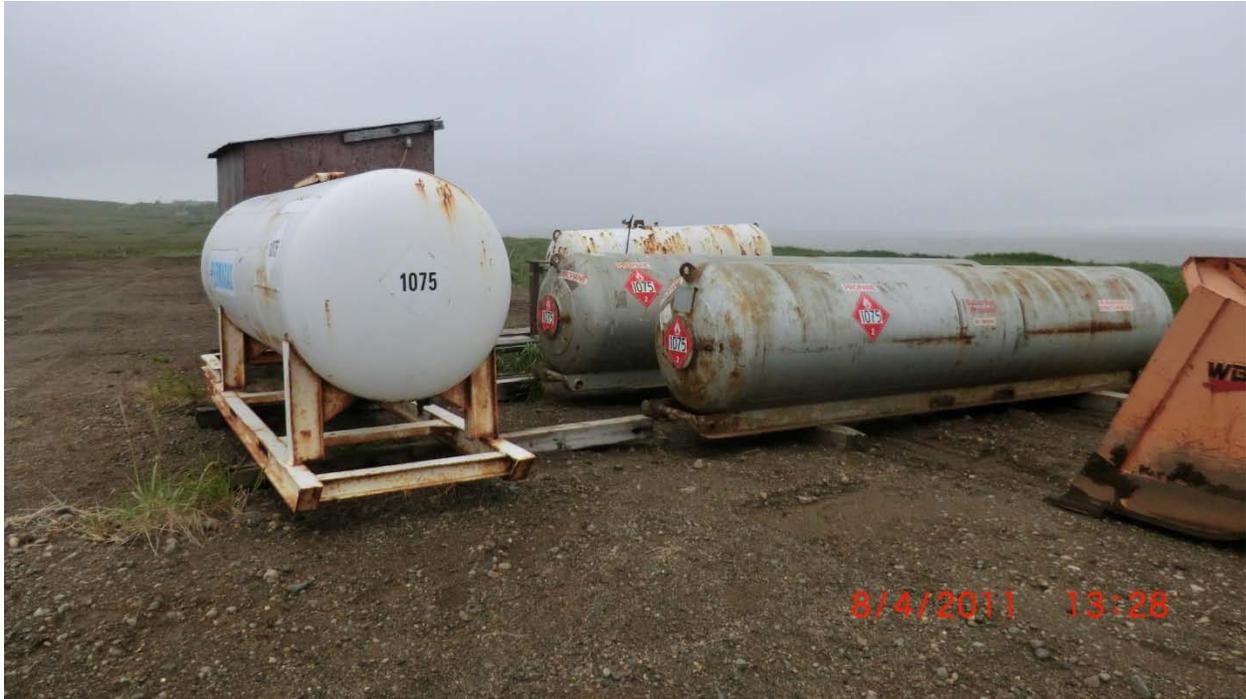
Fuel transfer also includes propane delivery. Propane tanks are hoisted from the barge to a loader on the beach which carries the tank up the beach to a storage area near the tank farm (Figure 5).

Figure 5: Propane tanks stored near the tank farm

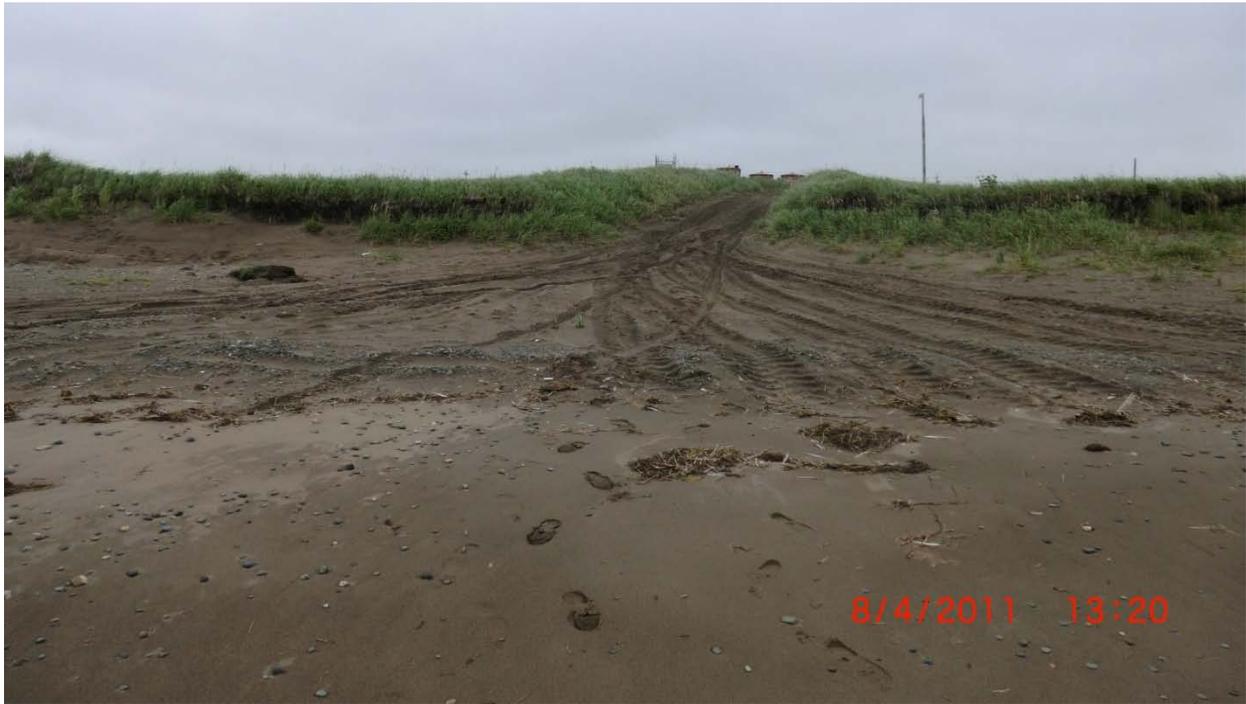
Malcolm Brown noted that, generally, there were no needs for improvement at this site. The most difficult aspect of operations noted was transferring the propane tanks to the shore. At the top of the swash zone, the loader climbs a short steep slope through soft sand (**Figure 6**). His suggestion was to add some gravel to this area to provide a better driving surface. Gravel is available for purchase in Pilot Point from the Pilot Point Native Corporation.

Figure 6: Access road to the beach at the fuel transfer site

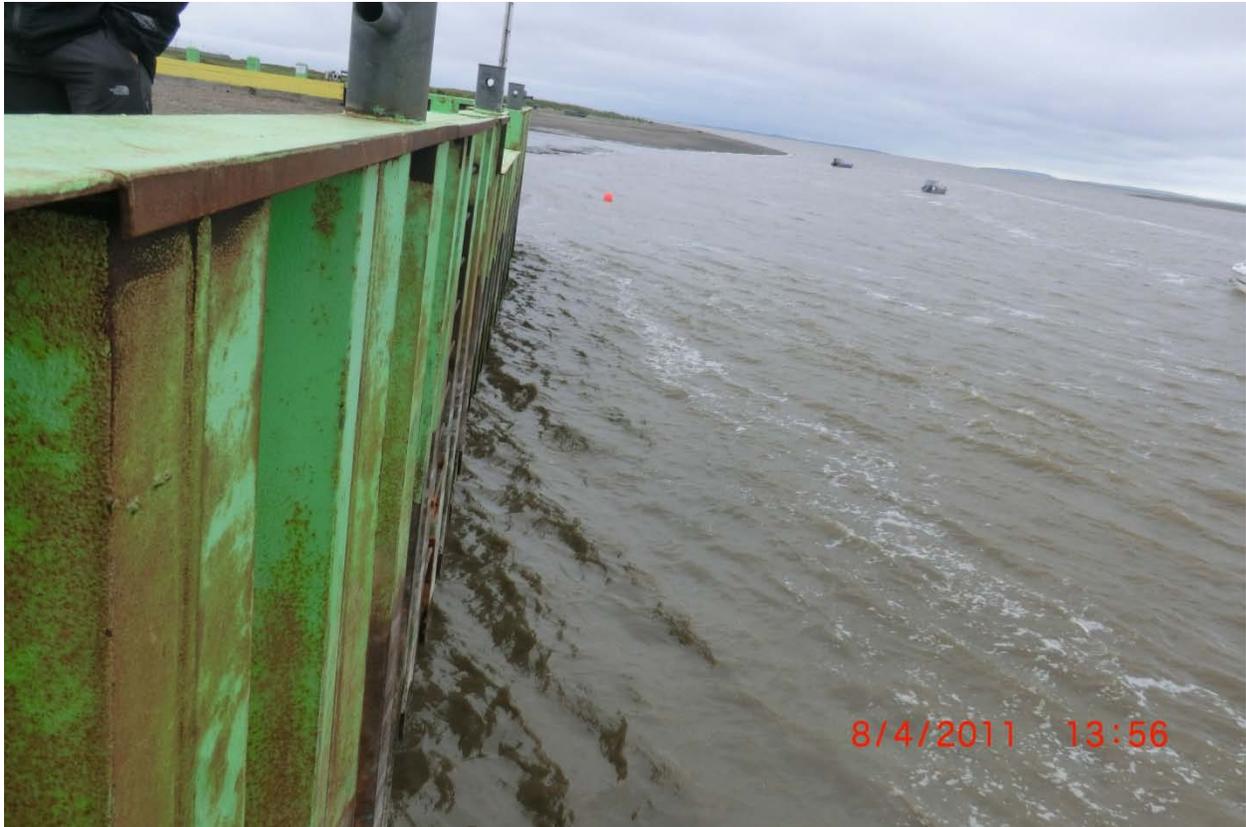
The bulkhead has a 100-foot-long steel sheet pile mooring face with six bollards welded onto the pile cap (Figure 7). The ends of the steel sheet pile wall are bent towards the shore about 20 feet. The bulkhead is protected from scour by timber retaining walls that extend back to shore. The timber retaining walls are tied back soldier pile walls with timber lagging. The tiebacks are steel cables that presumably tie into deadmen buried in the fill. The bulkhead was reportedly built by Knik Construction, but those we spoke to were uncertain when it was constructed.

The steel portions of the project appeared to be in fair condition and the wall was holding its shape. Corrosion was noted throughout the steel; however, the corrosion was not severe enough to compromise the structure.

Figure 7: Looking downstream along the face of the bulkhead at the mouth of Dago Creek. Note bollards along the top of the bulkhead.

Since mooring points (bollards) at this facility already exist, there is no need to install additional mooring points. The city manager concurred. Installation of mooring points is not recommended for this landing. There appears to be merit in further investigation of the bulkhead facility, though this is outside of the scope of the mooring points investigation.

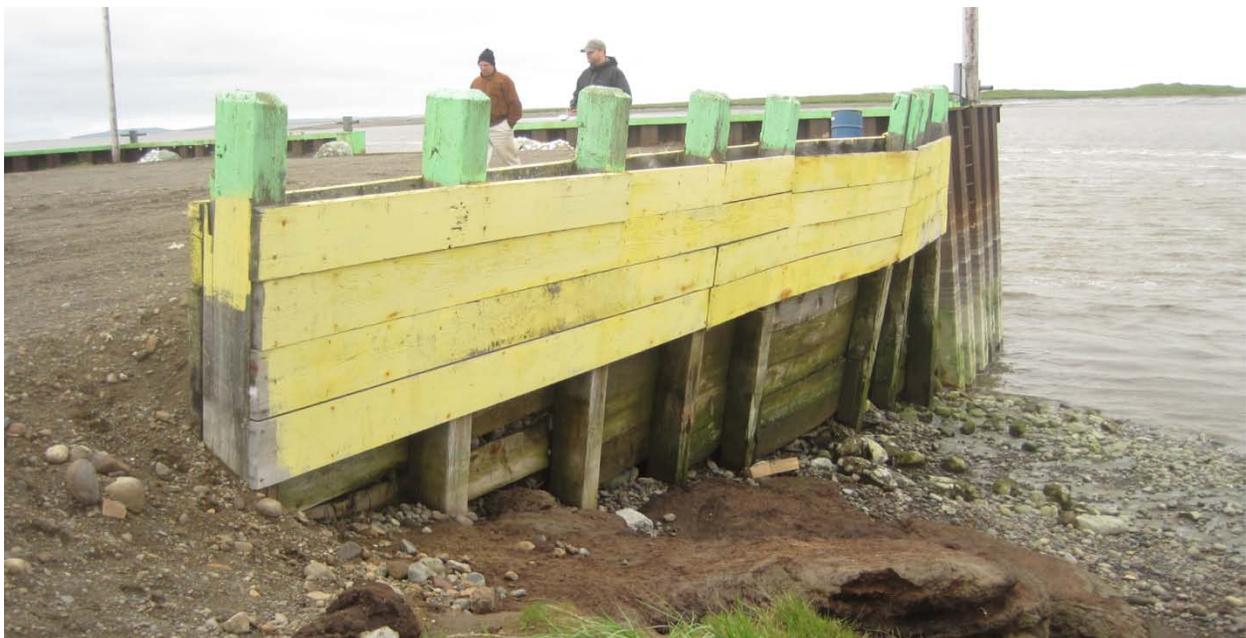
The timber portions of the structure were failing. The upstream retaining wall was tilting severely outward and had lost a significant amount of fill (Figures 8 and 9). The downstream wall was in better condition, but loss of fill was observed (Figure 10). Several broken soldier piles were found, and large gaps in the lagging was found (Figure 11).

Figure 8: Upstream tilting wall of the bulkhead

There appears to be merit in further investigation of repairs for the bulkhead facility, though this is outside the scope of the mooring points investigation.

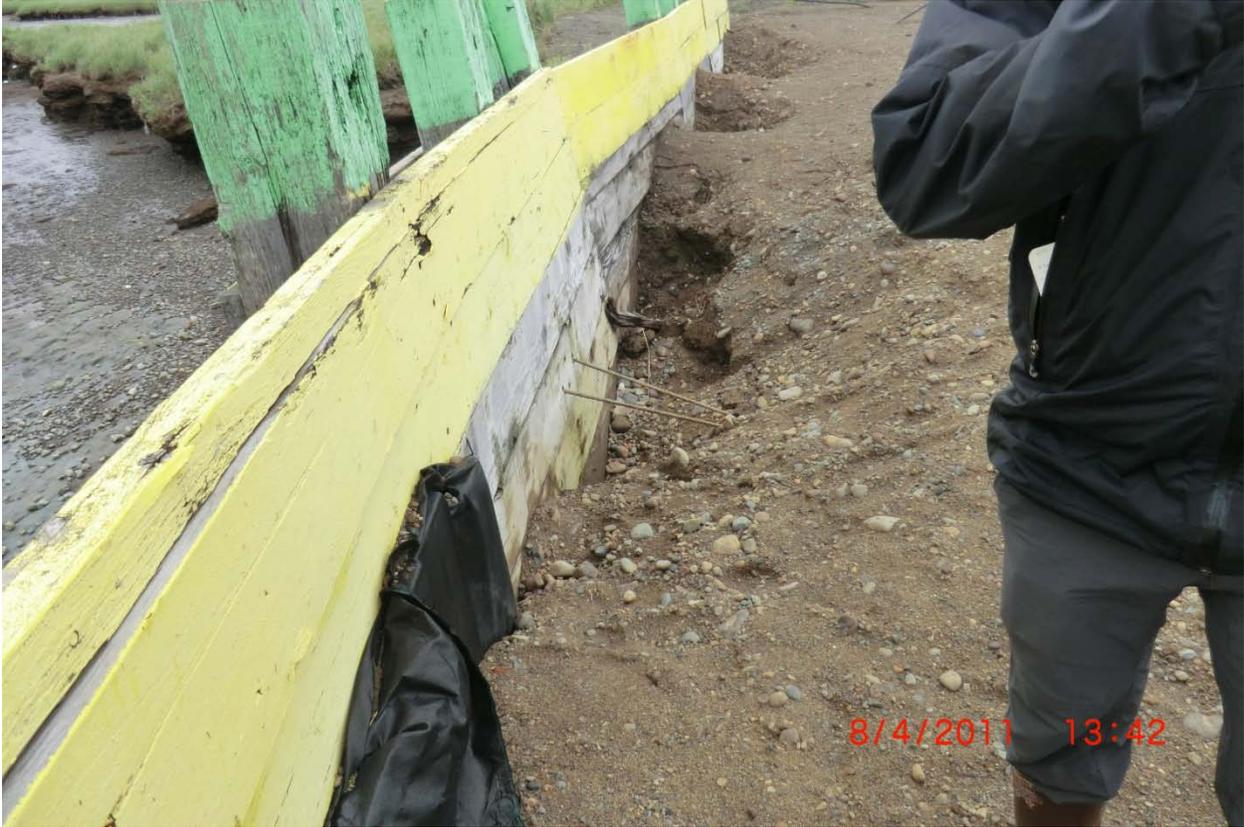
Figure 9: Loss of fill behind the upstream retaining wall. Note exposed tieback cables.

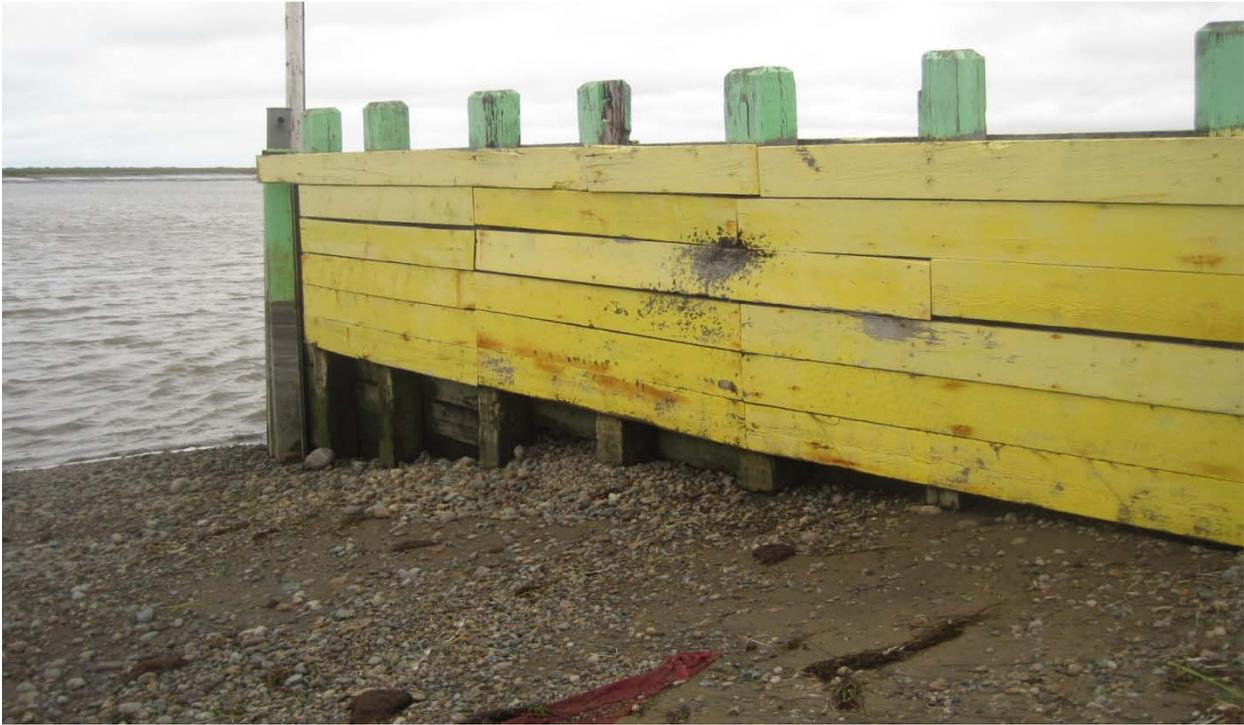
Figure 10: Downstream wall of the bulkhead

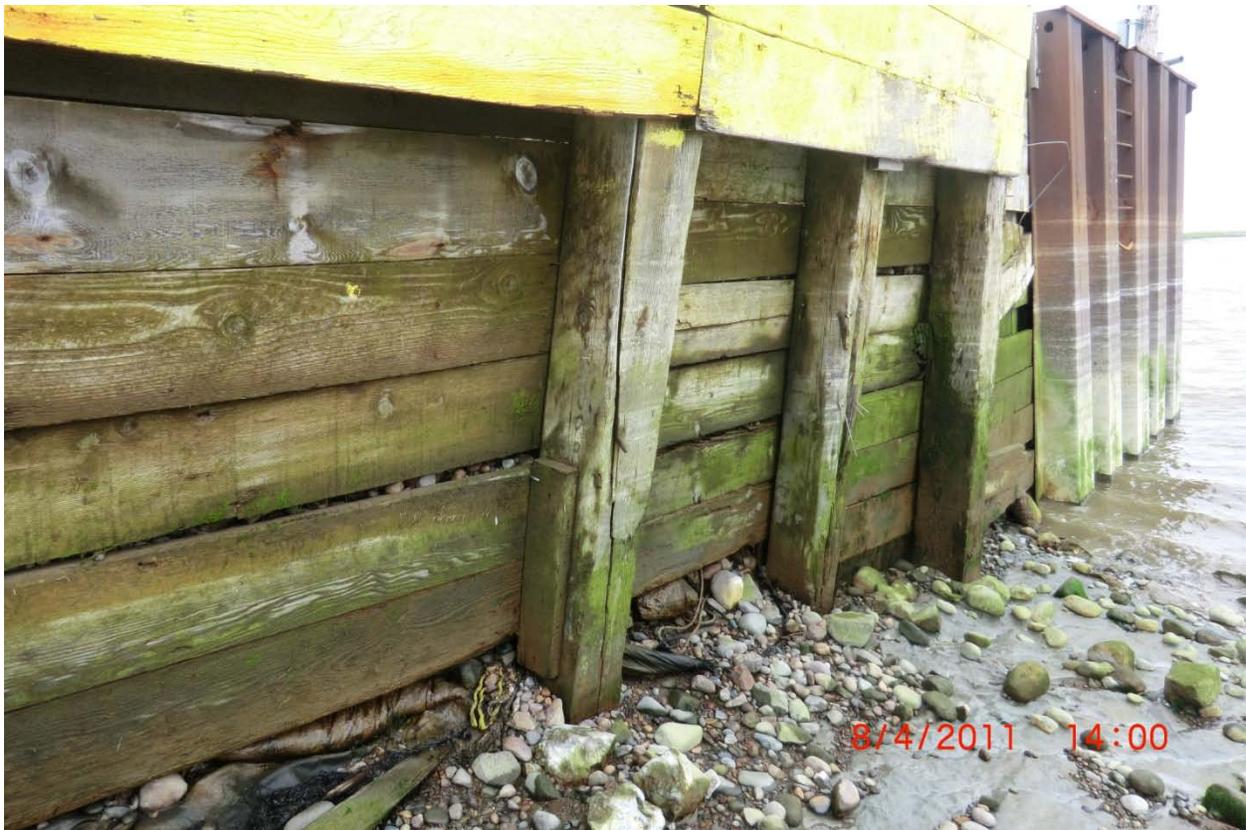
The former mayor of Pilot Point stated that the toe of the wall (Figure 11) is dry at low tide. This restricts use of the dock to a portion of the tide cycle. He noted that placing the wall 30 to 50 feet farther out into Dago Creek would provide full tide access to the bulkhead and assist in fishery operations.

Figure 11: Toe of the timber retaining wall. Note splintered soldier piles and fill visible between gaps in the lagging.
