Reconnaissance Report for Red Cove Road (School Loop Road) Sand Point, Alaska

Final

October 2006

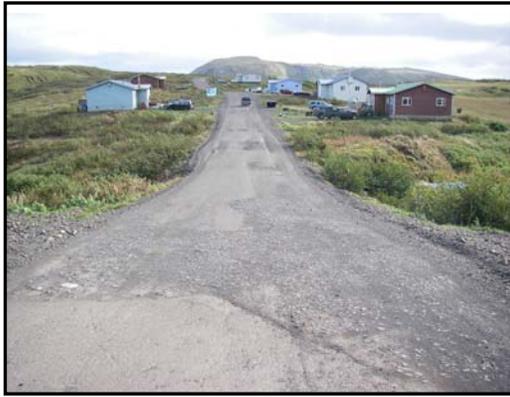
The horizontal geometry of the roadway consisted of long curves and generally short tangent sections running in and around the neighborhood houses. The roadway was generally flat with the steepest grade occurring near the entrance of the school. There appeared to be only one area, near the entrance to the clinic, where sight distance may be of concern. During improvement of the facility, it appeared that normal re-grading and re-shaping of the roadway embankment in this area may alleviate the problem. The surface of the roadway varied from a partially deteriorated asphalt surface to a completely deteriorated asphalt surface, resembling that of a gravel roadway. This variance can be seen in Figure 1 below.

Partially Deteriorated Asphalt Surface

Embankment Recommendations: To reconstruct this roadway back to a paved surface, initially, the existing asphalt should be completely removed exposing the original native fill material. Through conversations with Paul Karlsen and from observations of the general condition of the asphalt, removing the asphalt should be a fairly easy task. Once the existing asphalt is removed, the remaining material should be a well-graded angular gravel material that can be used for the roadway embankment. Once this material is adequately compacted in place, it can act as a good sub base. Then a standard Aggregate Base Course meeting the proper gradation requirements (D-1), can be placed and compacted on the sub base. An overall improved structural section results, that's ready to accept asphalt. With this improved structural section and properly placed and compacted asphalt, the roadway surface should not deteriorate as quickly as before, should be more resistant to the development of potholes, and should reduce the City's maintenance effort.

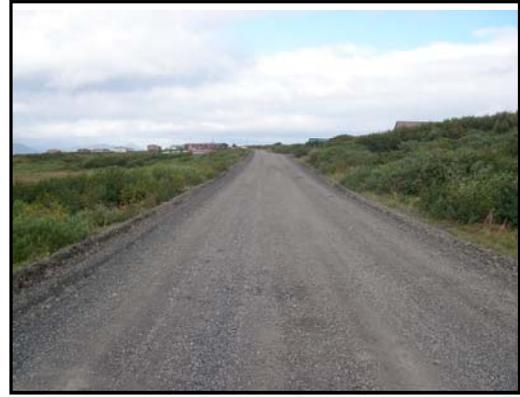
Figure 1

Completely Deteriorated Asphalt Surface

In the areas that exhibited a completely deteriorated asphalt surface, the existing embankment appeared recently maintained, shaped, graded, and overall in good condition. The continual upkeep and maintenance of the roadway has kept the embankment material in adequate condition and will allow it to be used for any proposed improvements to the facility. Figure 2 depicts the entire Loop and the approximate locations of the partially and completely deteriorated asphalt surfaces. Figure 2 also shows the locations of the culverts along the roadway.

The entire Loop was initially an asphalt pavement surface. In the areas where the asphalt was completely deteriorated, the asphalt material appeared to break down and separate into its

aggregate components leaving behind a surface consistent with a gravel roadway. The surface material in these areas appeared well graded with angular coarse aggregate. This type of material, once adequately consolidated, is similar to an aggregate base course material that is often used in the structural section immediately below the asphalt surface.

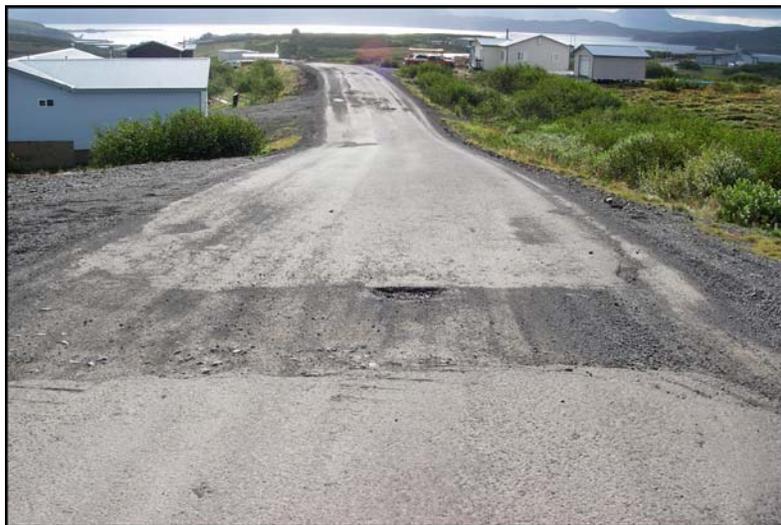
There were several locations along the Loop with evidence of trenching across the roadway to facilitate utility installations throughout the community. These areas exhibited pavement breakdown, potholing, and uneven surfaces. These trenches were all repaired with a compacted gravel material leaving behind a break in the asphalt pavement. A re-grading of the embankment and a paving of the surface will allow these trench sections to be completely repaired leaving behind a smooth continuous asphalt surface. Figure 3 below depicts an area that was trenched and repaired.

Additional Roadway Recommendations: During the reconstruction and paving effort, surrounding issues can be addressed to ensure a high quality finished product. Sight distance and visibility concerns in the vicinity of the clinic entrance can be improved through regarding of the embankment while preparing the sub grade for pavement. Also, future utility and related improvements in and around the community should be coordinated so that any crossings or trenching of the roadway can be completed prior to paving operations.

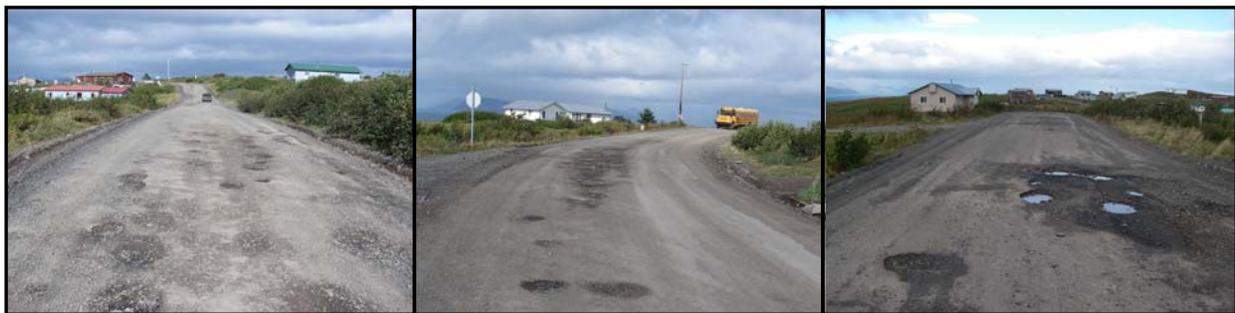
In both the partially and completely deteriorated asphalt surface sections, a substantial amount of potholes were observed along the entire length of the roadway. While driving around the Loop, it was almost impossible to avoid hitting numerous potholes. Several sections of the Loop require drivers to either drive on the wrong side of the road, or significantly decrease speed in an attempt to avoid or minimize the impacts with potholes. Figure 4 depicts several of locations along the roadway where significant potholing was observed.

Potholes form from a multitude of factors including insufficient asphalt thickness, poor quality of asphalt, inadequate compaction of the structural section, and poor drainage. Water will seep into any cracks in the asphalt, and through freeze/thaw cycles, weaken both the sub structure and asphalt. The heavy wheel loads then break up the weak asphalt creating the potholes. The formation of potholes is accelerated in wet and cold climates similar to the climate of Sand Point. Quality construction practices combined with good maintenance can minimize the development of potholes.

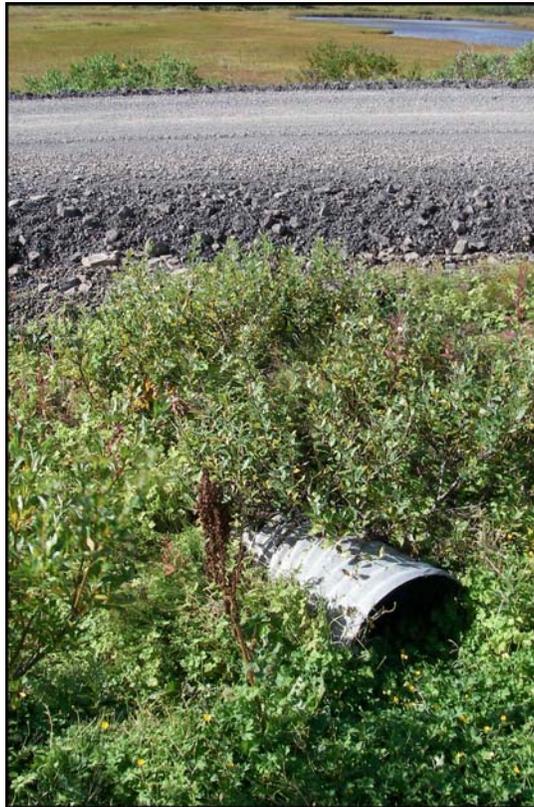
Figure 5
(Upstream Side)

Culvert #1 is 24" in diameter with approximately 5-6 feet of cover material on the down stream side, and 2-3 feet of cover on the upstream side. The side slopes on the downstream side were measured at approximately 1.2:1 (Horizontal: Vertical). The overall length of the culvert is approximately 50 feet. This culvert appeared in good condition and should not need any additional work during the improvement of the facility. Figures 5 and 6 below depict the upstream and downstream sides of Culvert #1, respectively.

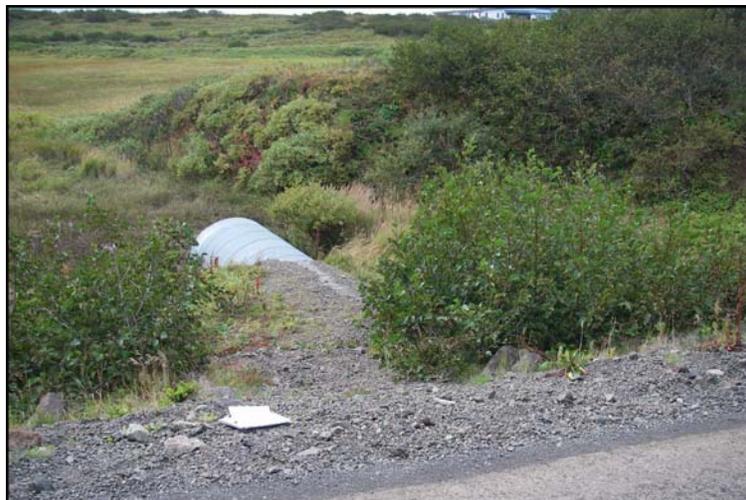
Figure 7
(Upstream Side)

Culvert #2 is the largest culvert along the Loop at 60" in diameter with approximately 10 feet of cover material on the downstream side and approximately 3.5 feet of cover material on the upstream side. The embankment slope on the downstream side was measured at approximately 1.3:1 (H:V). The overall length of the culvert is approximately 80 feet. The large and steep embankment slope on the downstream side warrants the investigation of a possible guardrail installation. Analysis and recommendations for this area are shown under the Recommendations portion of the report. Figures 7 and 8 below depict the upstream and downstream side of Culvert #2, respectively.

Culverts #2 and #5 are located in sections where the roadway embankment slopes are relatively steep and high. In the area of Culvert #2, the slope was measured at approximately 1.3:1 on the downstream side with an embankment height approaching 20 feet. There are two options to try and improve safety at this location. A guardrail may be warranted at this location, although a cost-effective analysis in accordance with the State Highway Preconstruction Manual would need to be performed to confirm the need. Alternatively, additionally embankment material can be placed on the downstream side to flatten the slope to a transversable 3:1 slope. This would require an extension of the existing culvert, but would alleviate any future maintenance concerns associated with a guardrail.

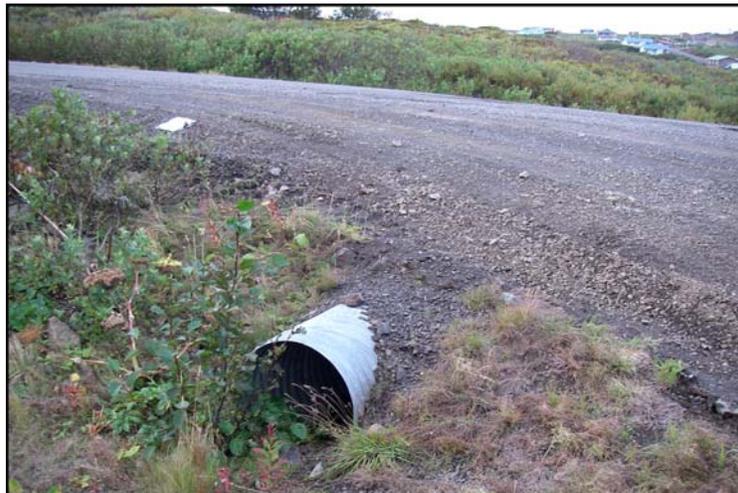
Figure 9
(Upstream Side)

Culvert #3 is 24" in diameter located next to the intersection of the landfill road and the School Loop Road. There was approximately 1-2 feet of cover material on both the upstream and downstream sides of the culvert. The overall length of the culvert was approximately 50 feet and the culvert was dry at the time of the inspection. This culvert appeared in good condition and should not need any additional work during the improvement of the facility. Figures 9 and 10 depict the upstream and downstream side of Culvert #3, respectively.

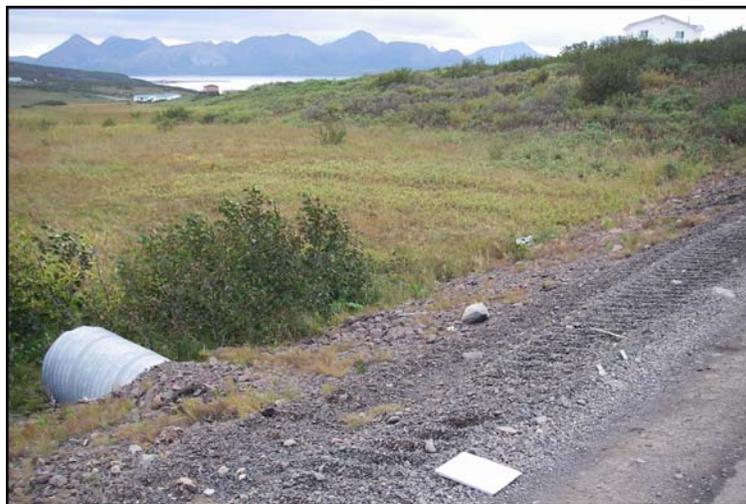
Figure 11
(Upstream Side)

Culvert #4 is 36" in diameter with approximately 2-3 feet of cover on the upstream side and 3-4 feet of cover on the down stream side. The overall length of this culvert was approximately 60 feet. This culvert appeared in good condition and should not need any additional work during the improvement of the facility. Figures 11 and 12 depict the upstream and downstream side of Culvert #4, respectively.

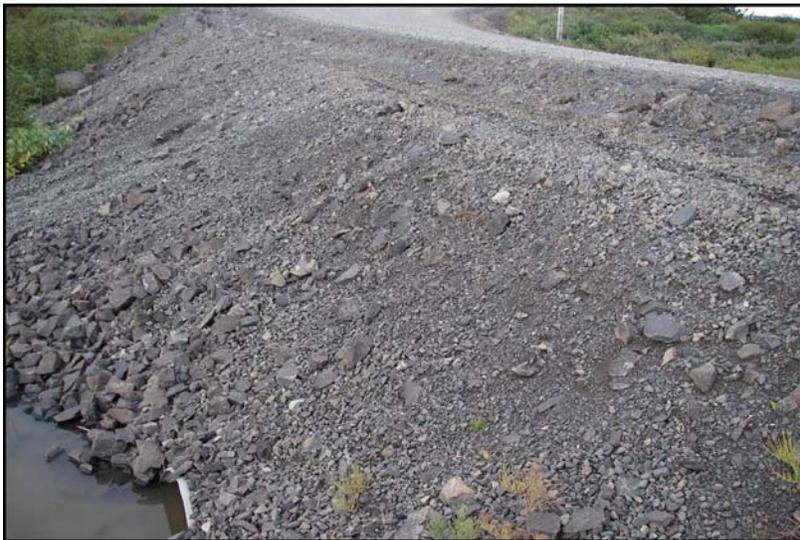
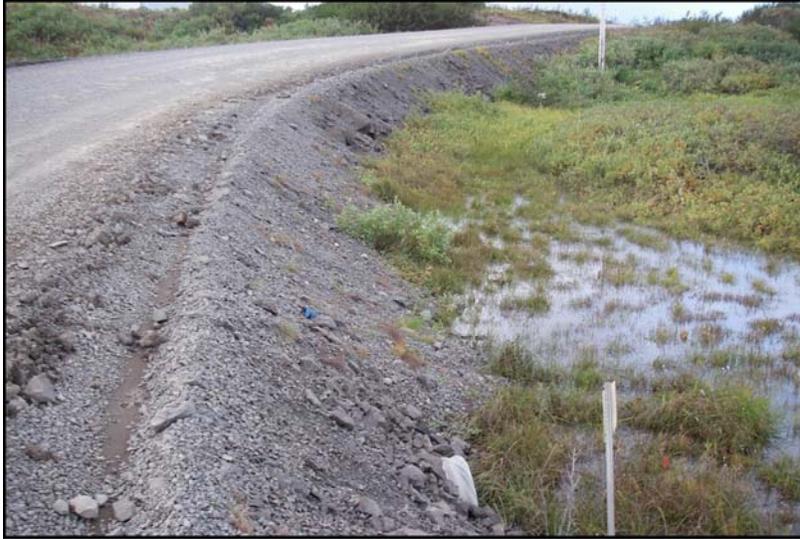
Culvert #5 is 24" in diameter with approximately 4-5 feet of cover material on both ends of the culvert. This culvert terminated at the toe of the fill slopes and was located in an area with standing water on both sides of the roadway embankment. At the time of the inspections, the culvert was approximately 2/3 full with standing water and did not appear to have an obvious *upstream* or *downstream* side. Overall, the culvert was in good condition. Figures 13 and 14 depict the southwest and northeast side of Culvert #5, respectively.

A similar situation exists with culvert #5. The embankment height is approximately 4-5 feet, the slopes are relatively steep, and there is standing water on both sides of the roadway. Once again, a cost effective analysis can be performed, or the existing culvert can be lengthened to allow flattening of the side slopes to a transversable 3:1 slope.

Overall, the five culverts along the roadway appeared to be in good condition. If the embankment height is increased during improvement of the facility, the culverts appear adequately long enough to deal with wider slope limits except for Culvert #5 where end sections may need to be installed to withstand the wider embankment.

Due to the additional costs associated with guardrail maintenance and replacement, and the readily available land adjacent to both Culverts #2 and #5, it would be our recommendation to simply flatten the slopes to a transversable 3:1 and lengthen the culverts as needed. At the same time it would be beneficial to undertake additional drainage improvement in this area.

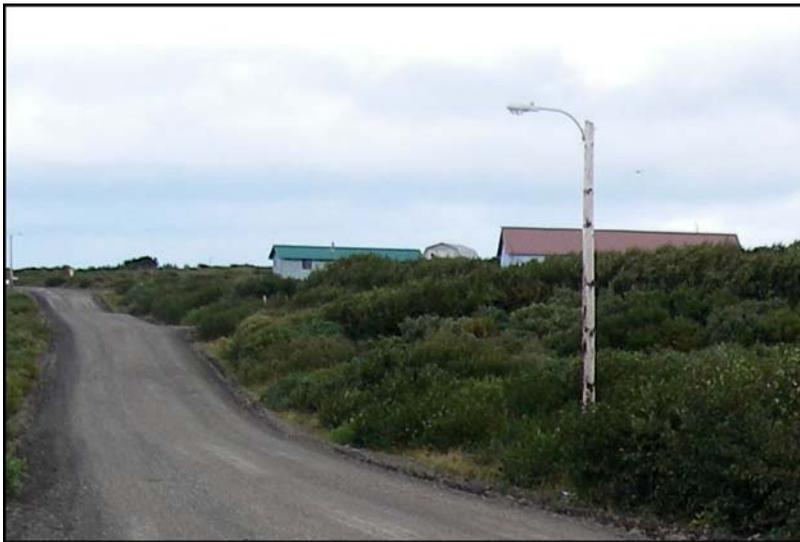
The Loop had limited lighting that appeared to be along approximately 75% of its length and was contained only in the areas with houses or buildings. The lighting system consisted of single wooden poles with single lights spaced on the order of 1000 feet. Figure 15 depicts the typical lights found along the roadway.

Presently, the lighting on the Loop is only contained in the areas with existing homes and buildings. The existing lights have significant spacing in certain areas and provide light from a fairly low elevation minimizing their effectiveness. To improve the current roadway lighting, additional light poles can be provided near the Landfill Road intersection, the frequency of lights poles can be increased, and the existing lights can be replaced with taller poles and more up to date lighting methods. With these improvements, the type, quantity, efficiency, and overall height of the lighting is enhanced, which ultimately provides increased illumination along the Loop and improved safety.
