SELDOVIA BOAT HARBOR IMPROVEMENTS
TECHNICAL REPORT

FEBRUARY 2011

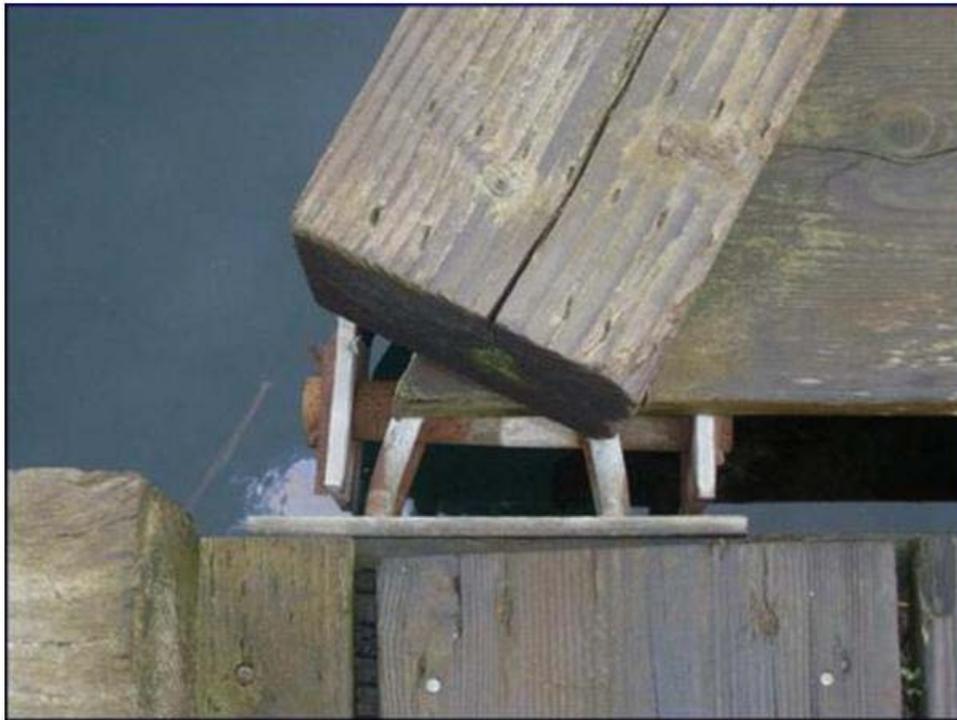
Figure 6. Old finger pin connections along many floats create unstable surfaces

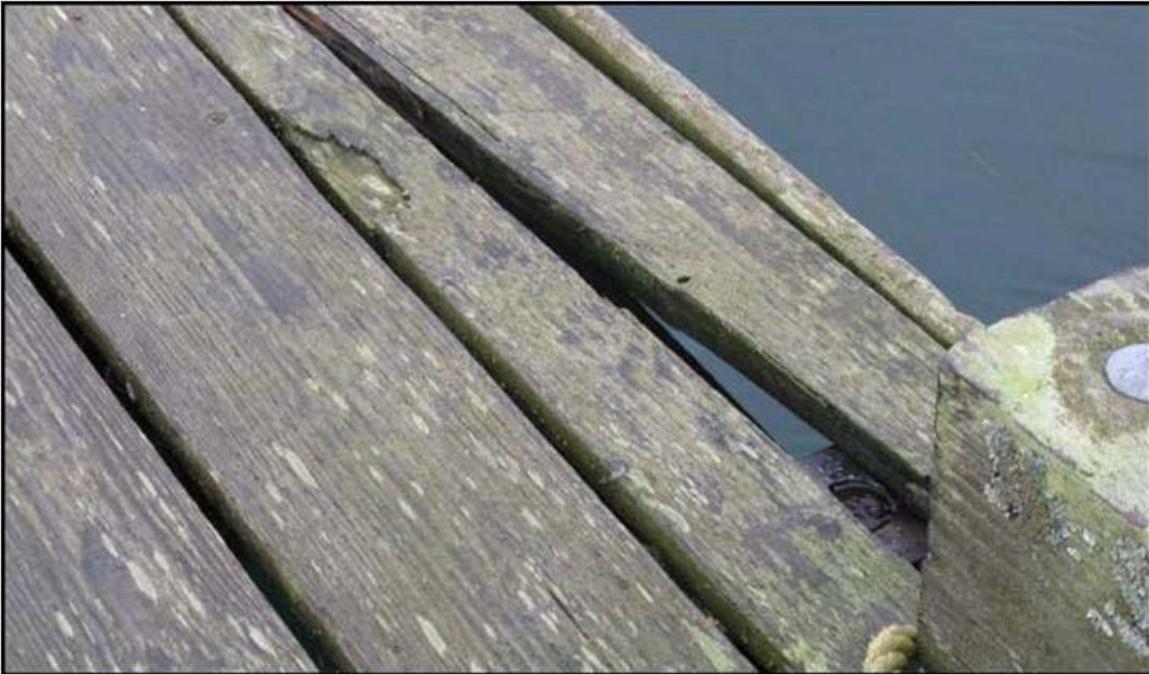
Figure 9. Cracked decking on D Float

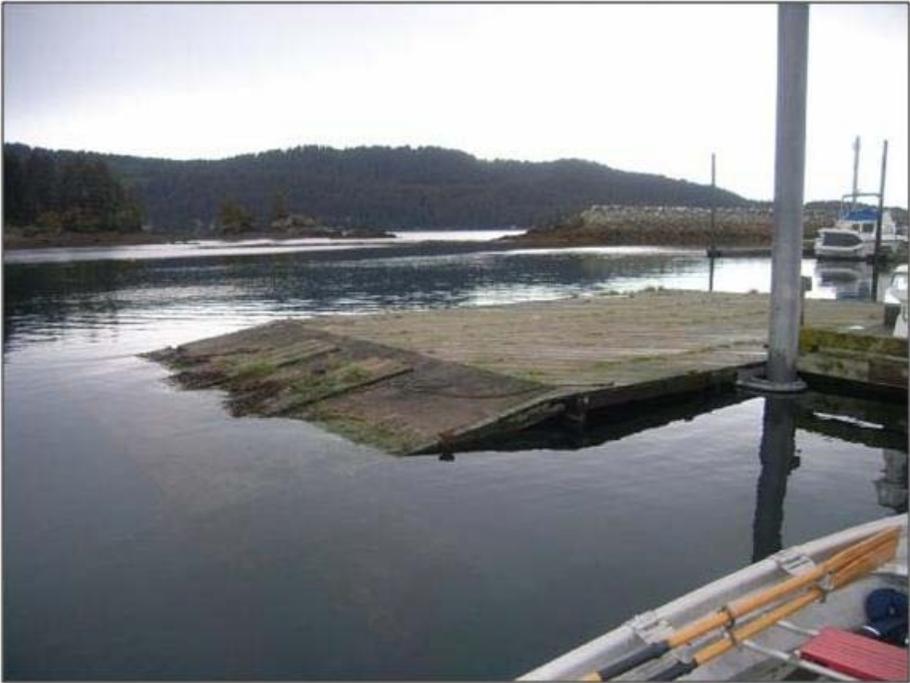
accelerating its deterioration. The float plane dock is shown in Figure 10. In addition, seaplanes tend to cause navigation hazards as they enter through the main harbor entrance. There is not enough room in the harbor entrance to accommodate both vessel and plane traffic. Though the opening to the south of the main breakwater is not considered a navigable channel, seaplanes tend to utilize this access point at higher tides when the shoal is covered.

Figure 10. Float plane dock with vegetation growing on decking and ramps

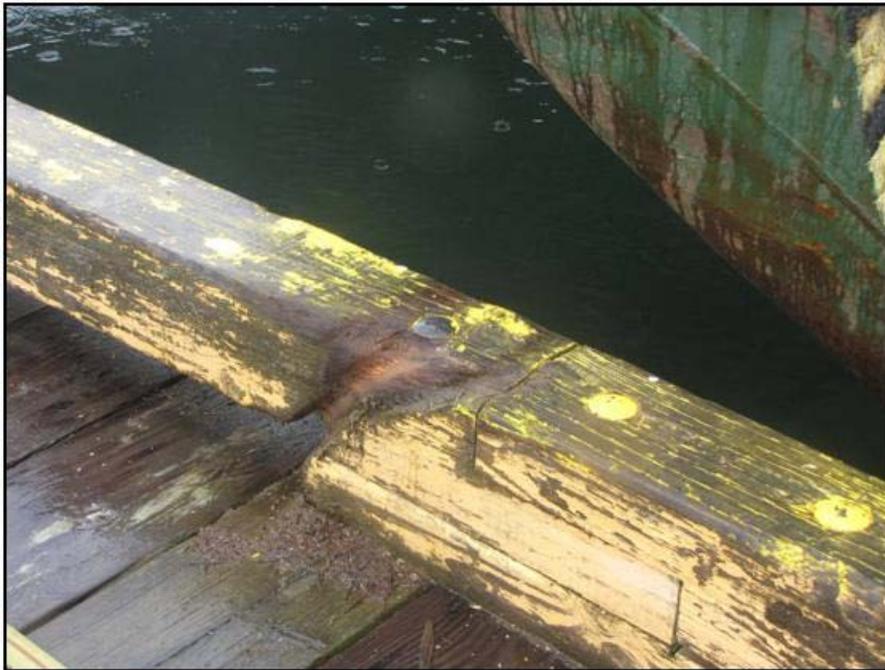
Figure 12. Worn bull rail along the main float

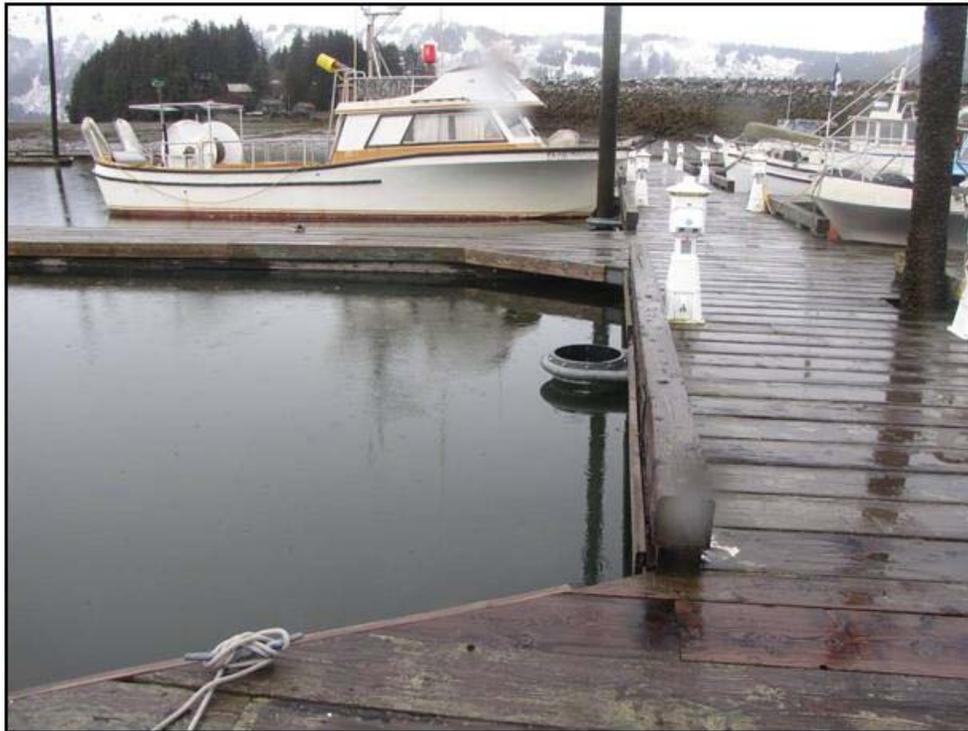
As previously mentioned, some repair and upgrade work has already been completed. As part of that effort, many of the harbor's wooden piles were replaced by steel piles. However, as the city reports, several of the new pilings were not able to be placed. Seldovia resident Jim Hopkins worked on the project to replace the pilings and reported that several of the locations for new pilings were located on material that was far too rocky to achieve an adequate pile depth with the equipment being used. At some of these locations the piles were driven until refusal and at several other locations there was no penetration at all, so the piles were not placed. The new galvanized steel piles are missing in two locations on the main float, three on the C float, and two on the B float. Also, old wood pilings on the finger floats need to be removed and disposed of along the B float, C float, D float, and E float. Figure 13 shows the location of a missing pile.

Figure 13. An empty pile collar shows where a new steel pile could not be driven due to rocky conditions

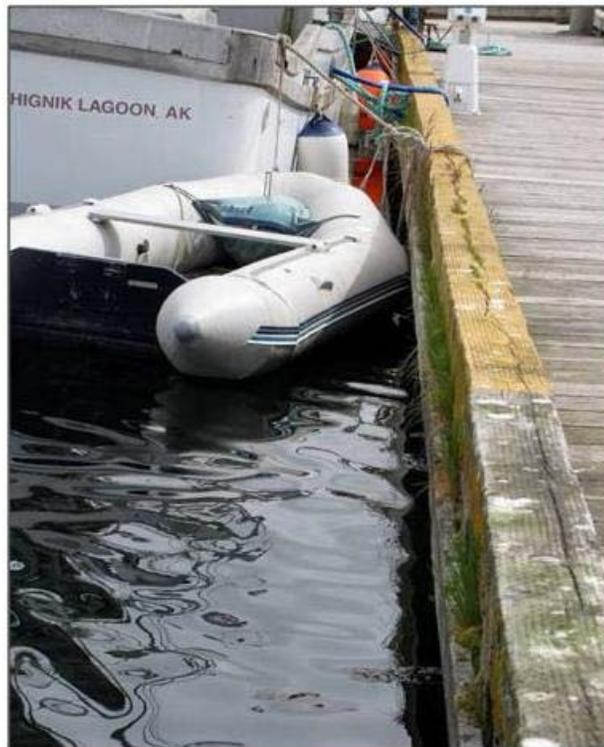
Figure A-7. Vegetation by Decking and in Bull Rail

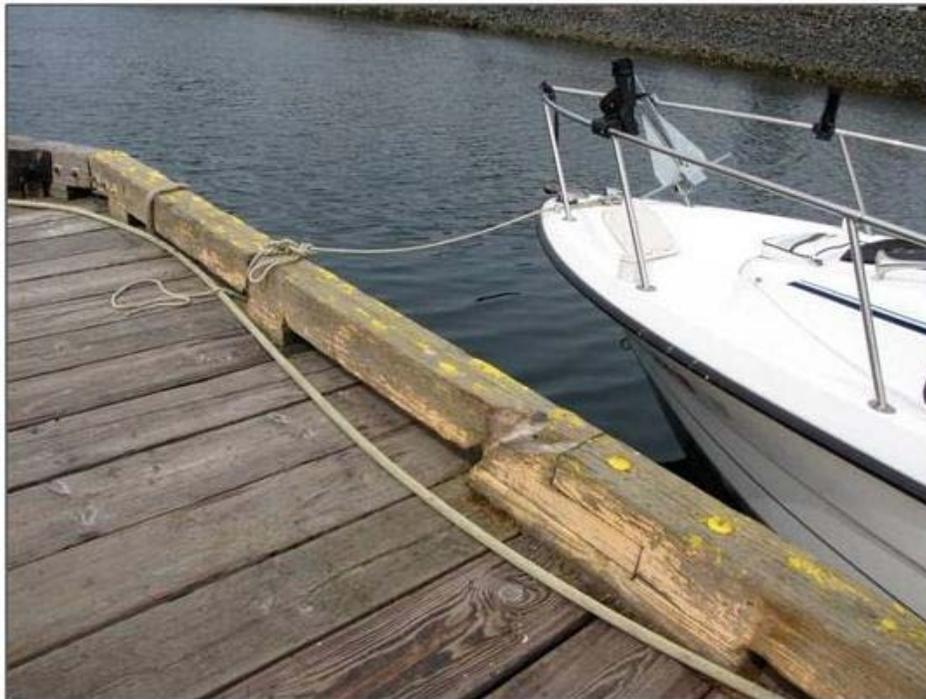
Figure A-9. Worn Bull Rail

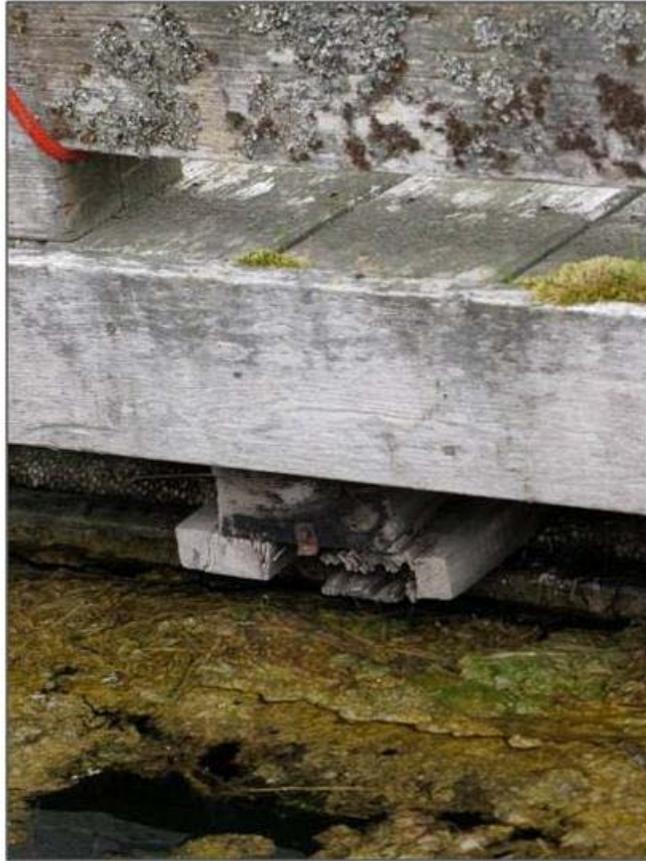
Figure A-10. Rotting Substructure

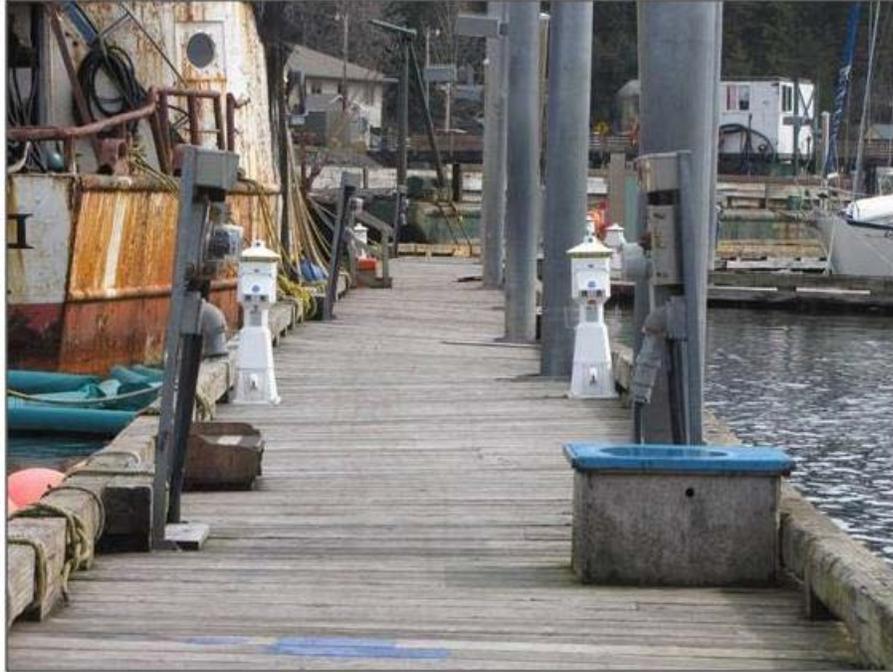
Figure A-11. North Main Float Needing Replacement

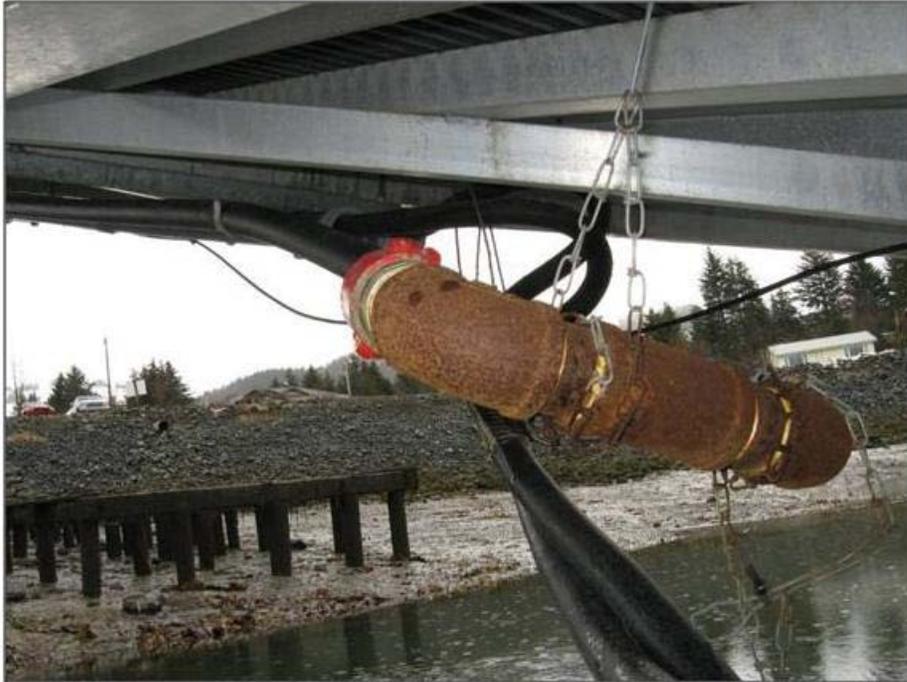
Figure A-16. Existing 2-inch polypropylene pipe with a 2-inch galvanized tee connection and capped ends located under the ramp. The 2-inch galvanized pipe would be replaced with new 2-inch HDPE tee. Left side of the tee would supply the north main float; right side would supply the south main float.

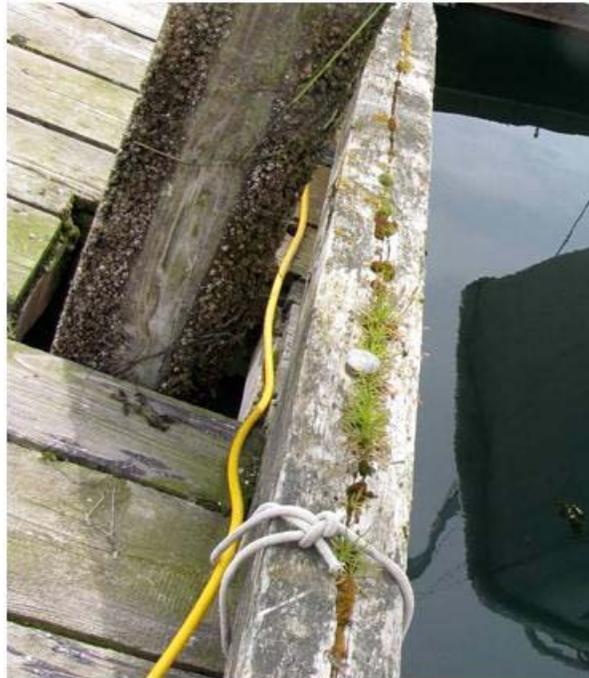
Figure A-28. B Float Splitting Bull Rail

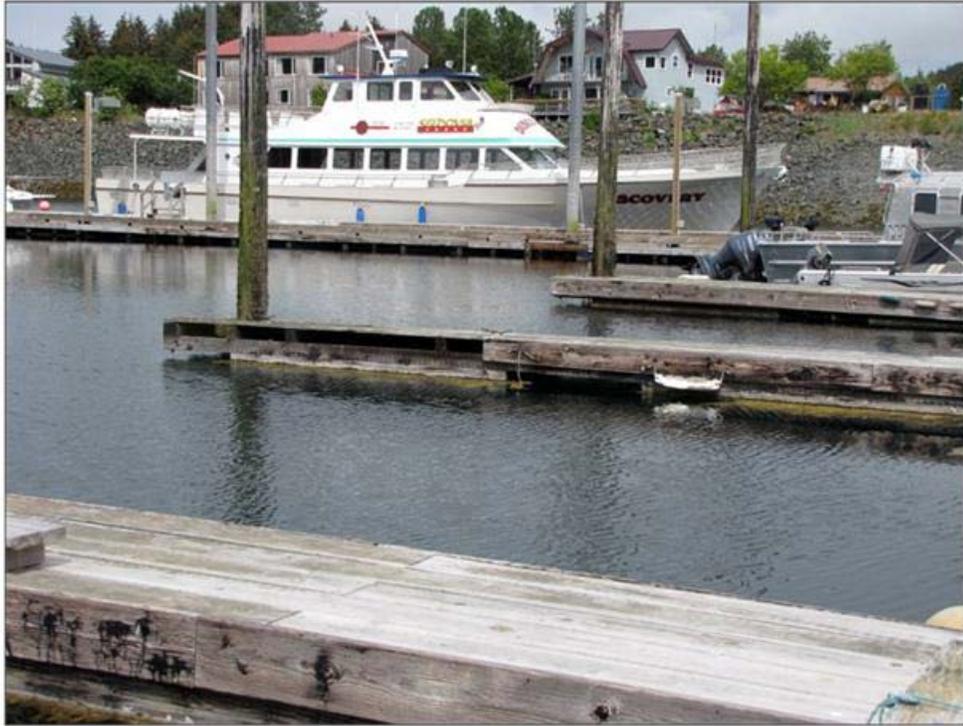
Figure A-34. Deteriorating finger float

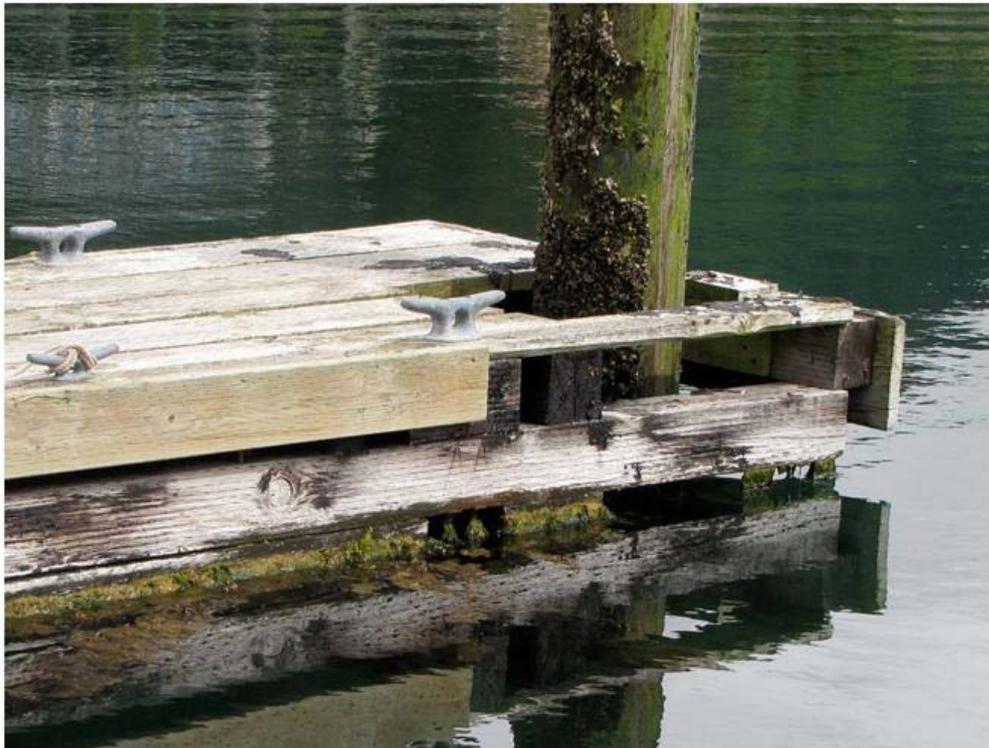
Figure A-35. Missing side plank on finger float

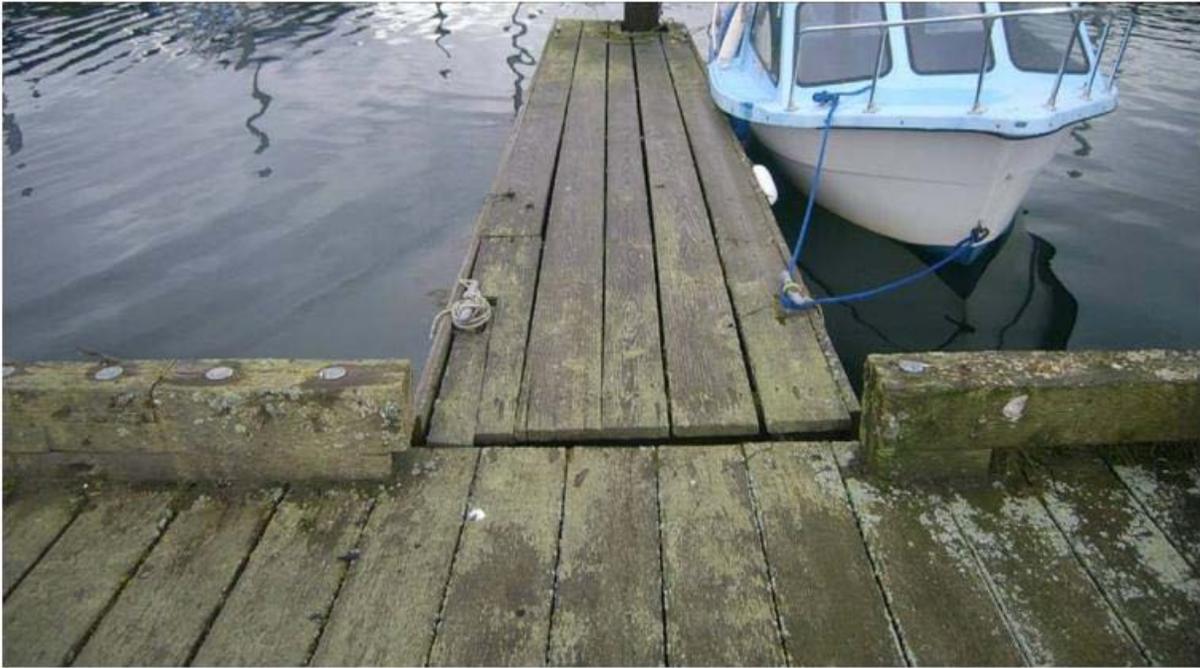
Figure A-36. Moss on decking and bull rails

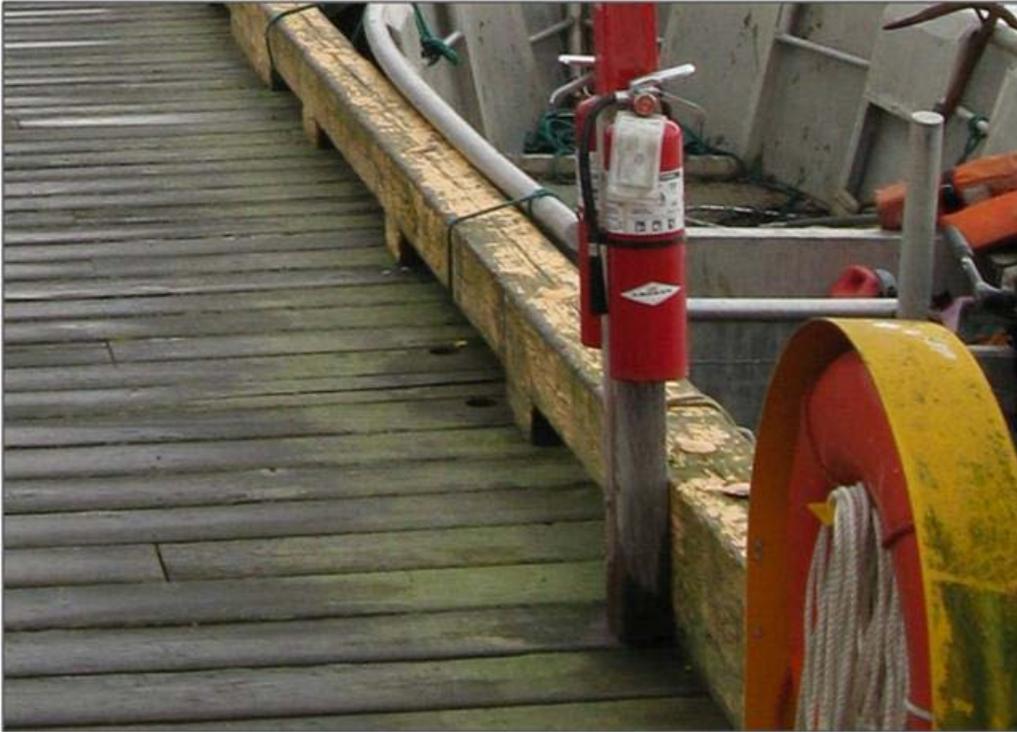
Figure A-38. Cracked deck plank and moss growing on decking

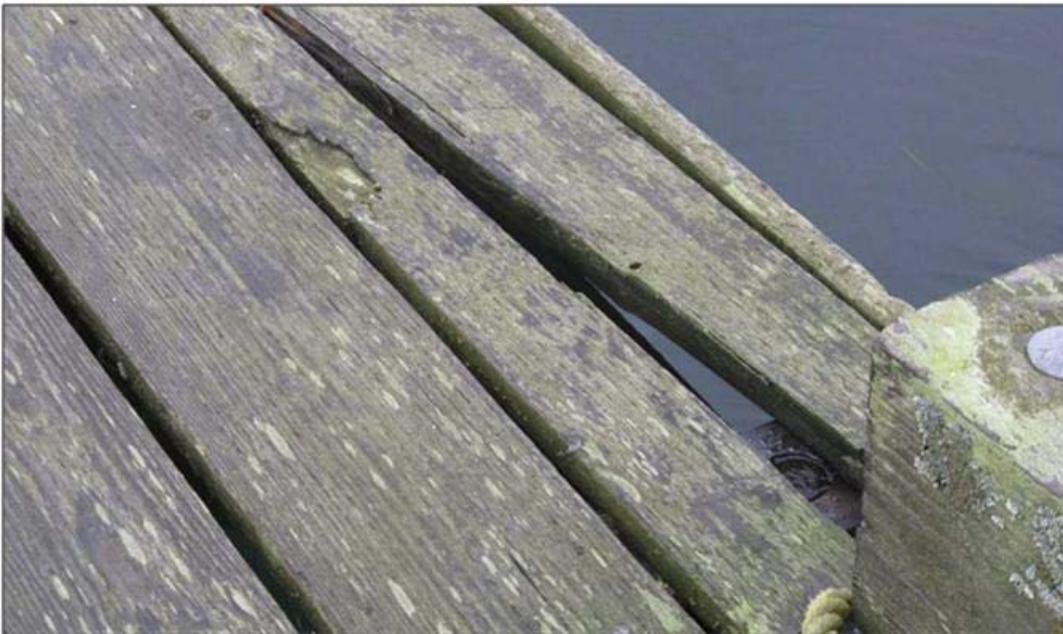
Figure A-39. D Float deck damage

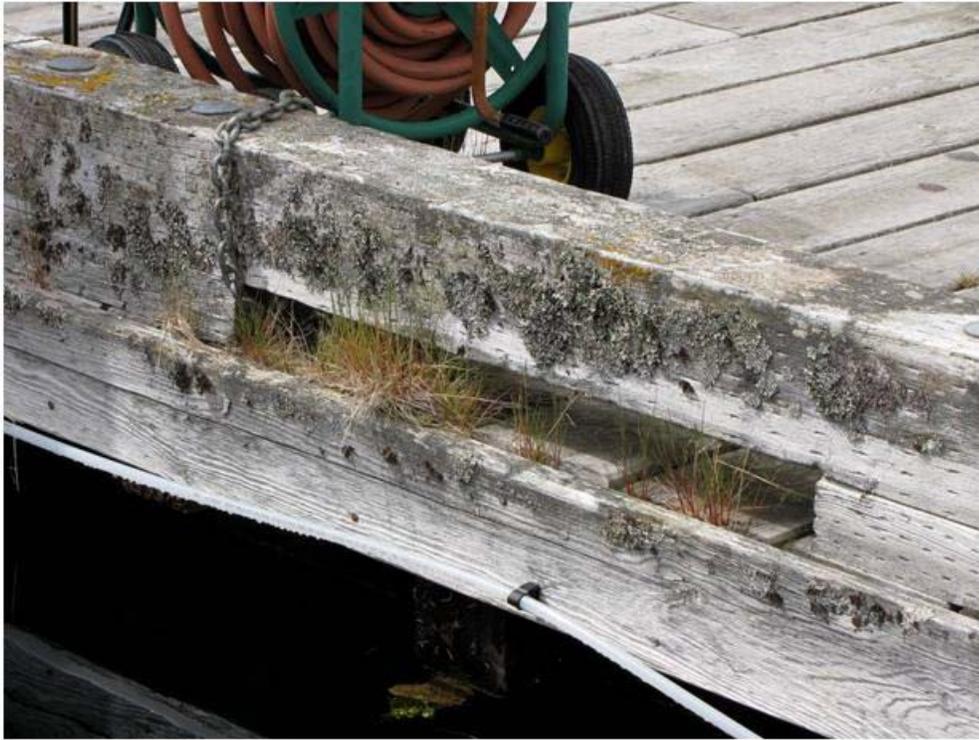
Figure A-40. Grass and moss growing on decking and bull rail

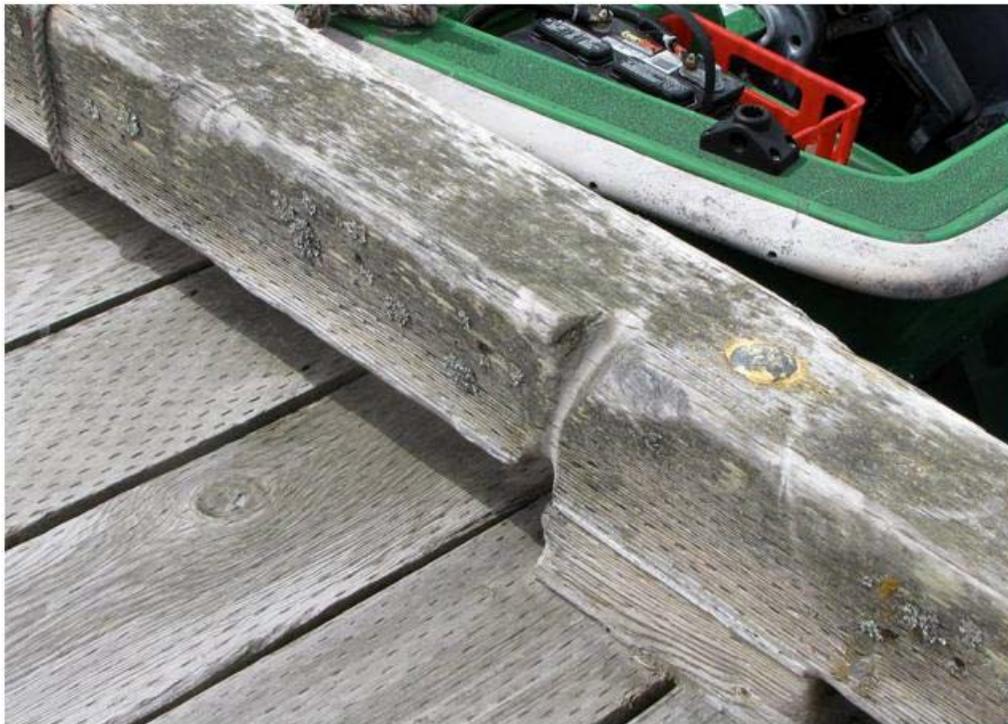
Figure A-41. Worn bull rail

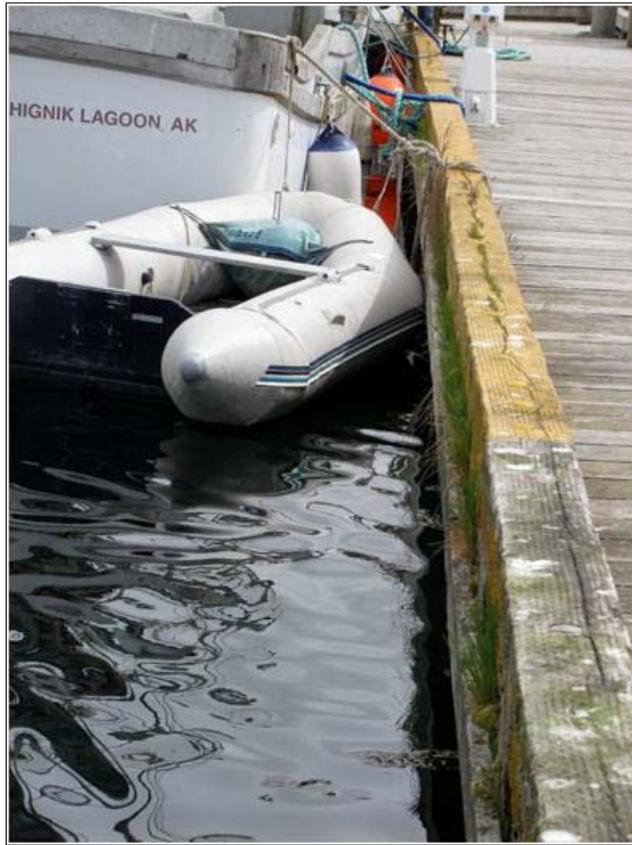
Figure A-43. South main float with split bull rail and grass growing

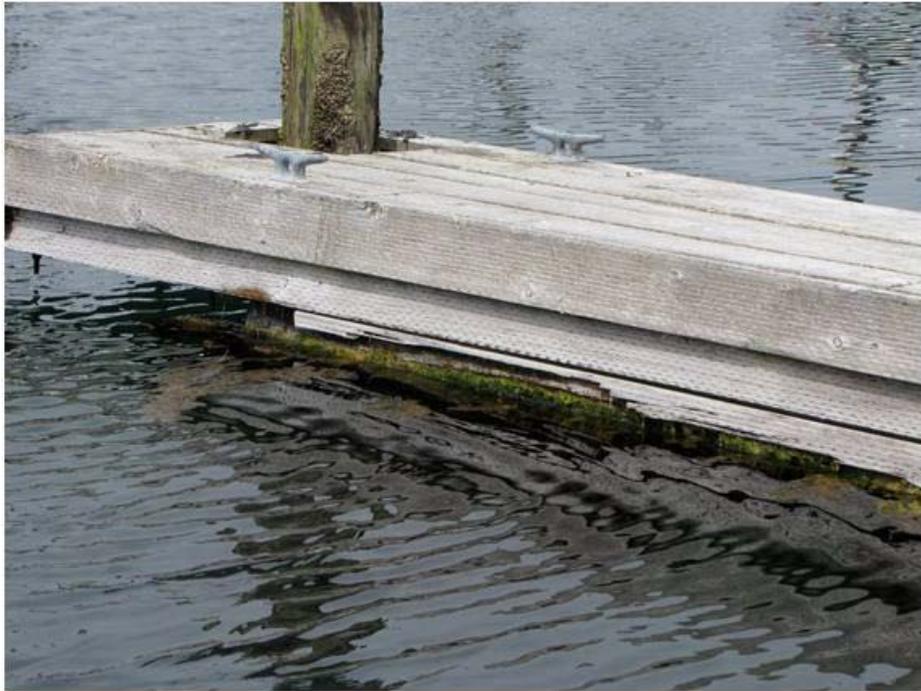
Figure A-45. Deteriorating finger float substructure

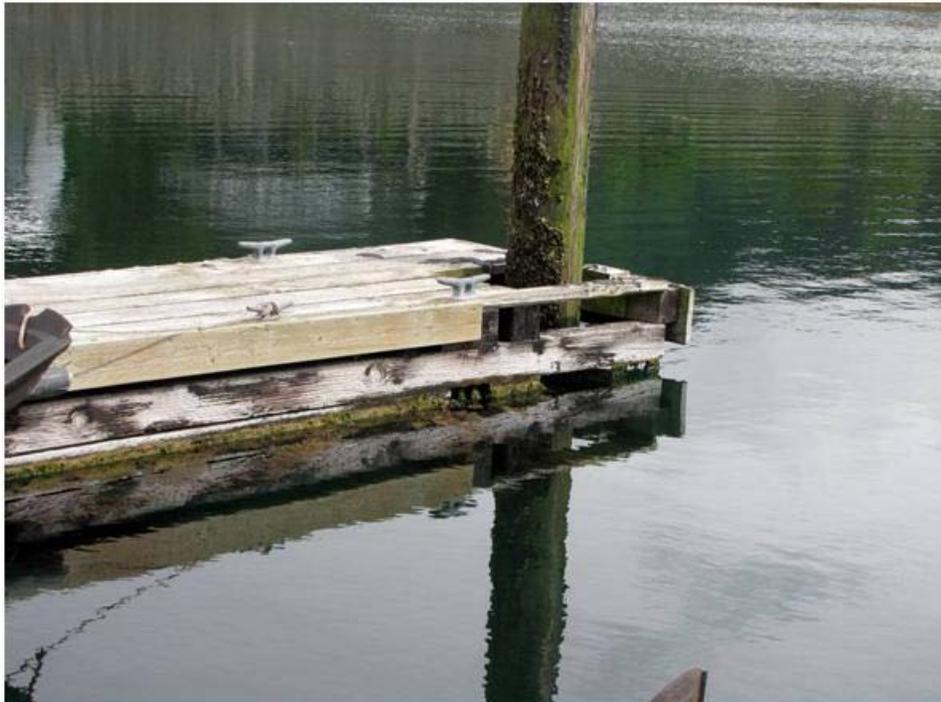
Figure A-46. Deteriorating Finger Float

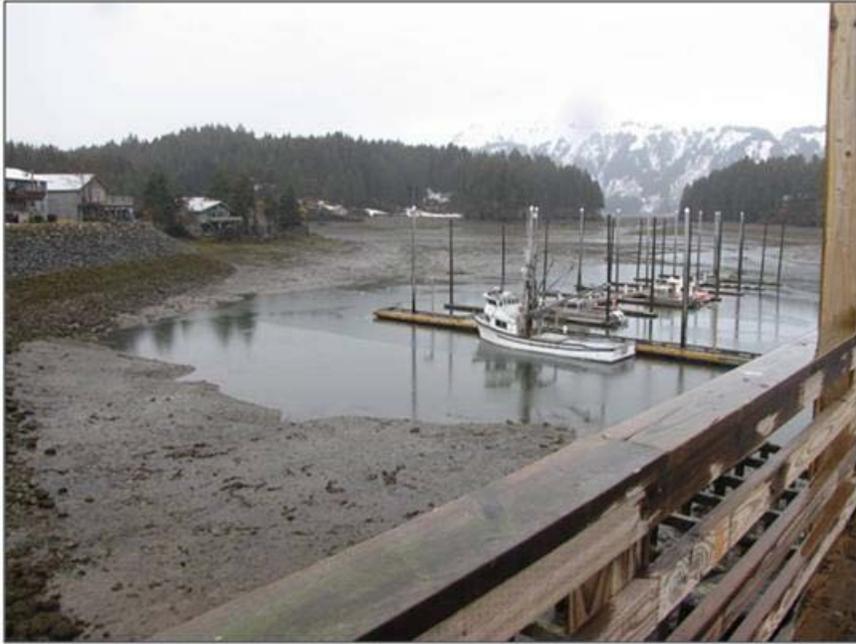
Figure A-50. Area South of E Float Needing Dredging (located in background behind visible dock)

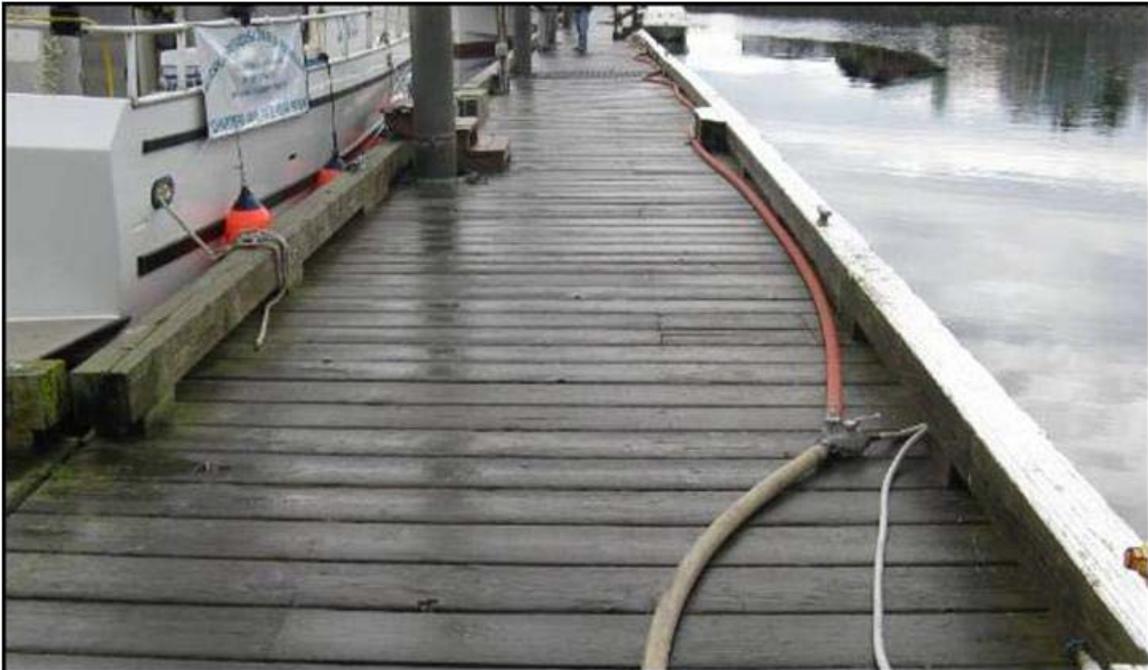
The main run of the dock system has worn decking and bull rails. Both appear solid, but have a fair amount of moss, wear marks, and cracking. In some areas, the bull rail has vegetation growing out of cracks. Towards the north end, the main run appears warped as if the floatation is unevenly distributed. In the same northern area, the dock appears to be significantly undersized for the type of vessels that are moored to it. The main run needs 6, 3-phase meters replaced. The water system being used is a series of fire hoses with connections to previously installed water spigots. The city reports they are using this system now because the older system was breaking daily and had become a maintenance burden. The city reports that if the fire hose system were adjusted for easy installation and safe placement, they would be very satisfied. To the south along the main run the decking and bull rail show similar signs of wear as the north end. There is also warping of the main run dock showing an uneven distribution of floatation.

Figure D-3. Main Run Show Decking Wear and Hose Watering System

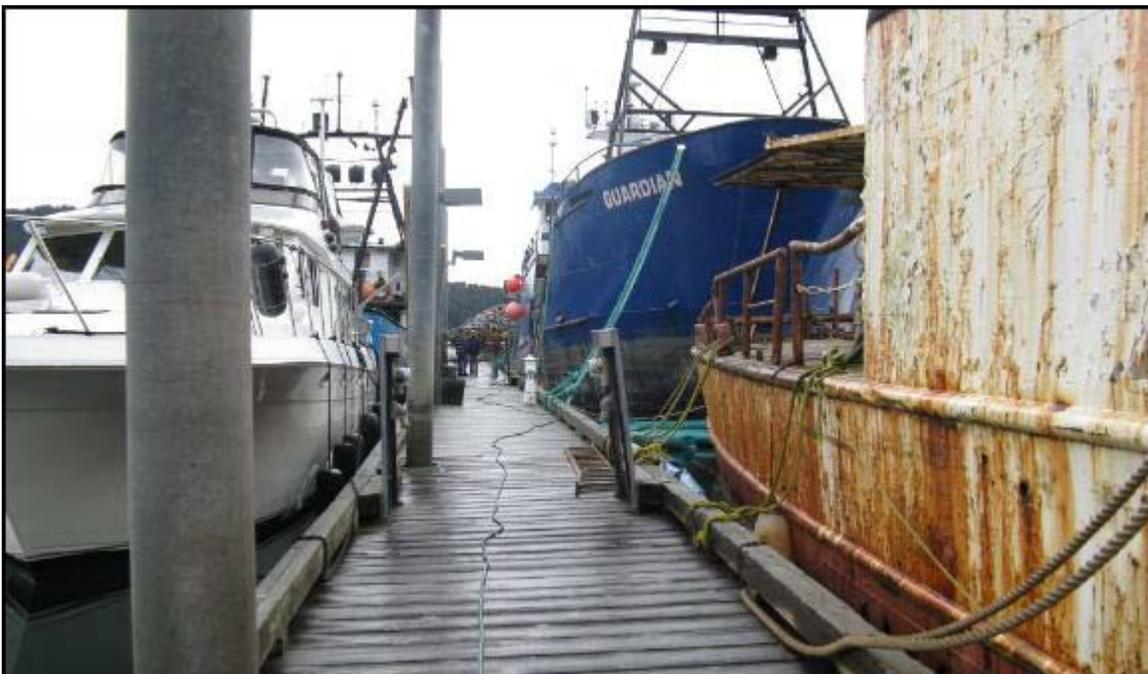
Figure D-4. Main Run Warping

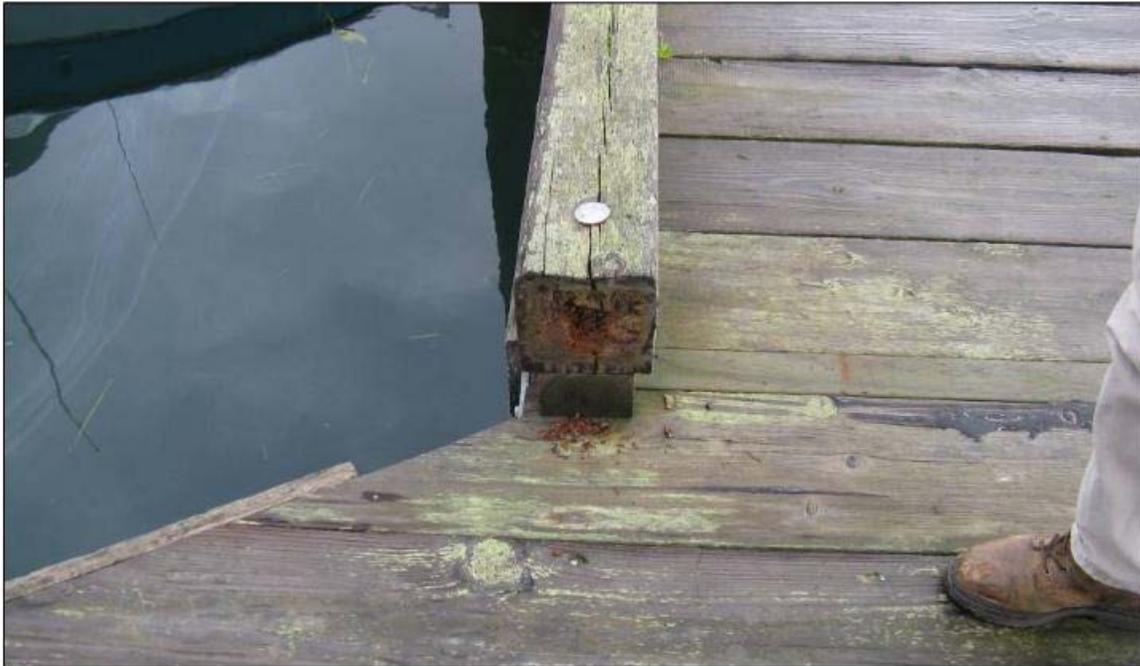
Figure D-9. B Dock Bull Rail Rot

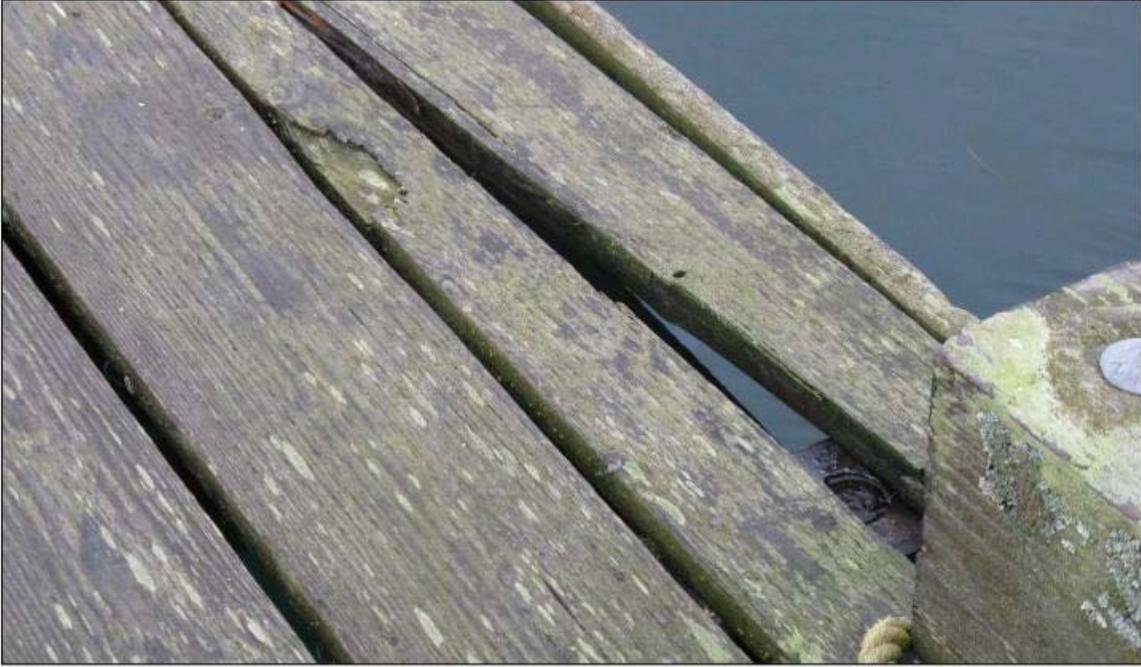
D Dock has worn decking and bull rails. Both appear solid, but have a fair amount of moss, wear marks, and cracking. In some areas, the bull rail has vegetation growing out of cracks. The finger piers are fastened using a pin system leaving the fingers to not be stable. The slippery nature of the decking in combination with the finger pier instability provides for a potential safety hazard. About 3 to 5 of the new metal piles are missing. 10 wood piles need to be removed. D dock has no finger piers to the north. If installed, these finger piers could provide more moorage.

Figure D-11. D Dock - Decking Damage

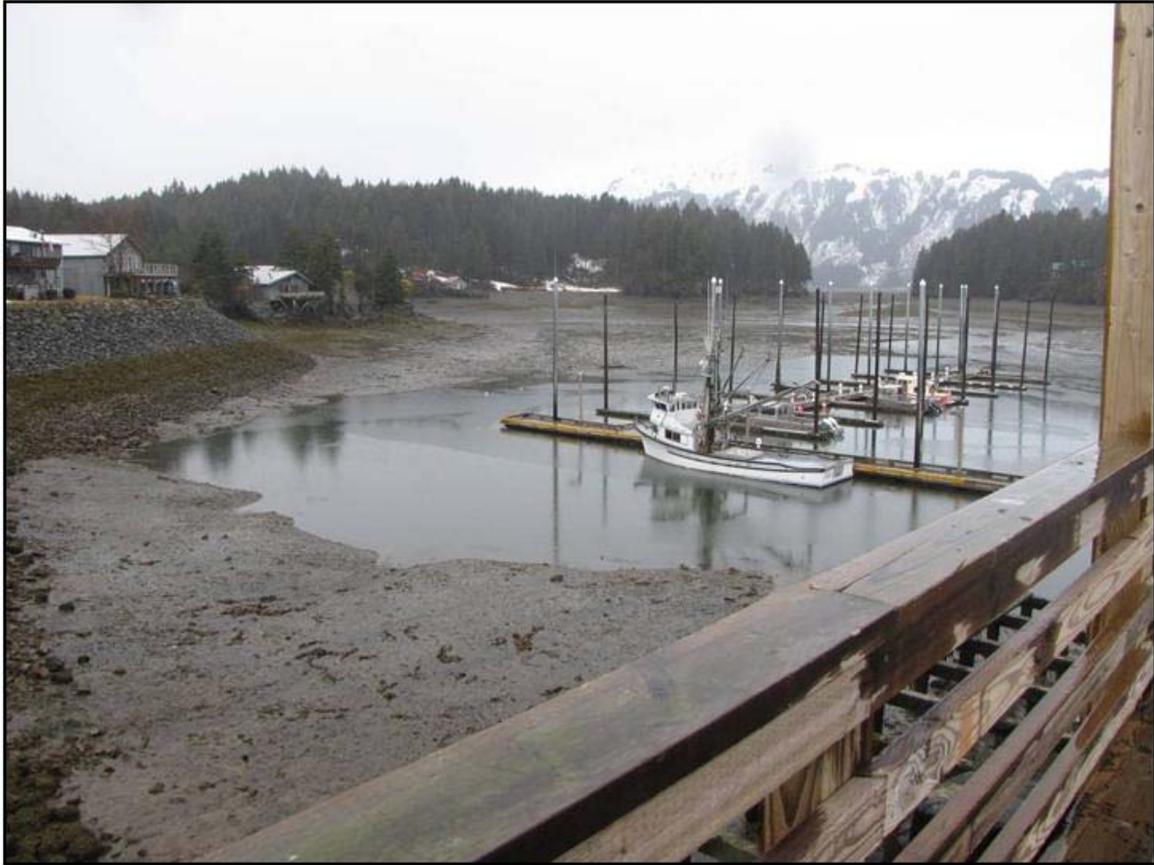
Harbor Depth – From C Float southward, the harbor is shallower than the Federal harbor depth of 12 feet. Several boats are limited in their ability to maneuver at low tides and many groundings have been reported. When boats are moored at the ends of the docks nearest the breakwater, deeper draft vessels cannot navigate around them because the channel is too shallow away from the docks. Moorage of vessels at the D and E float are limited to either shallow draft vessels or to the few spots where deeper water exists.

Figure D-18. The south end of the harbor at D and E docks are too shallow to navigate or moor at the lowest tides

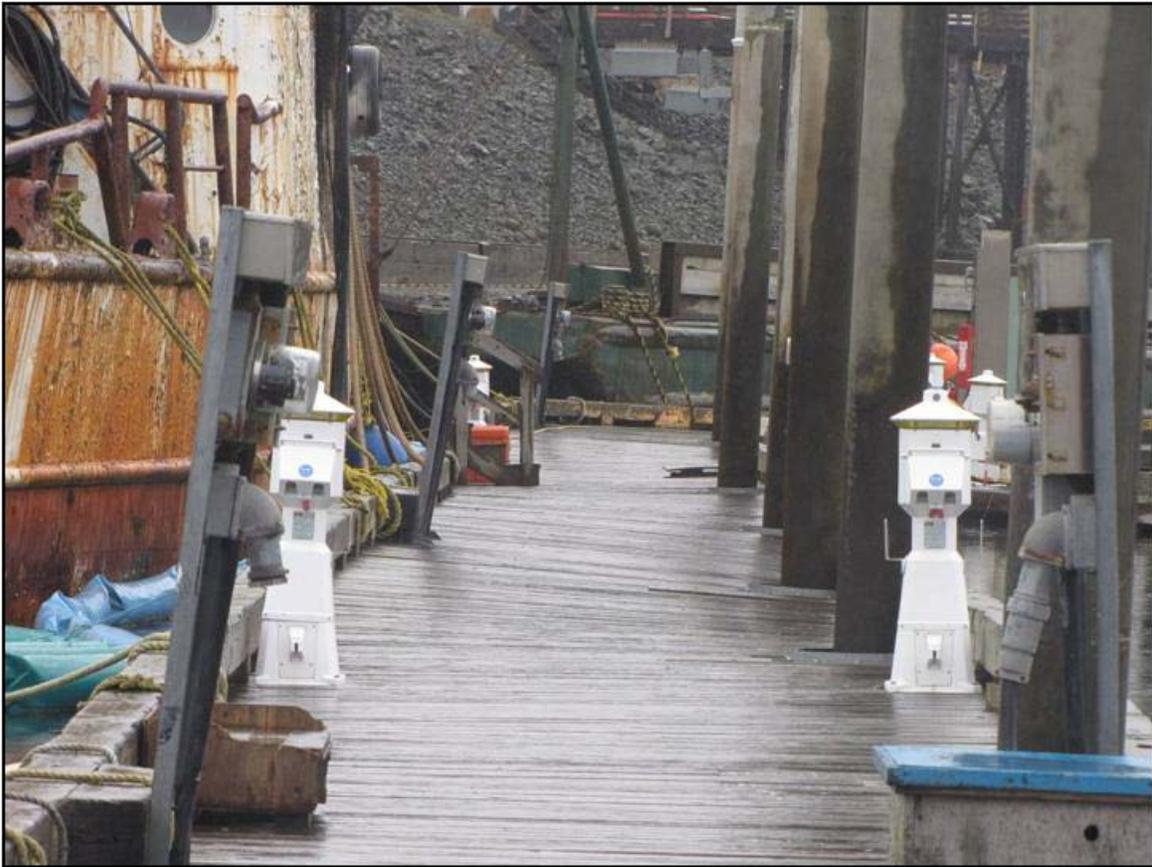
Figure D-19. Warping of the main float is very evident near the north end

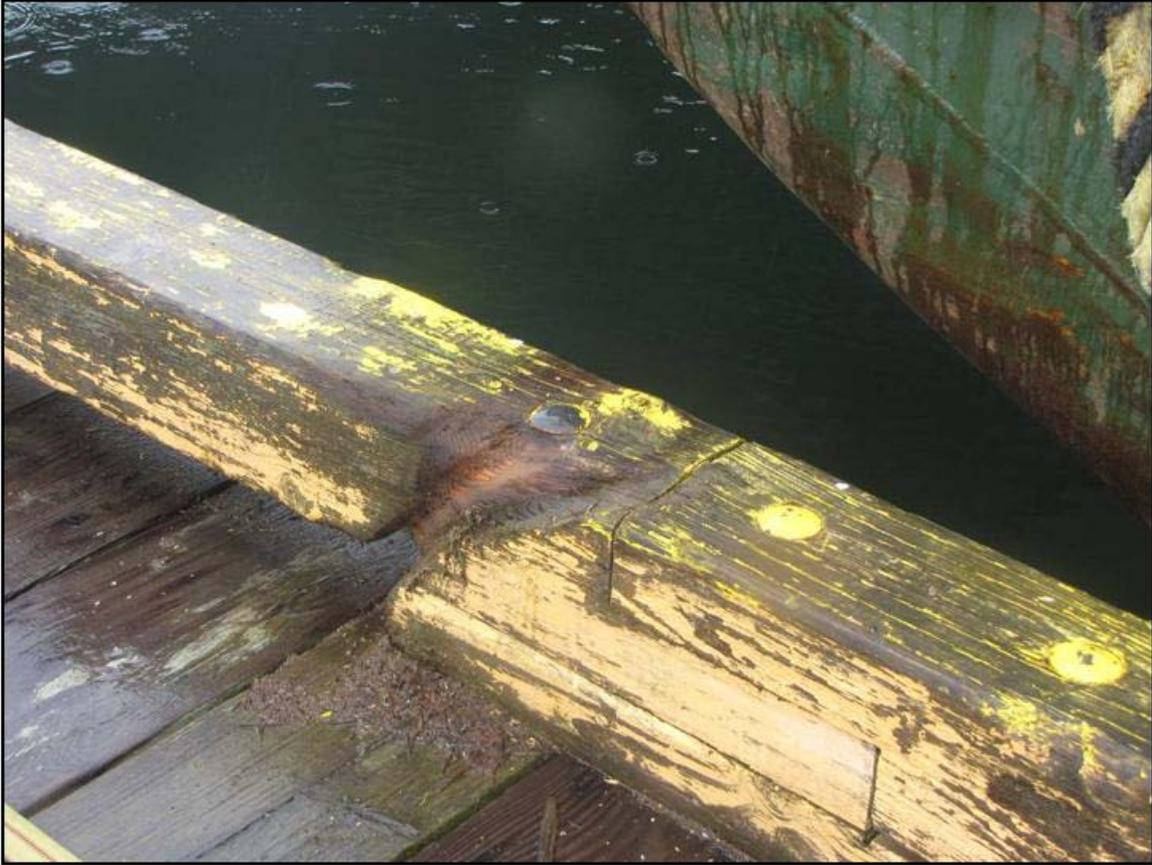
Figure D-20. Bull rails along the main dock are exhibiting significant wear in many places

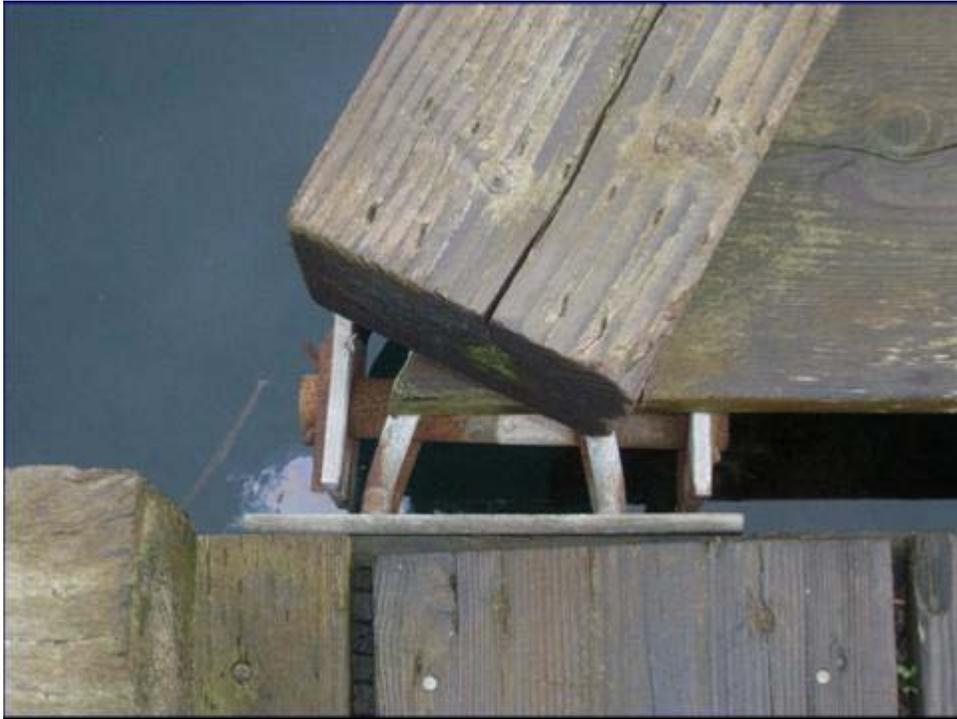
Figure D-21. This is an example of the pin connection for many of the older finger piers

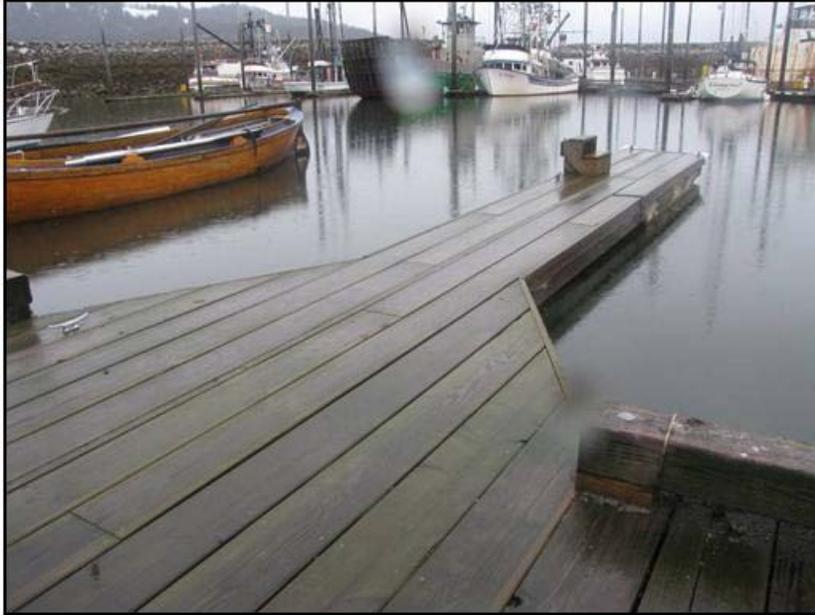
Figure D-22. B Dock Finger float with gusset. Boat owners do not like the design because they can only moor bow in
