SELDOVIA BOAT HARBOR IMPROVEMENTS
TECHNICAL REPORT

FEBRUARY 2011

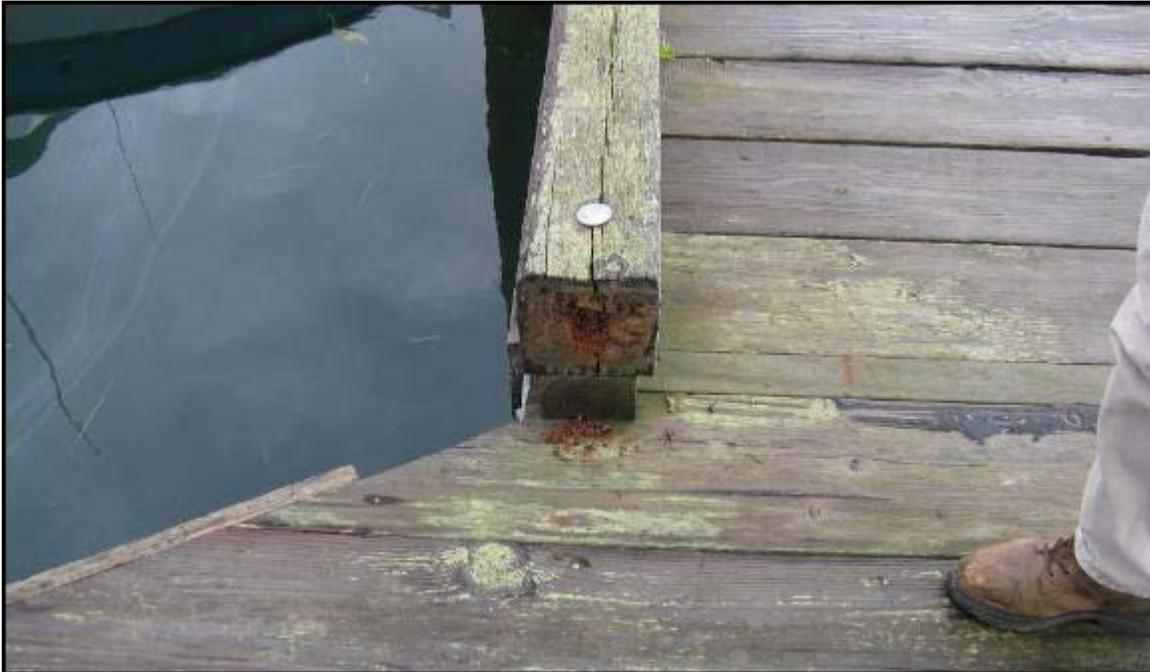
Figure D-24. A typical example of a deteriorating bull rail on B dock

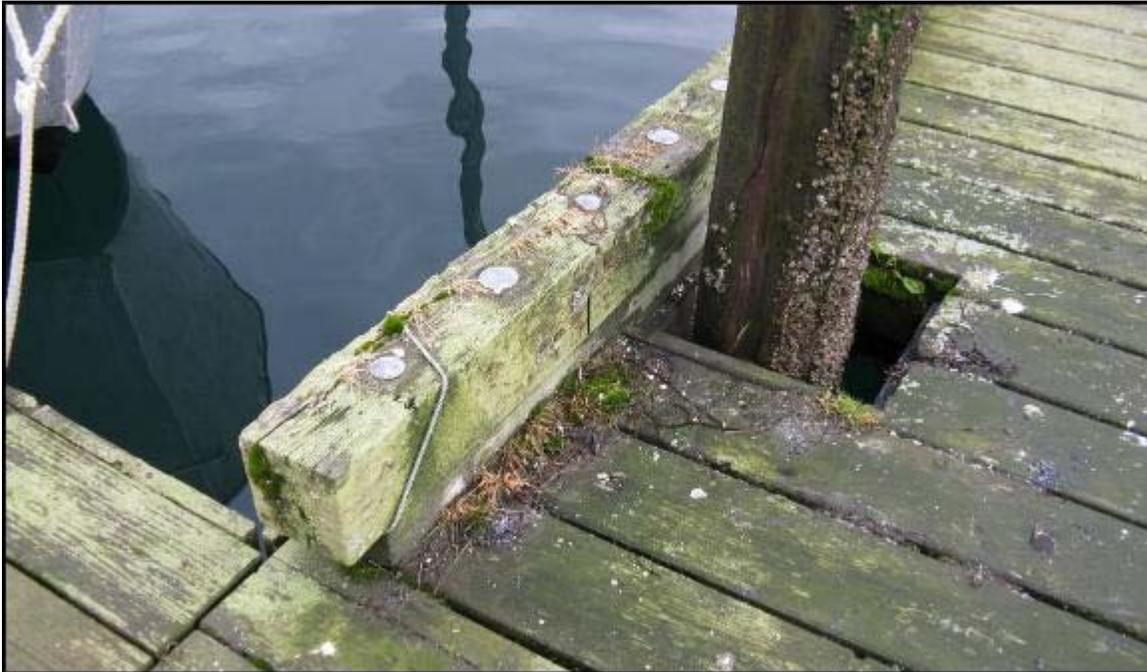
Figure D-25. A typical example of decking and rotting bull rail on C dock

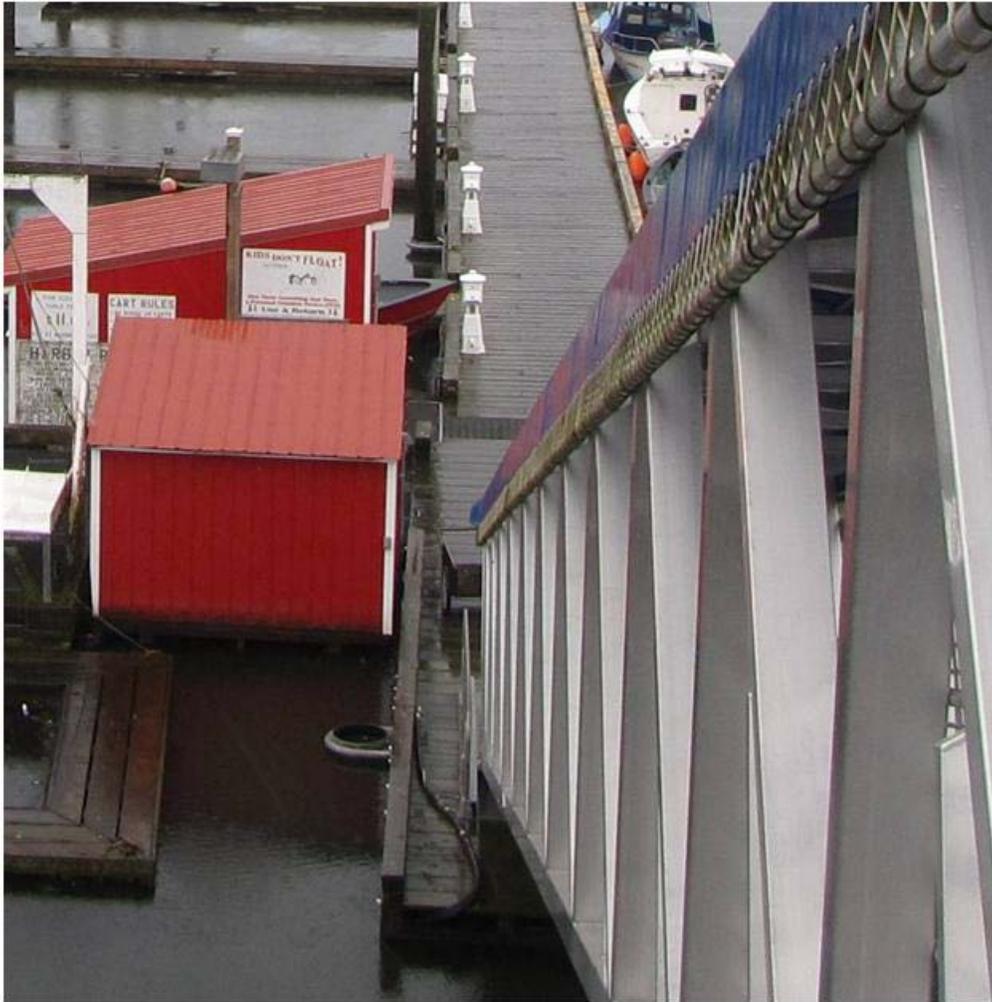
Figure D-26. An empty pile collar at the base of the gangway

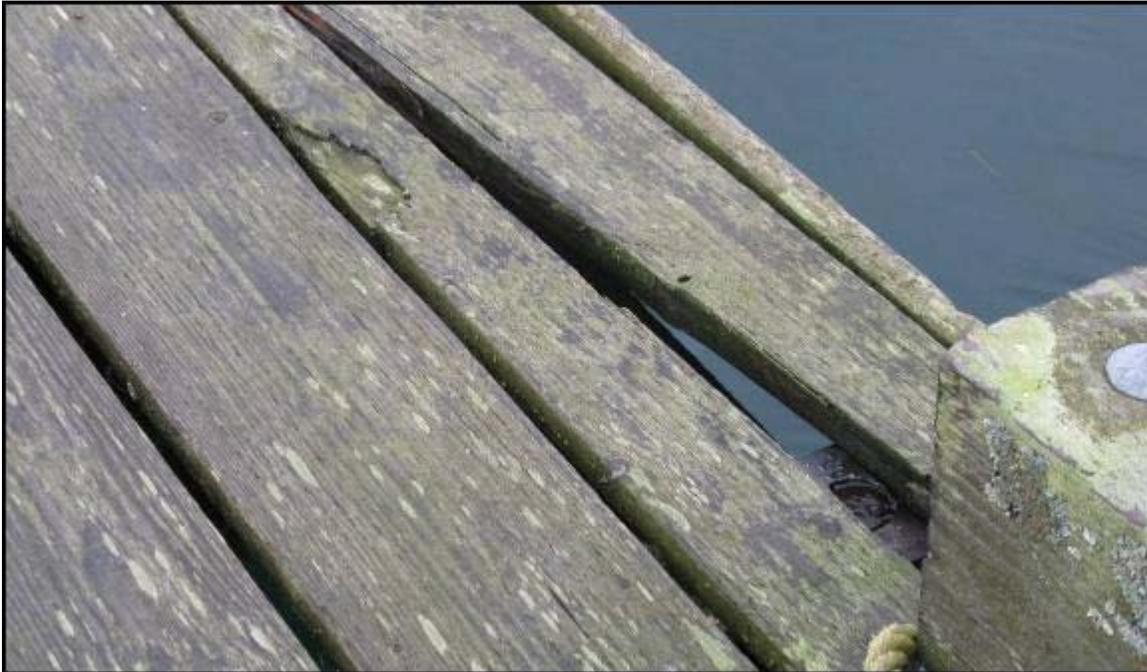
Figure D-27. Decking damage along E Dock

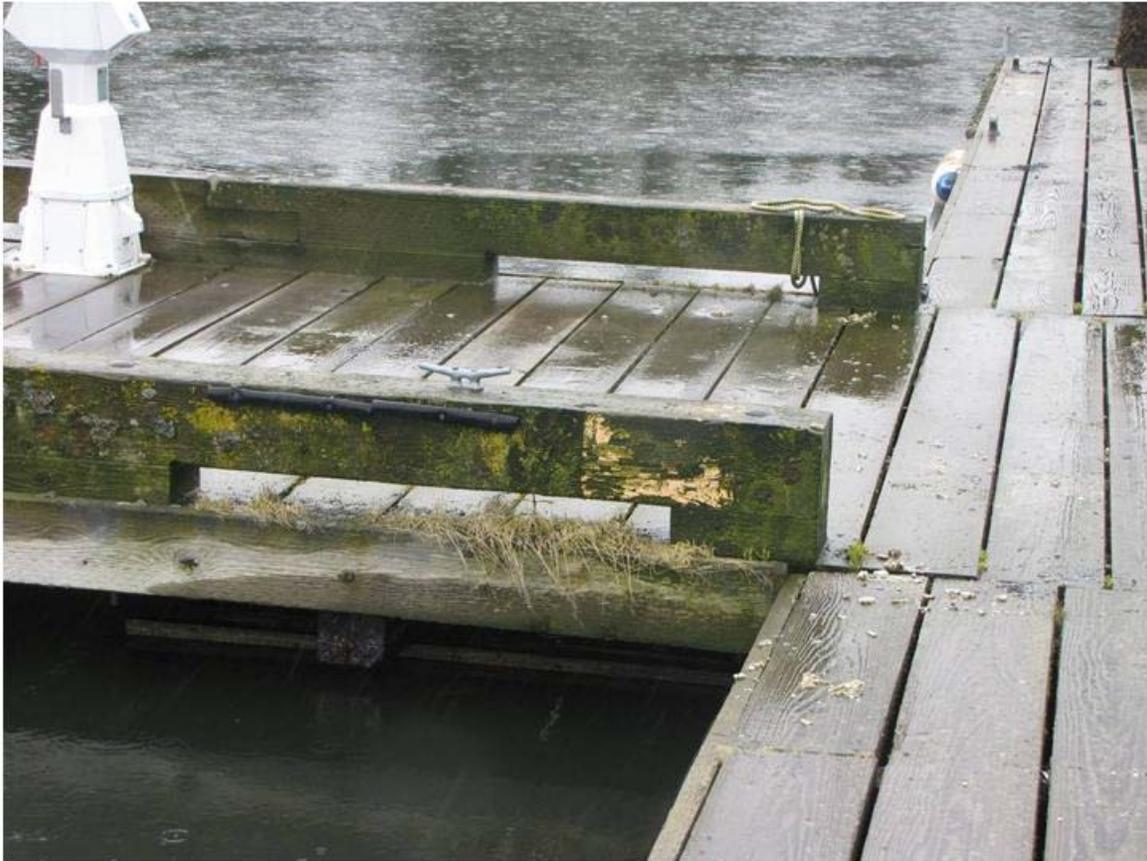
Figure D-28. Grass and moss growing on D dock

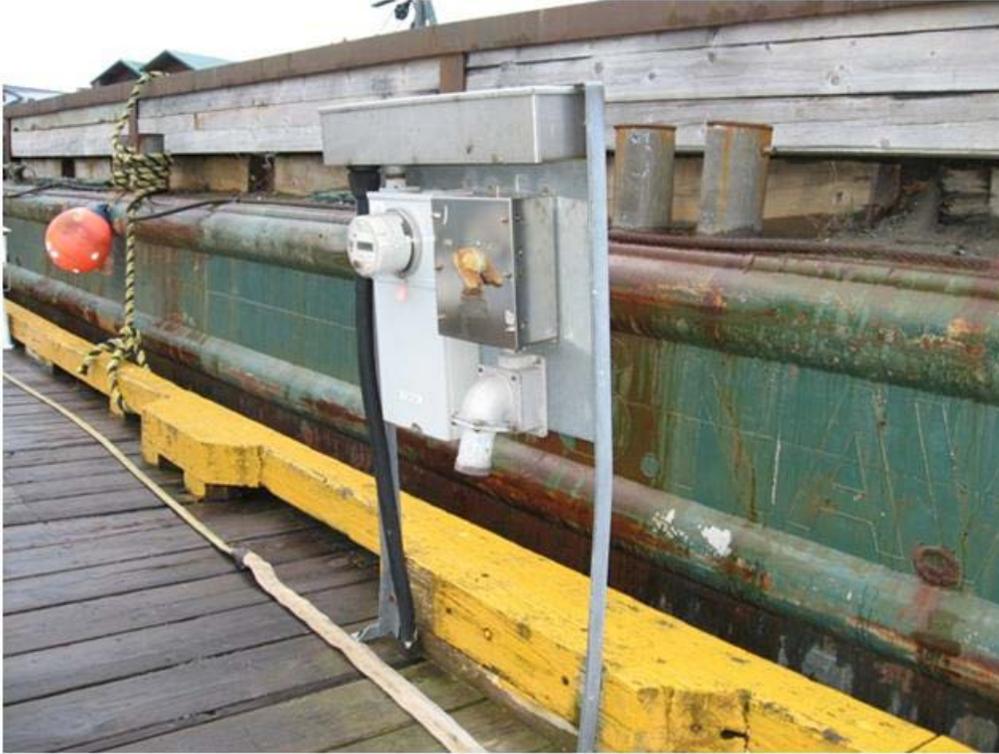
Figure D-37. An older panel along the main dock
