SITE VISIT MEMORANDUM

DATE January 14, 2009

PROJECT NO. 06144 Selawik Clinic

SUBJECT Site Visit Revised

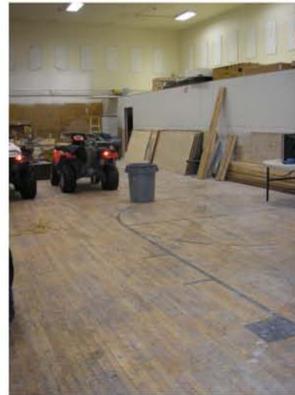
Man camp-warm storage.jpg

6. Gideon took me to see the heated storage building where all the paints and drywall compound is being stored. The temperature of the space was approximately 60F.

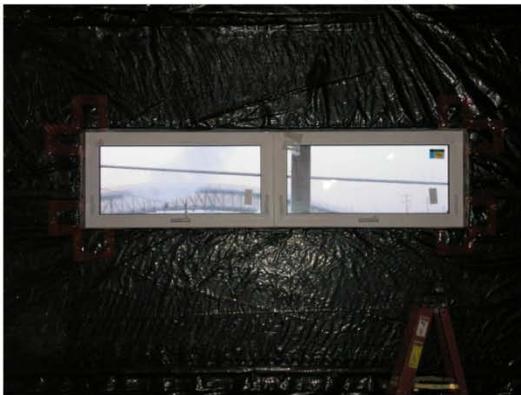
VR at windows.jpg

1. The vapor retarder was approximately 85% complete upon my arrival and was nearly 100% before my departure. The vapor retarder that was installed is the specified and submitted Griffolyn Type-65, appeared to be installed per specification section 07190 and great care was taken to properly terminate the vapor retarder into exterior openings. The specified and submitted vapor retarder tape and sealant was also being used.

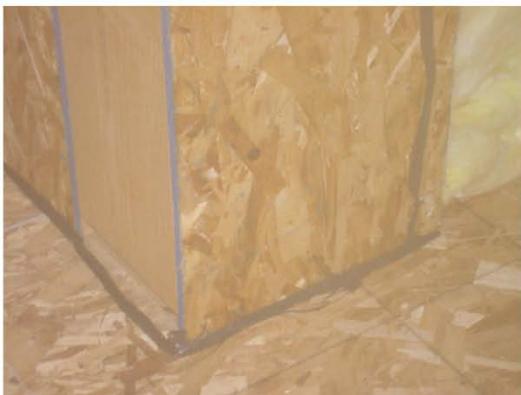
Tremco sealant at corner.jpg

I performed a vapor retarder installation site visit on January 5, 2008 between 0930 and 1700 hours. The skies were clear and temperatures were between -25F and -45F. The building interior was in the low 60F to allow the Tremco sealant to flow and adhere properly.

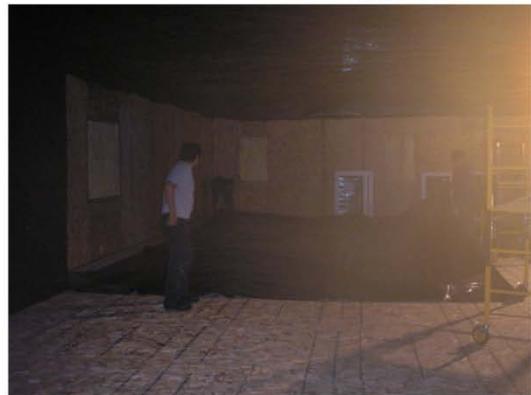
2. The R-19 batt ceiling insulation was installed and the ceiling vapor retarder was essentially complete with the exception of a small amount of lap taping to be accomplished. See photo VR installation.jpg on the last page of the report for area of building still awaiting vapor retarder installation.
