Subject: Selawik Clinic

Following is a report of yesterday's trip to Selawik with my observations on the status of roughed-in mechanical systems at the clinic.

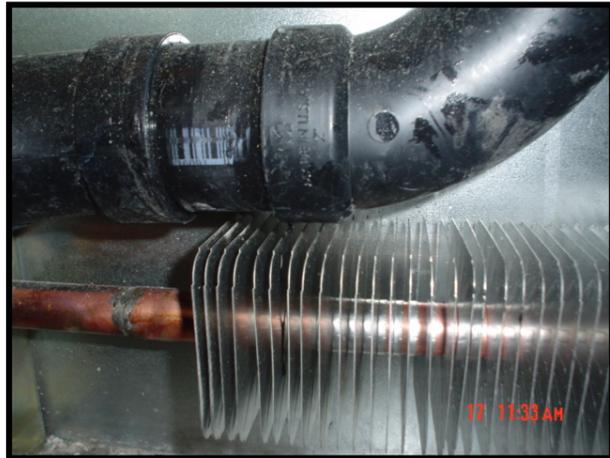
10. There is not yet a rough-in for the thermostat in the Comm room to control exhaust fan EF-3, or in the Morgue to control EF-4.
11. A section of fintube in the plumbing chase is located directly beneath a plumbing waste pipe, and the two are nearly in direct contact, as shown in the adjacent photograph. The fintube should be relocated away from the waste pipe.
