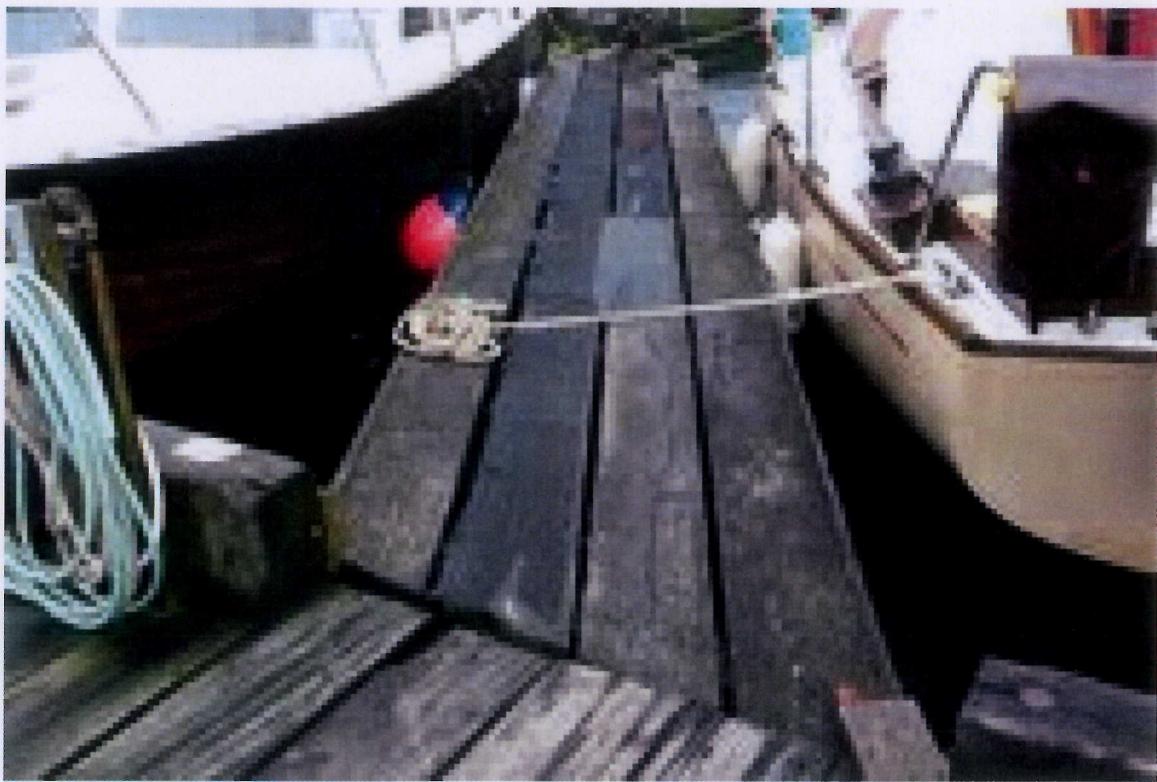
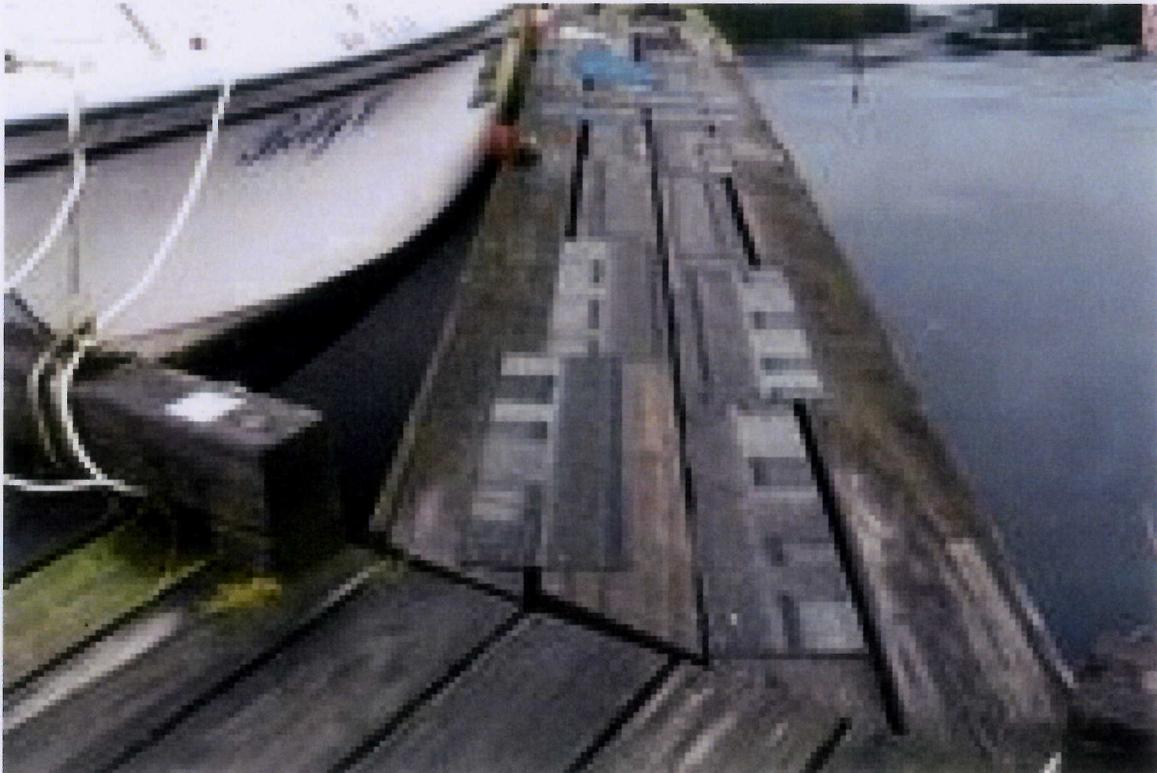
TYPICAL 32 FOOT + 42 FOOT FINGER FLOATS REPURPOSED
DURING PHASE I.

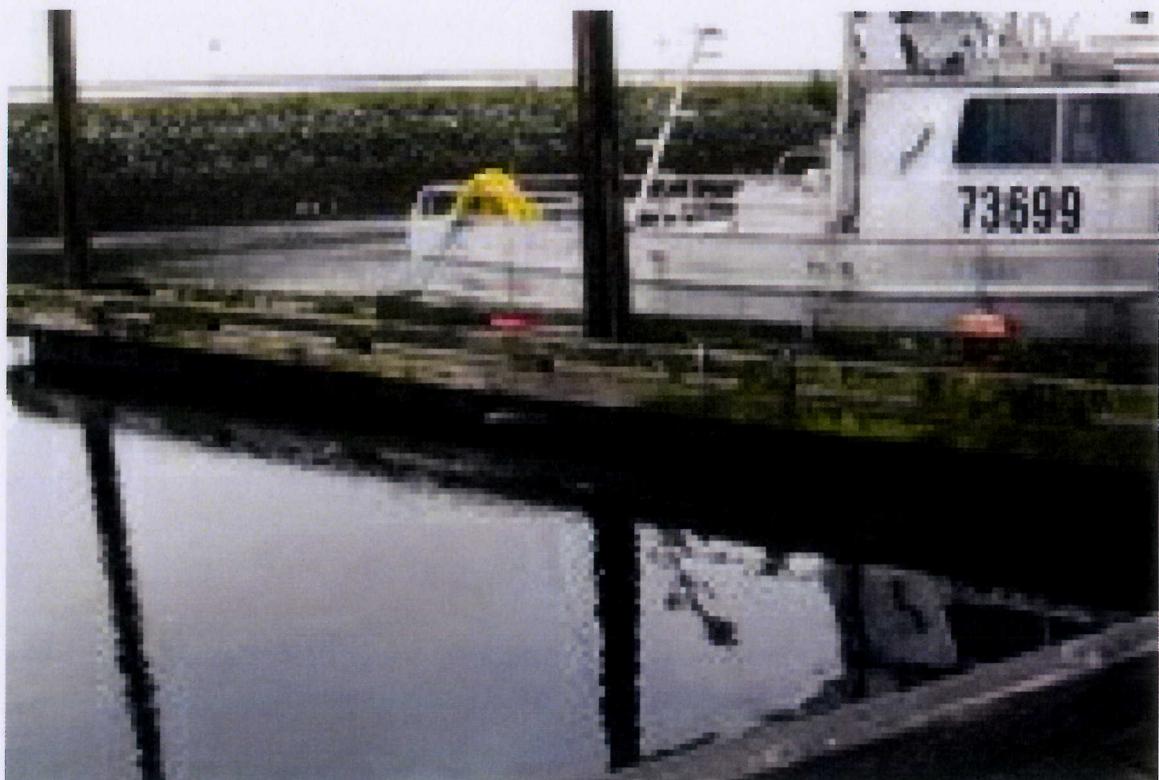
TYPICAL 50 FOOT FINGER BOAT REPLACED DURING PHASE II

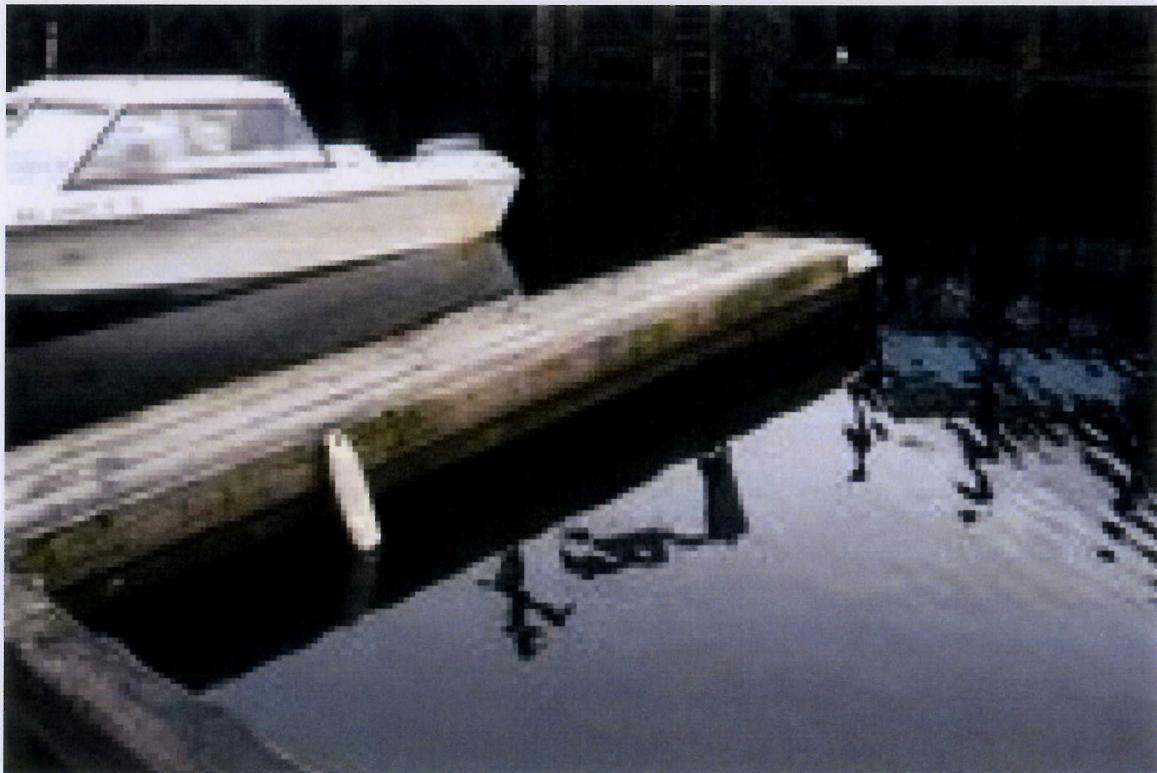
TYPICAL SKIFF FINGER REPLACED DURING PHASES I + II

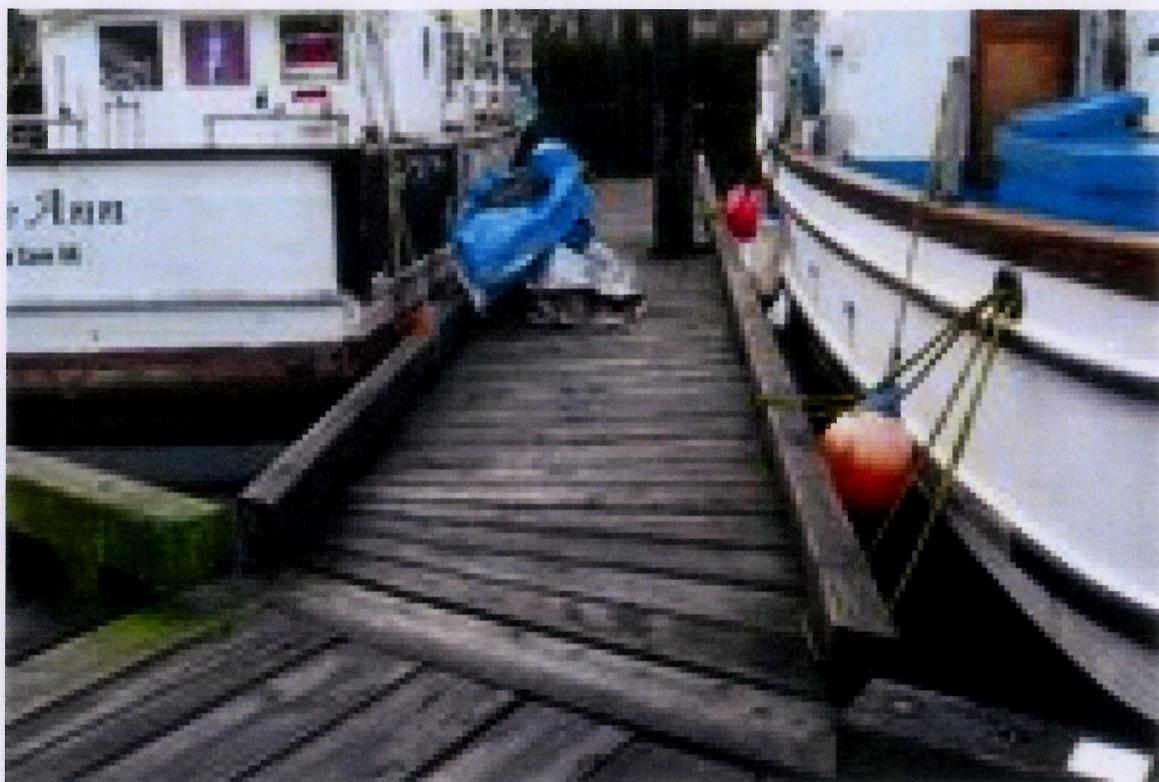
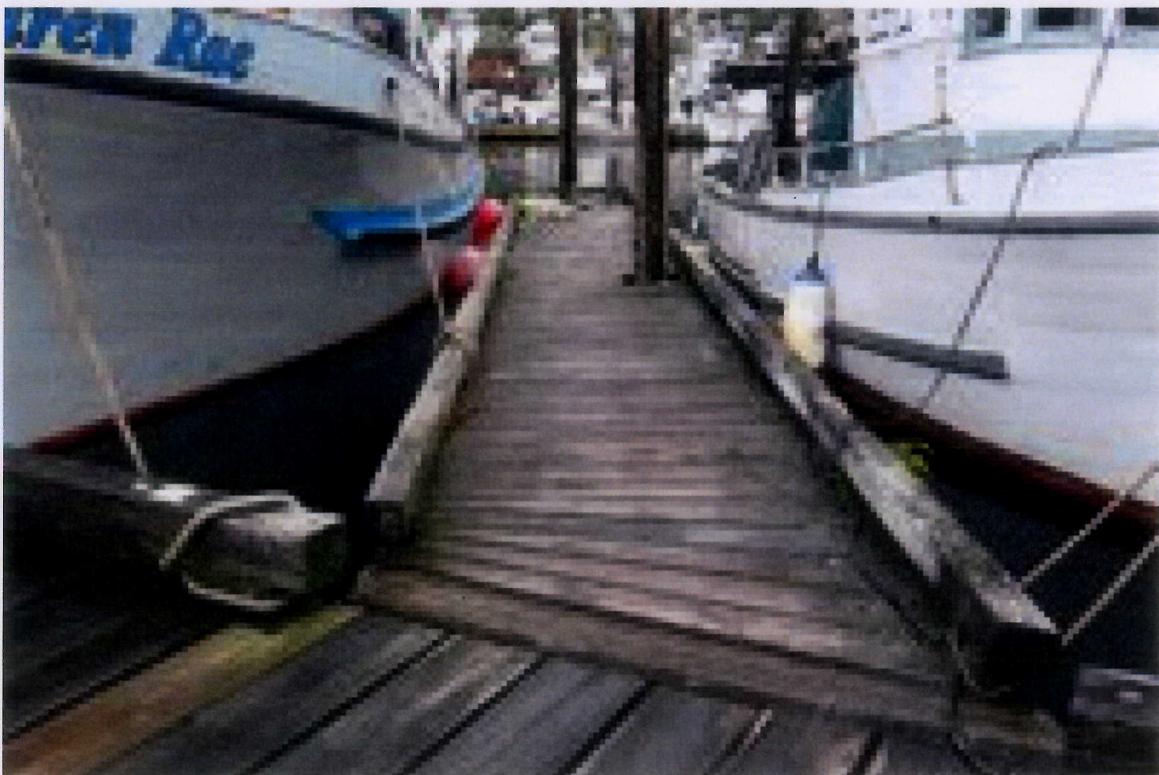
TYPICAL 50 FOOT FINGER FLOATS REPLICATED DURING PHASE II

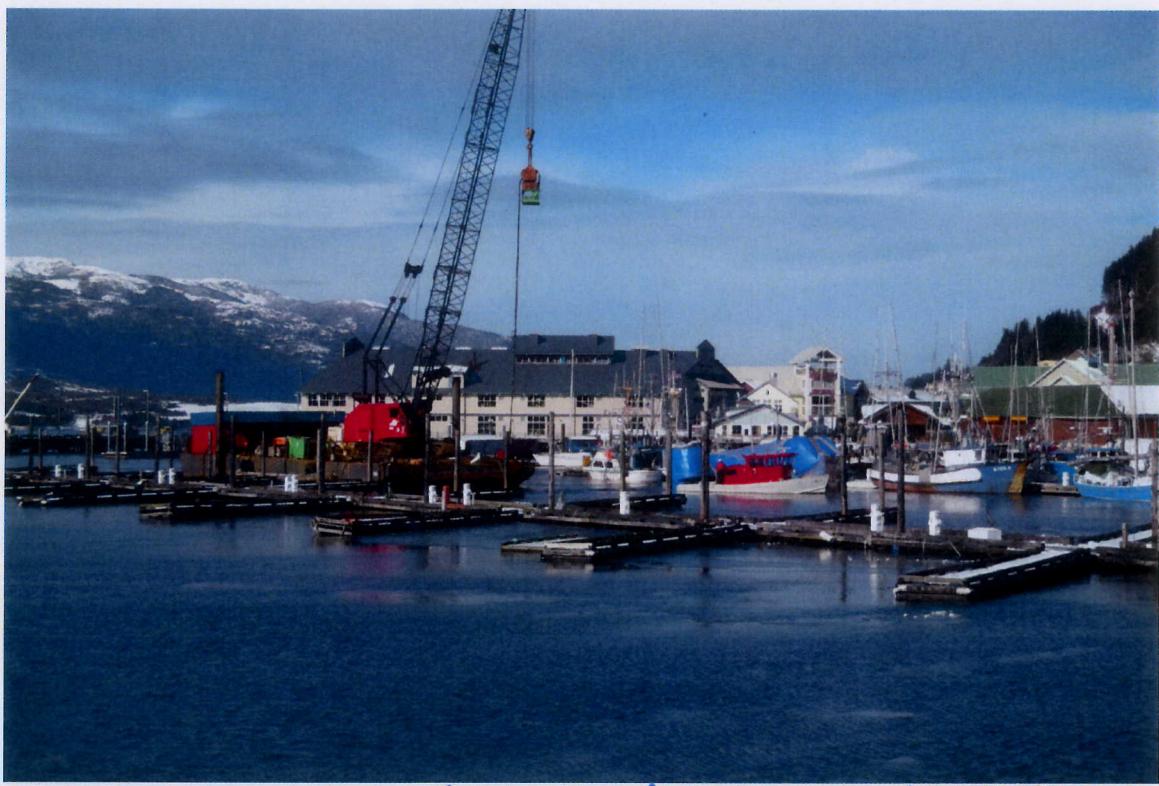
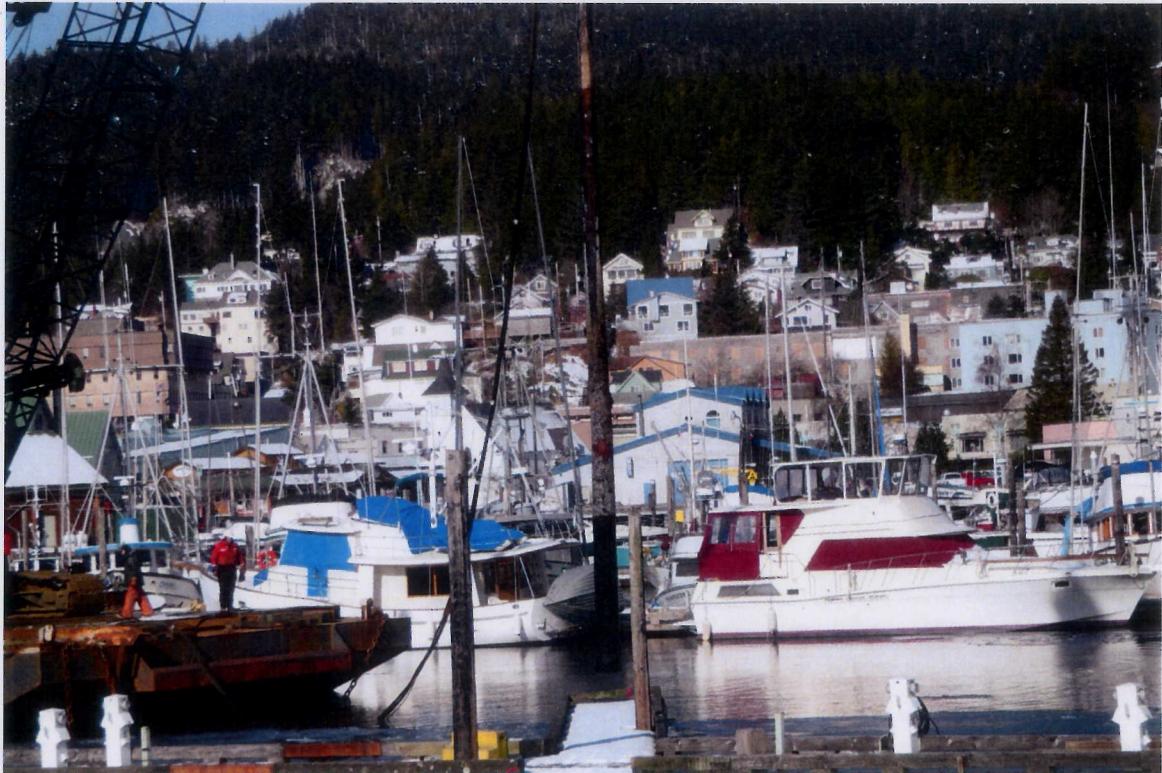
DETERIORATED WOODEN PILES WERE PULLED DURING PHASE II
WORK ON FLOAT 5 FINGER PLOTS
