# Rasmus Enge Memorial Bridge Evaluation

## Task 1—Condition Assessment

Prepared for:  
City of Petersburg  
P.O. Box 329  
Petersburg, Alaska 99833

APRIL 2012

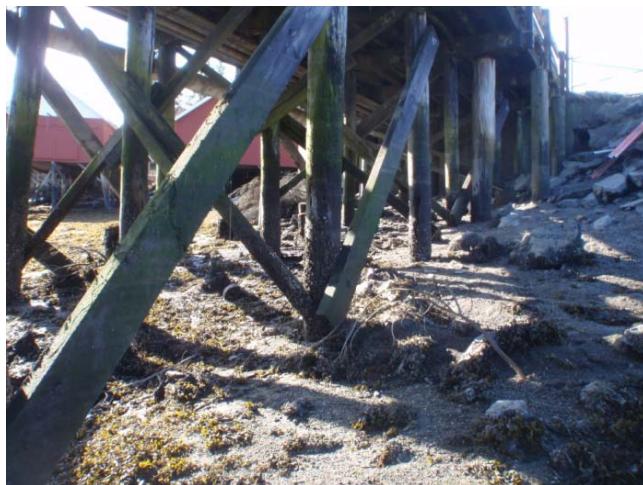
Typical condition of piles. DS side looking toward NE abutment.

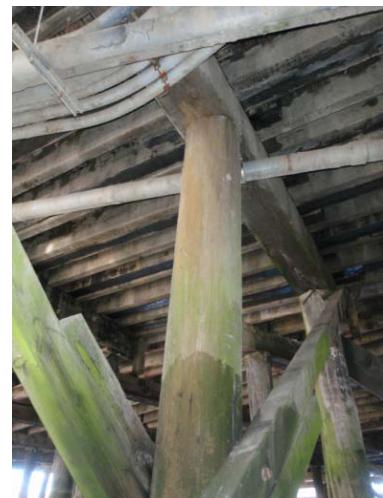
Typical pile w/ surface growth and no visible sign of creosote treatment on upper half of pile.

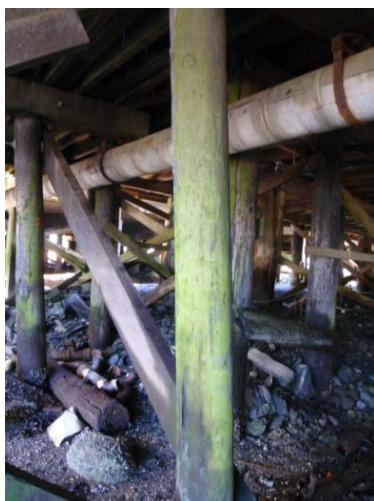
Typical surface growth/mold found on pile.

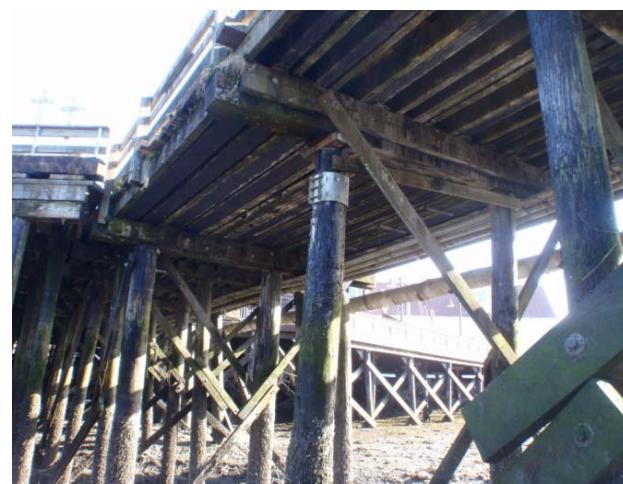
- Surface fungus/mold on pile cap.
- Pile A with metal band around top of pile – pile top has multiple splits.
- Pile C has vertical split near top of pile.
- FE lower left cross brace split.

Pile C at Bent #9 w/ metal band at top of pile.

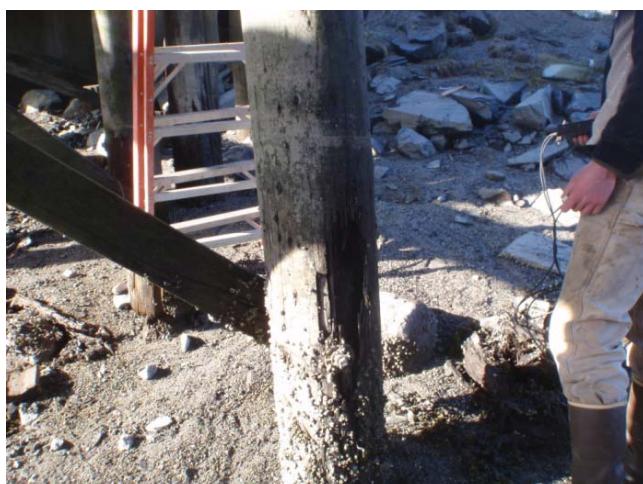
- Surface fungus/mold on cap.
- Pile A has deteriorated portion near bottom; deteriorated area approx. 5-in wide by 24-in long and extends approx. 3 inches into pile. Micro second timer readings adjacent to area indicate sound material.
- NE lower left cross brace split.
- FE lower right cross brace split.

Damaged Pile A at Bent #5.

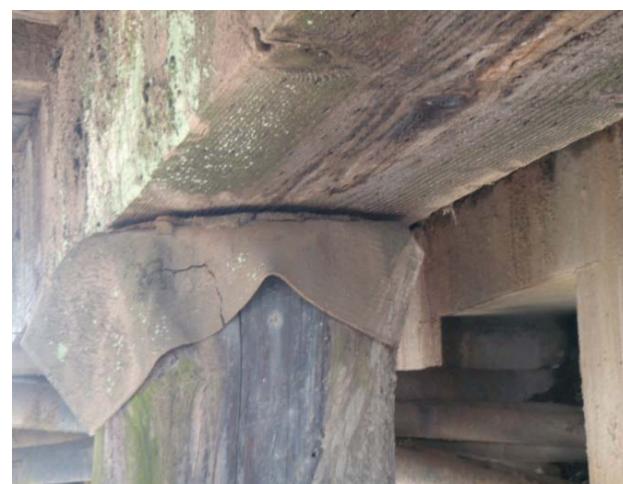
- Surface fungus/mold on pile cap.
- US end of pile cap split.
- Pile B not in full contact w/ pile cap (shim req'd).
- Electrical conduit partially melted – hole thru conduit; melted wire sheathing.

Pile B at Bent #2 not in contact w/pile cap.

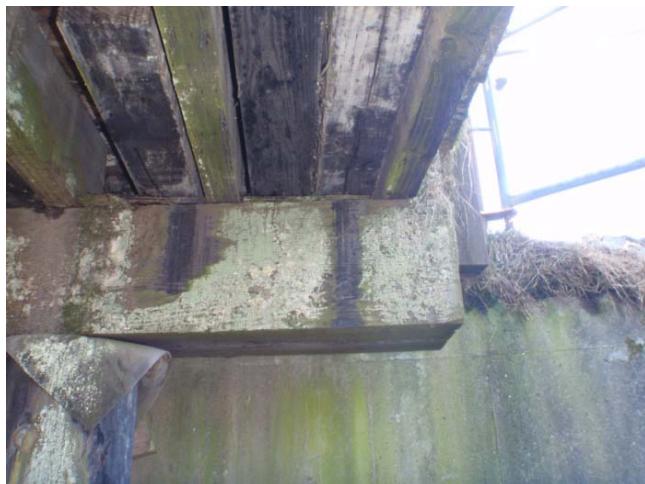
Typical surface fungus and mold growth.

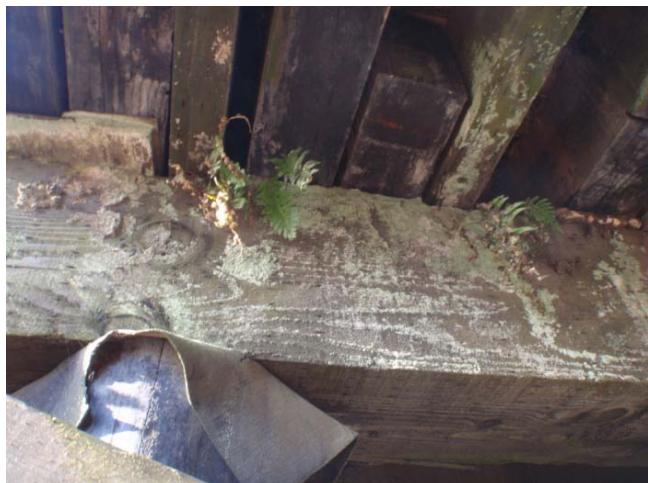
Typical surface fungus and mold growth.

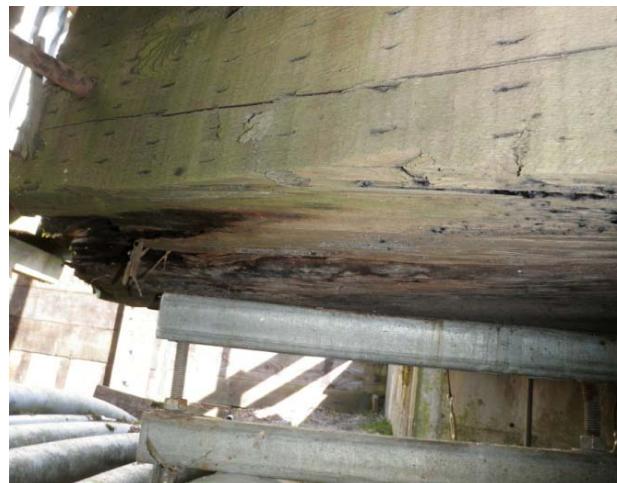
Rot/decay at DS end of pile cap at Bent #42.

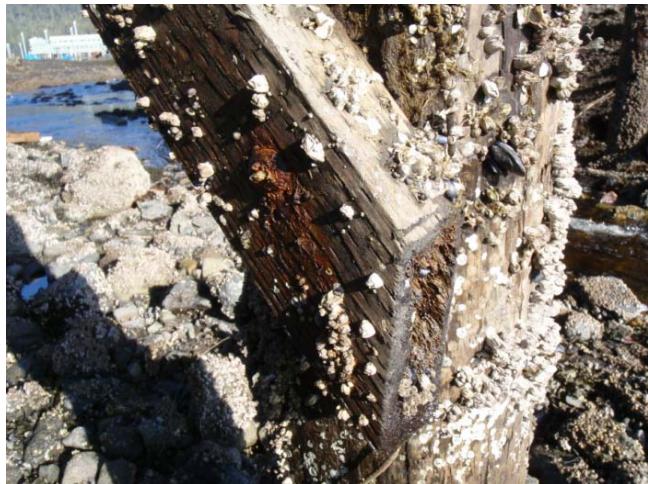
Typical rotten cross bracing end at pile connection.

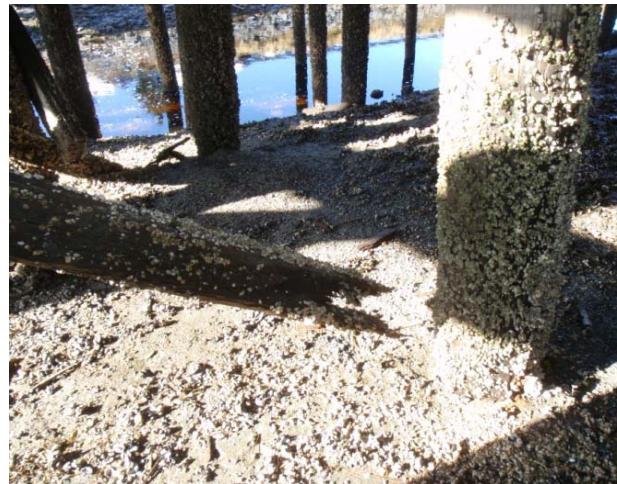
- Surface fungus/mold on pile cap.
- Pile A has vertical split near top of pile.
- Pile B has vertical split near top of pile; not in complete bearing w/ cap (shims req'd).
- Pile C has hole 2-ft from mudline (approx. 3-in dia. by 11-in deep). Micro second timer readings adjacent to area indicate sound material.
- FE lower right cross brace broken/disconnected.

Rotten/broken cross bracing at Bent #10.

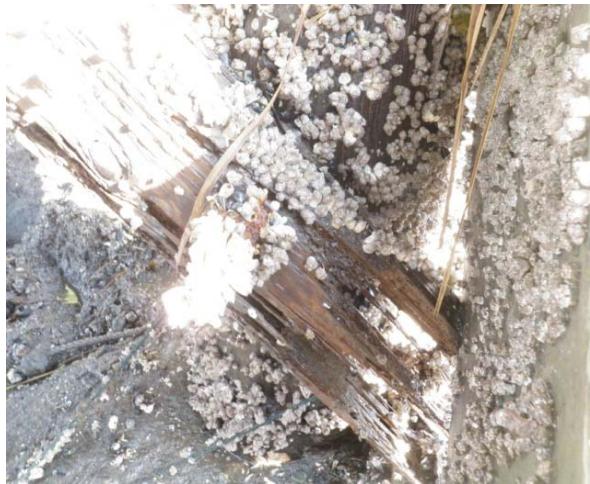
Typical rotten/broken cross bracing at pile connection.

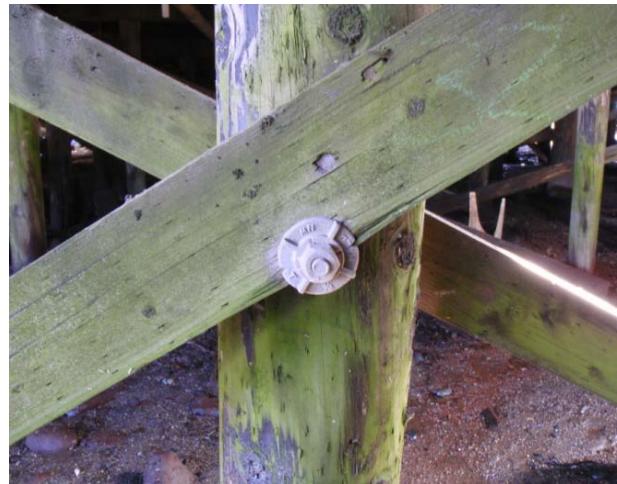
- Pile cap split at US end.
- NE cross brace at Pile B placed/drilled at edge of brace member.
- NE lower cross brace split.

Bent #32 cross bracing connection at center pile.

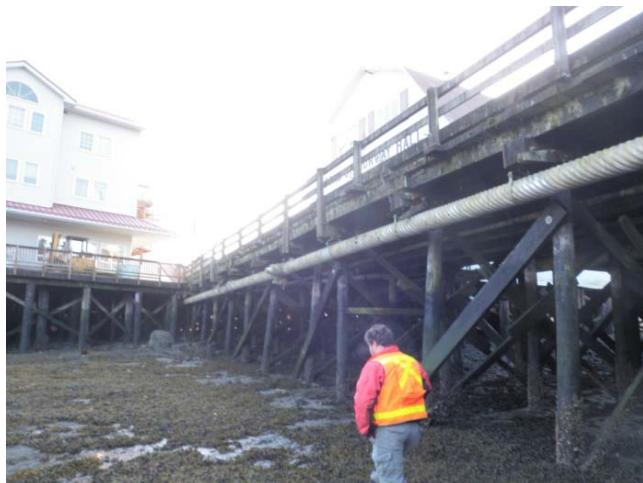
Typical condition of DS insulated utility pipe.

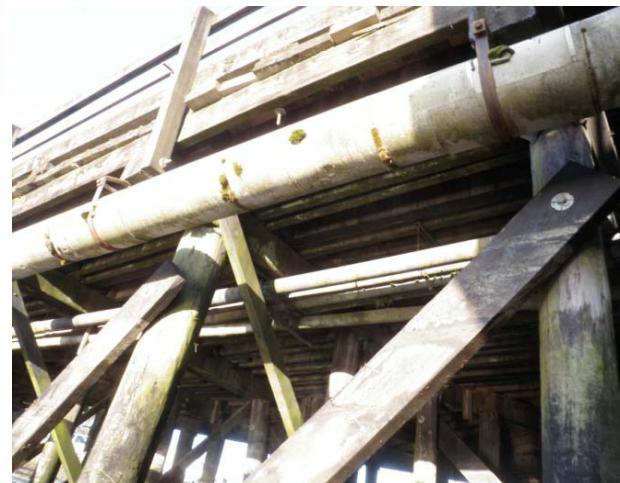
Typical condition of US insulated utility pipe.  
Hangers w/ minor corrosion and minor surface growth on pipe jacketing.

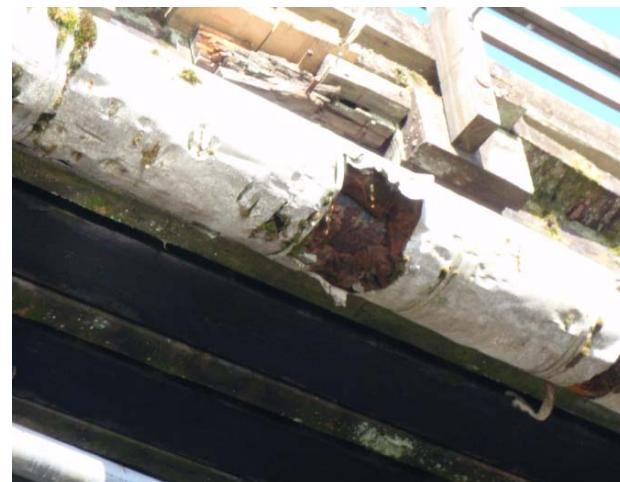
Damaged insulation/jacketing on US utility pipe between Bents #9 and #10.

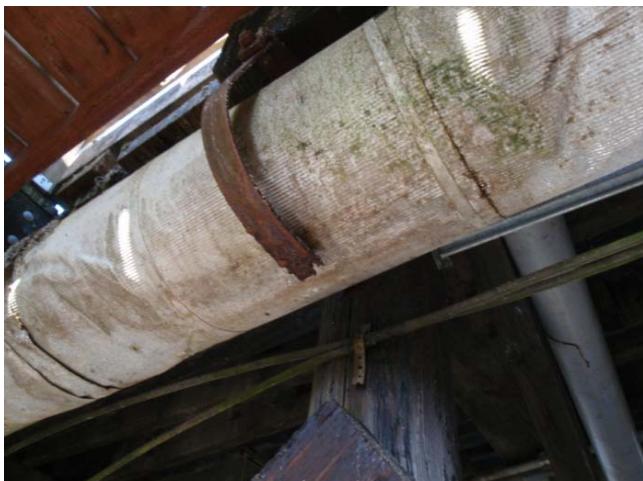
- Surface fungus/mold on pile cap.
- Pile C split at top.
- Corroded/broken utility support bracket (right side sewer).
- Minor physical damage to pipe outer jacketing (US side sewer) – 3 locations.

Corroded and broken pipe hanger near Bent #26.

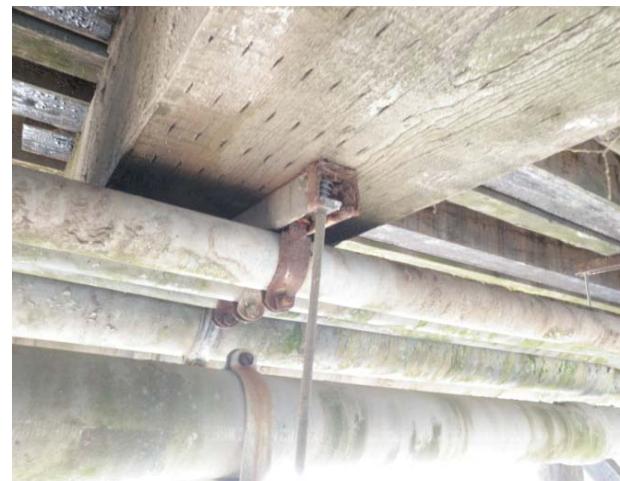
Typical corrosion of electrical conduit support.

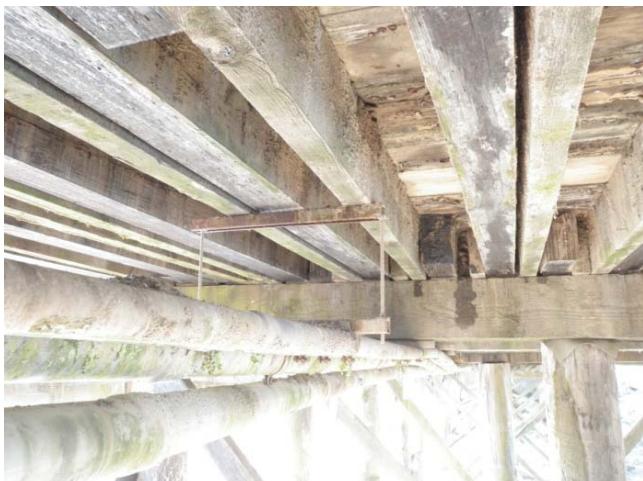
Typical corrosion of electrical conduit support.

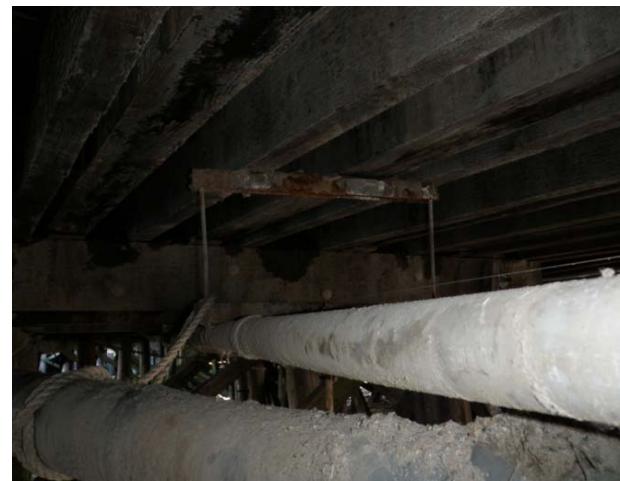
Typical corrosion of electrical conduit support.

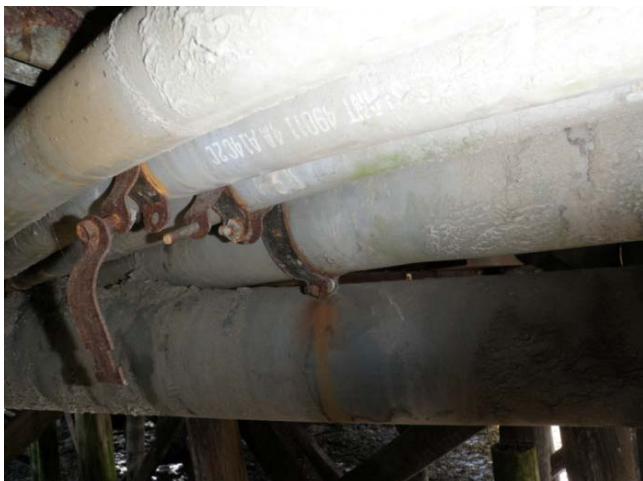
Broken/disconnected conduit hangers.
