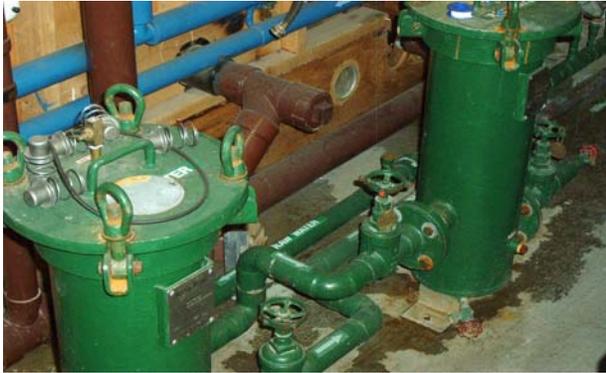
Micron filter units, replaced filters in both. Water on the floor is the source of ice under building. Water is from various leaks.

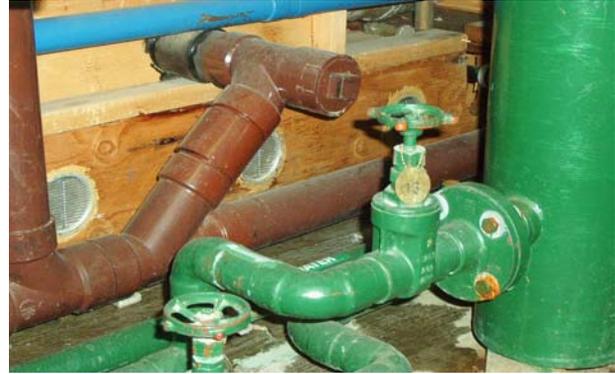
Another view of water on floor from leaks several different leaks that have been repaired.

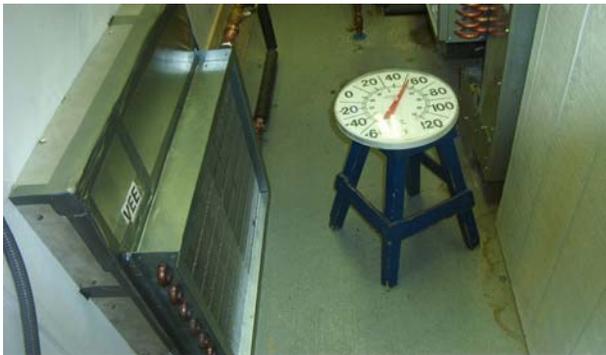
Motorized grill and pre heat coil for dryer make up air. Temperature of air shown. Outside temp was 0 degrees F.

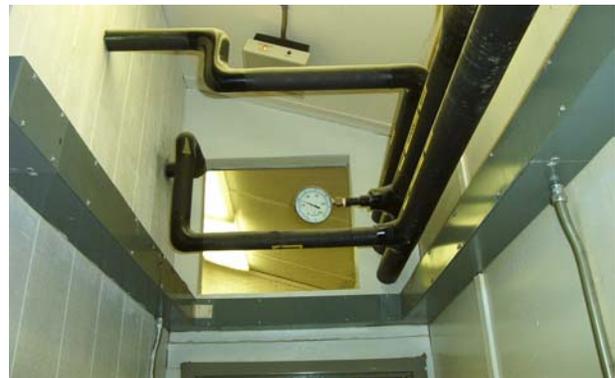
Air entered dryer area prior to installation of motorized grill, we blocked this air passage with plywood.

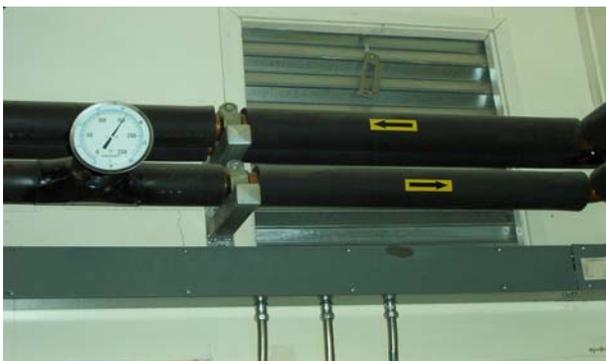
Air passage from boiler room to plant. This allowed makeup air to dryers prior to installation of motorized grill. We closed this passage.

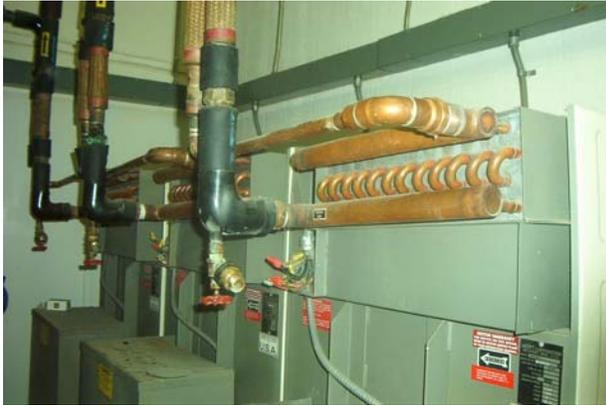
Picture of old dryers and coils

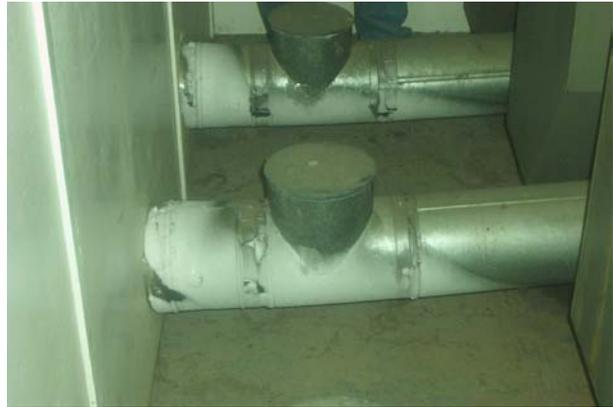
Picture of dryer vents with frost prior to replacement of dryers

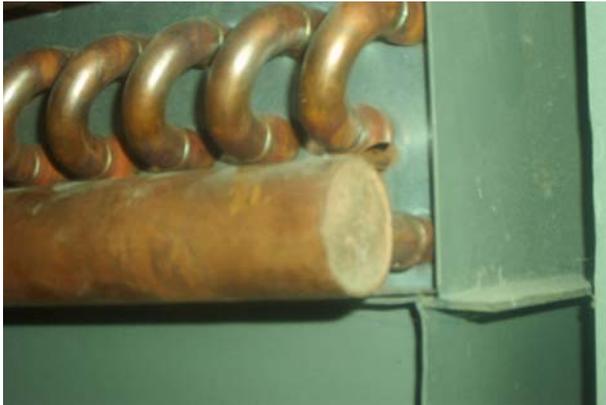
Broken dryer coils prior to replacing dryers

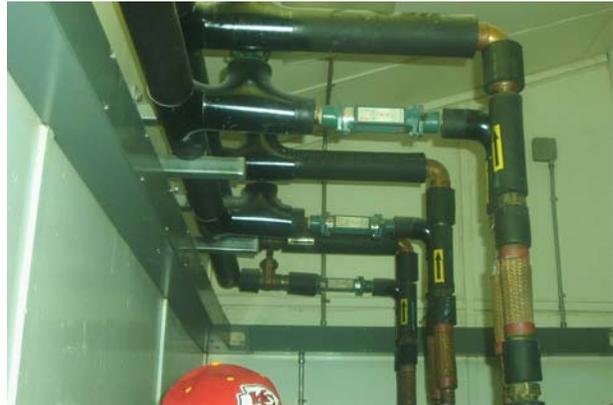
Piping of dryer coils prior to replacing with new dryers

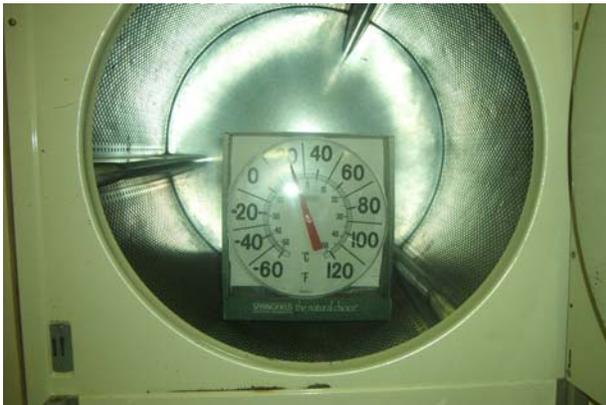
Picture showing air temp of dryer on a cold day prior to installation of air damper.

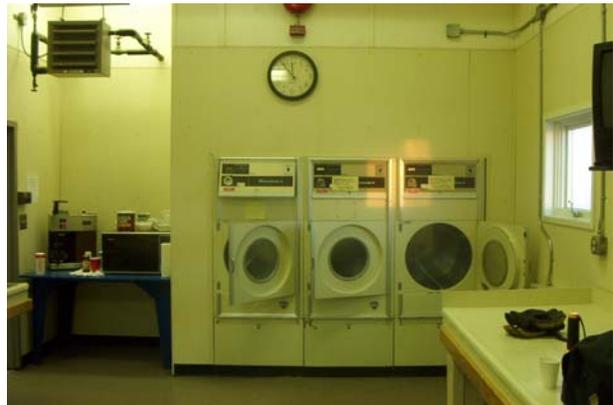
The old dryers prior to replacement with new dryers

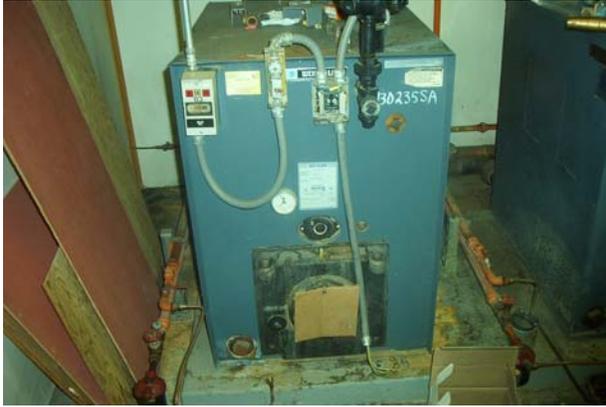
Boiler 1 burner blew off of unit prior to our arrival.

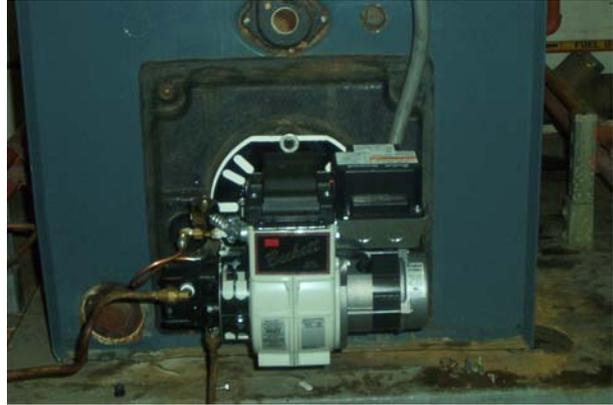
New burner installed on boiler.

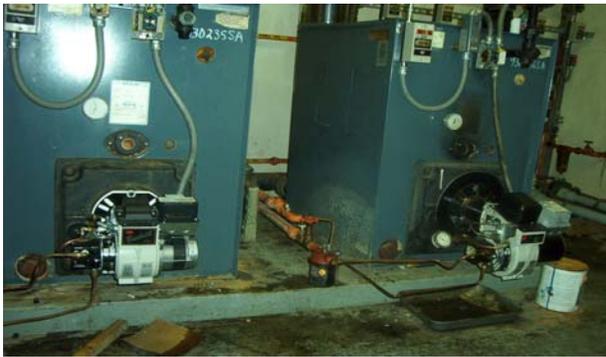
Both boilers up and running after adjusting flame, and water and high limit to work with waste heat system.

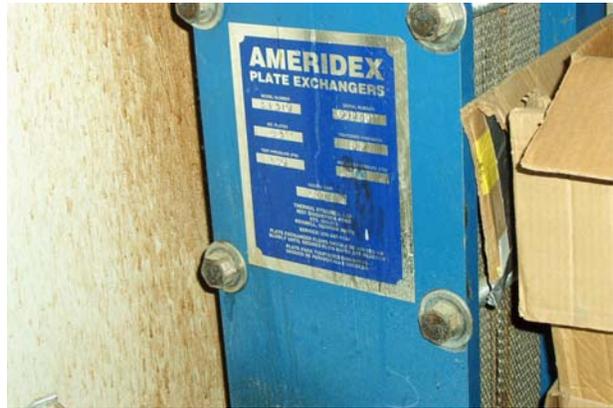
Plate heat exchanger for waste heat system from generator plant.

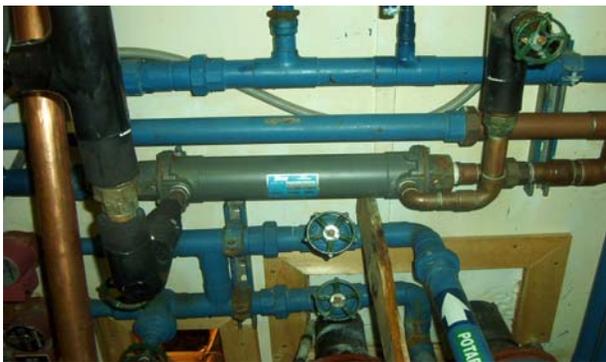
Youngs in line heat exchanger, wrong unit for this application, changed this one out with plate heat exchanger.

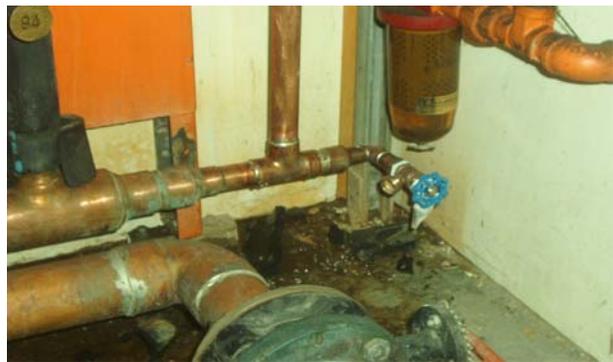
Added boiler drain to bottom of return manifold in boiler room, to allow bleeding of system.

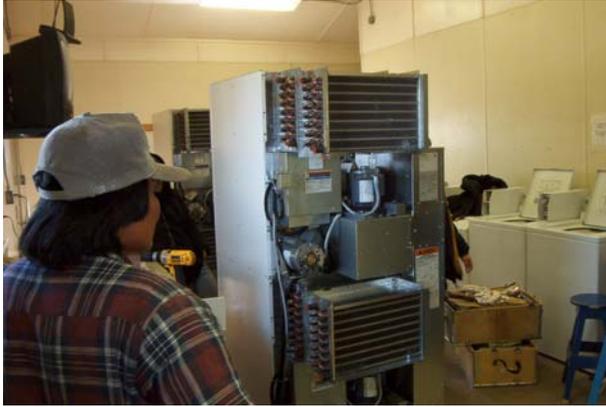
New dryers as we install second heat coil to each of the stacked dryers.

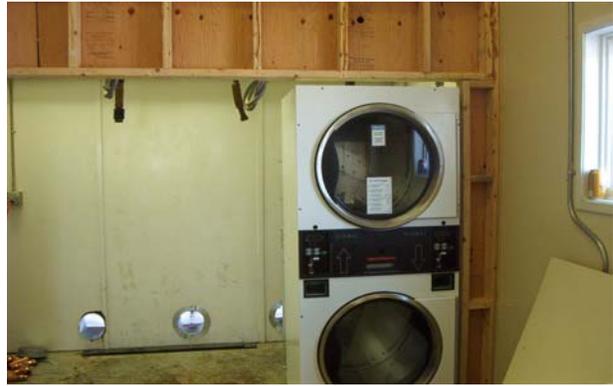
Picture shows new dryer being installed in place.

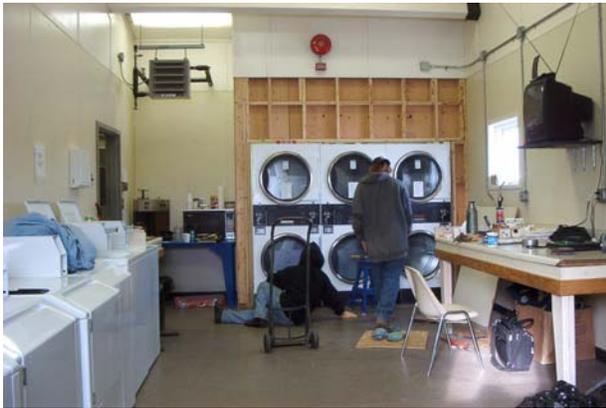
Showing all six new dryers in place.

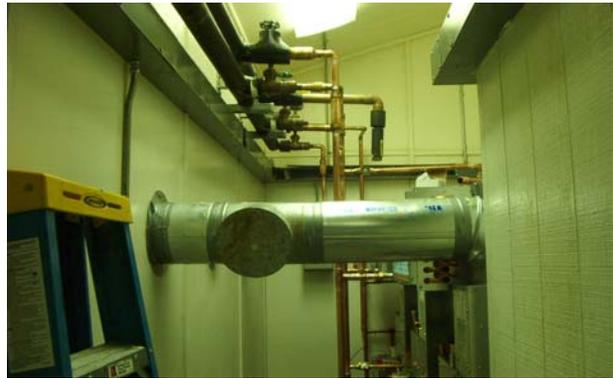
Behind new dryers showing exhaust vent and hot water piping.

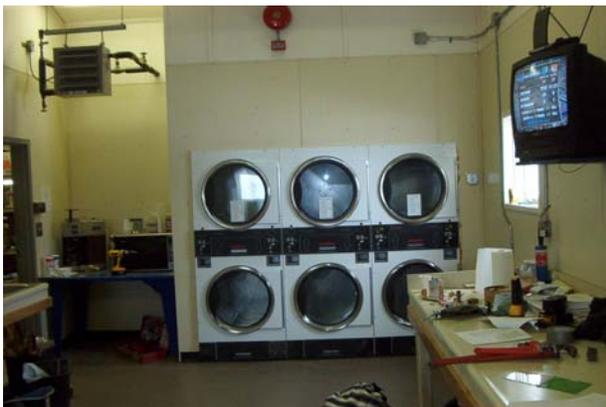
New dryers installed from the front.

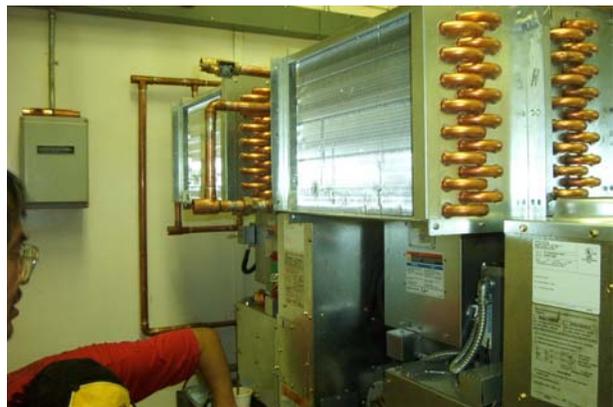
Behind new dryers as piping is being installed.
