DISTRICT TRIP REPORT

Project: Denali Commission Moorings Points Phase 4

Description: White Mountain Trip Report

Date: 1 September 2011

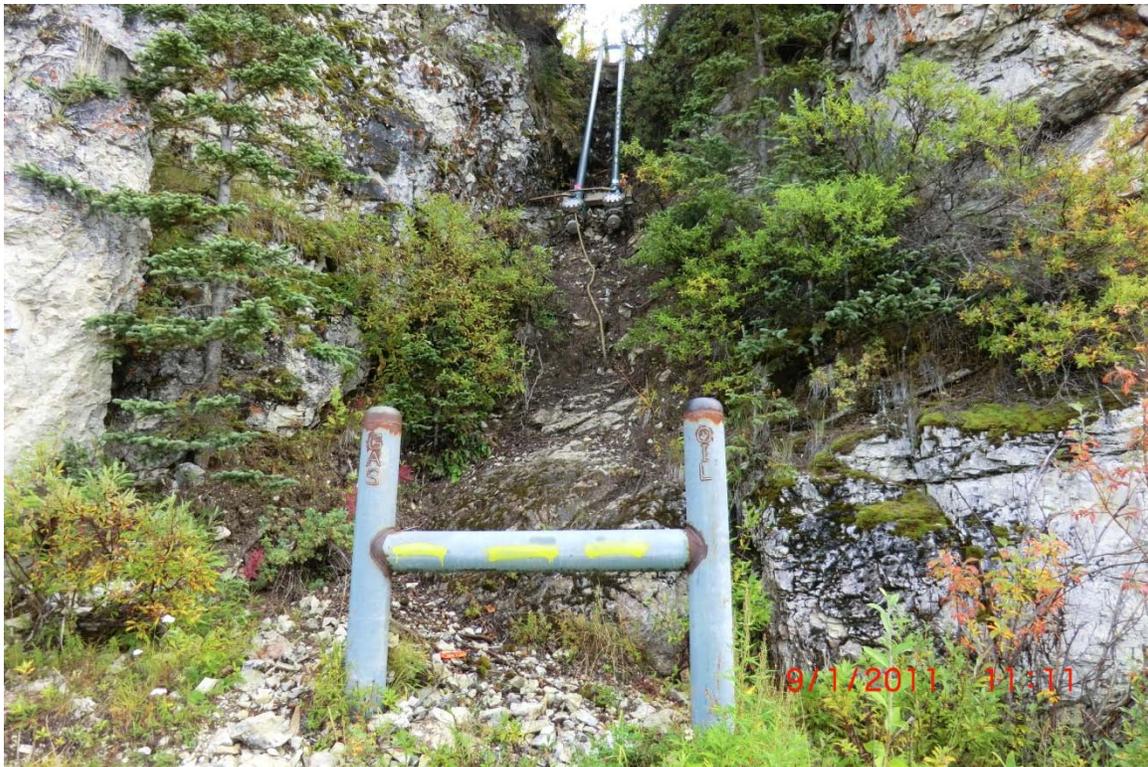
The fuel header is upstream from the village along a rocky outcrop along the Fish River. From the header, fuel pipes head up a cleared gap in the outcrop to the tank farm located above (Photo 1). There is no direct access to the tank farm from this landing site.

Photo 1. Fuel Header

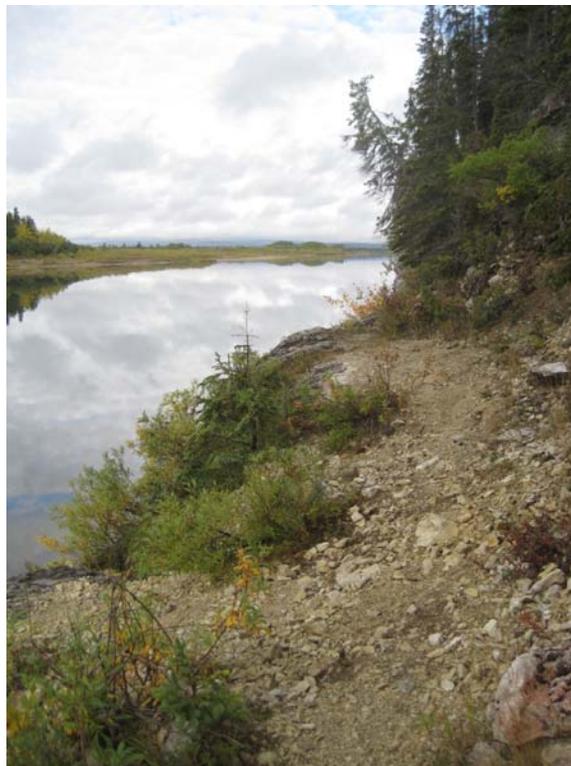
Along the base of the outcrop there is a narrow band of rocky soil that could present difficult equipment access and drilling conditions (Photo 2).

Photo 2. Narrow band of rocky soil at base of outcrop

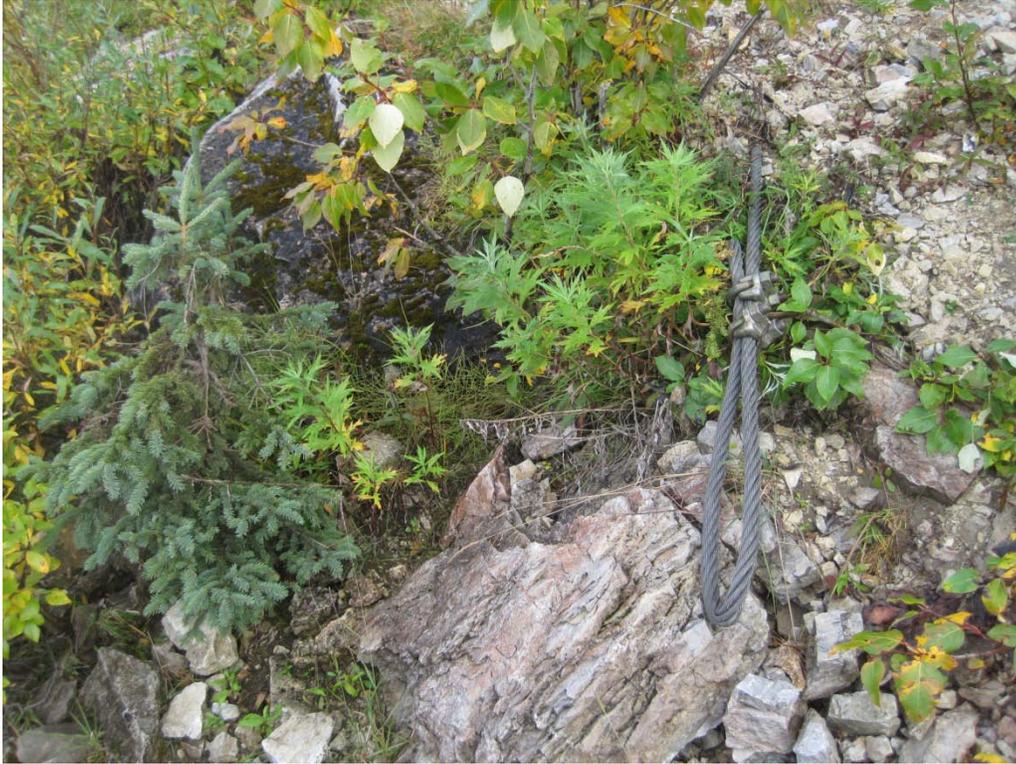
Tie-down cables were found 110 feet upstream and 90 feet downstream of the fuel header (Photos 3 – 4). According to the Tribal Administrator, these tie-down cables were installed by contractor STG as part of the construction of the Denali Commission funded tank farm. According to Alaska Department of Commerce data, this project was completed in 2005.

The existing tie-down cables at the fuel landing appear to be sufficient and in good working order. Installation of additional mooring points at this location are not recommended.

Photo 3. Existing upstream tie-down cable

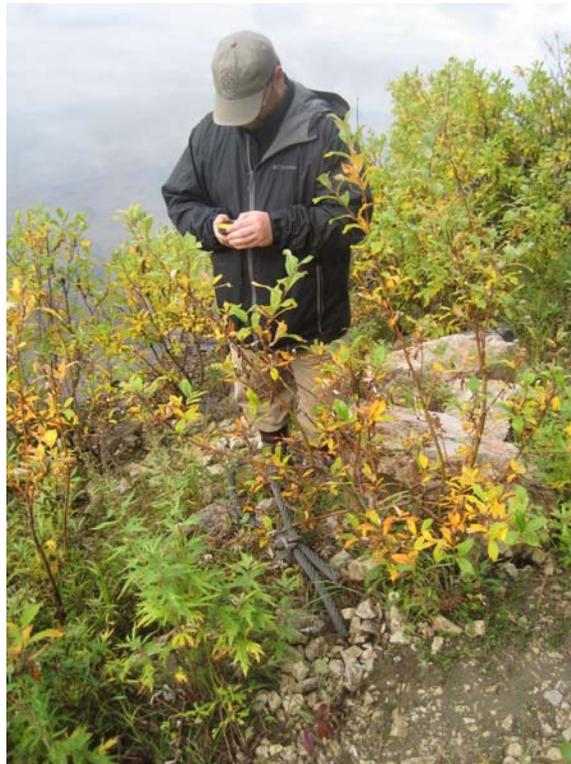
Photo 4. Corps employee standing adjacent to existing downstream tie-down cable

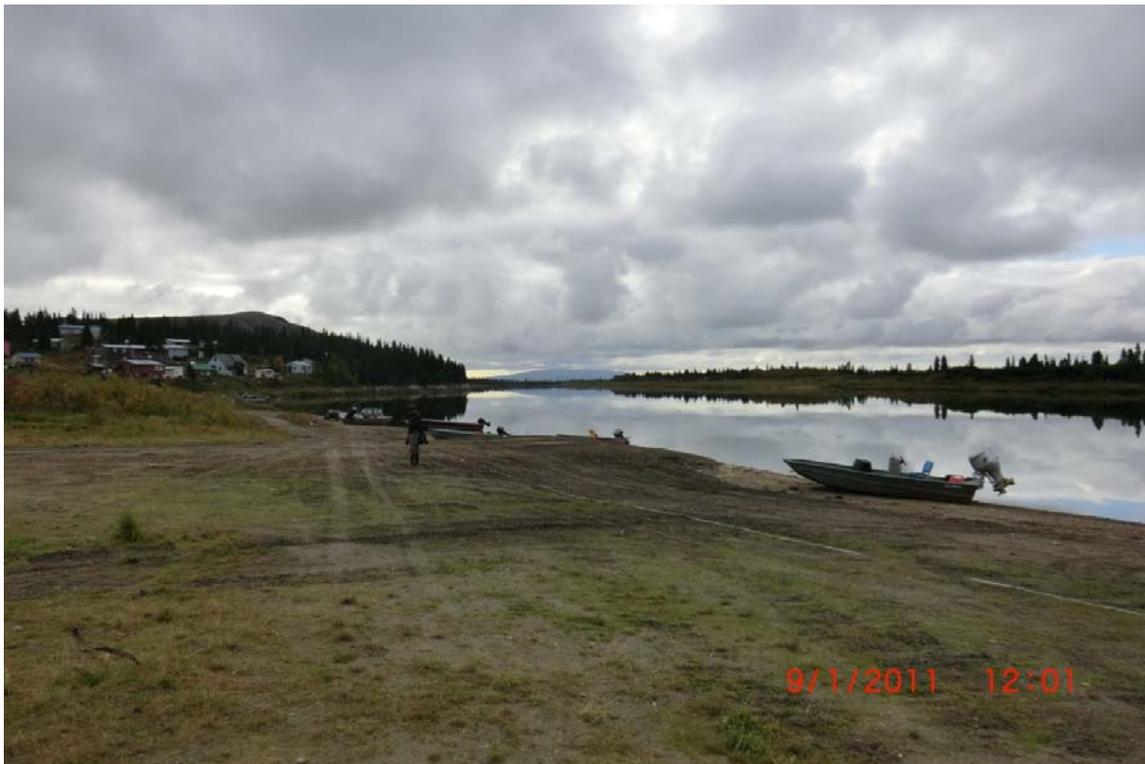
The freight barge landing consists of a small gravel ramp perpendicular to the Fish River. It is located within a broad, shallow sloped beach (Photo 5).

According to the Tribal Administrator, White Mountain does not receive annual freight shipments. This landing site is only utilized during construction projects in the village. Due to the shallow nature of the Fish River, the village store receives their goods by plane as opposed to barge.

Photo 5. Freight Landing Site.

Since this landing site only is utilized on an occasional basis the installation of mooring points are not recommended.

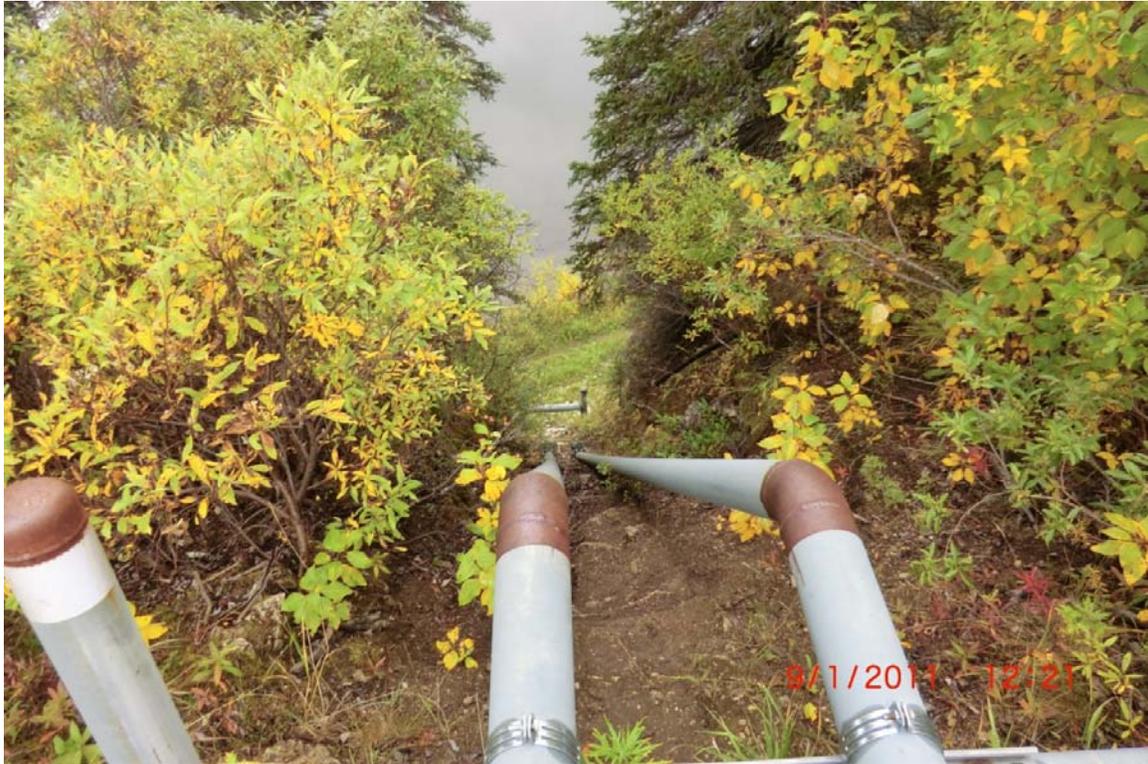
While not specifically part of the scope of this site visit, the team looked at the fuel storage tanks at White Mountain. The tanks were built by STG in 2005 and appear to be in good condition based on visual inspection of the exterior. The team noted significant rust on welded pipe connections throughout the project. Straight runs of pipe did not show much corrosion, but at

welds, and pipe fittings, the exposed pipe surfaces were oxidized (Photos 6, 7 and 8). It appears that the pipes connecting the tanks and their fittings were not coated after the pipeline and site piping were assembled. Without reference to contract documents, it was not known if coating the piping after welding was required for this project.

Photo 6. Corrosion at pipe welds and fittings above the fuel headers.

No mooring points are recommended in White Mountain. The existing fuel landing possesses recently installed and competent tie down cables. The community does not receive regular freight shipments by barge, therefore mooring points are not recommended at the freight landing at this time. Although outside the scope of this site visit, corrosion was noted at the tank farm. Effectively addressing the corrosion could extend the useful life of the tank farm.

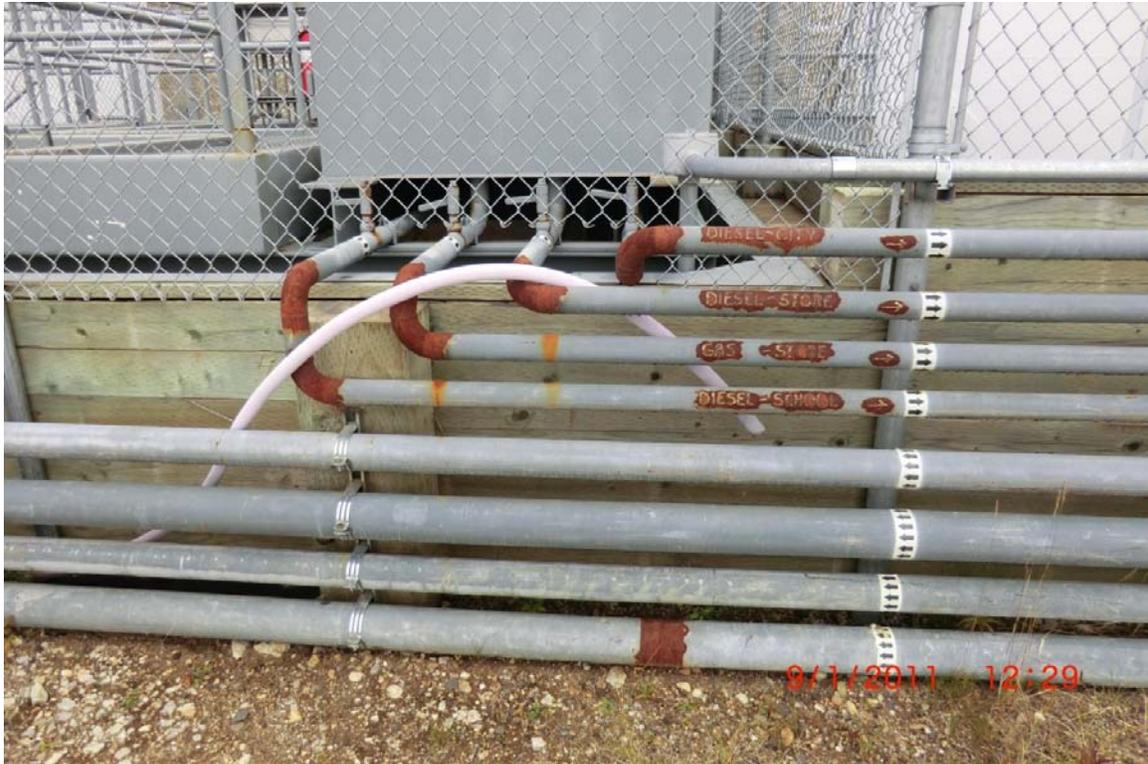
Photo 7. Corrosion at pipe welds and fittings along the tank farm perimeter.

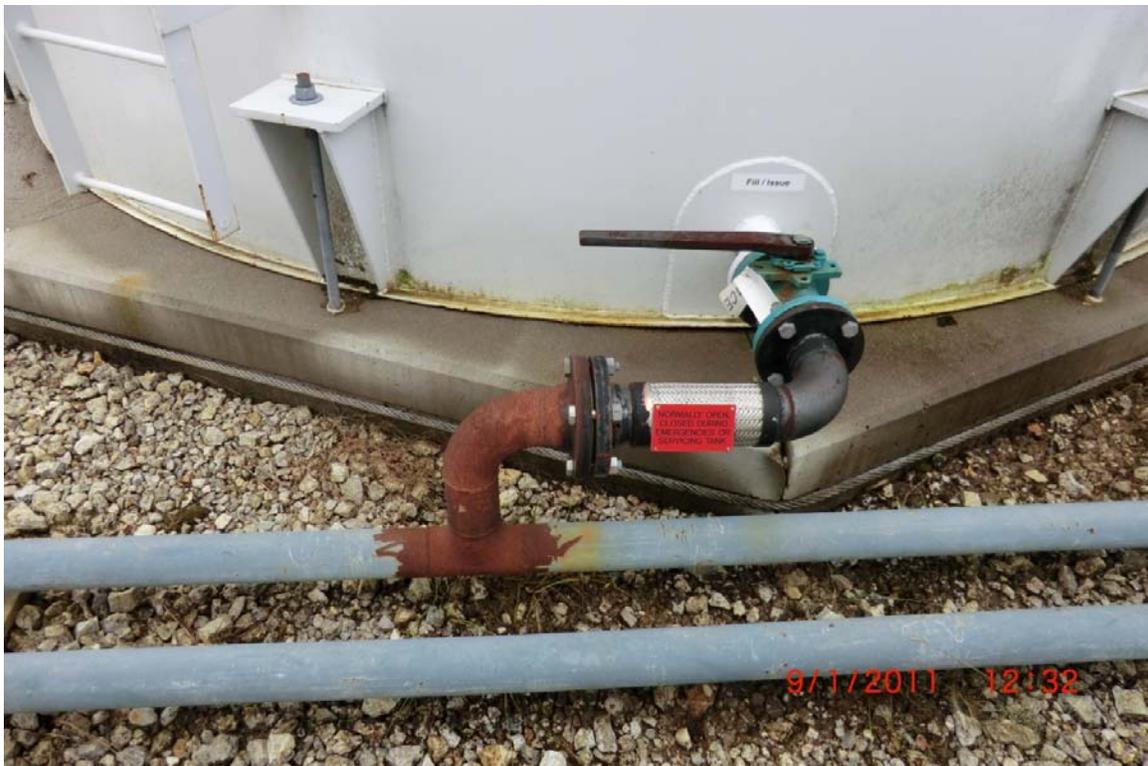
Photo 8. Corrosion at pipe welds and fittings inside the tank farm perimeter.
