FINAL REPORT
BULK FUEL FACILITY ASSESSMENT
VARIOUS LOCATIONS, ALASKA
CONTRACT TFSADNC17D0001, DELIVERY ORDER 20342918F00012

MARCH 2019

Prepared for:
Denali Commission
510 L Street, Suite 410
Anchorage, AK 99501

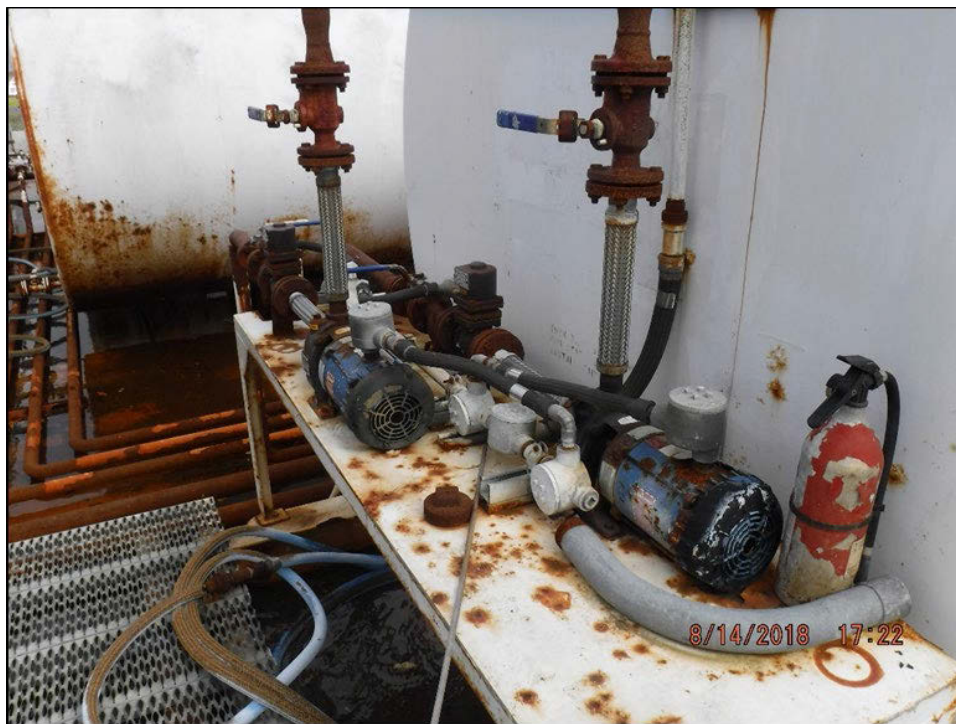
Photograph 6: Typical condition of infrastructure.

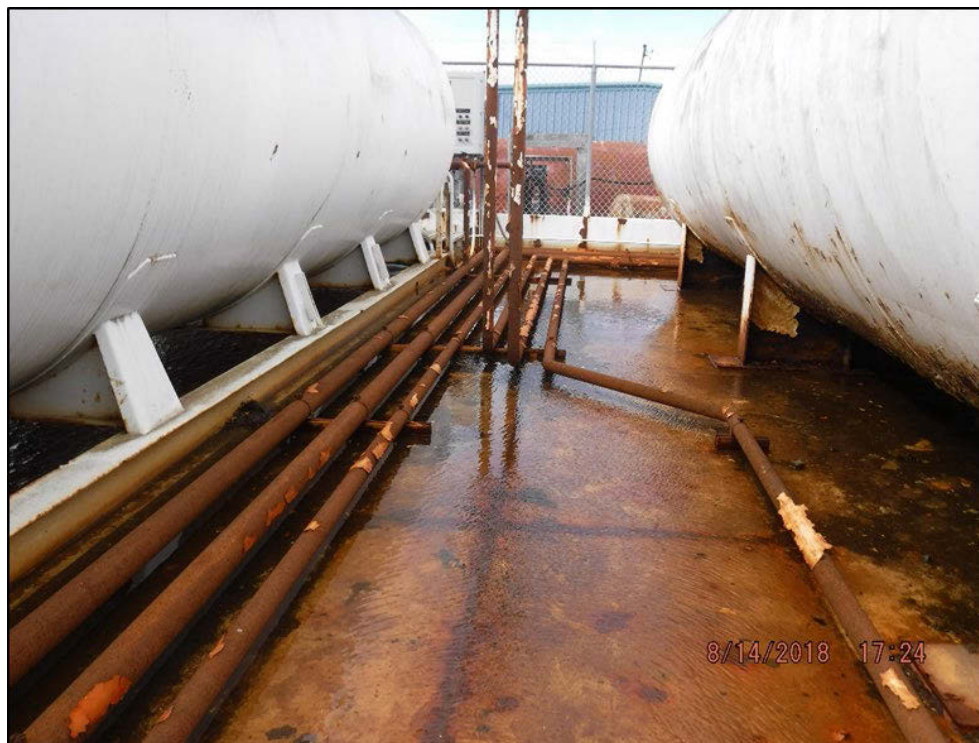
Photograph 7: Looking north along pipe runs. Note standing water present.

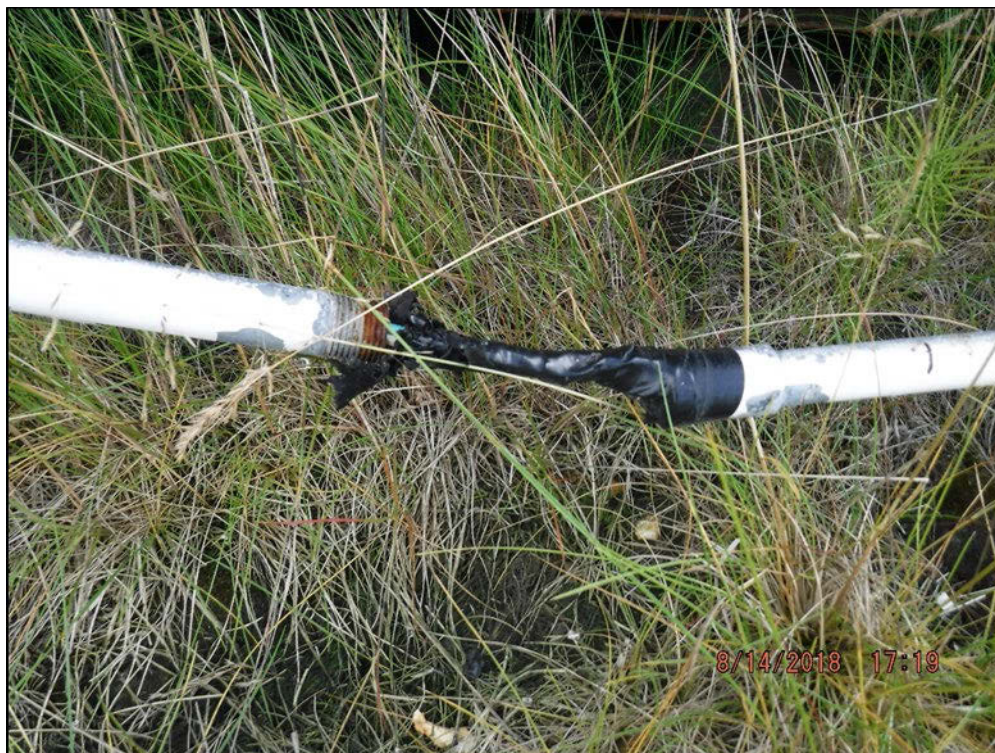
Photograph 9: Broken security light electrical conduit.

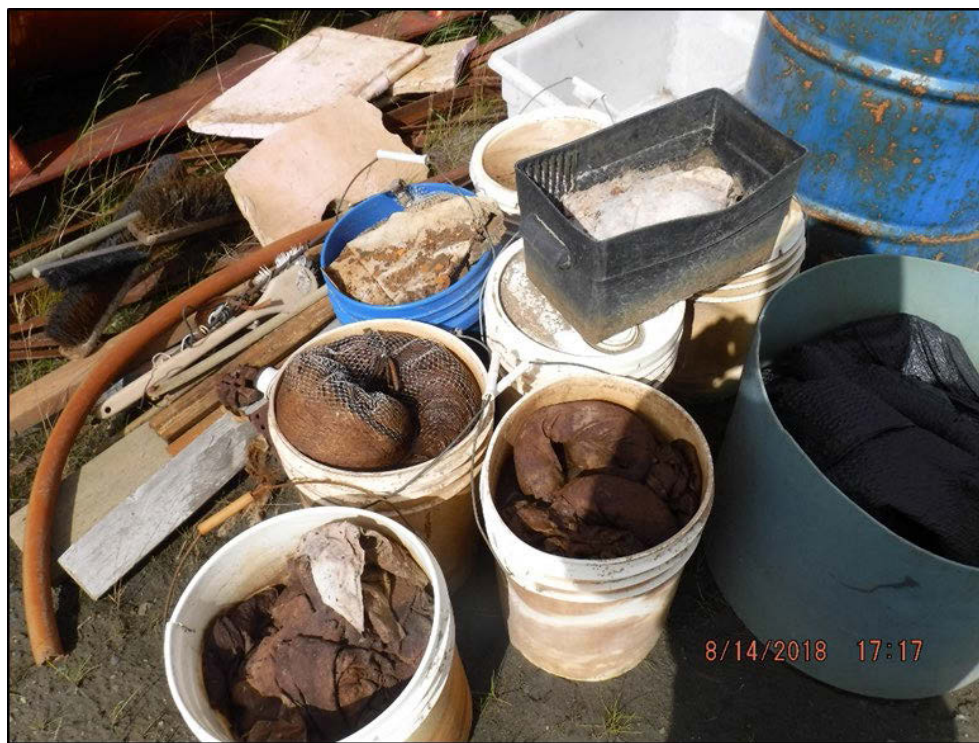
Photograph 10: Fuel saturated booms and sorbent pads outside of containment.

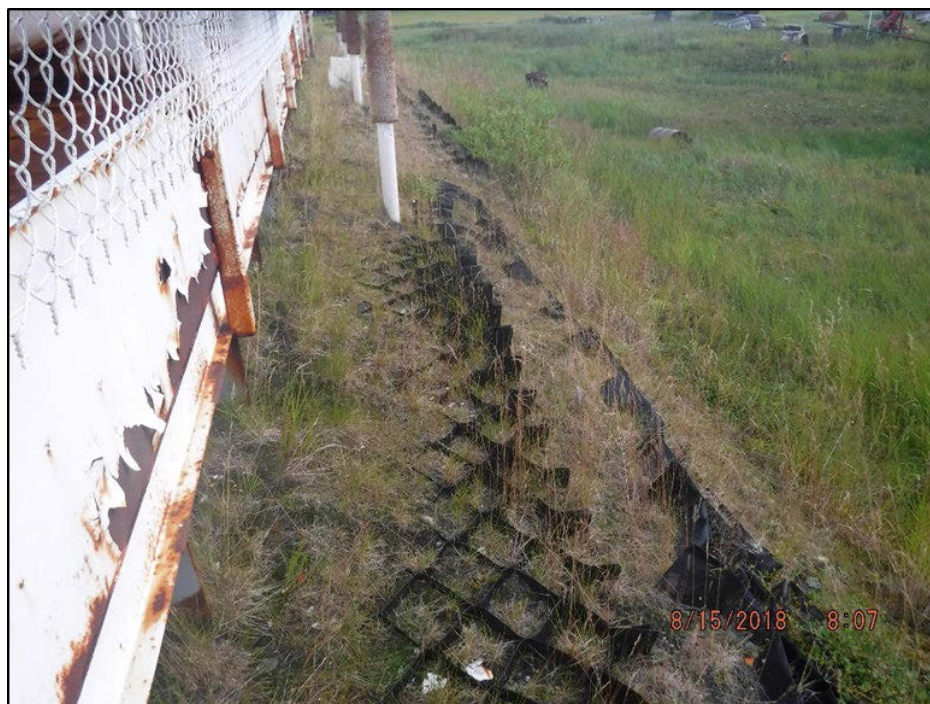
Photograph 12: Looking north along east edge of containment. Typical condition of pad edge with exposed cellular confinement.

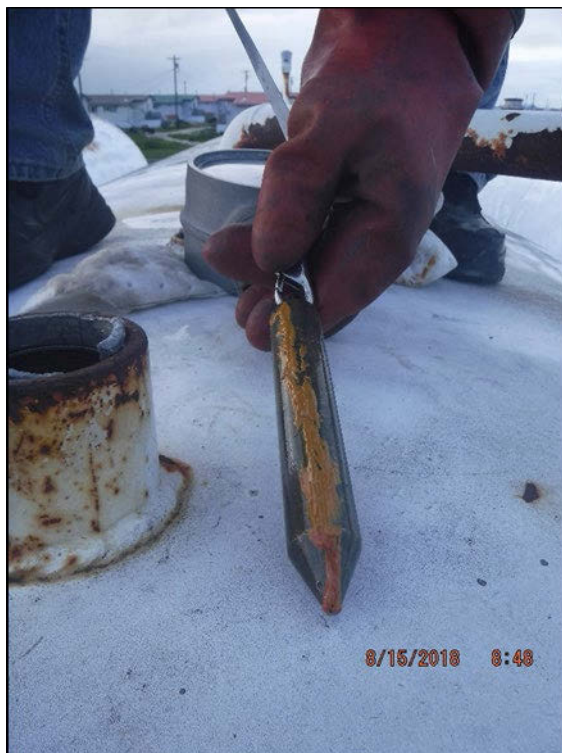
Photograph 13: Water finding past showing 1 inch of water in Tank #11.

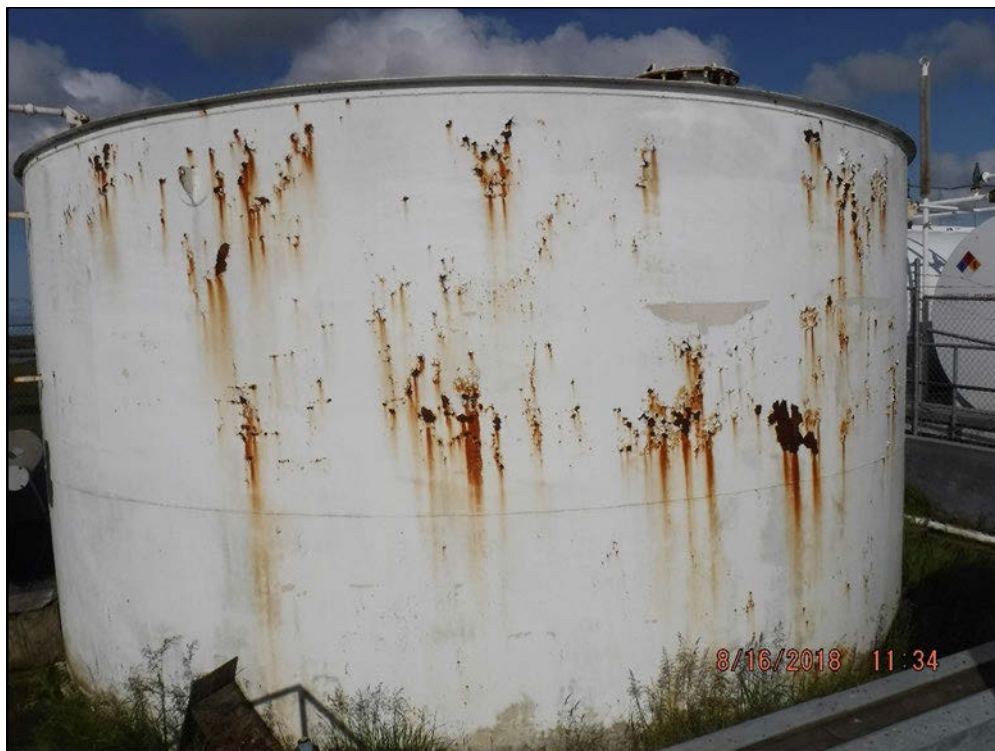
Photograph 15: Looking west at Tank #19. Note condition of LKSD tank and containment.

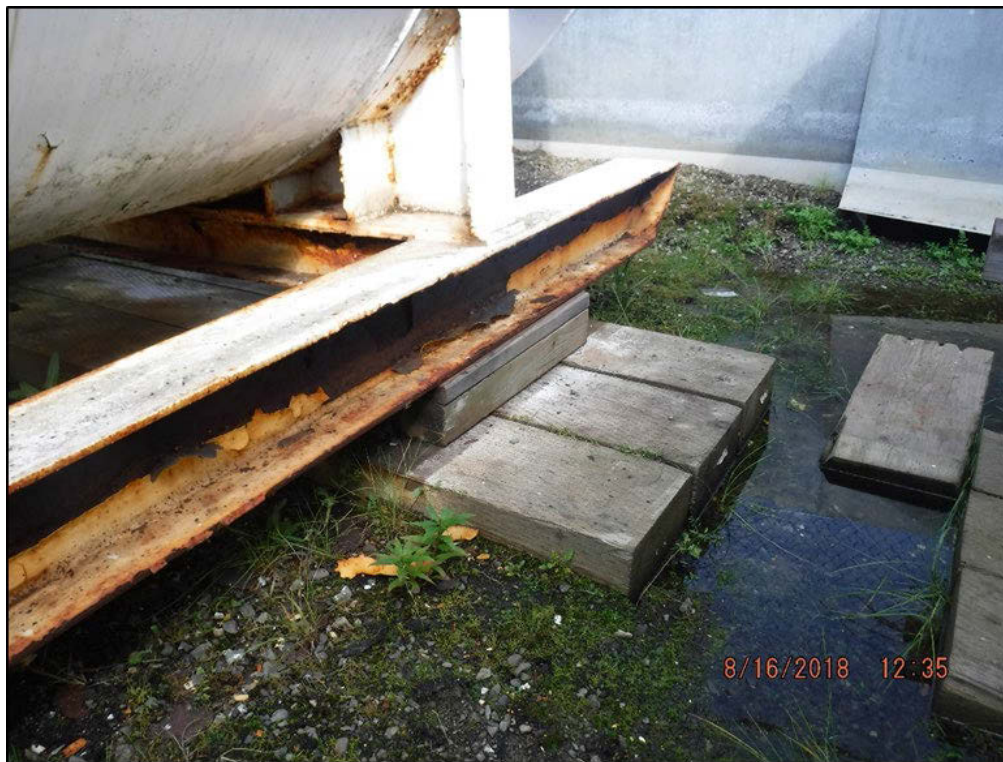
Photograph 20: Typical use of dimensional lumber used for cribbing on top of original treated wood foundation.

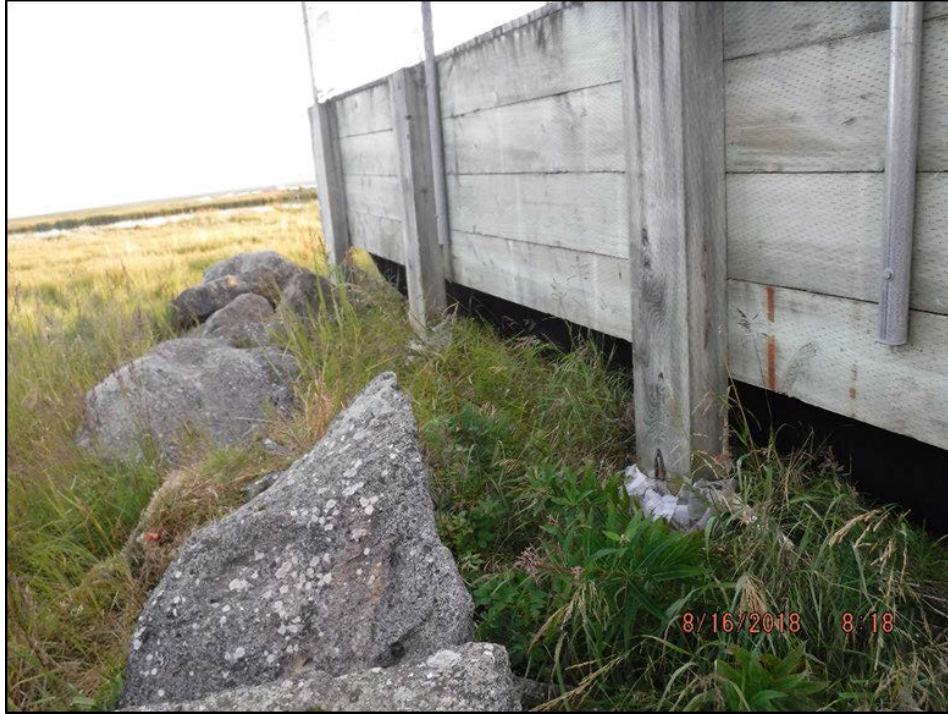
Photograph 21: Northwest corner of tank farm containment. Construction drawings show that the bottom timber should lie on the ground surface. Note stretched geotextile and liner material.

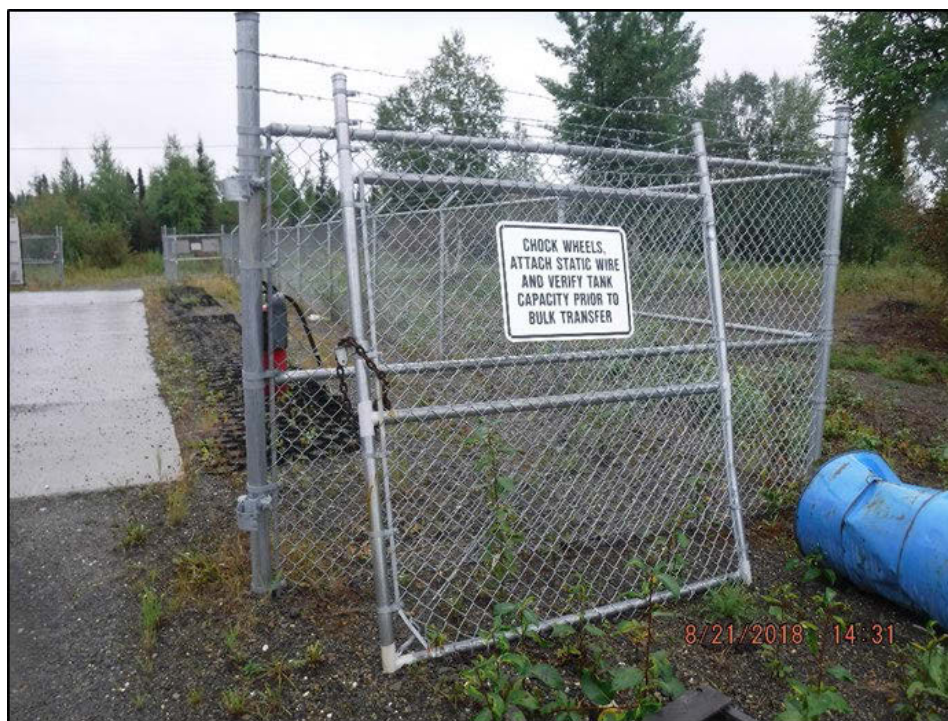
Photograph 6: Entrance gate that was damaged and removed before our arrival on site.

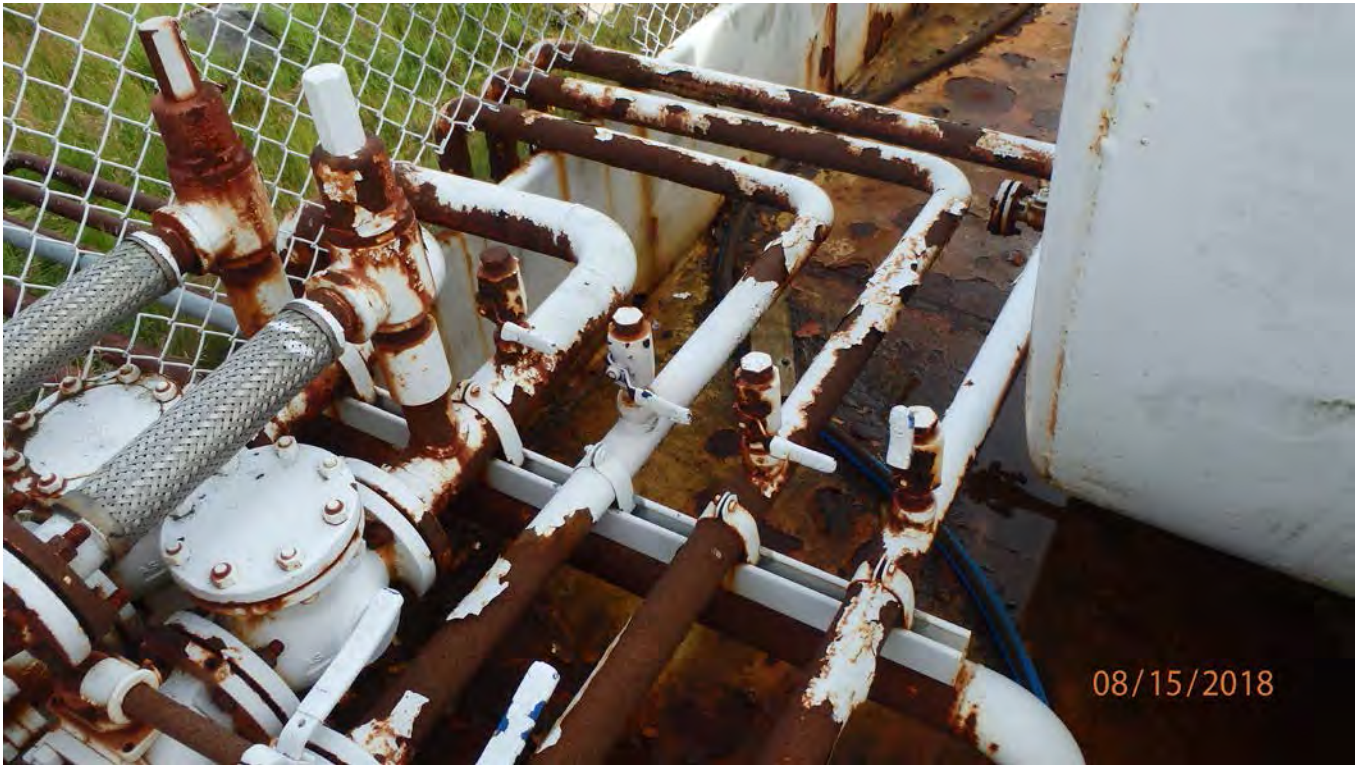
Cargo and service lines at tank farm wall. Highpoint vent valve on 2-inch line to Council tank is corroded in the open position

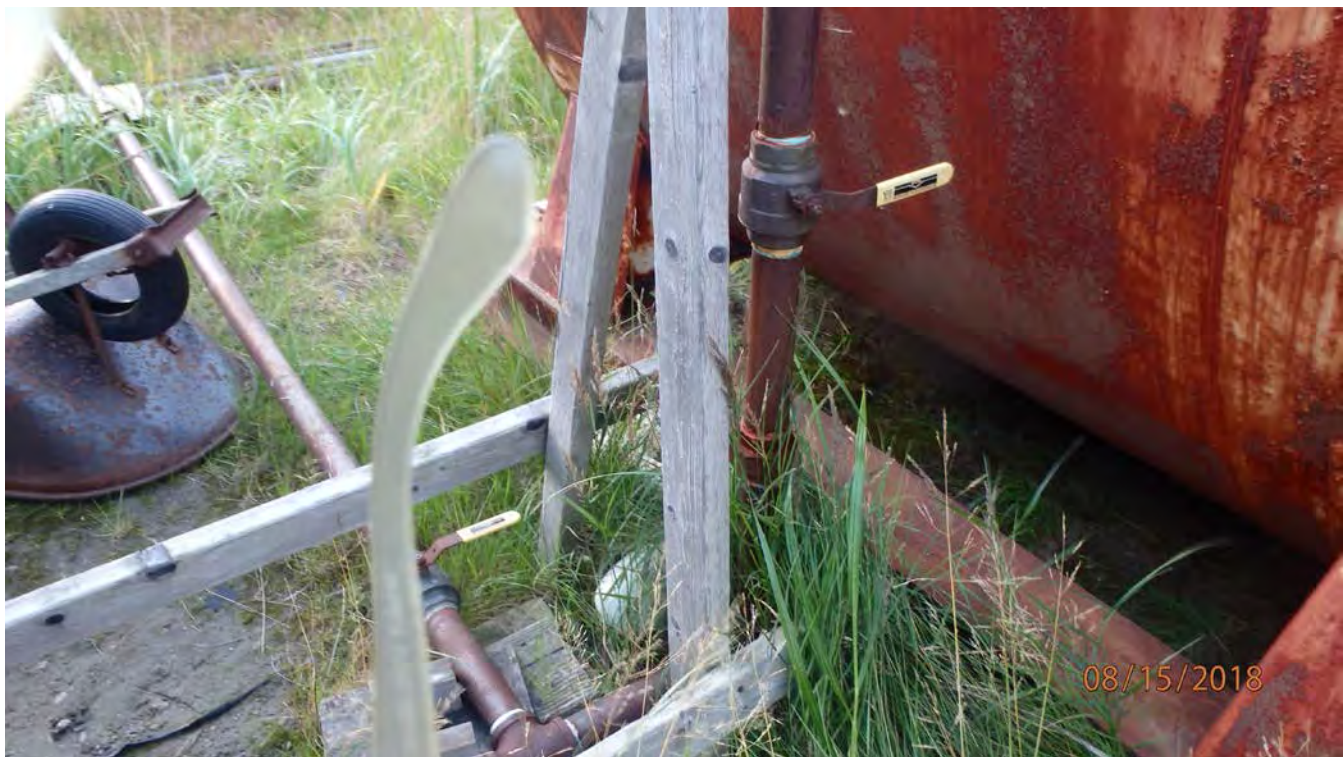
Brass Valves on piping to winter dispenser and council tank.

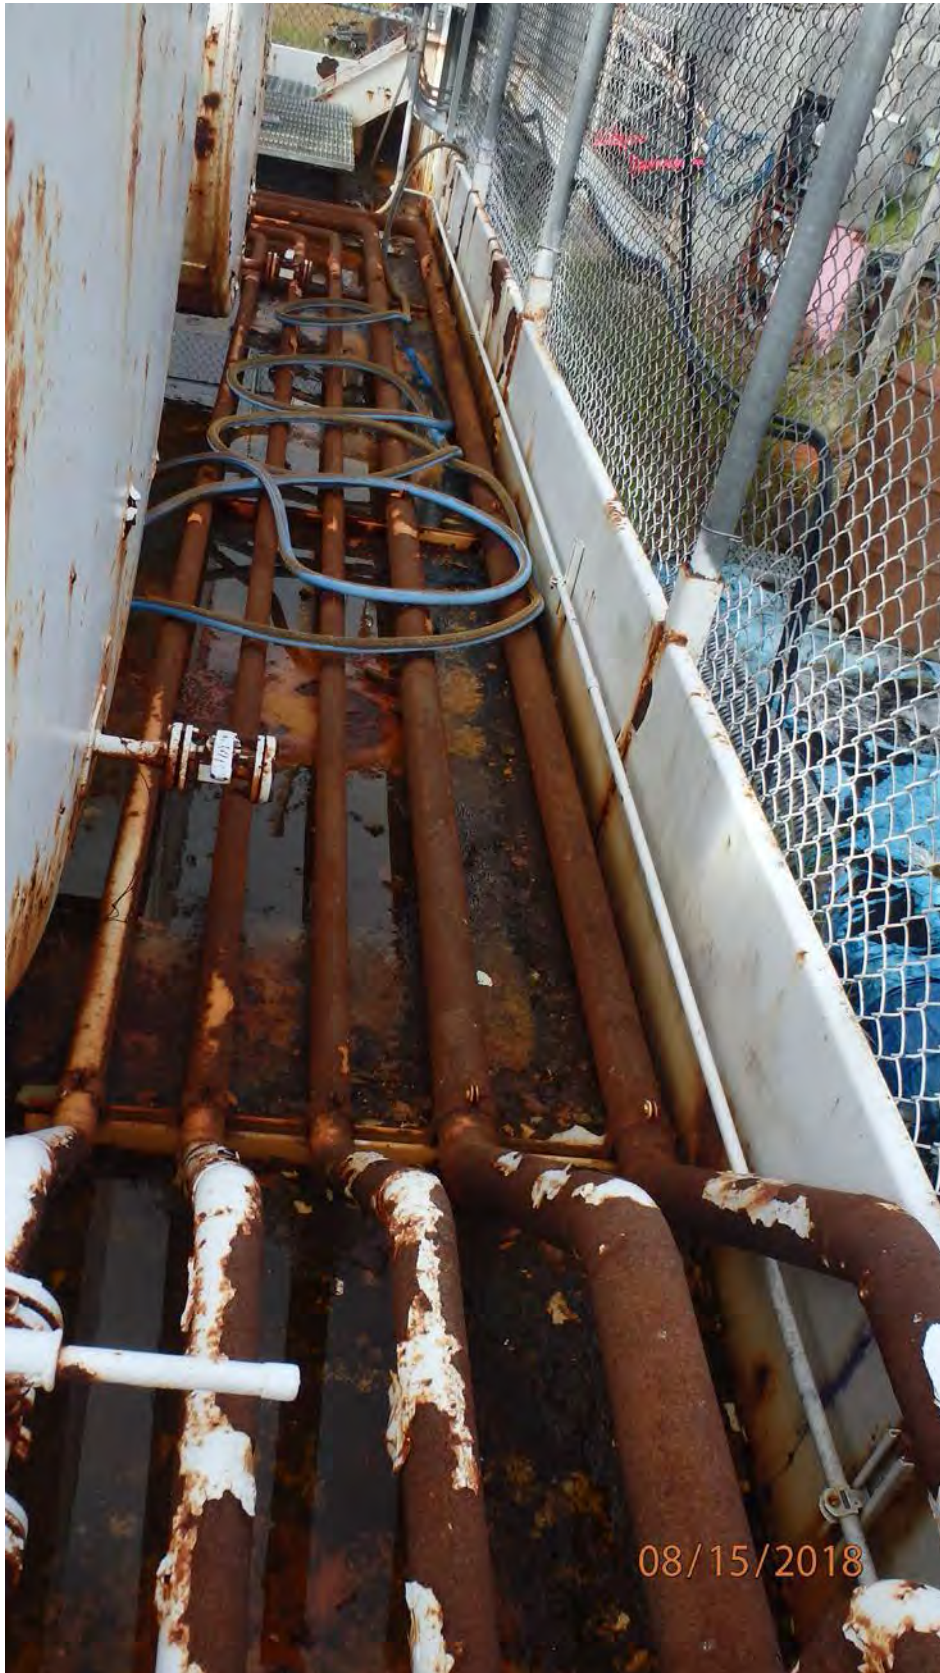
Typical tankfarm piping condition showing complete coating failure and generalized corrosion.

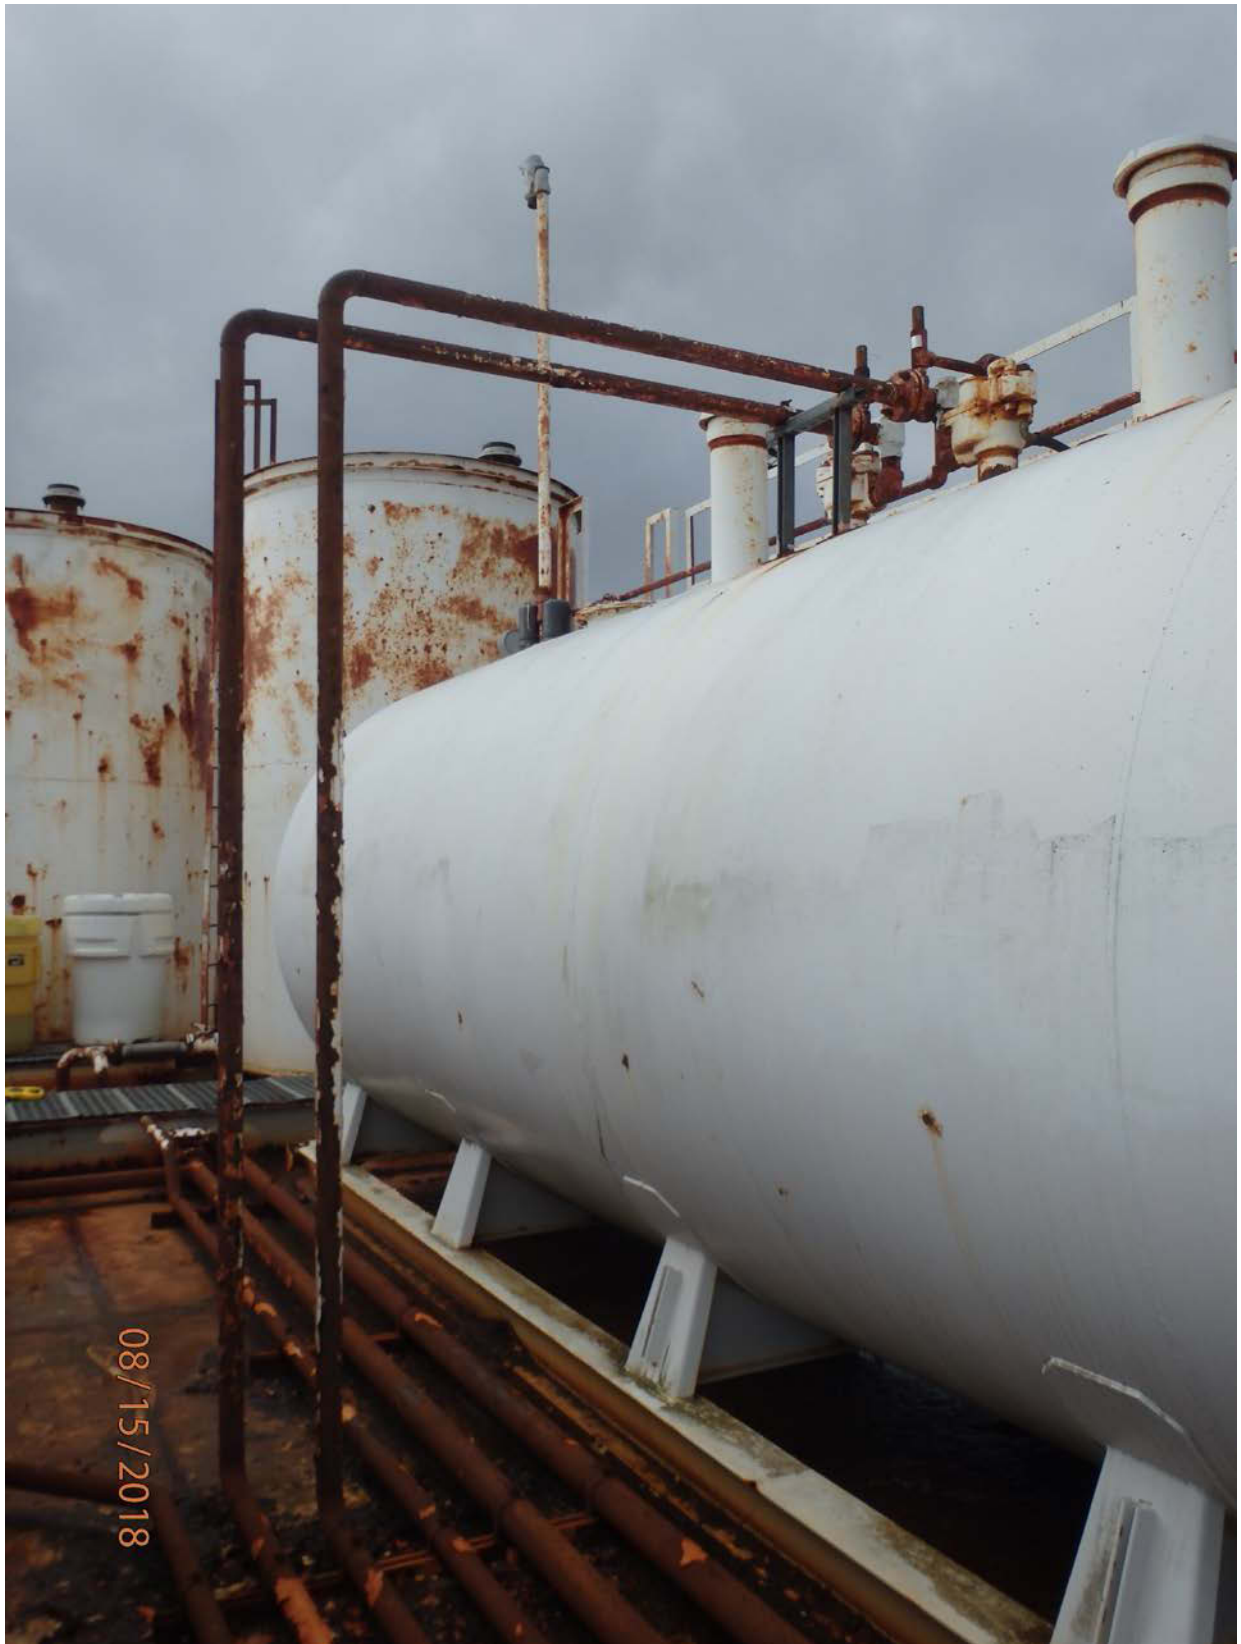
Typical tankfarm piping condition showing complete coating failure and generalized corrosion.

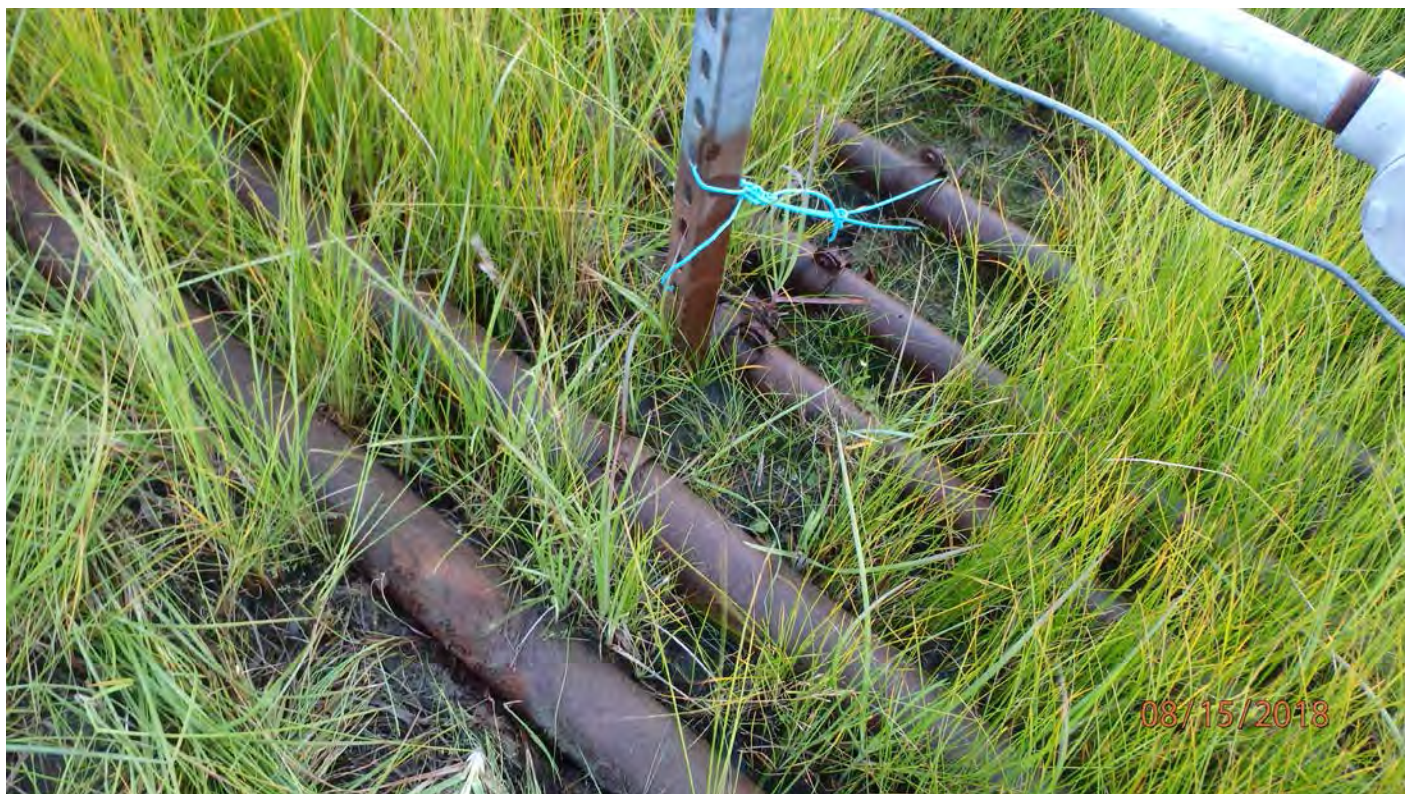
Low piping from marine header to tank farm. ~190 feet of piping is in contact with the ground or submerged for part of the year.

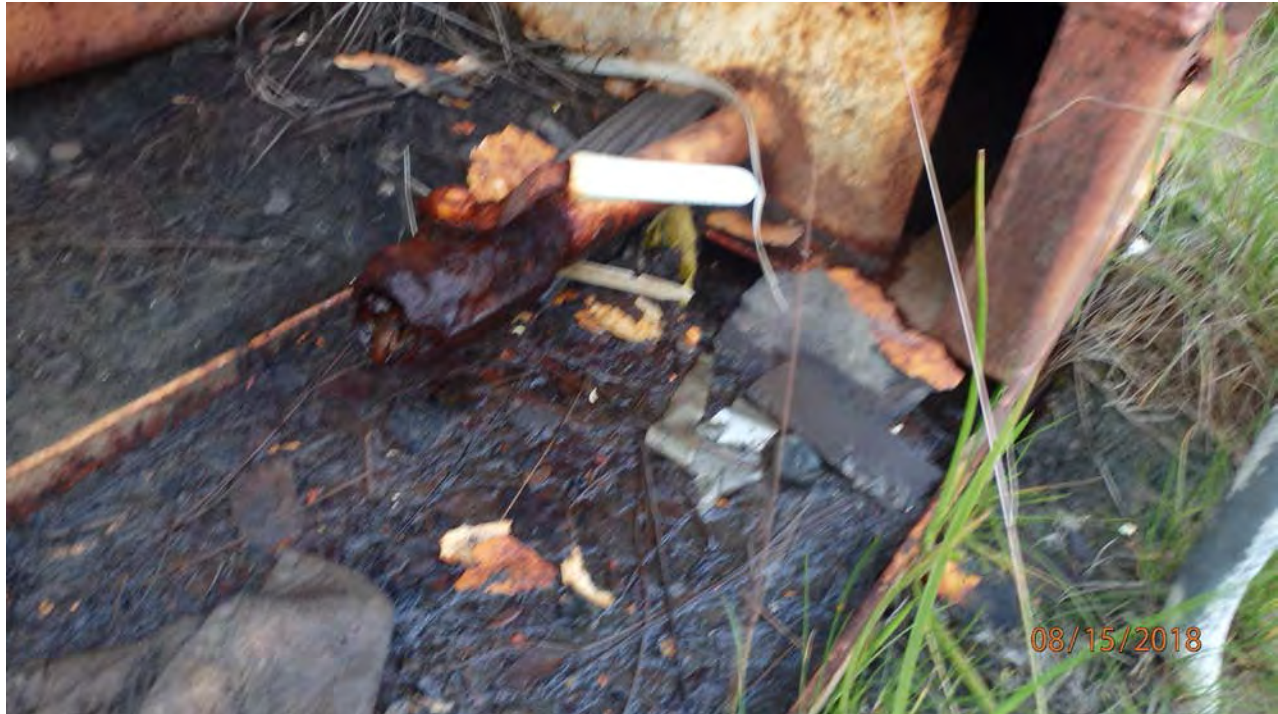
Dispenser containment drain valve found failed and leaking.

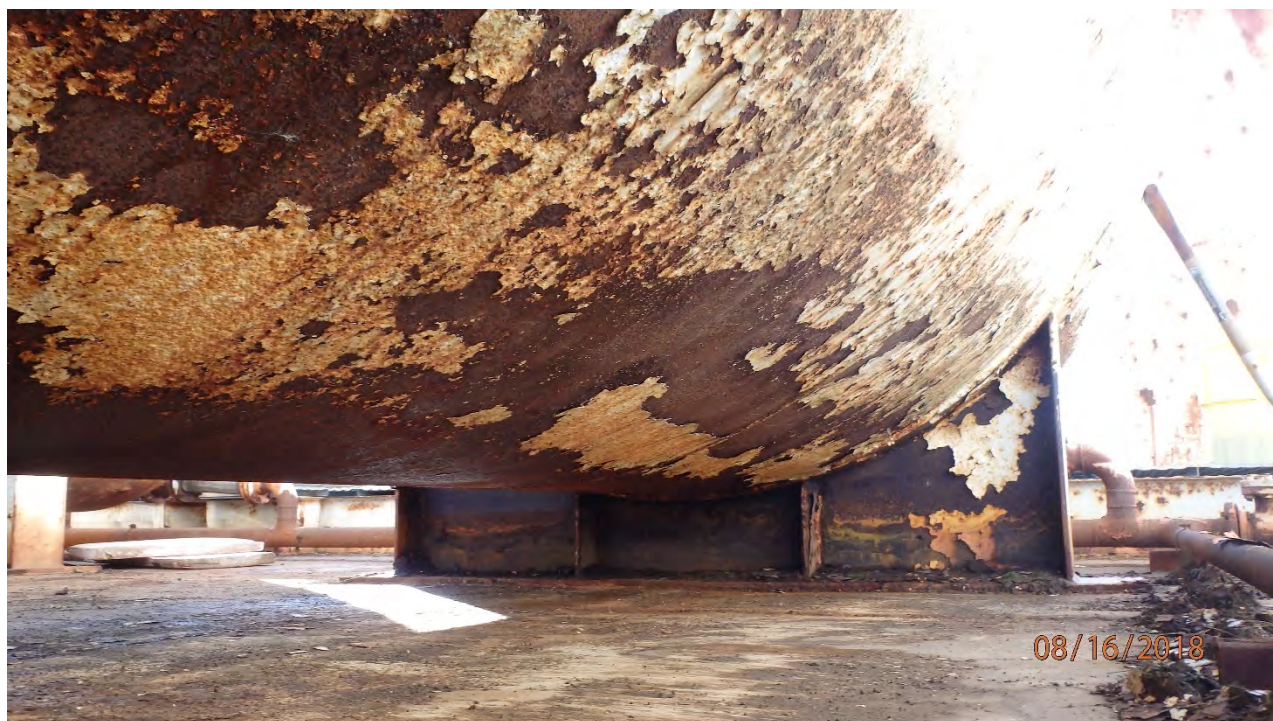
FIGURE 4: TYPICAL COATING CONDITION FOR THE BOTTOM 4 TO 8 FEET OF ALL TANK SHELLS. ALL TANKS SHOW SOME DEGREE OF CORROSION IN THIS AREA WITH TANK 4 EXHIBITING THE WORST PITTING AND GENERAL WALL LOSS.

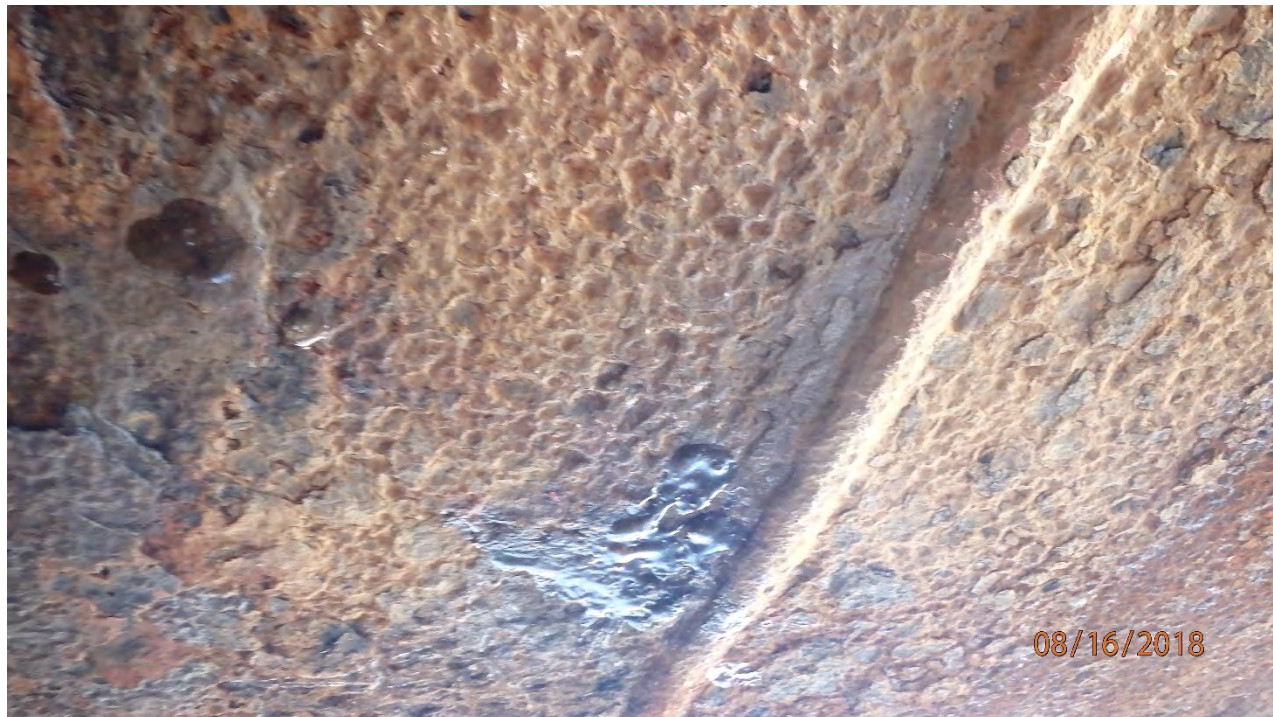
FIGURE 5: TANK 4 TYPICAL BOTTOM CONDITION WITH EXTERNAL PITTING TO 80 MILS DEEP.

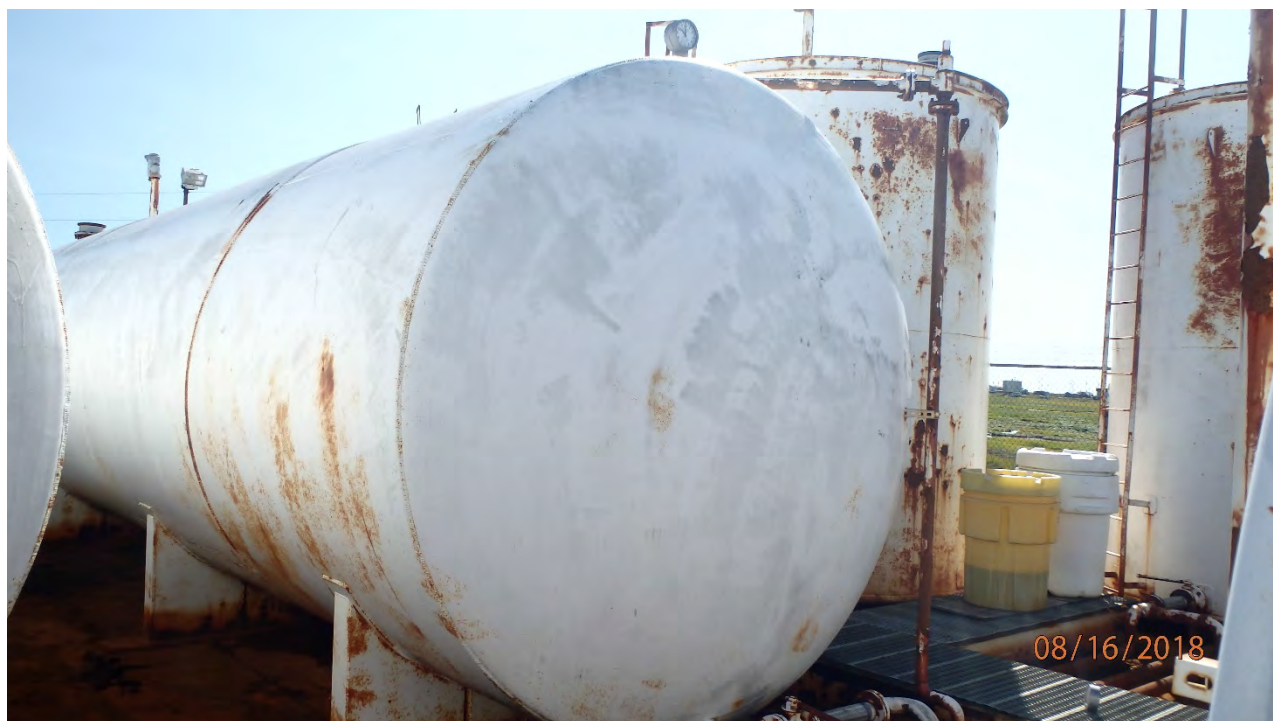
FIGURE 6: TYPICAL SHELL AND ELLIPTICAL HEAD COATING CONDITION FOR TANKS 10, 11 AND 12. 23,000 GALLONS EACH.

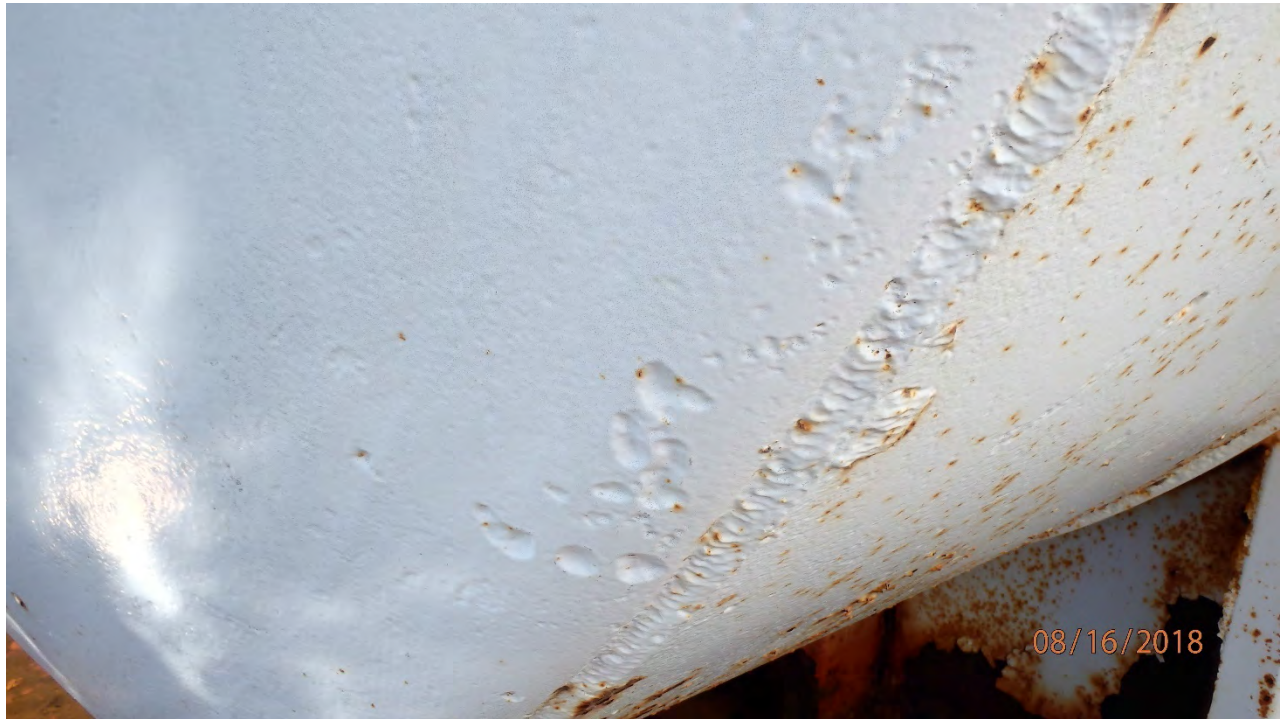
FIGURE 7: TYPICAL ISOLATED PITTING ON THE ELLIPTICAL HEADS FOR TANKS 10-12. MAXIMUM DEPTH 100 MILS

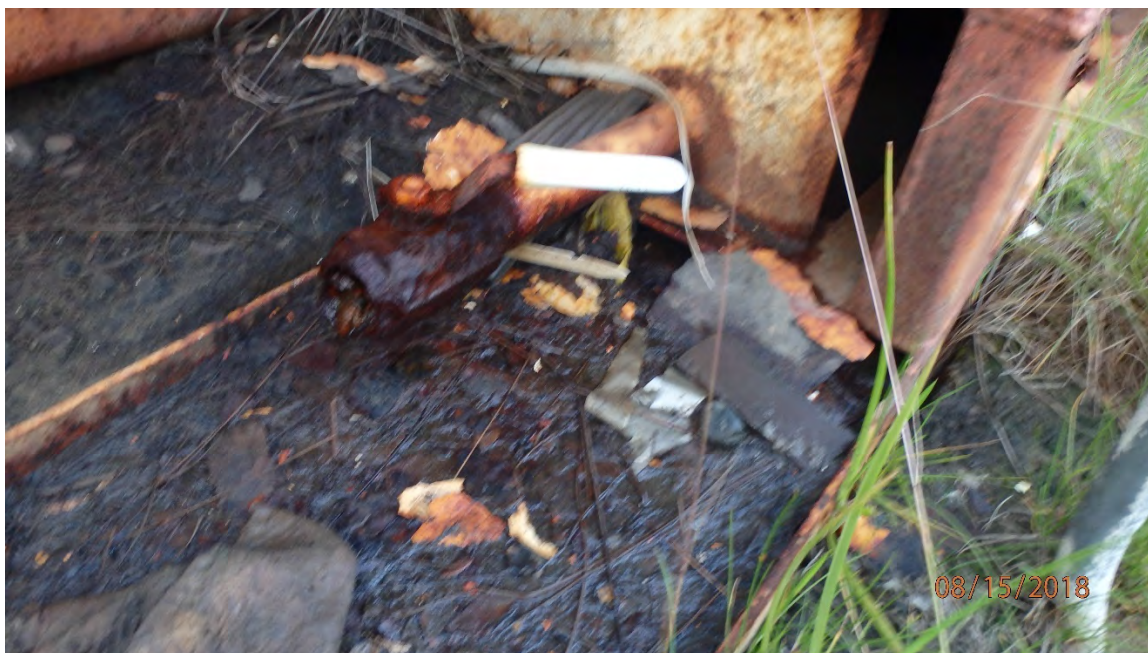
FIGURE 12: FAILED CONTAINMENT DRAIN VALVE FOR DISPENSER CABINET AT RIVER. VALVE WAS FOUND DRIPPING WATER DURING INSPECTION.

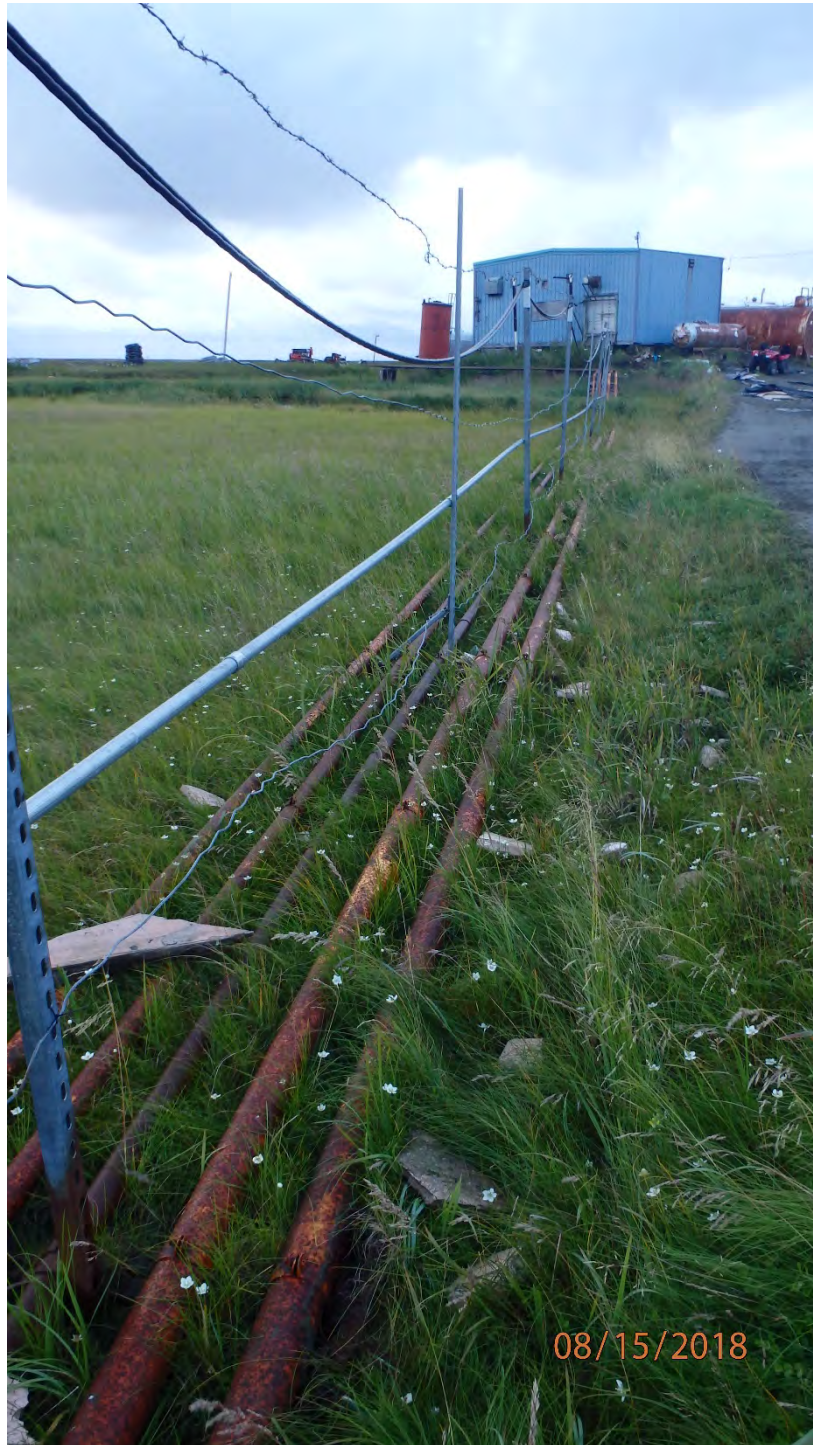
FIGURE 13: ~190 FEET OF CARGO AND SERVICE PIPING ON GRADE BETWEEN DISPENSER AND OLD POWER PLANT.

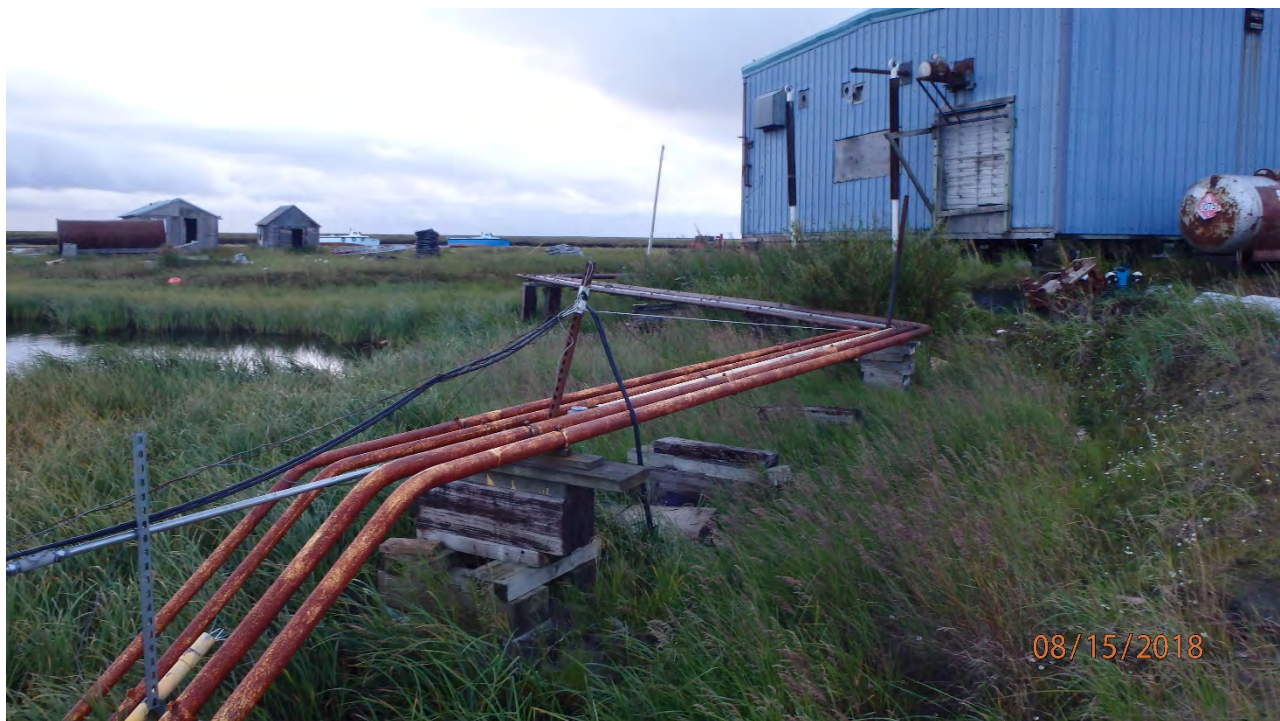
FIGURE 15: CARGO AND SERVICE PIPING CONDITION, 2018.

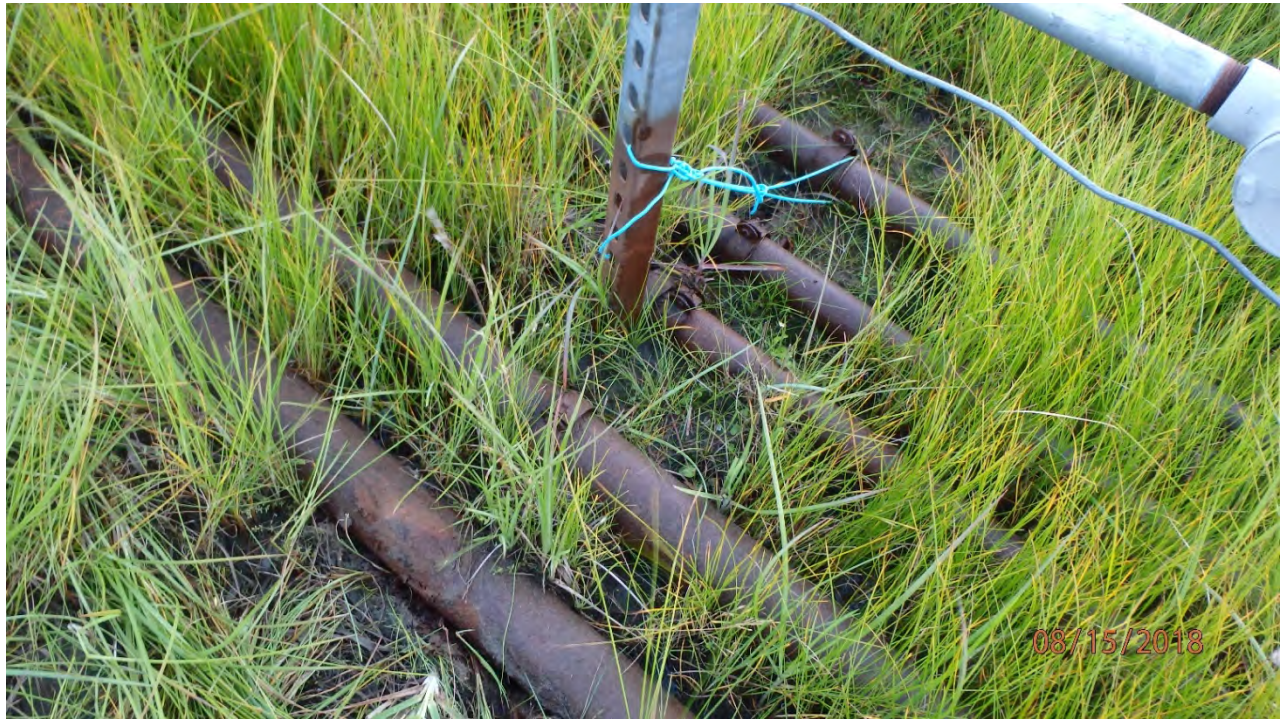
FIGURE 16: TYPICAL CARGO AND SERVICE LINE CONDITION IN LOW AREA, IN CONTACT WITH SOIL/WATER, SOME PIPE CLAMPS COMPLETELY CORRODED.
