FINAL REPORT
BULK FUEL FACILITY ASSESSMENT
VARIOUS LOCATIONS, ALASKA
CONTRACT TFSADNC17D0001, DELIVERY ORDER 20342918F00012

MARCH 2019

Prepared for:
Denali Commission
510 L Street, Suite 410
Anchorage, AK 99501

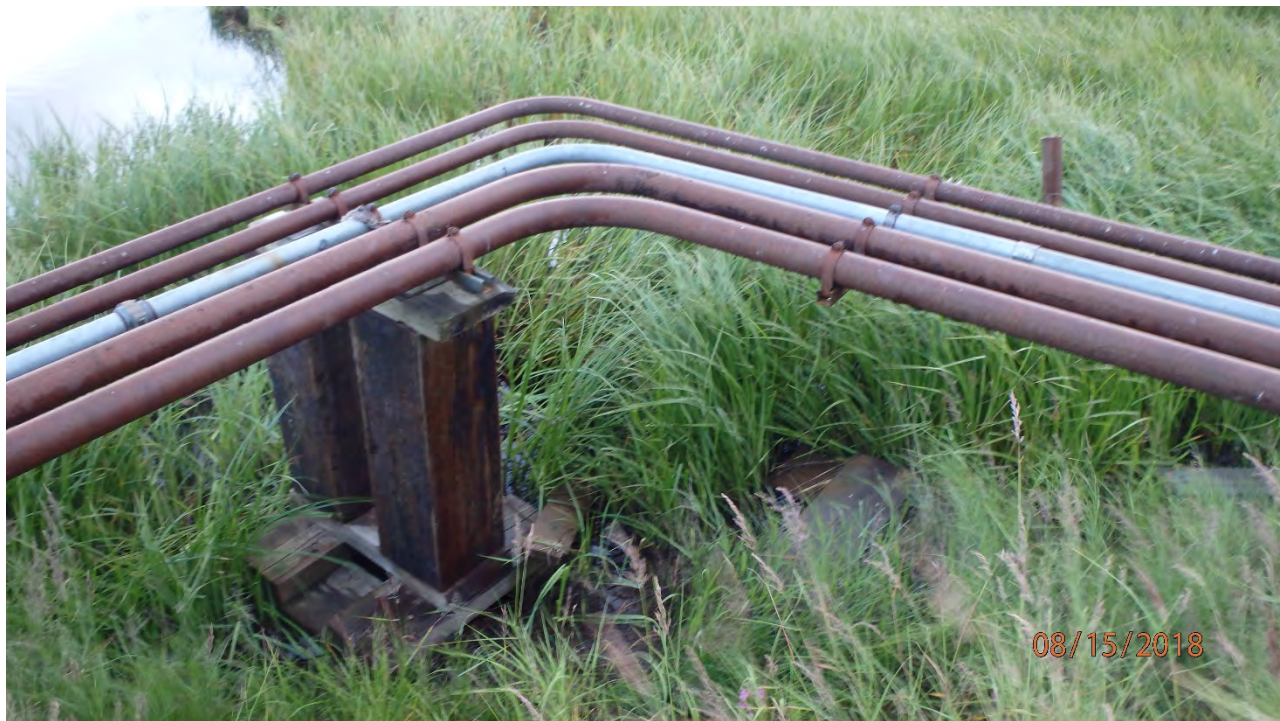
FIGURE 17: PIPE IS SUPPORTED ON UNSECURED CRIB PILES THAT HAVE FALLEN OVER IN SOME AREAS.

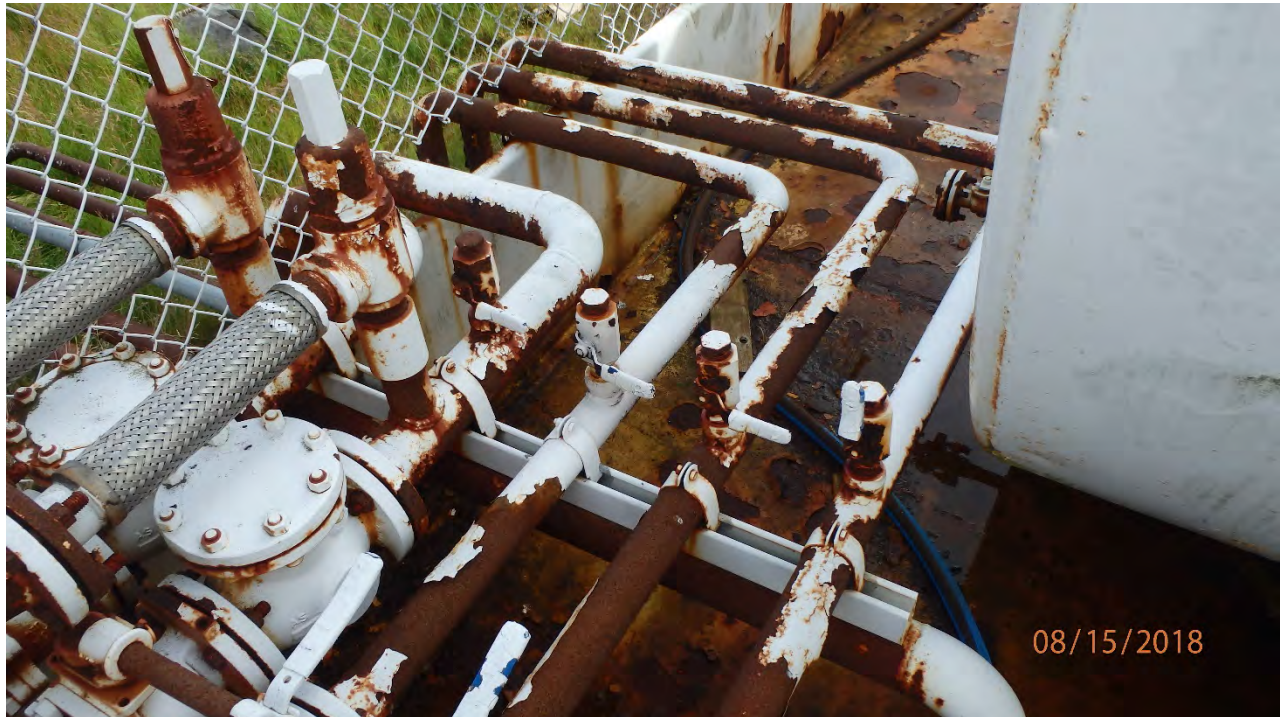
FIGURE 18: CARGO AND SERVICE PIPING CONDITION AS IT ENTERS CONTAINMENT. NOTE HIGH POINT VENT FOR LINE ON RIGHT (COUNCIL TANK AND WINTER DISPENSER) IS SEIZED IN THE OPEN POSITION.

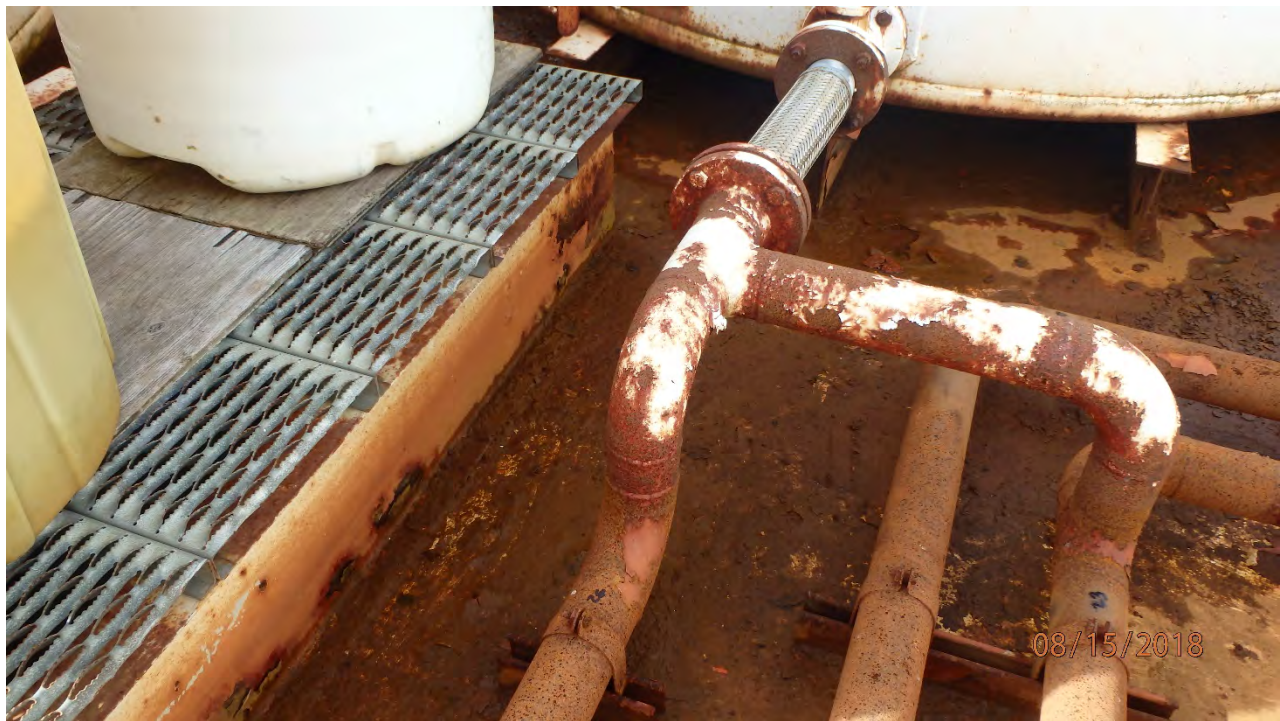
FIGURE 19: CROSS OVER TO FOUR ABANDONED VERTICAL TANKS. NO ISOLATION VALVES UNTIL TANK NOZZLES. 1 LARGE DEAD-LEG.

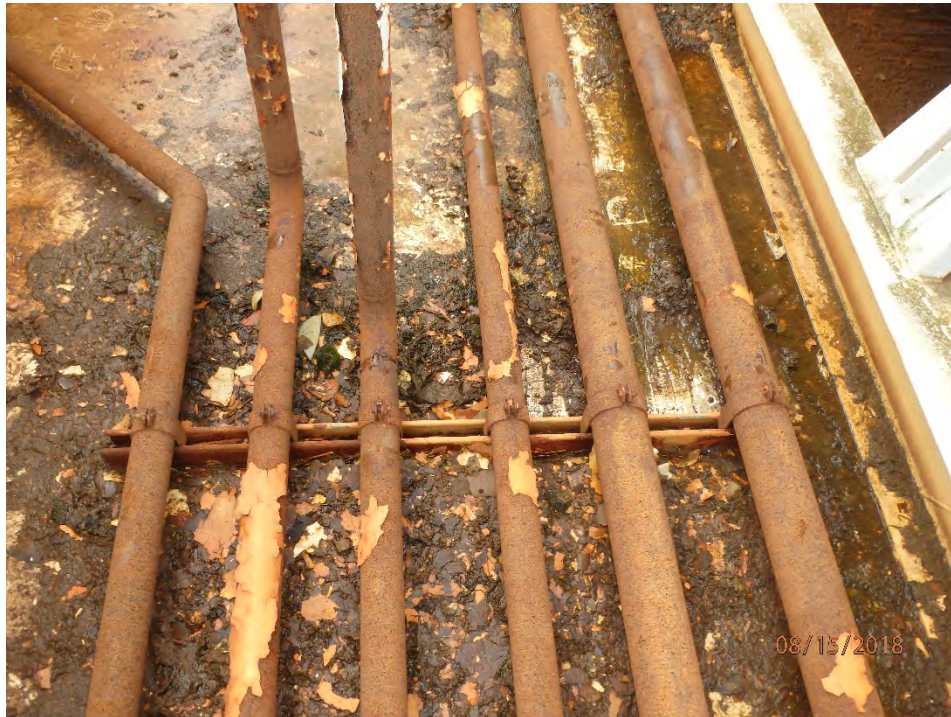
FIGURE 20: TYPICAL PIPING CONDITION IN TANK FARM. PIPING WAS PARTIALLY SUBMERGED ON ARRIVAL. PIPING IS CLAMPED TO UNI-STRUT WHICH IS WELDED TO THE FLOOR OF CONTAINMENT.

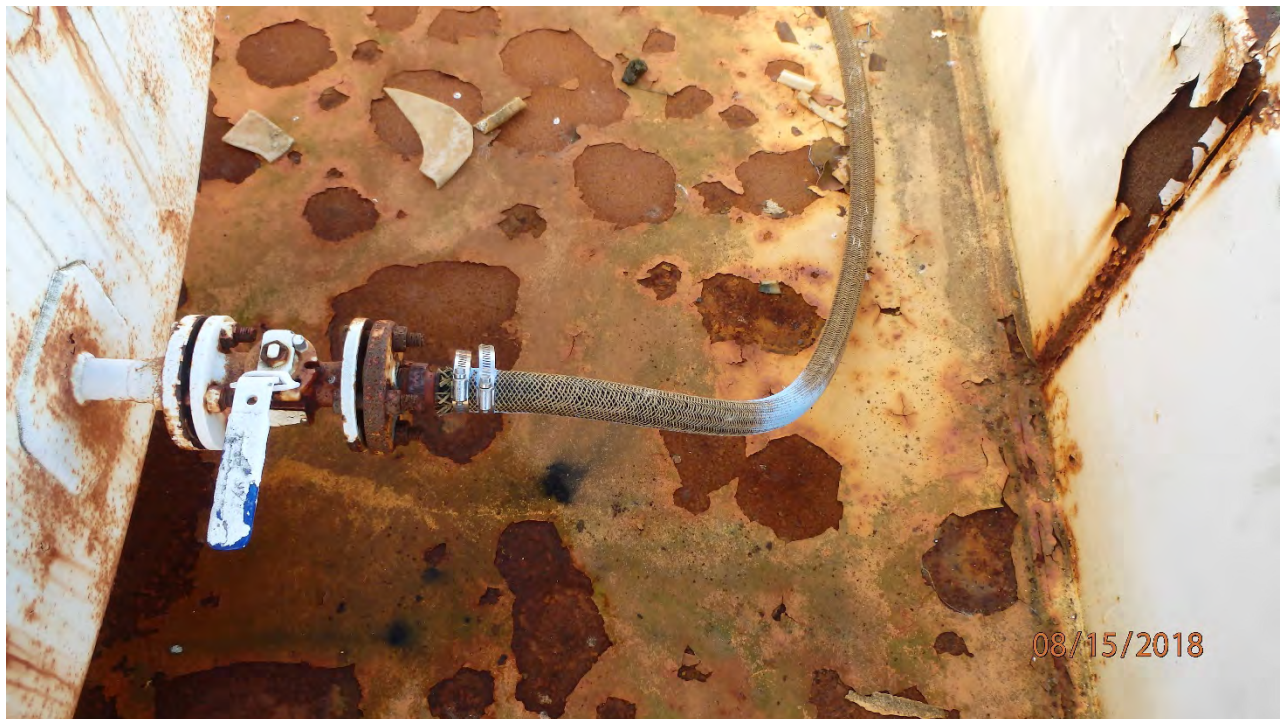
FIGURE 21: FUEL TRANSFER HOSE CONNECTED TO WATER-DRAW NOZZLE ON TANK 5. NO LOCK ON VALVE AND HOSE TERMINATES OUTSIDE OF CONTAINMENT IN OLD DISPENSER SHACK. NOTE UV DEGRADATION OF RUBBER.

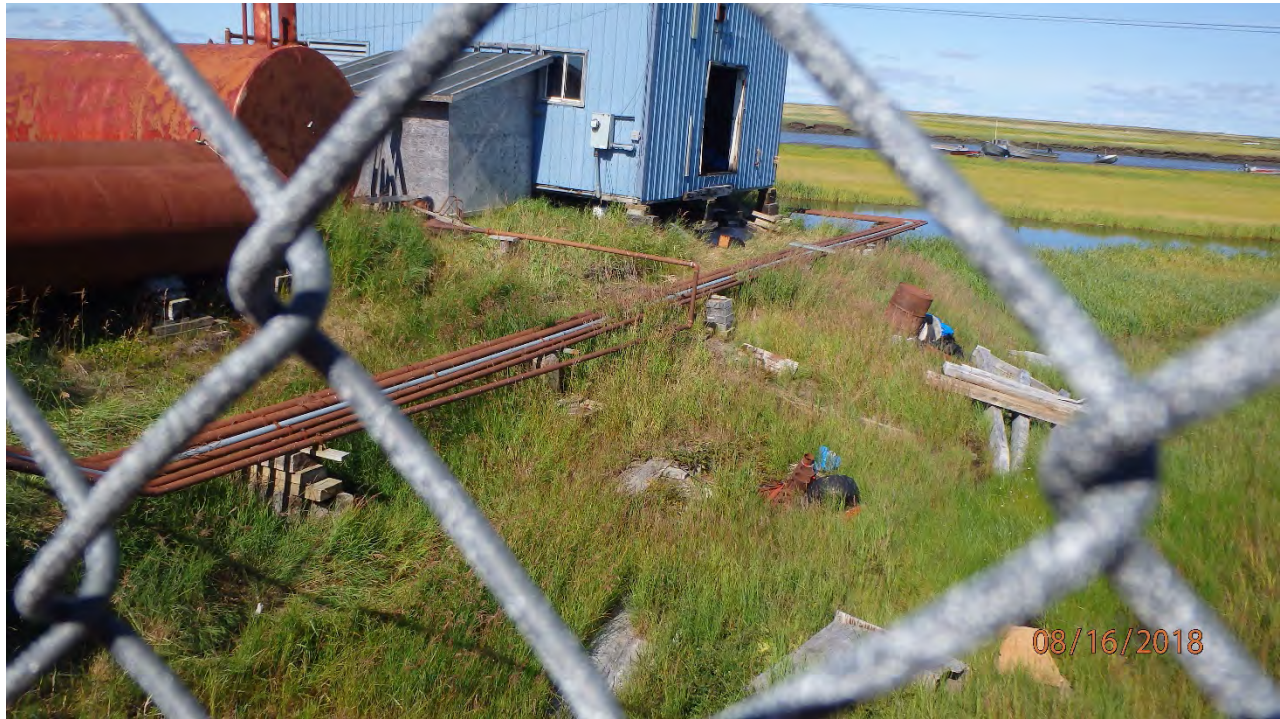
FIGURE 22: SERVICE LINE TO SECONDARY DISPENSER AND COUNCIL TANK ON THE RIGHT SIDE OF PIPE RUN. NOTE SAG BECAUSE PIPING IS OFF OF SUPPORT. OPERATOR WAS WORKING TO FIX THIS WHILE WE WERE ON SITE.

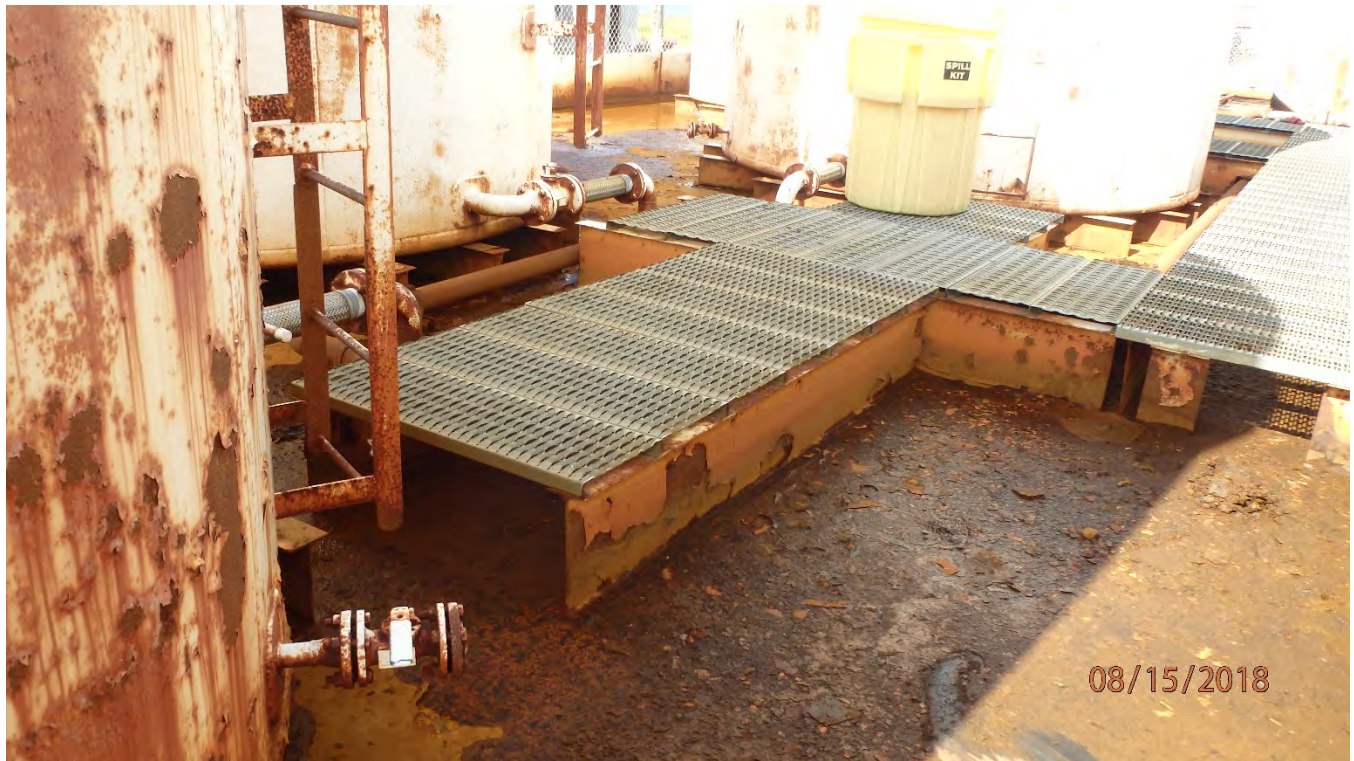
FIGURE 24: STEEL CONTAINMENT GENERAL CONDITION, NOTE FAILING COATINGS AND RUST/DEBRIS BUILD-UP.

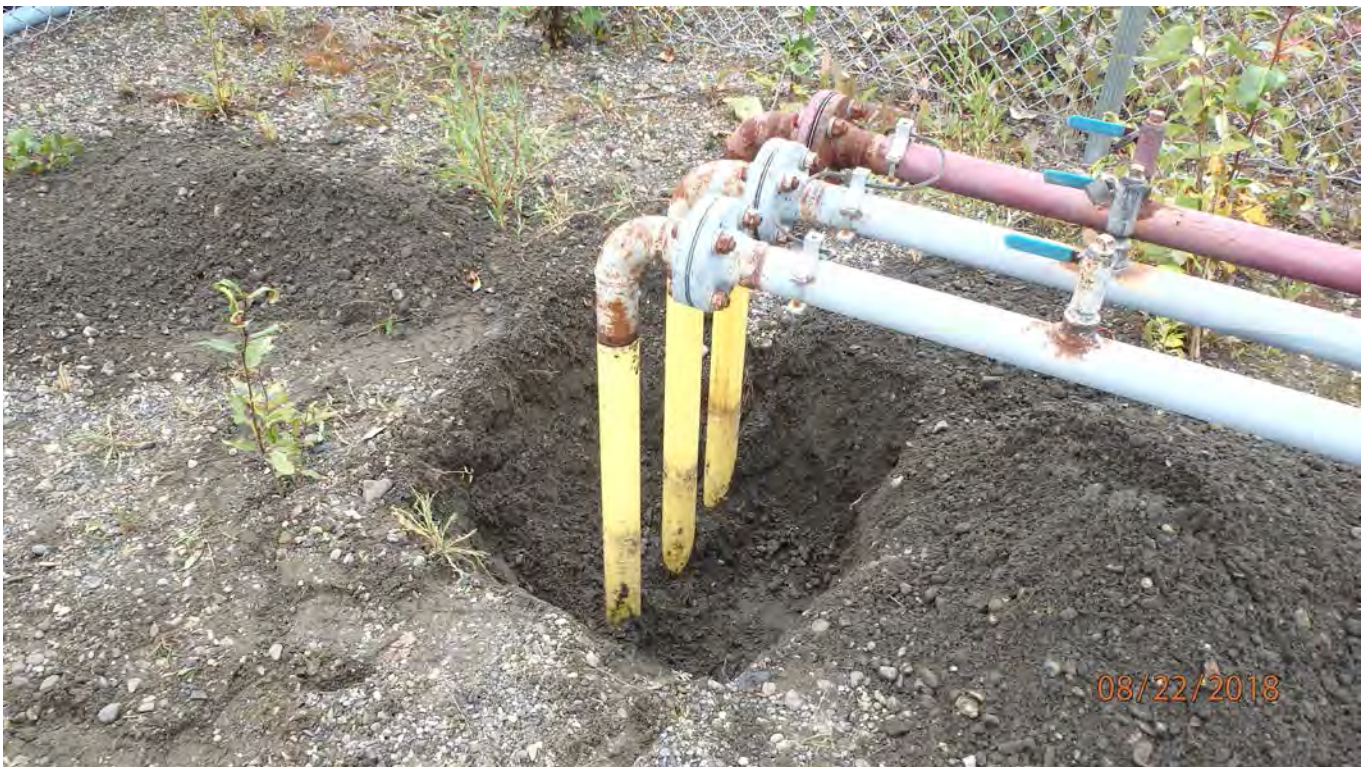
General piping condition with surface rust at all welded connections, elbows and flanges. Below grade yellow jacket in excellent condition.

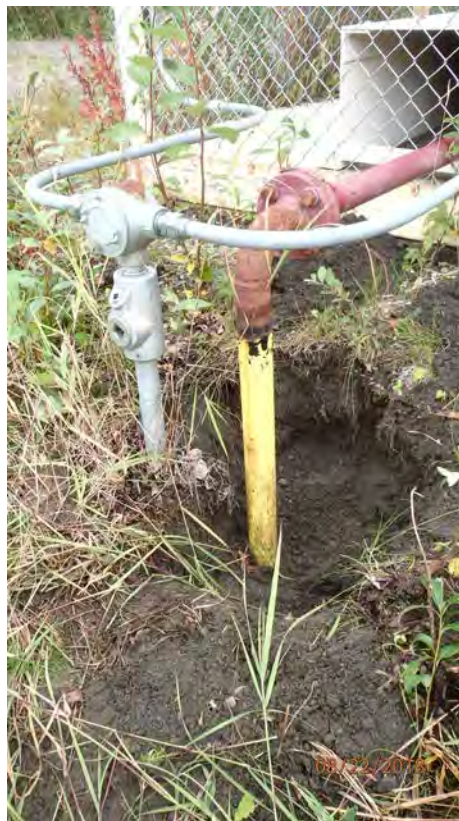
Coating condition at gasoline dispenser transition.

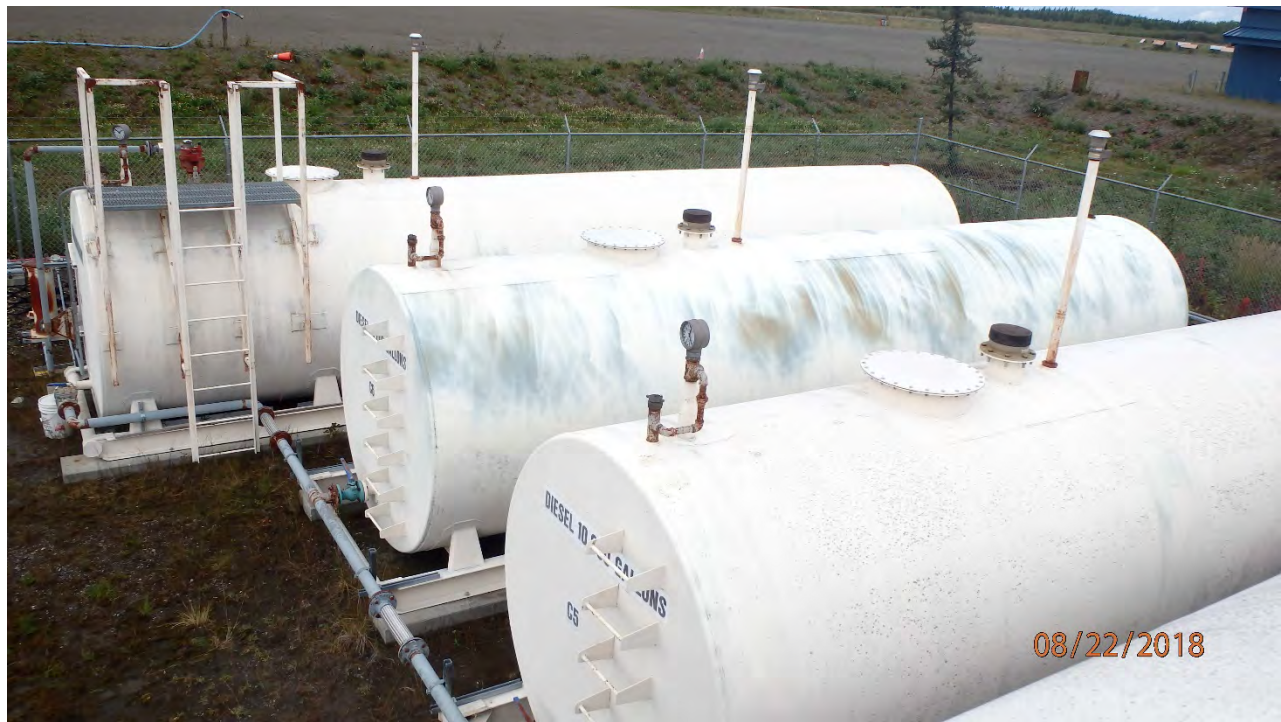
FIGURE 5: REFURBISHED TANKS SHOWING COATINGS FAILURES DUE TO UV DEGRADATION

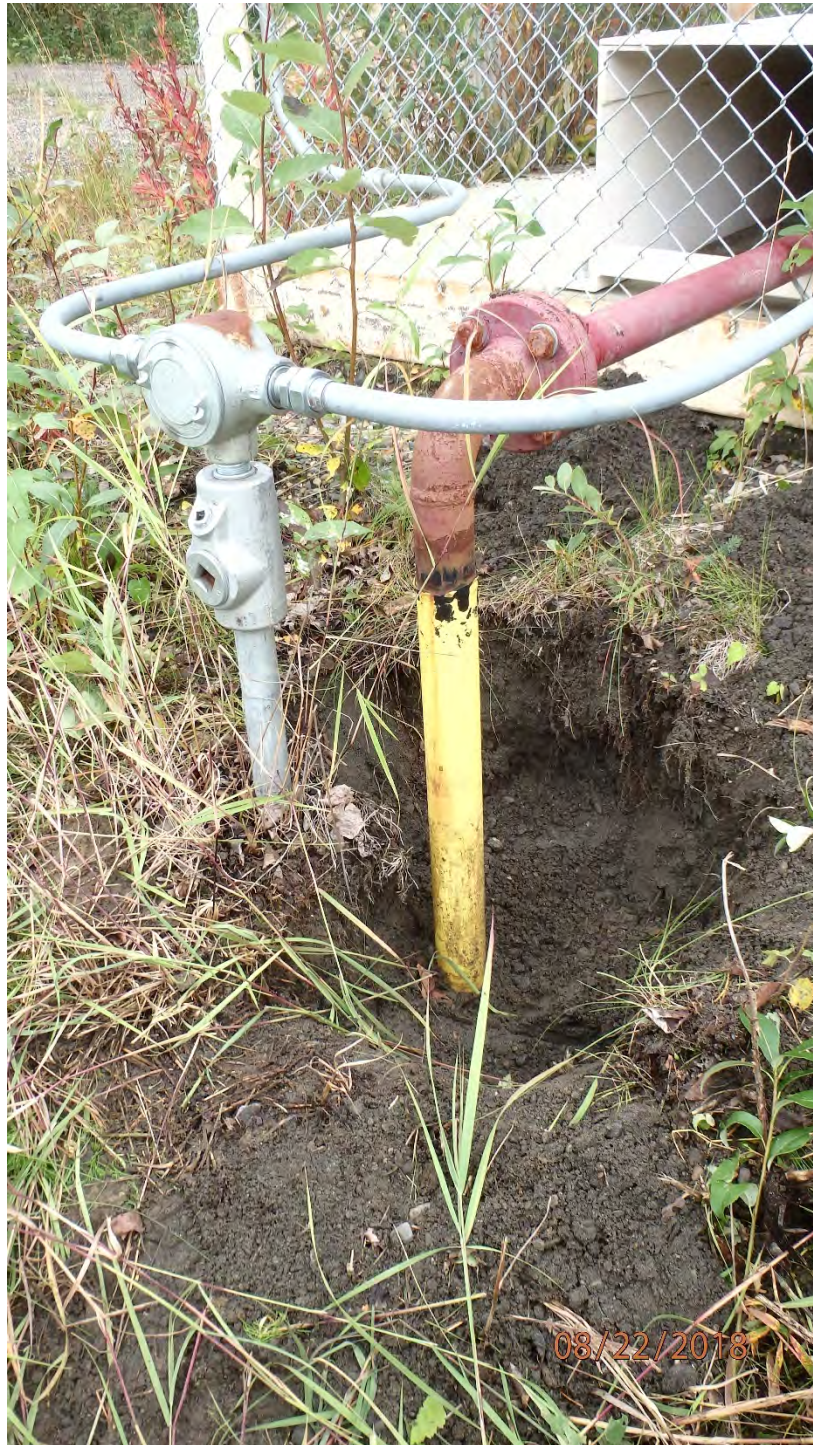
FIGURE 15: GASOLINE DISPENSER RISER 18-INCH DEEP EXCAVATION. COATING IN EXCELLENT CONDITION.

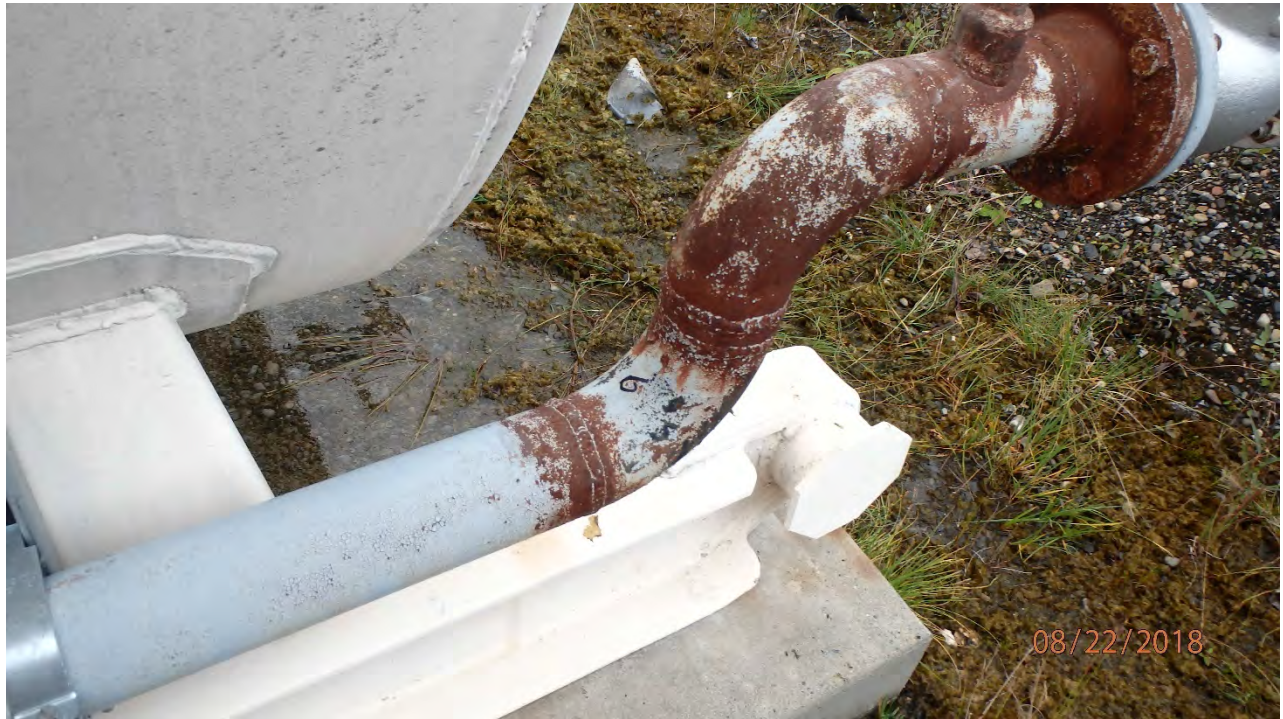
FIGURE 16: TYPICAL CONDITION FOR WELD ZONES, FITTINGS AND FLANGES ON THE DIESEL PIPING.

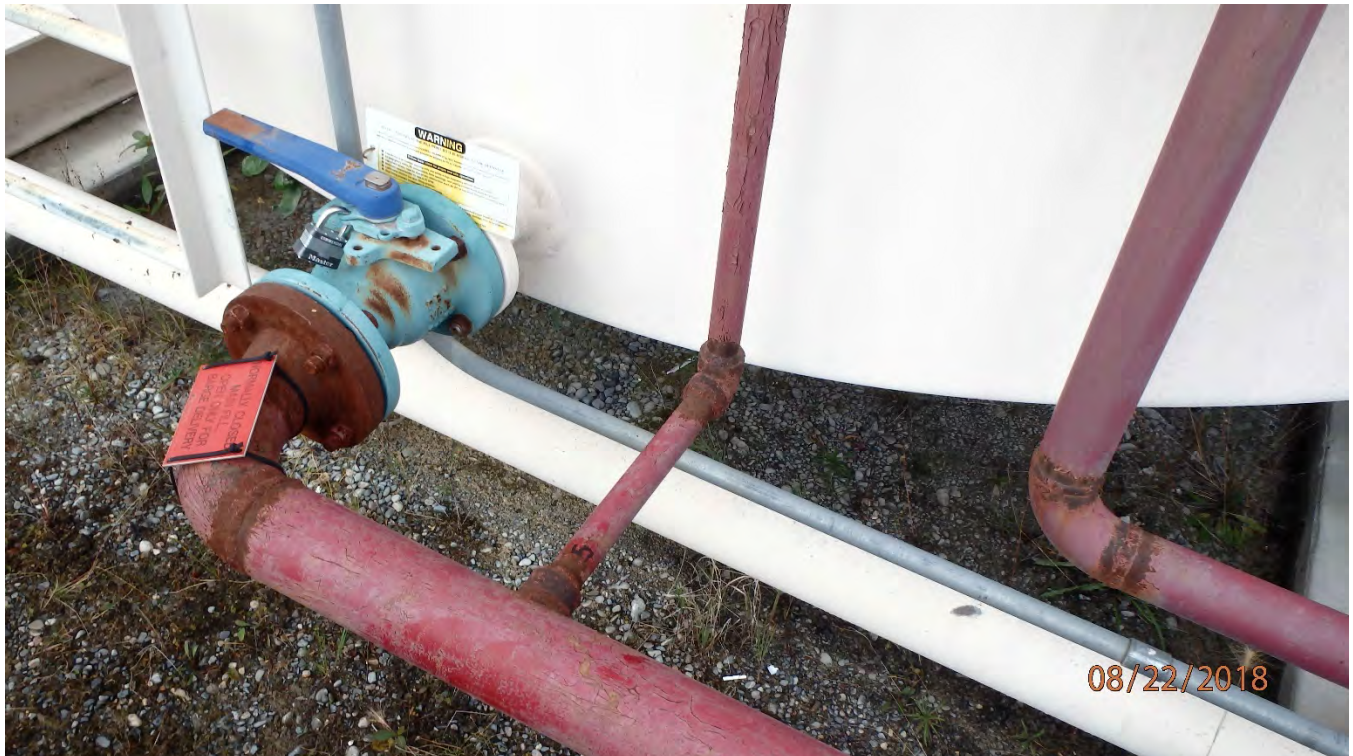
FIGURE 17: TYPICAL CONDITION FOR WELD ZONES, FITTINGS AND FLANGES ON THE GASOLINE PIPING.

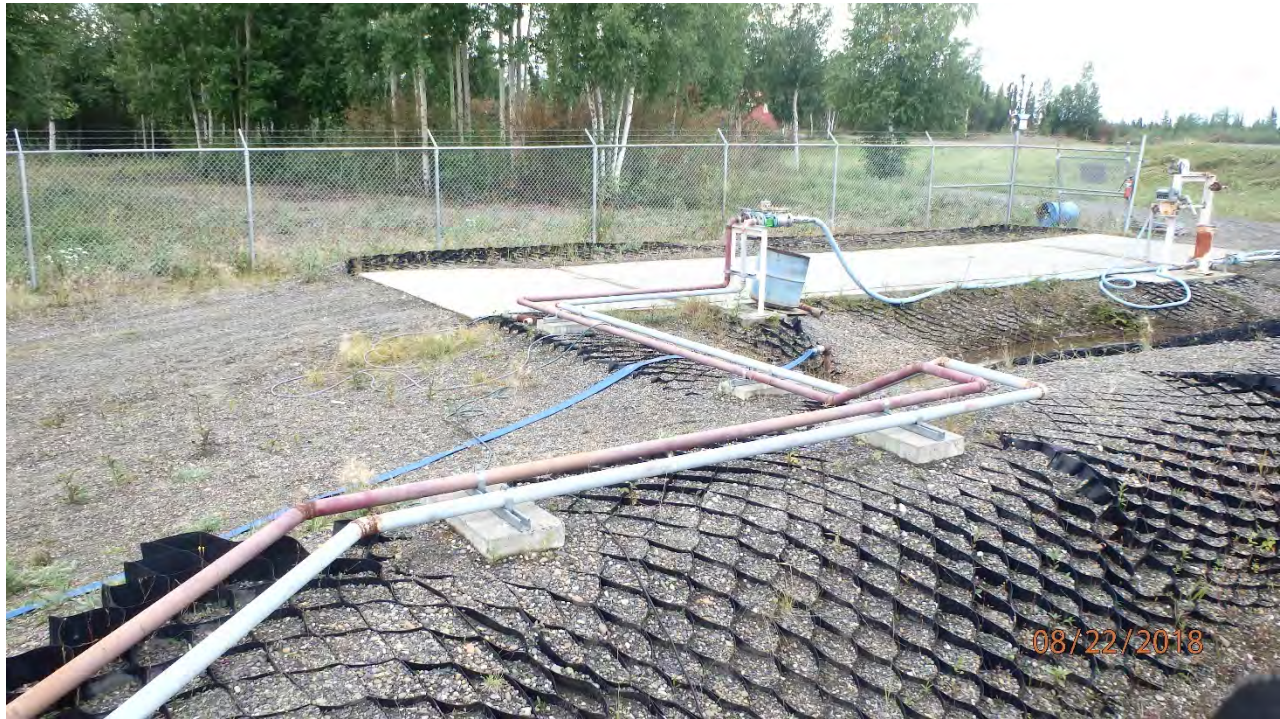
FIGURE 18: HEADER PIPING AT TRUCK RACK. NOTE FUEL HOSE FOR OFFLOADING AIRCRAFT IS LEFT ATTACHED AND EXPOSED BETWEEN FUEL DELIVERIES. NOTE GEOGRID FORMWORK IS EXPOSED.

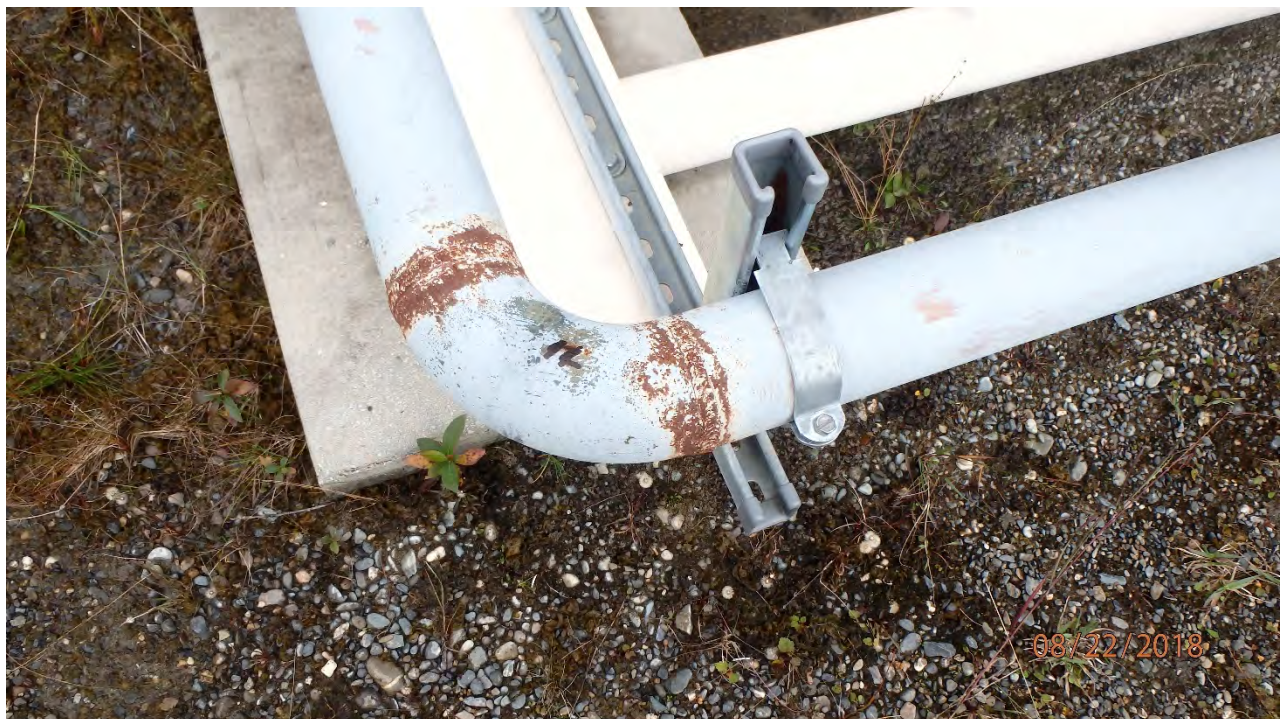
FIGURE 19: GALVANIZED UNI-STRUT AND PIPE CLAMP HANGERS/SUPPORTS. POSSIBILITY FOR DISSIMILAR METALS CORROSION IF PIPE COATINGS FAIL.

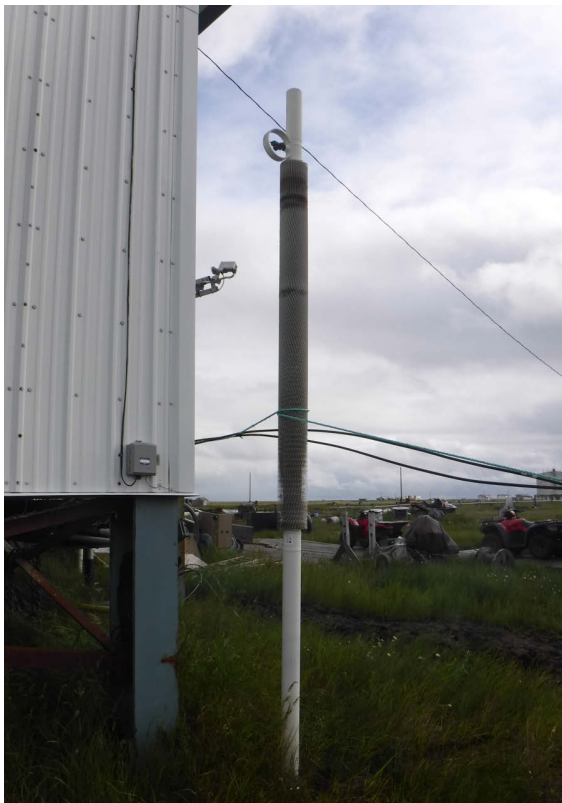
Figure 6: Cables wrapped around Unit #1

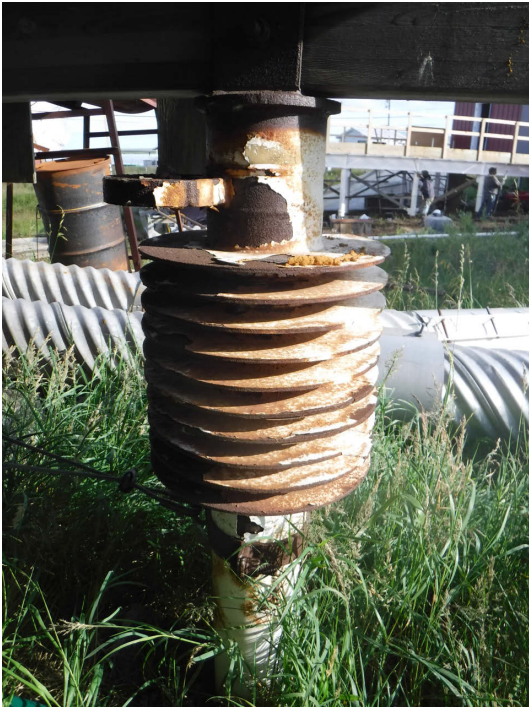
Figure 9: Corrosion, Old Power House
