ALASKA DISTRICT TRIP REPORT

Project: Denali Commission Mooring Points Phase 4

Description: Fort Yukon Trip Report

Dates: 11 August 2011

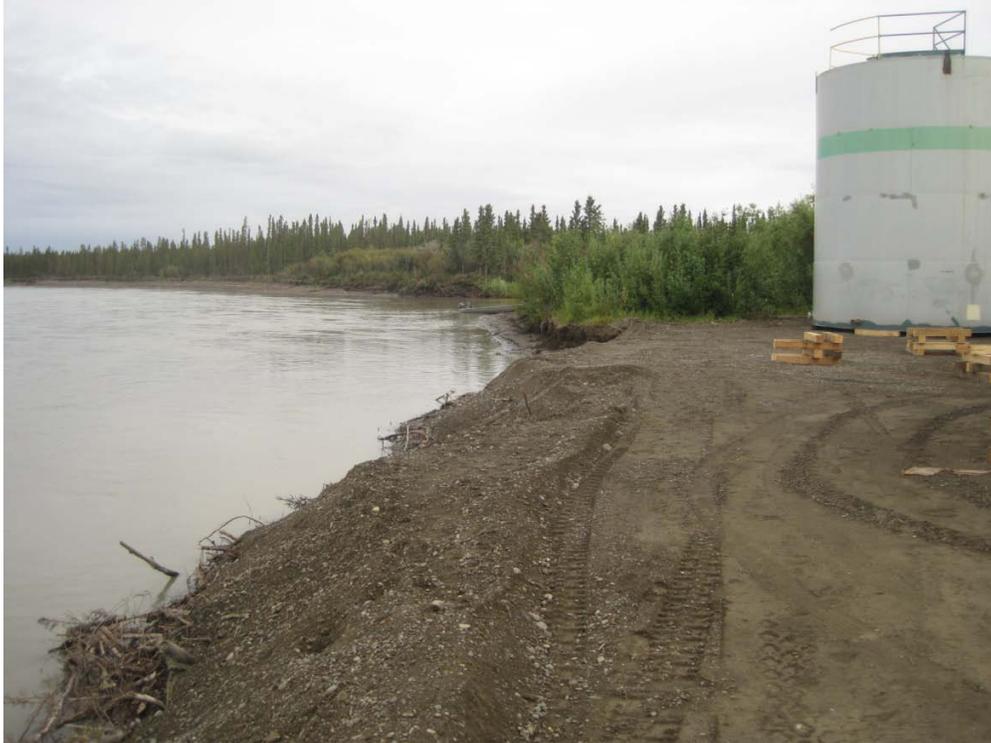
There is no ramp landing at this landing site. It simply consists of a gravel stream bank with a cleared, unimproved staging area adjacent to it (Photo 1). Barges moor broadside, parallel to the river, to offload cargo.

According to Gary Lawrence, the streambank along the staging area had recently been replenished with gravel (Photo 1) to replace portions of the bank that had been lost to erosion.

Photo 1. Downstream Landing Site. Note lack of ramp and recently placed gravel to replenish bank material lost to erosion.

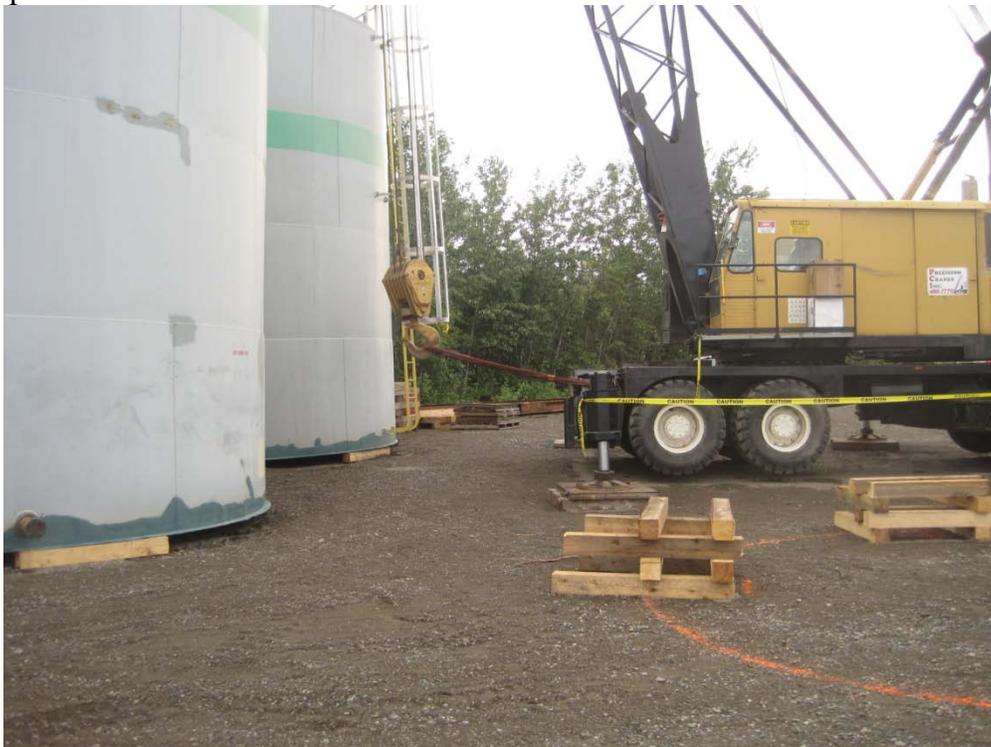
During our visit, the staging area was occupied by fuel storage tanks and a crane related to the tank farm relocation project (Photo 2).

Photo 2. Tank Farm relocation equipment stored at Downstream Landing Site during site visit.

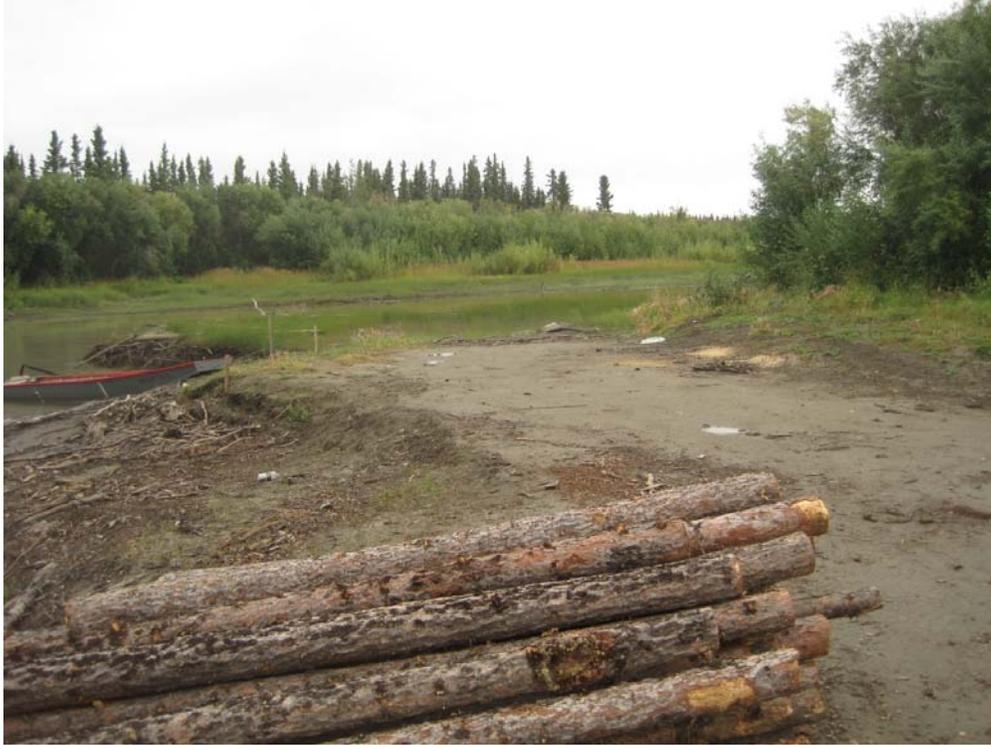
An unimproved road leads from the downstream end of the clearing to Joe Ward Slough (Photo 3). Several skiffs were moored near the mouth of Joe Ward Slough during our visit. Gary Lawrence did not think that blockage of this road by a mooring line for the few hours freight is offloaded would be an unacceptable inconvenience to the community, especially since barge companies have been providing advance notice of their arrivals.

Photo 3. Access road from Downstream Landing Area to Joe Ward Slough

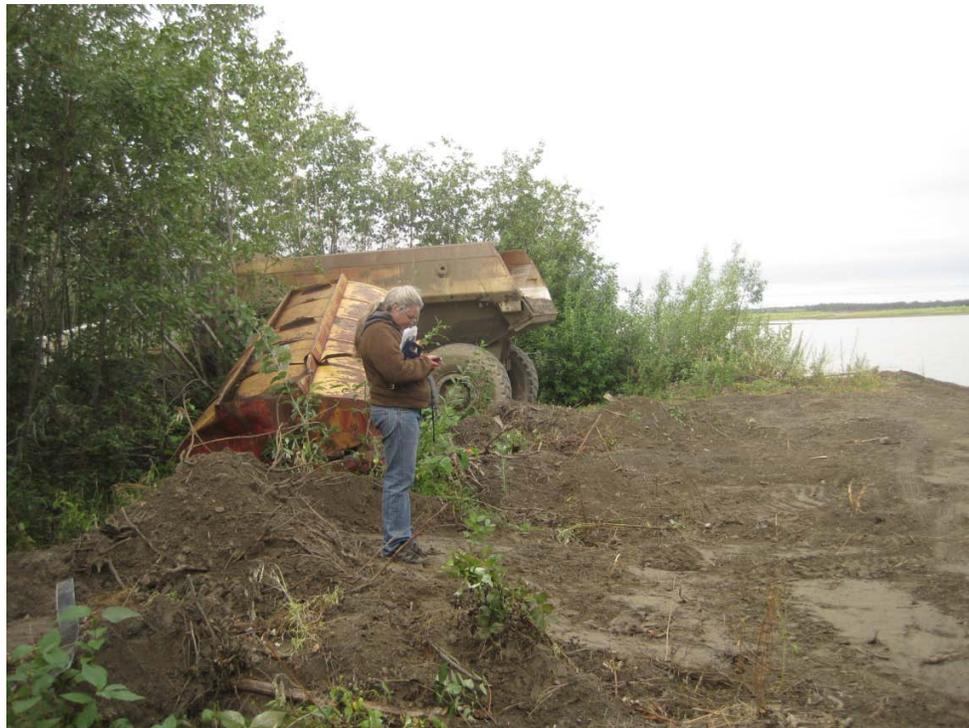
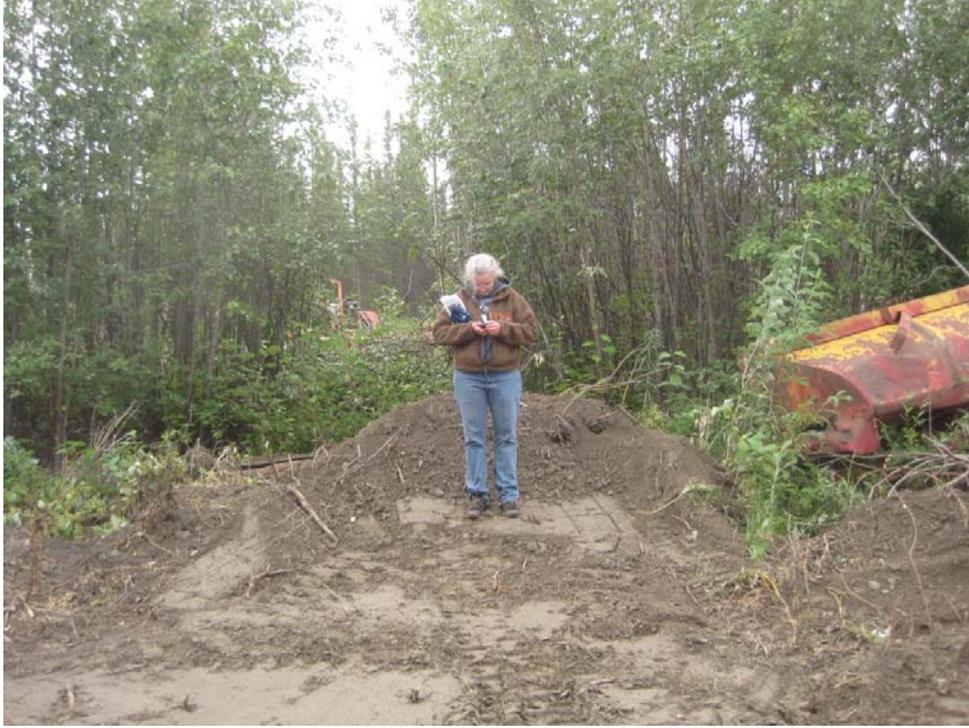
Photo 4. Corps employee standing at proposed location of upstream mooring point; view is toward the Yukon River

Photo 5. Corps employee standing at proposed location of upstream mooring point, view is upstream

A below grade freeze back pile mooring point is recommended at the upstream end of the cleared staging area and 64 feet inland from the top of bank (Photos 4 and 5). Coordinates of this location are 66°34'15.20"N and 145°17'13.80"W. An additional below grade freeze back pile mooring point is recommended adjacent to the existing tie-down cable at the vegetation line of the staging area near its downstream end and 51 feet from the top of bank. GPS coordinates of this location are 66°34'16.50"N and 145°17'14.52"W.

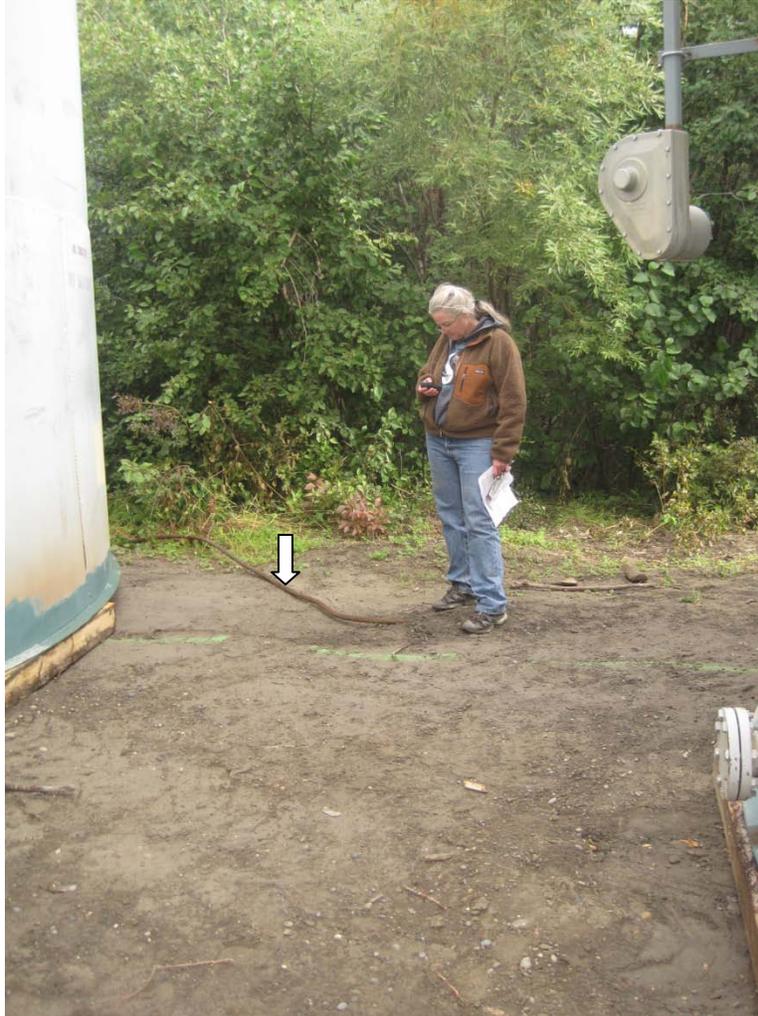
An existing tie-down cable was found near the vegetation line of the staging area near its downstream end. A broken tie-down cable was also found near the mouth of Joe Ward Slough. Another tie-down cable was found upstream of the landing area extending over the top of bank down to the river.

Photo 6. Corps employee standing at proposed location of downstream mooring point; view is inland. Note existing tie-down cable adjacent to Corps employee.

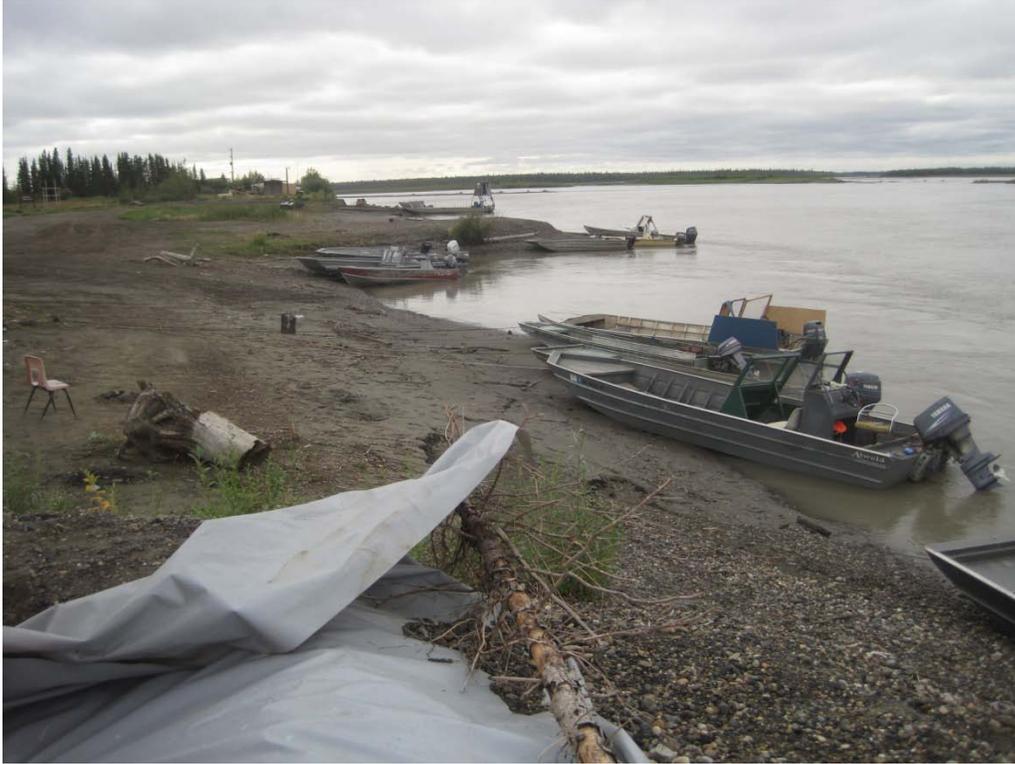
This landing consists of a series of small embayments separated by what remains of gravel finger dikes (Photo 7). Numerous skiffs and a small barge were beached along this landing site during our site investigation (Photo 7).

Photo 7. Upstream Landing Site embayment with beached skiffs; small barge visible at far end, looking upstream

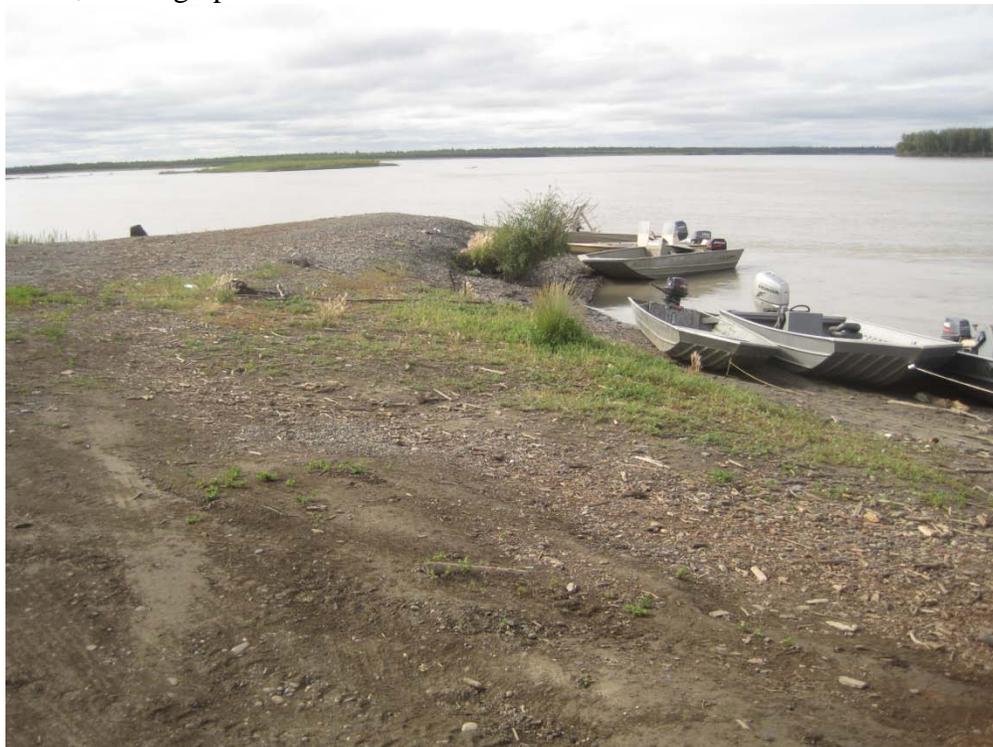
According to Gary Lawrence, the finger dikes (Photo 8) were constructed by the Native Village of Fort Yukon as an erosion protection measure. The dikes suffered damage during the last spring breakup with at least one being entirely eroded away.

Photo 8. Finger dike at Upstream Landing Site, looking upstream

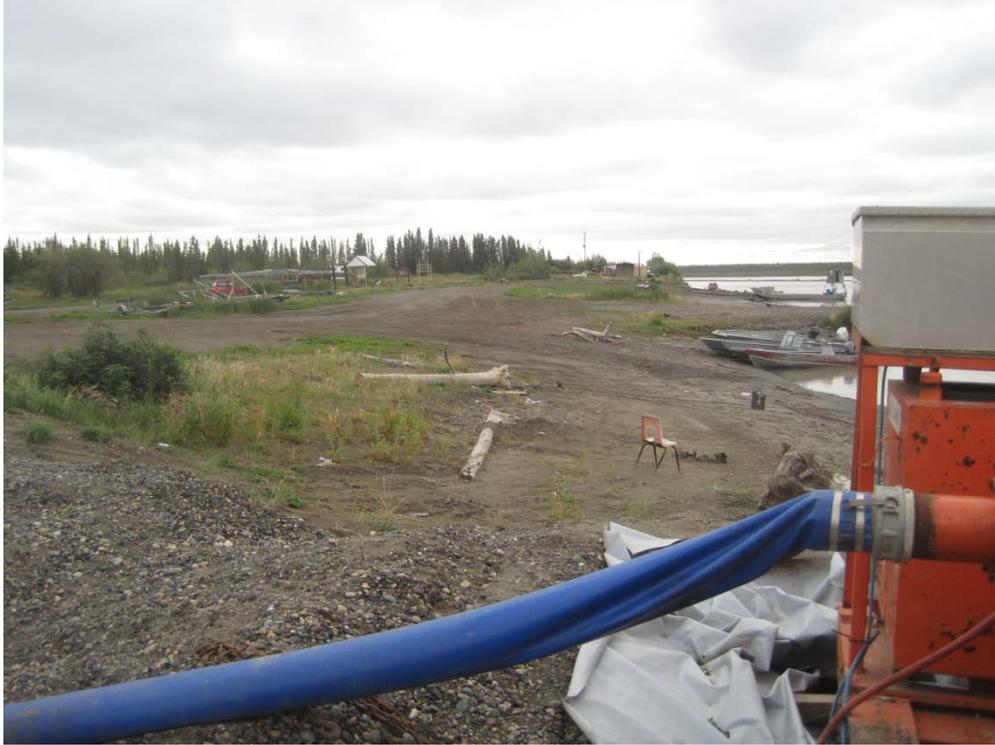
The upland area along this landing site is a mixture of grassy and unvegetated vacant land (Photo 9). Brice Construction was using a portion of the landing area to store equipment and materials needed for the tank farm relocation project (Photo 10).

Photo 9. View of Upstream Landing Site, looking upstream

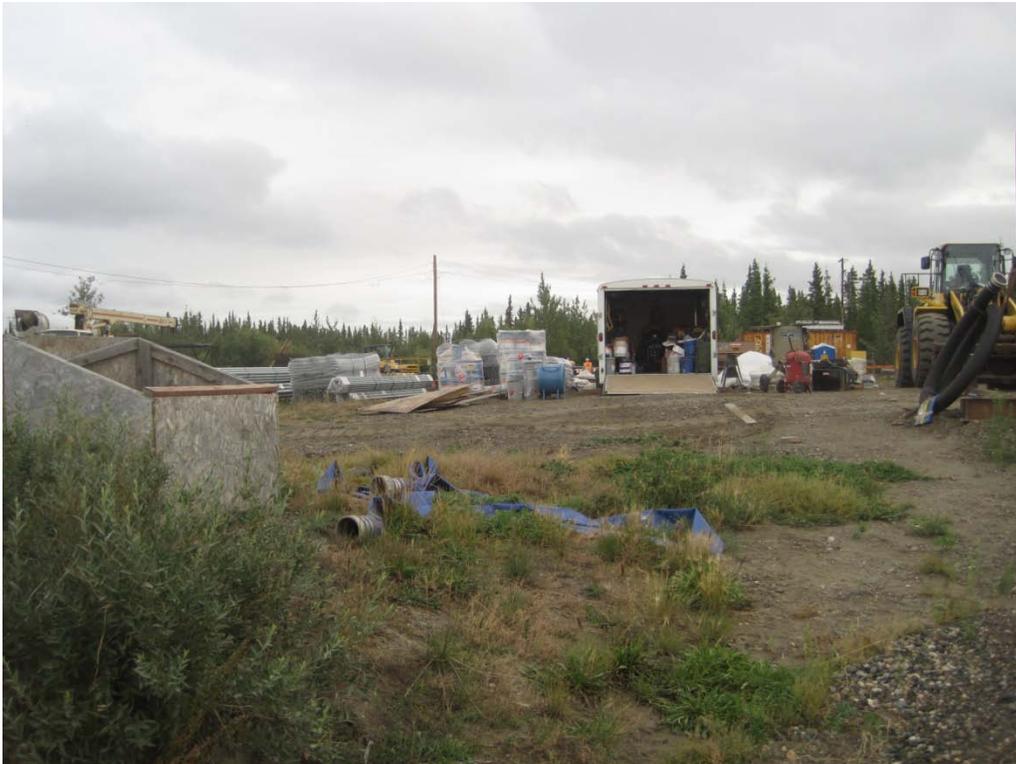
Photo 10. Brice Construction used portion of Upstream Landing Site

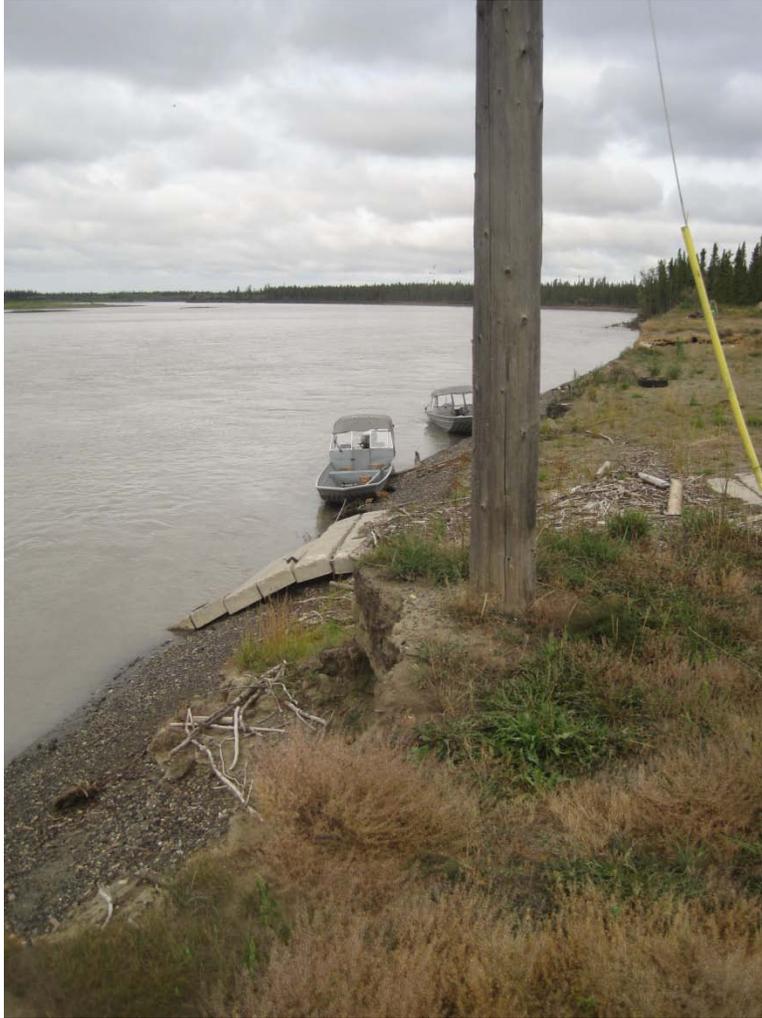
A utility pole immediately adjacent to the top of bank in the vicinity of this landing area indicates erosion (Photo 11).

Photo 11. Utility pole adjacent to eroding streambank

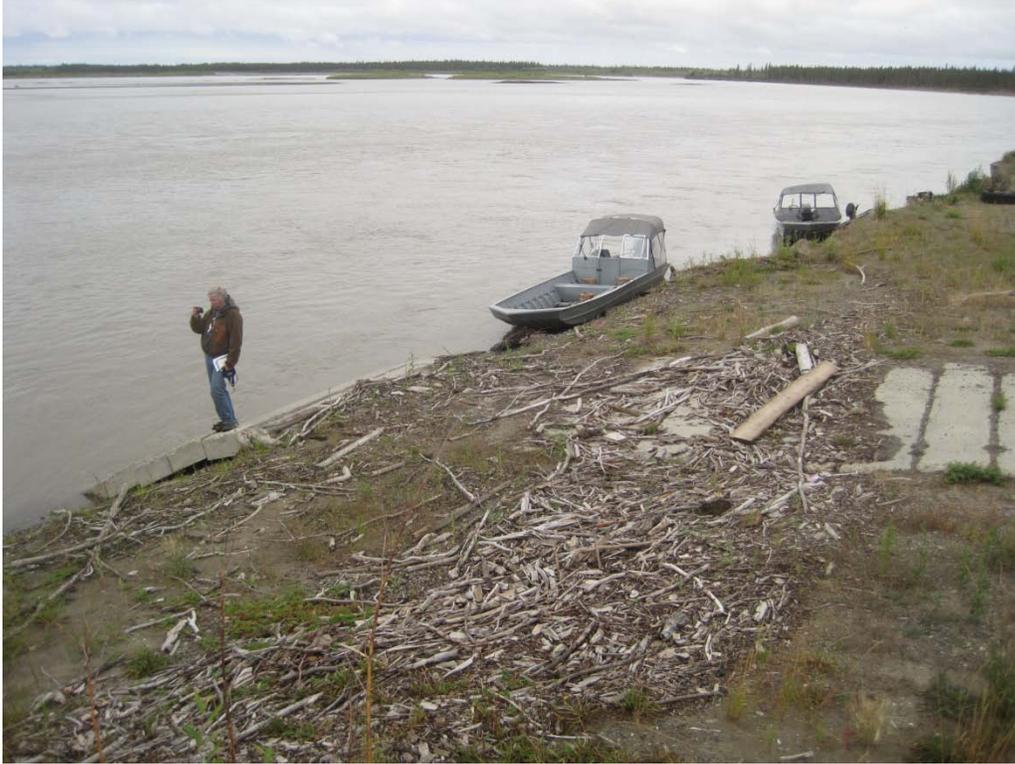
The downstream end of this landing area is bound by a concrete plank constructed ramp (Photo 12). The ramp had been compromised by gravel washing out from underneath it. Previous discussions with barge companies indicated that use of this ramp is avoided.

Photo 12. Corps employee standing atop compromised portion of concrete plank ramp

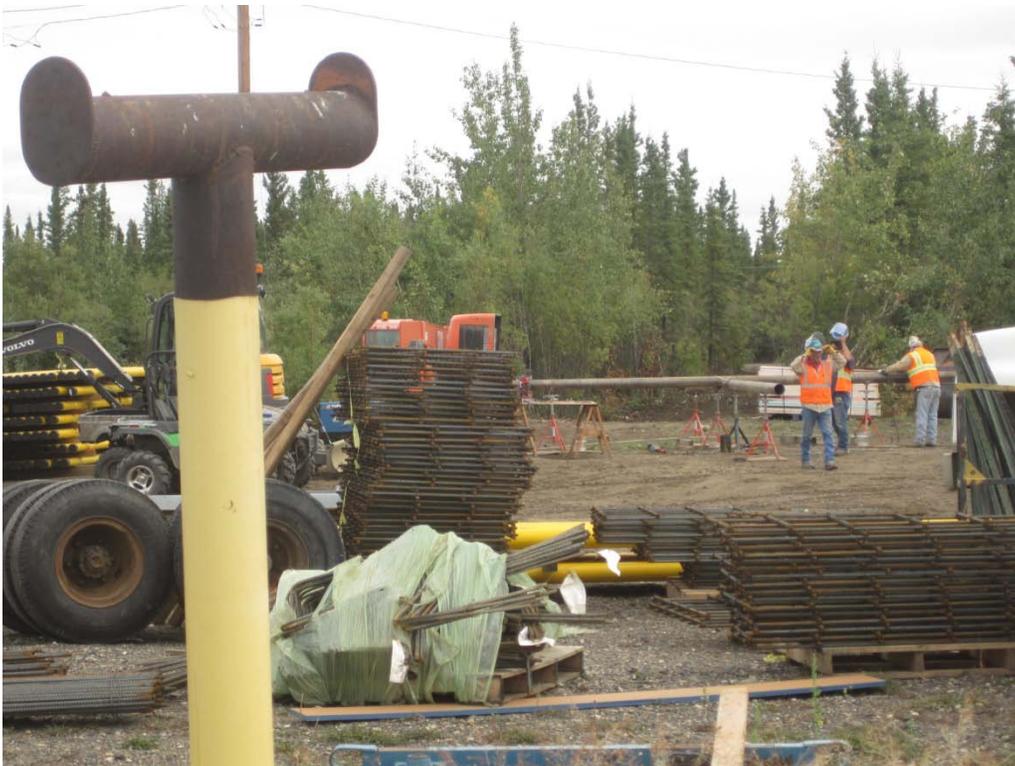
During the time of our visit, a right-of-way for the fuel line to the tank farm was being cleared (Photo 13). It was approximately 55 feet upstream of the concrete ramp. The location of the future fuel header will be somewhere in the vicinity of this right of way.

Photo 13. Right-of-way for fuel line to new tank farm is visible beyond the personnel.

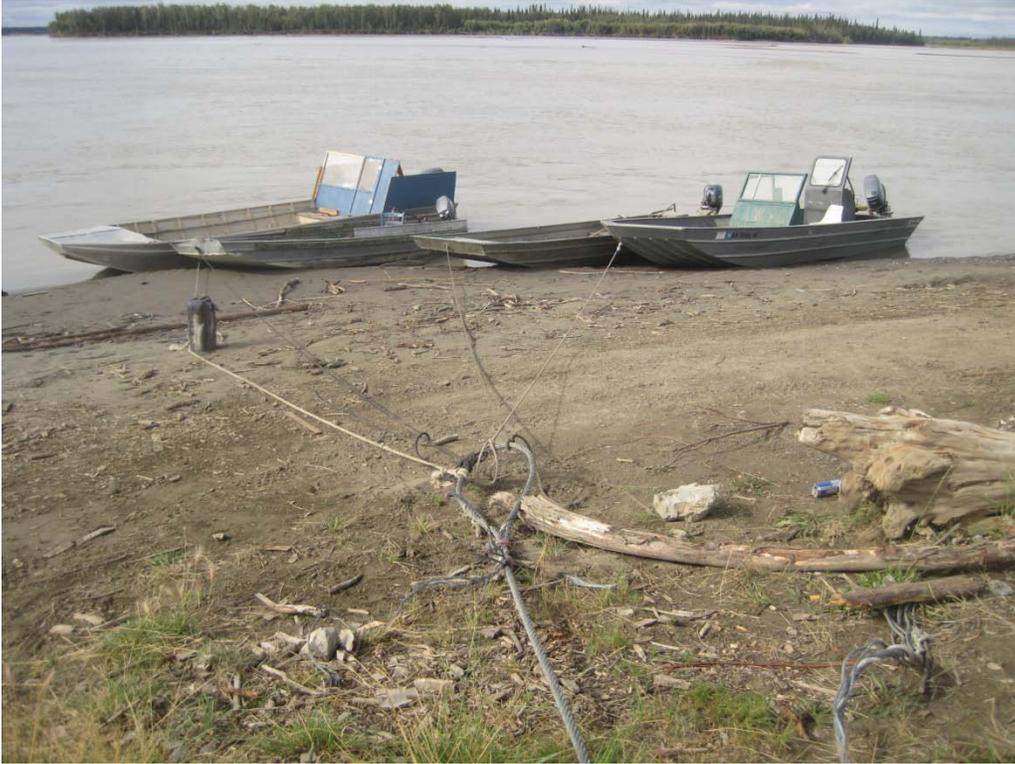
An existing tie-down cable was found approximately 200 feet upstream of the concrete plank ramp. Several skiffs were tied off to this cable (Photo 14).

Photo 14. Upstream Landing Site, existing tie-down cable with moored skiffs

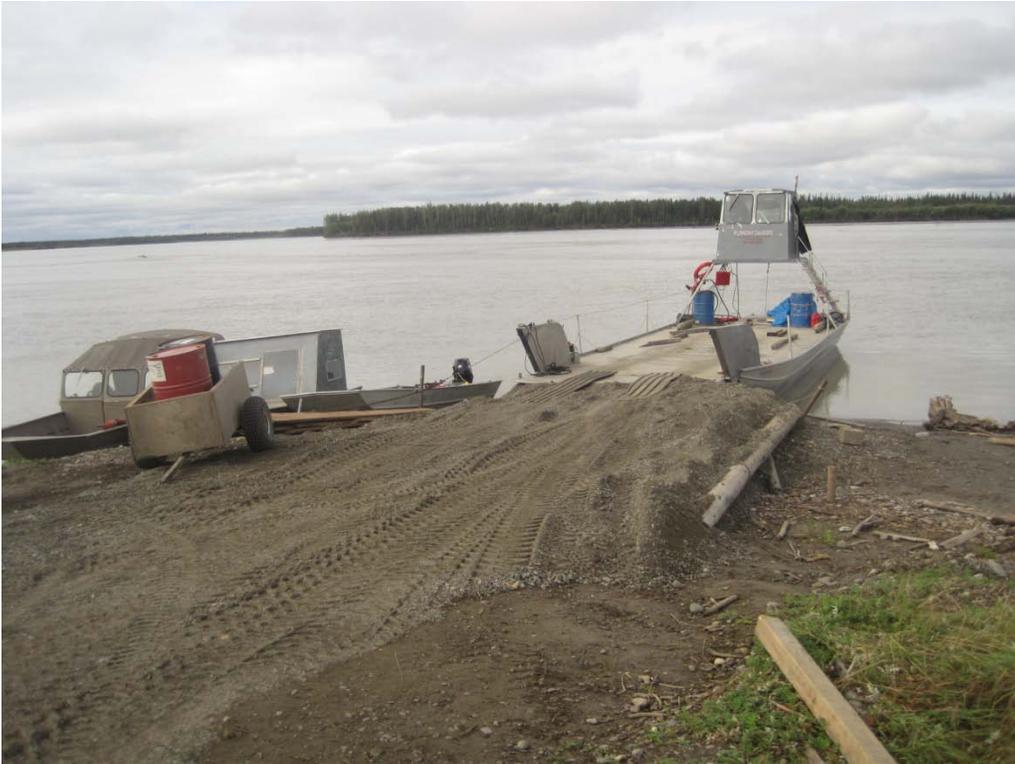
A gravel ramp angled into the river is located at the upstream end of this landing area. During the time of our visit, a small barge operated by Yukon Cargo was moored at the ramp (Photo 15). The barge was tied off to two small diameter pipes that were partially driven into the gravel ramp.

Photo 15. Small barge moored at upstream end of Upstream Landing Site

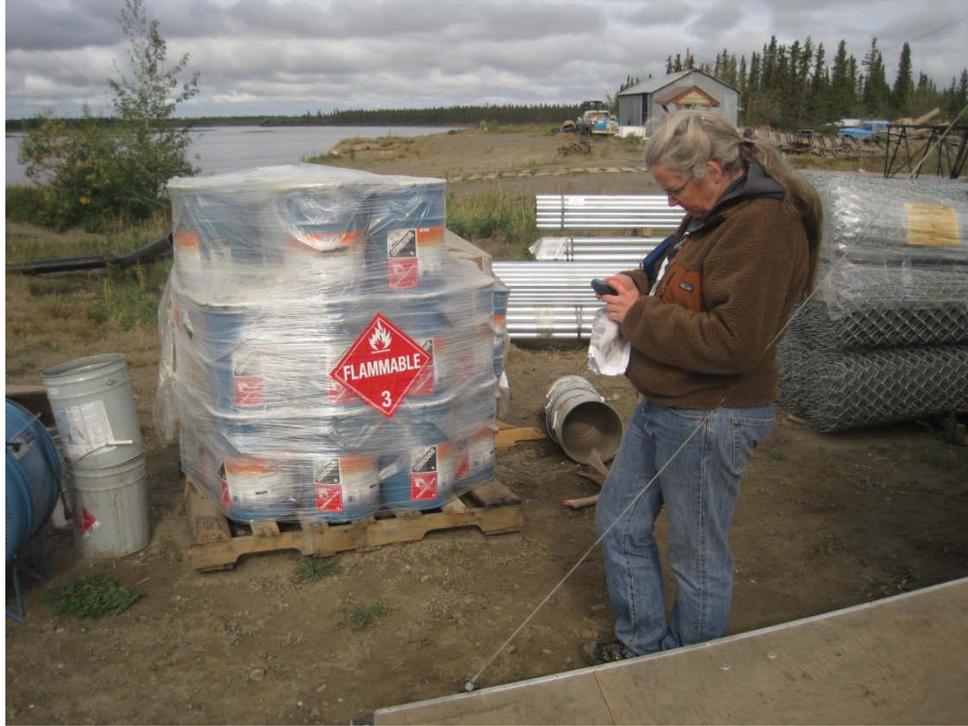
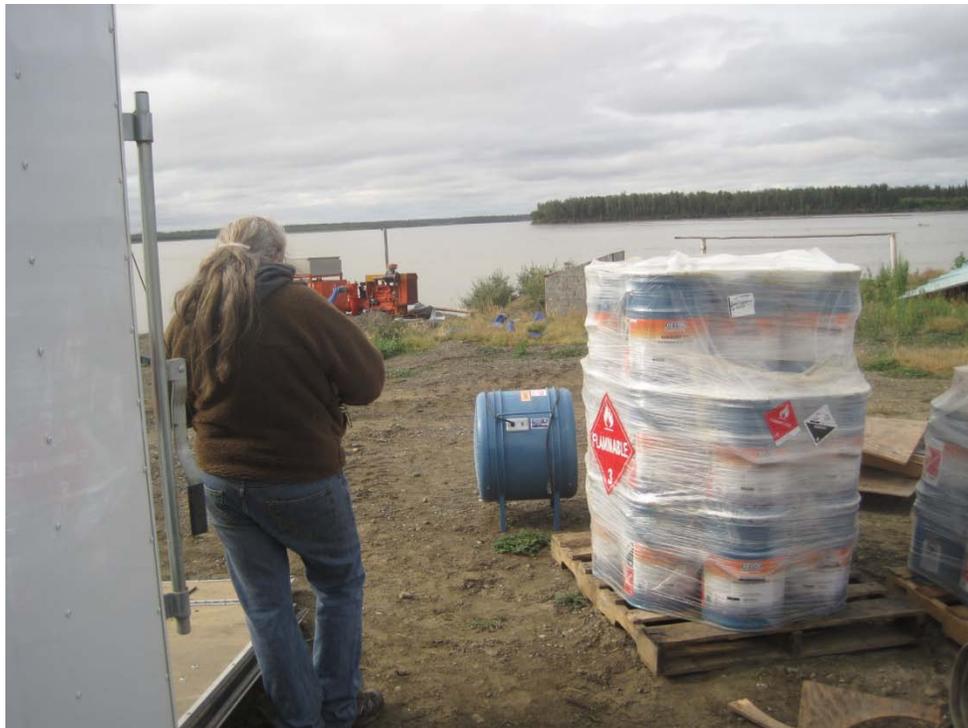
Photo 16. Corps employee standing at proposed location of downstream mooring point; view is downstream. Concrete plank ramp is visible beyond the stored materials.

Photo 17. Corps employee standing at proposed location of downstream mooring point; view is toward the Yukon River

A downstream, below grade freeze back pile mooring point installation is recommended 100 feet upstream of the concrete plank ramp and 70 feet inland from the top of bank (Photos 16 and 17). Coordinates of this location are 66°34'6.60"N and 145°17'2.22"W. An upstream, below grade freeze back pile mooring point installation is recommended at a location 200 feet upstream of the proposed downstream mooring point, 72 feet inland from the top of bank, and 40 feet downstream from the centerline of the adjacent finger dike (Photos 18 and 19). Coordinates of this location are 66°34'5.00"N and 145°16'59.40"W. At the time of our visit, there was some ongoing coordination regarding ANSCA 14(c) land transfers that could impact the ownership of the proposed upstream mooring point location. An alternate location for the upstream mooring point was also selected in case installation is not possible at the primary recommended site. This alternate location is 35 feet downstream from the proposed primary upstream location and 72 feet inland from the top of bank (Photo 20). Coordinates of this location are 66°34'6.09"N and 145°16'59.58"W.

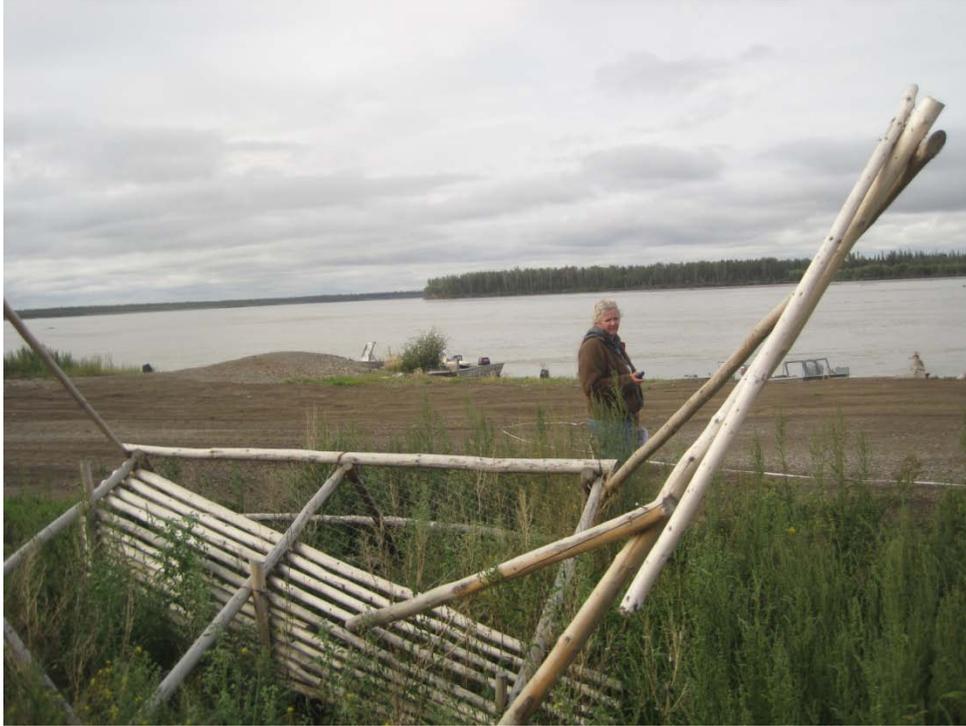
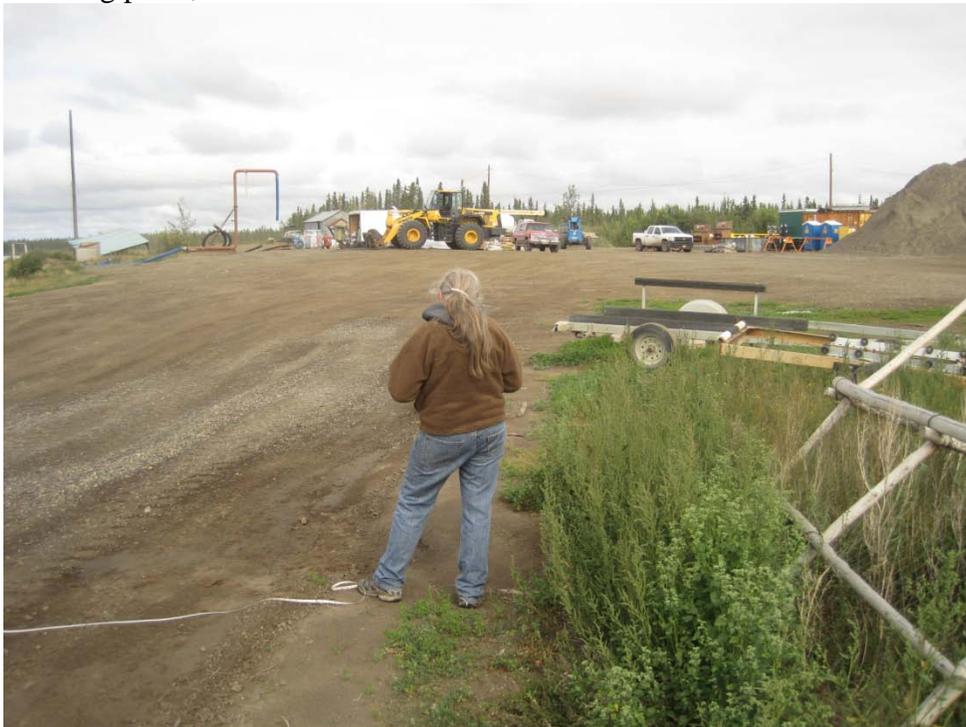
Photo 18. Corps employee standing at proposed location of primary upstream mooring point; view is toward the Yukon River

Photo 19. Corps employee standing at proposed location of primary upstream mooring point; view is downstream

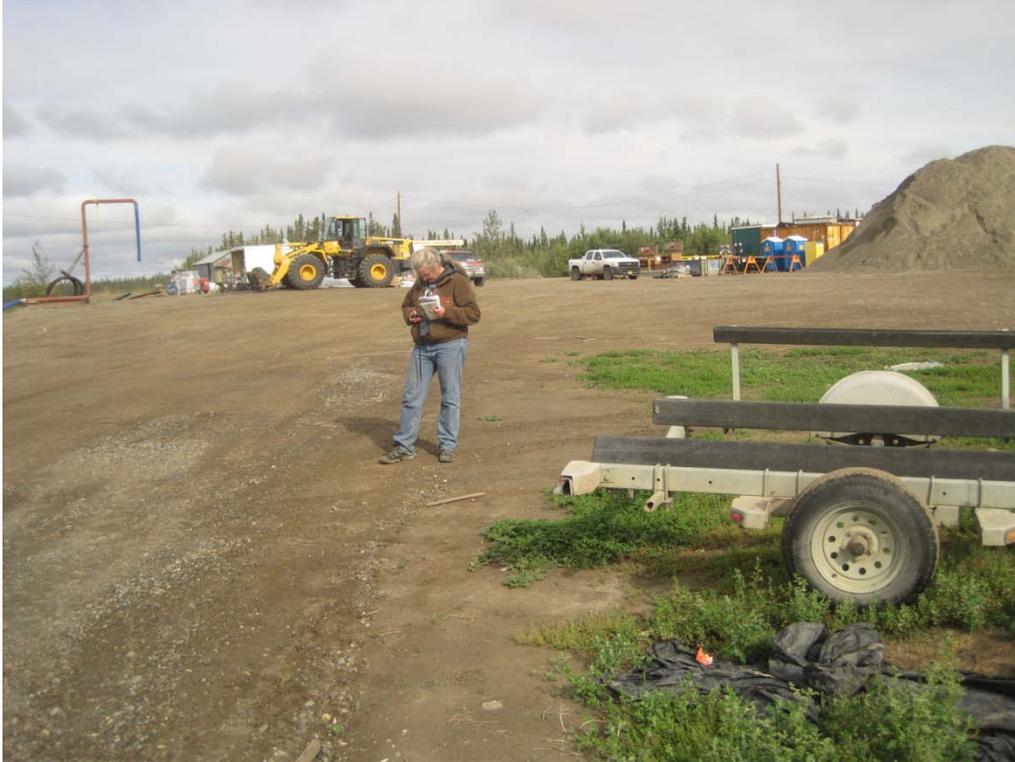
Photo 20. Corps employee standing at proposed location of alternate upstream mooring point; view is downstream
