Photos of Existing Wainwright Boat Launch (in August 2004)

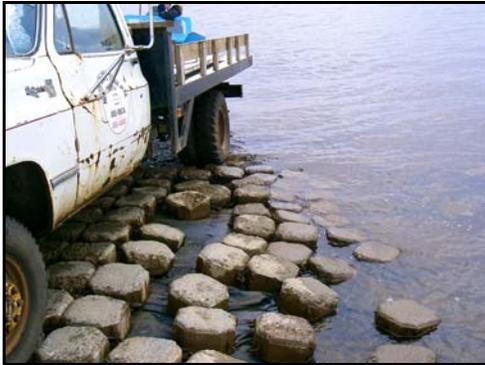
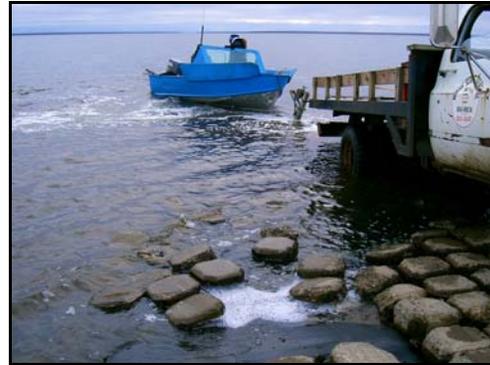
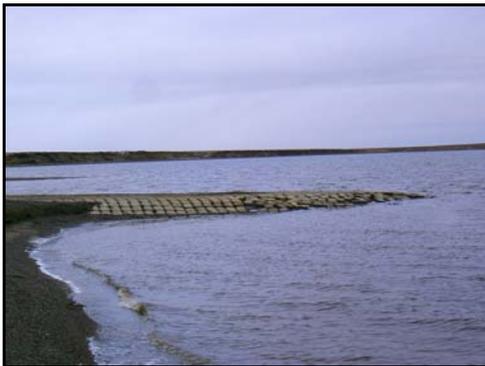
The Wainwright Lagoon Boat Ramp was built 20 years ago and has deteriorated to the extent that it no longer provides safe access for vehicles launching boats. Blocks have come loose exposing rusted steel cables and the underlying canvas, which can damage vehicles using the ramp. Many blocks at the end and sides of the ramp have come loose making the ramp dangerously narrow as the ramp extends into the water, as shown below:

View of Boat Ramp looking east

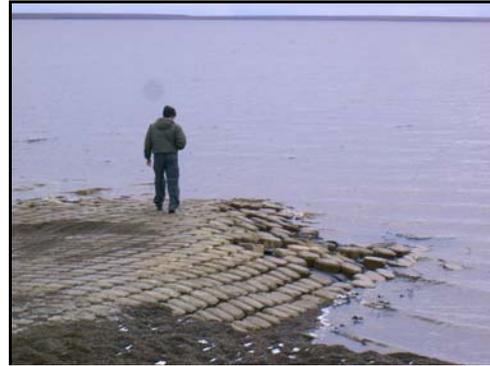
End of the ramp at low tide
