DISTRICT TRIP REPORT

Project: Denali Commission Moorings Points Phase 3 – Kuskokwim River

Description: Akiachak Trip Report

Date: 17 September 2010

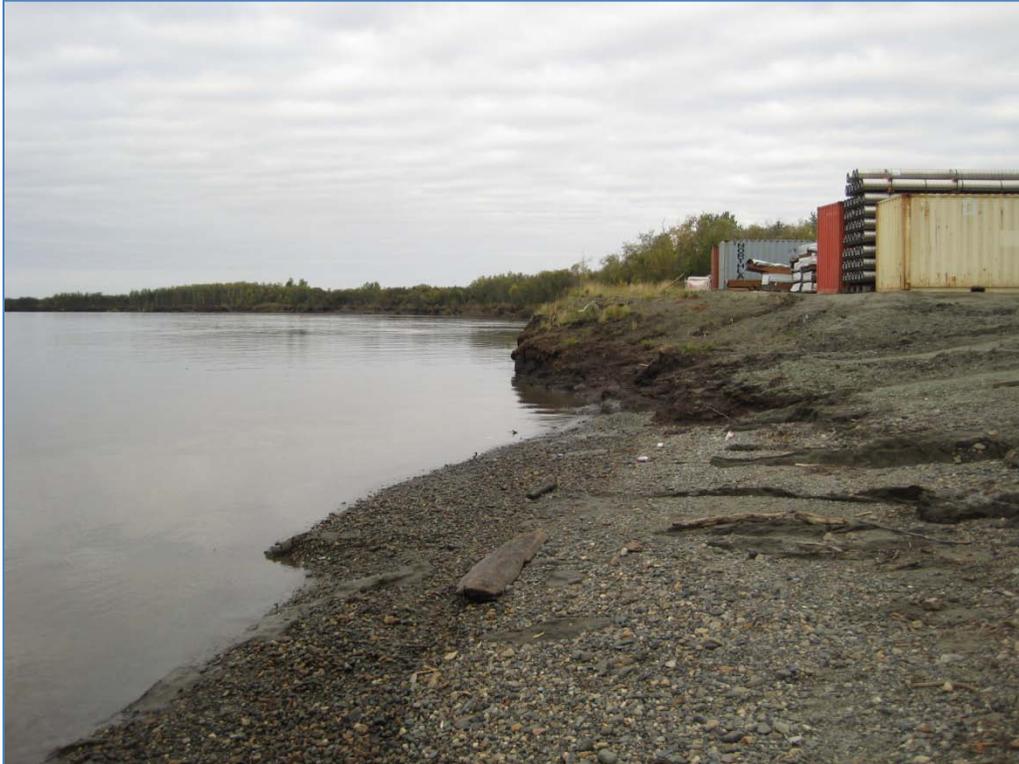
Photo 1: Landing Area Looking Downstream

There is one landing and adjacent staging area site in Akiachak used for both freight and fuel deliveries. The landing itself is a gentle sloping muddy bank (Photos 1 – 2). The proposed area is previously disturbed and without vegetation. Bank material is mainly sand and silt with little gravel. Placement of two mooring points at this site seems warranted.

Downstream the bank is nearly vertical due to ongoing erosion related to breakup (Photos 1 & 3). Bank material is similar to that in the barge landing area, sand and silt. Geotextile was seen near the top of the eroded bank.

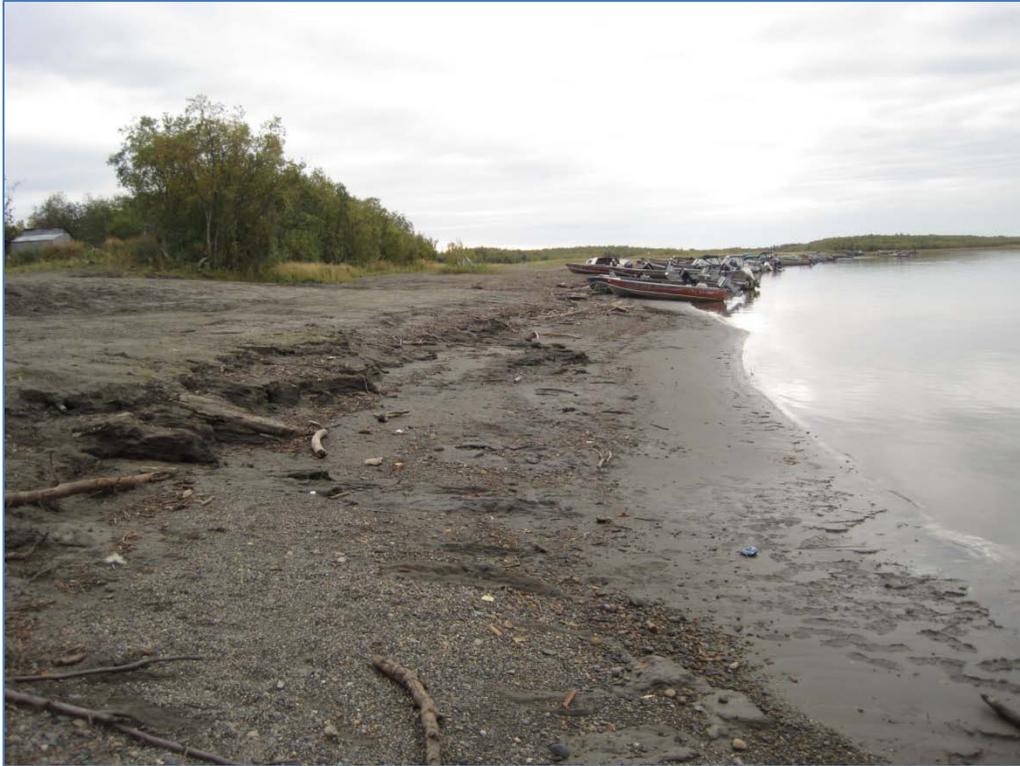
Photo 2: Landing Area Looking Upstream

Upstream of the barge landing is a skiff landing area (Photo 2). This area experiences high vehicle traffic associated with the skiff landing area. The vegetation is sparse and mainly located back from the edge of the river bank at the tree line.

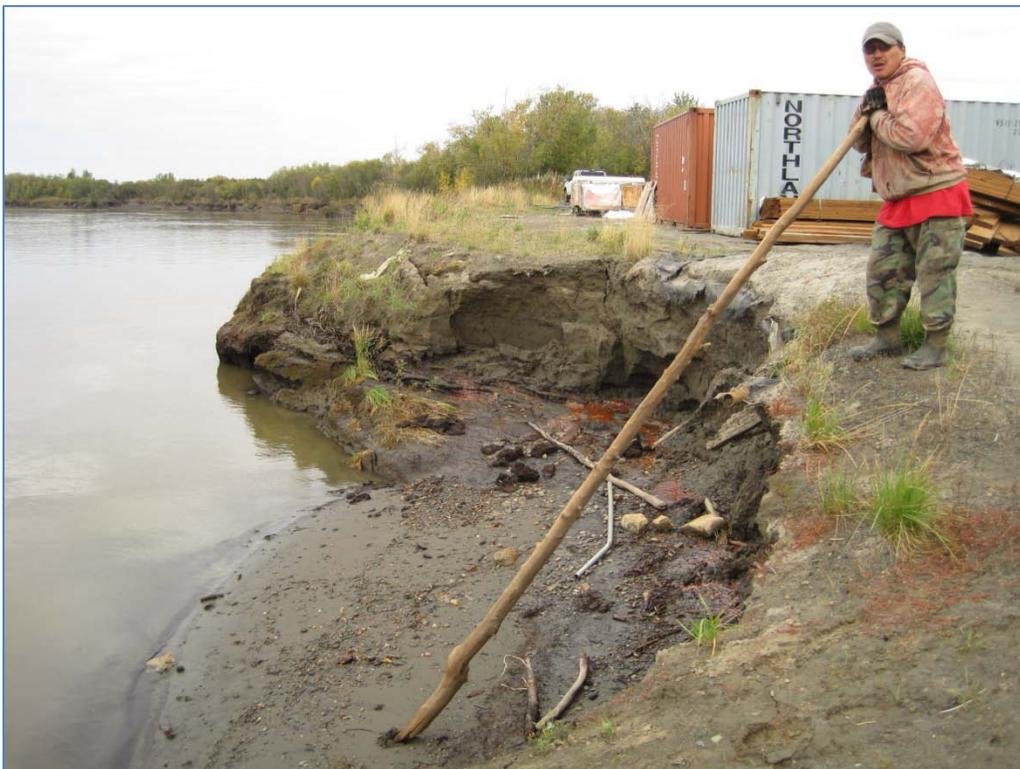
Photo 3: Erosion Adjacent to Staging Area

Erosion is evident approximately 100 feet downstream from the center of the landing area. The streambank here is vertical and a small embayment has formed in the bank with soil stress fractures propagating both upstream and downstream from the embayment (Photo 3). There is

also some geotextile fabric and an old discharge pipe of some sort daylighting out of the eroded bank within the embayment.

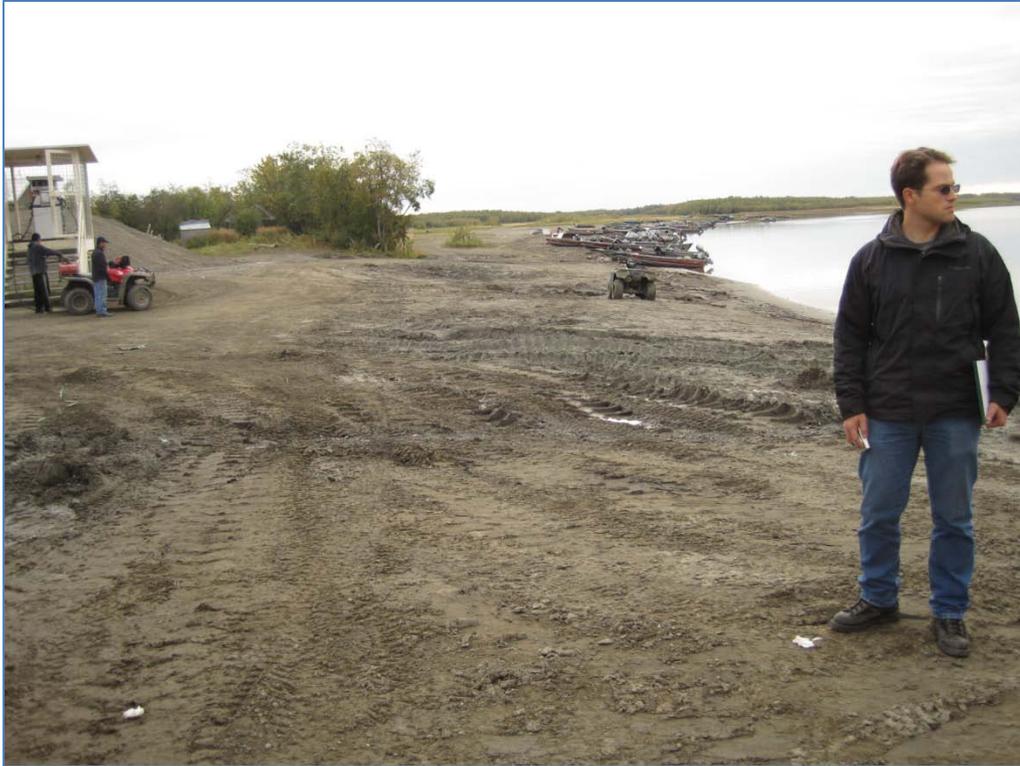
Photo 4: Landing Area and Fueling Station

The barge landing area appears to be generally centered about the fueling station located in the staging area (Photo 4).
