## **DISTRICT TRIP REPORT**

**Project:** Denali Commission Moorings Points Phase 3 – Kuskokwim River

**Description:** Crooked Creek Trip Report

**Date:** 8-9 September 2010

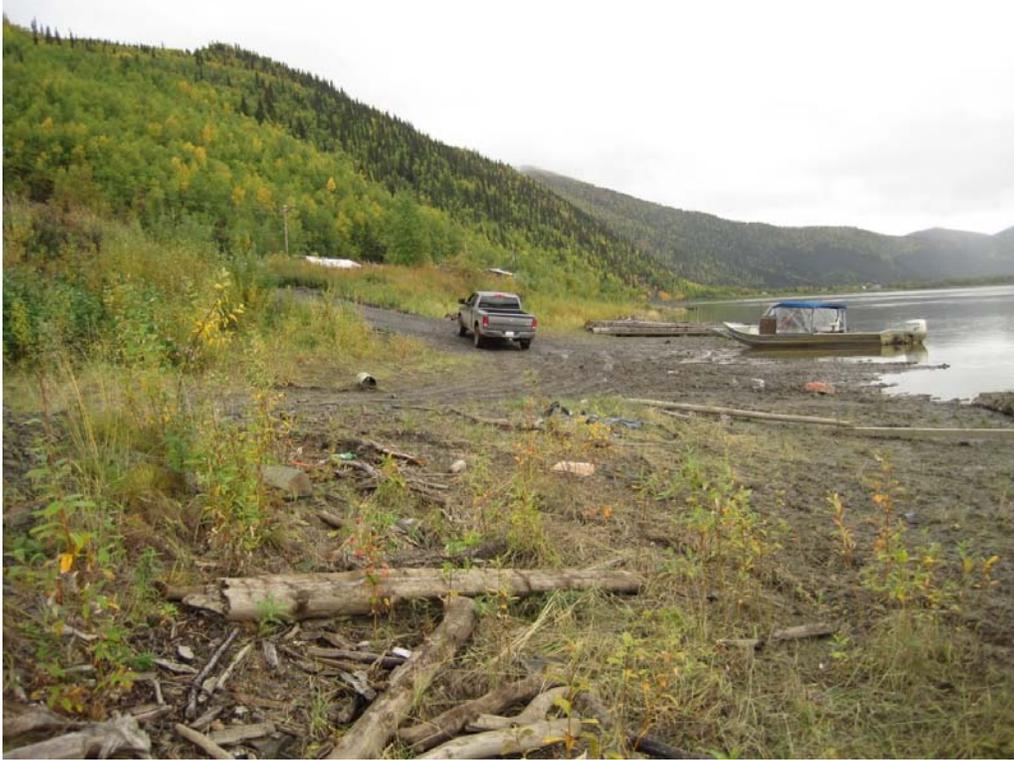
The landing area is muddy with a shallow slope extending into the water, which was high during our visit (Photo 1). According to Dan Felker, this site has been stable the 37 years he has lived in the village.

Photo 1: Fuel Barge Landing Area in upper Crooked Creek (looking upstream)

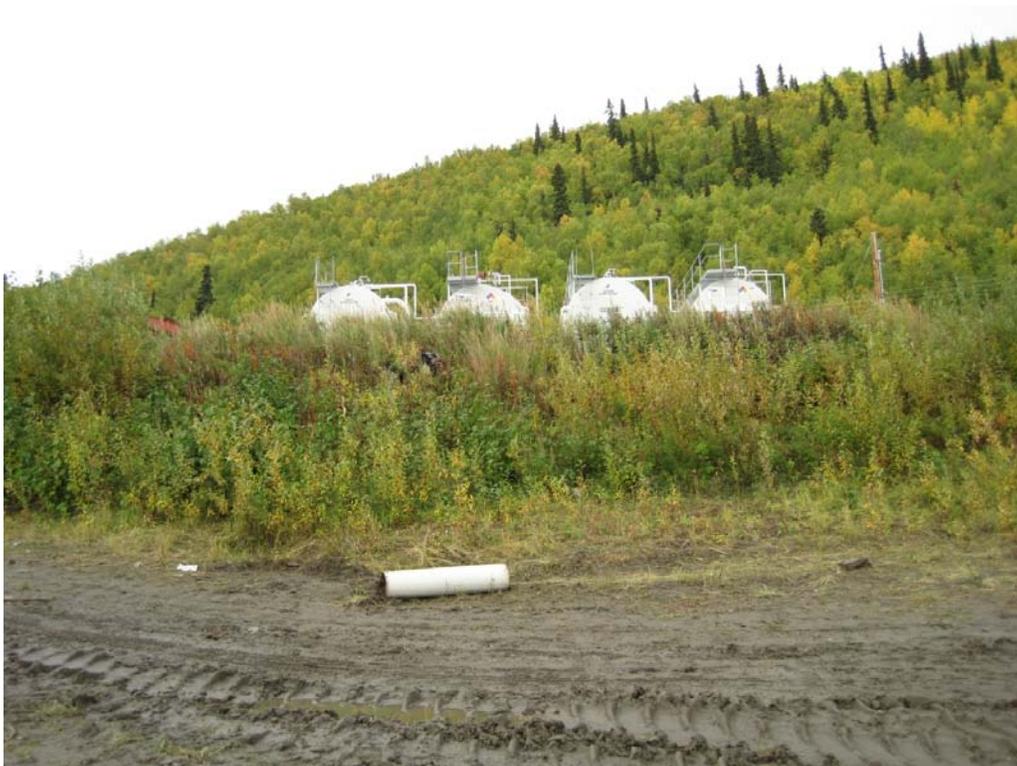
The main fuel tank farm for the village is located in the upper portion of the village (Photo 2). The land the tank farm is located on, the tank farm itself, and the landing area are privately owned by the daughter of Evelyn Thomas. There are also Native allotments and village property recently conveyed by the BLM in the vicinity of this landing area.

Photo 2: Crooked Creek tank farm

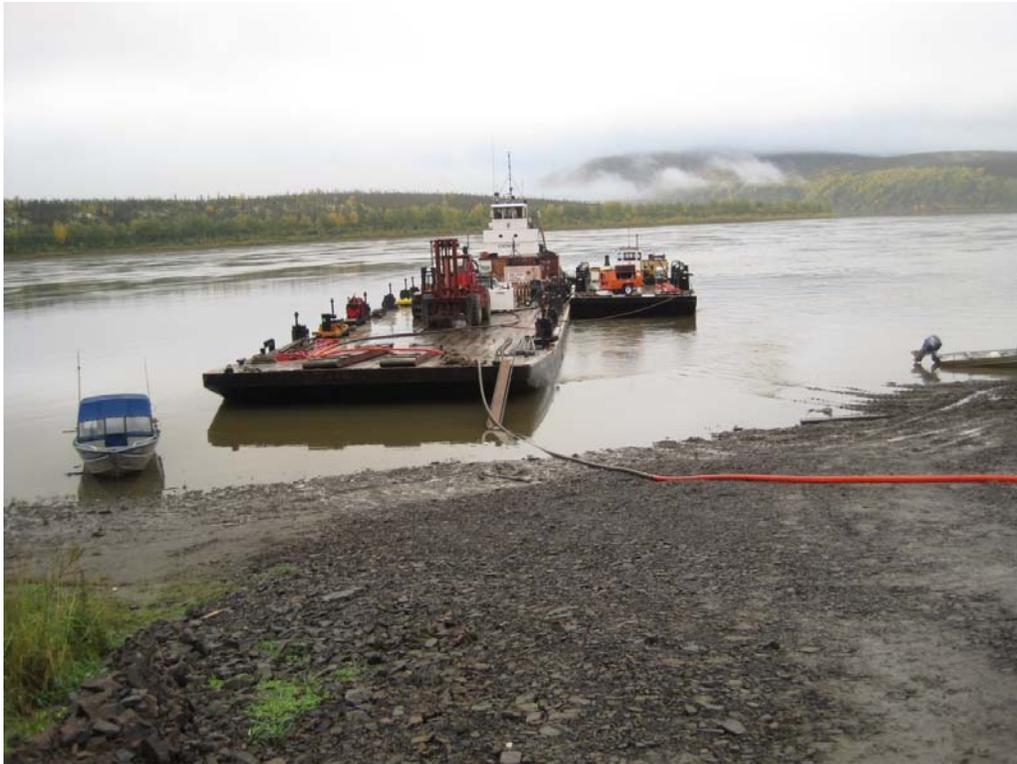
Fuel deliveries occur 3 – 4 times a year (Photo 3). Currently only Crowley delivers fuel to the community. Kuskokwim Leighterage does freight shipments to the village. Delta Western hasn't serviced Crooked Creek for years.

Photo 3: Crowley Delivering Fuel to Crooked Creek Tank Farm

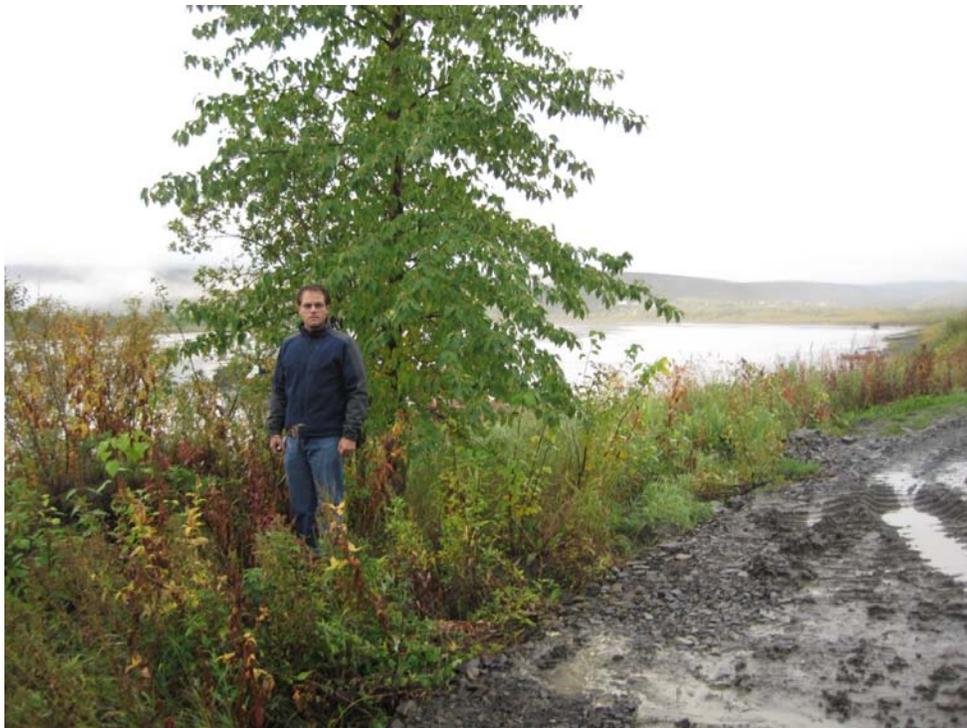
Photo 4: Merlin at Approximate Location of Potential Upstream Mooring Point at Fuel Barge Landing Site (looking downstream)

Tom Teason (Crowley) informed us that at lower water levels, shoals force the barge to go a bit upstream (near the location of a log raft during our site visit) and stop 50 feet offshore in order to come in with the fuel lines. Due to this, he recommended the mooring points be located upstream of the access road to the landing site, as opposed to one on each side. Steve Hoffman (Crowley) recommended the installation of one mooring point upstream of the landing area in the vicinity of a lone tree atop the bank (Photo 4). He also suggested that if a second mooring point is constructed, it should be installed downstream from the first in the vicinity of the access road (Photo 5). Crowley felt that above grade mooring points should be placed atop the bank in order to avoid ice damage while below grade mooring points are suitable to use at the toe of the bank.

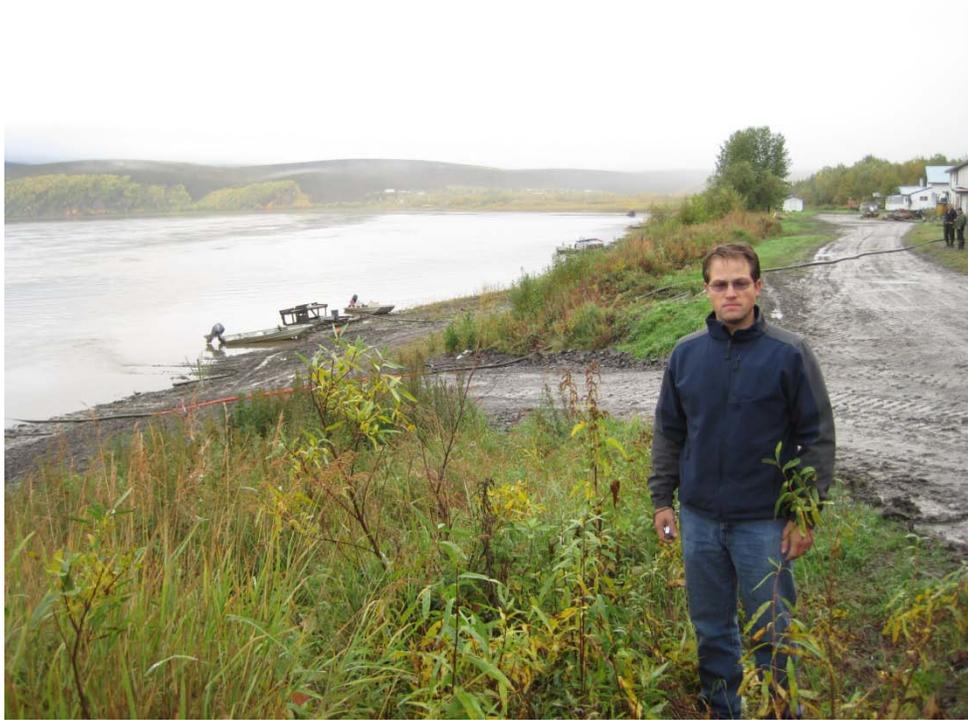
Photo 5: Merlin at Approximate Location of Potential Downstream Mooring Point at Fuel Barge Landing Site (looking downstream)

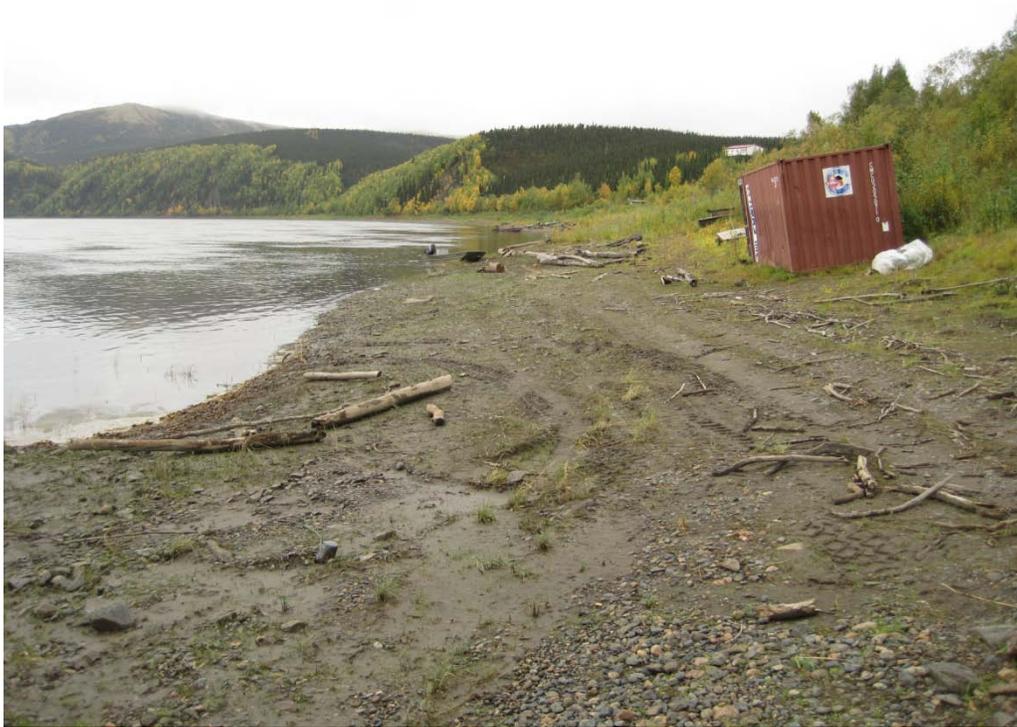
This site consists of 300 – 400’ of shallow, gravel and mud shoreline usable by the barges with an access road to an adjacent upland staging area (Photos 6 – 7). The landing area is bound by an approximate 10H:1V slope. The staging area is adjacent to the barge landing area and roughly 100ft x 200ft. The real estate here is apparently village owned.

Photo 6: Freight Barge Landing Site (looking downstream)

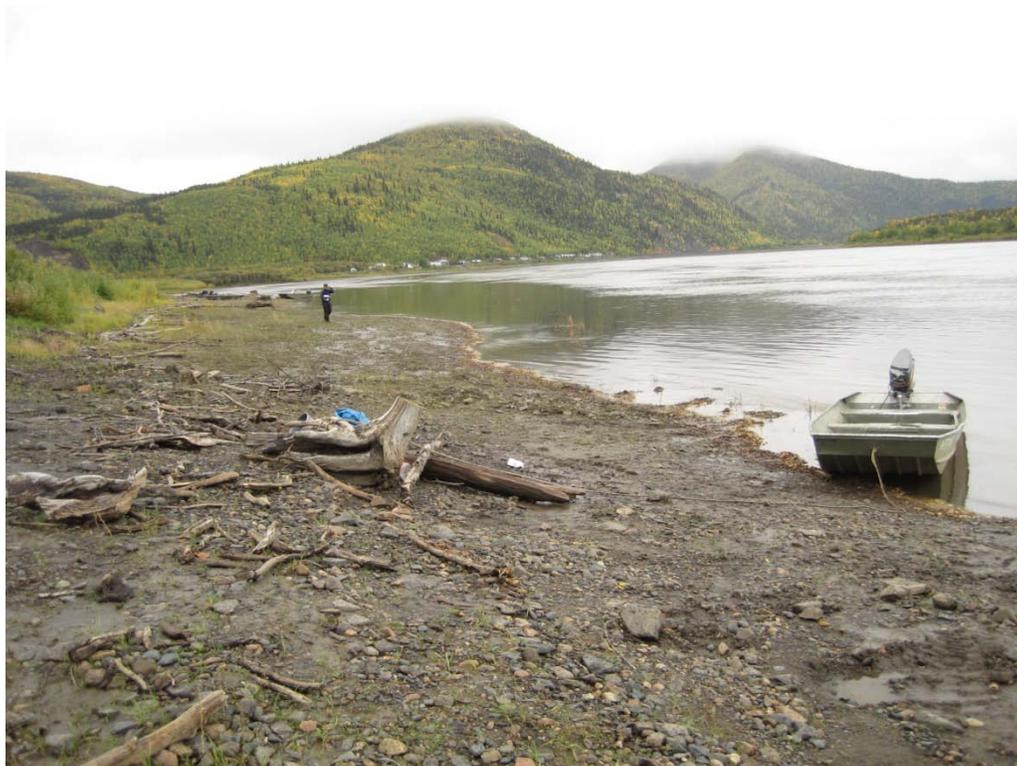
Photo 7: Freight Barge Landing Site (looking upstream)

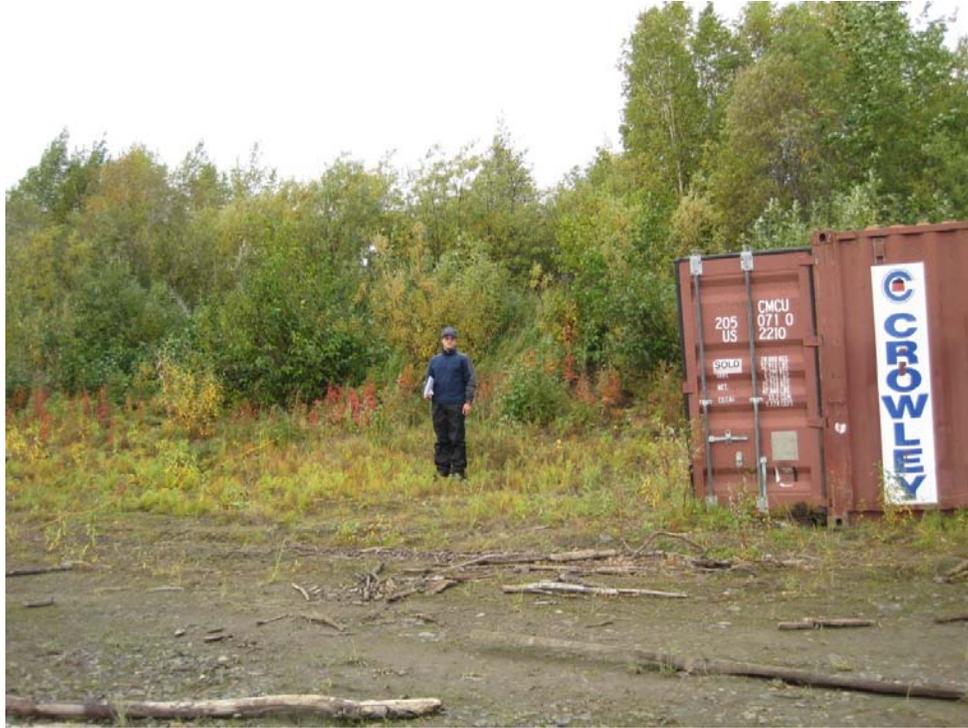
Photo 8: Approximate Location of Potential Downstream Mooring Point at Freight Barge Landing Site

Mooring points placed 200’ apart centered at the access road to the staging area placed at the toe of the slope to uplands seems appropriate at this site. This would place the downstream mooring point in the vicinity of a Crowley conex placed on the beach (Photo 8) and the upstream mooring point adjacent to the staging area and approximately 75’ downstream of a work shed located in the staging area (Photo 9). A third potential mooring point could be placed 175’ upstream of the access road adjacent to the staging area in front of the work shed (Photo 10). All three moorings would be located at the base of the staging area fill slope. Based upon follow up conversations with barging company representatives, a third mooring point was deemed unwarranted at this site.

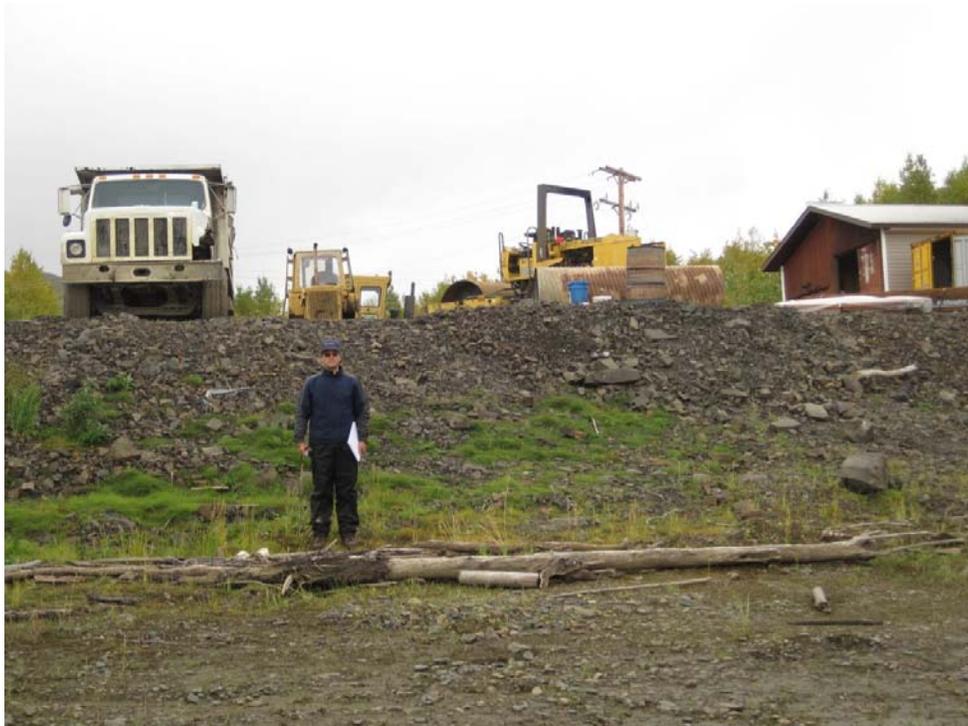
Photo 9: Approximate Location of Potential Upstream Mooring Point at Freight Barge Landing Site

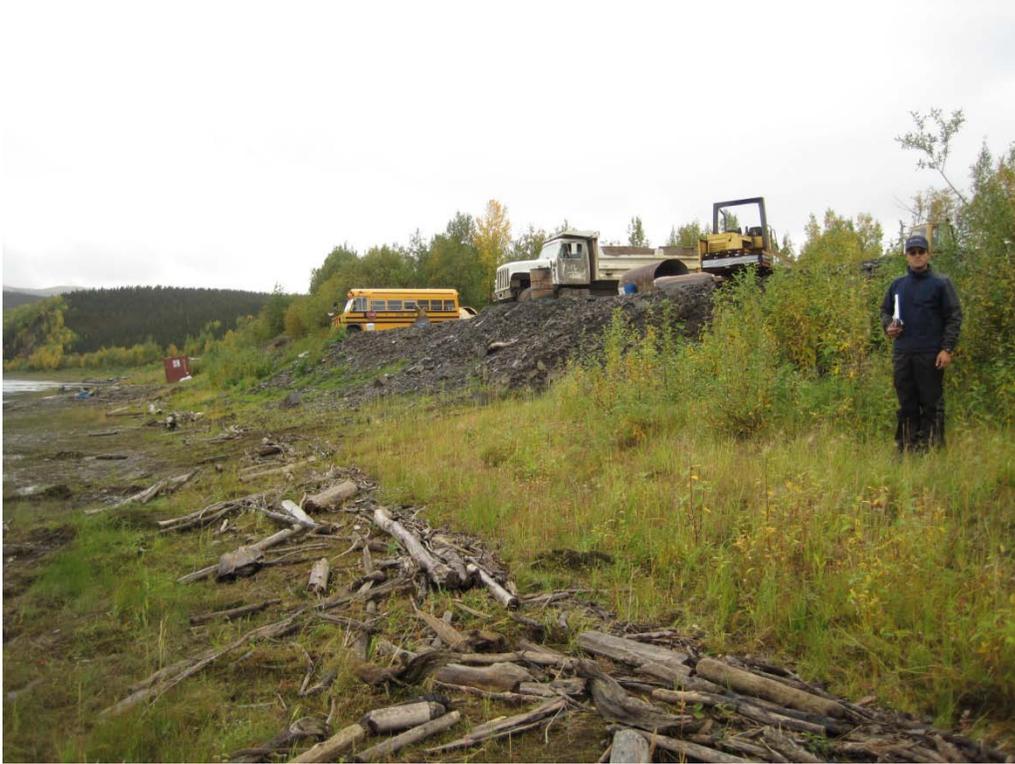
Photo 10: Approximate Location of Potential Optional Third Mooring Point at Freight Barge Landing Site (looking downstream)
