DISTRICT TRIP REPORT

Project: Denali Commission Eek Barge Landing Design

Description: Eek Trip Report

Date: 21 June 2010

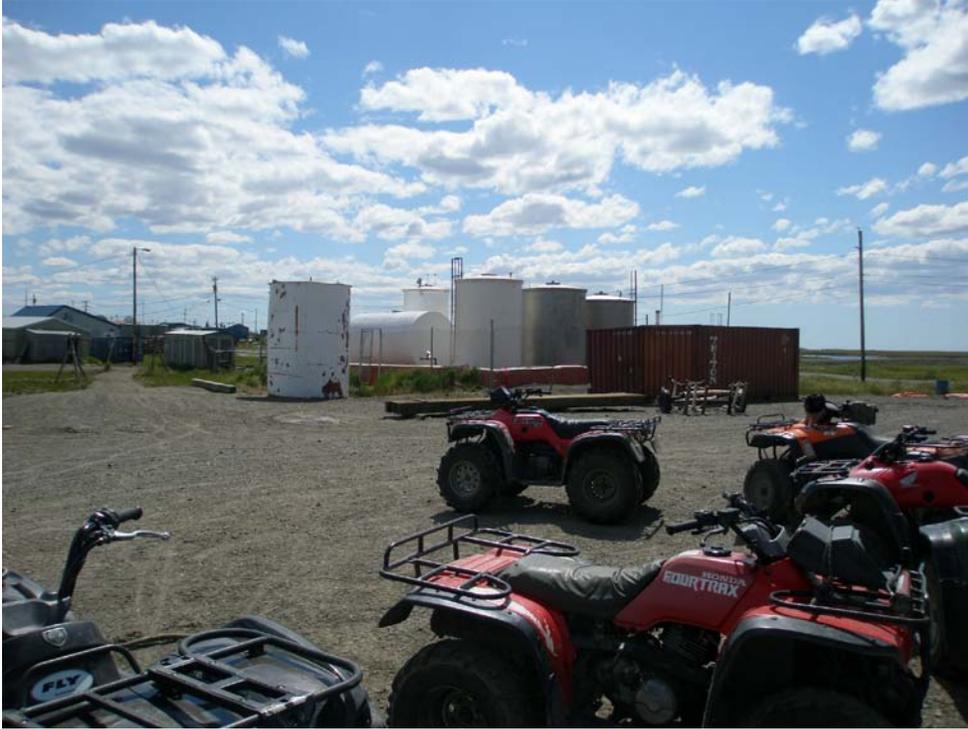
Figure 1. Tank farm

The existing barge landing is a gravel pad roughly 200ft x 180ft. The gravel pad appears to be on the order of four or five feet thick. The barge landing appears to be about three feet above normal high water. The area directly to the west of the gravel landing holds the fuel header and elevated fuel tank farm. The south portion of the landing is currently used as the staging and lay-down area for shipping containers.

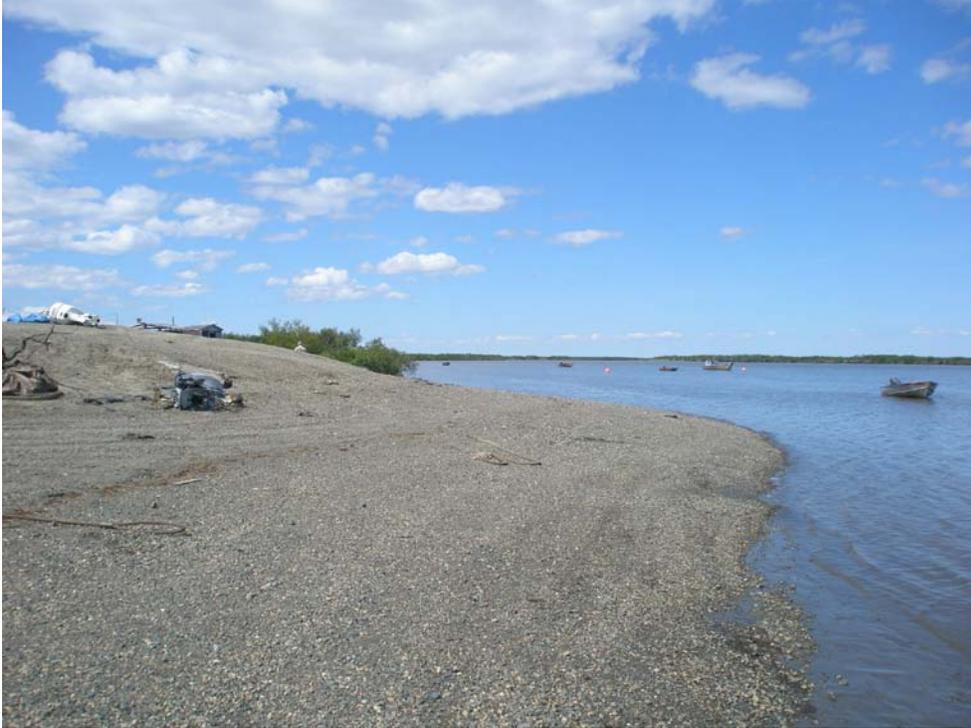
Figure 2. Beach area at the existing barge landing

Beach slopes in the area of the landing are roughly 1v:5h below the imported gravel pad. The beach there is mainly gravel and sand on the surface. The beach slopes upstream of the landing are shallower, roughly between a 1v:5h and a 1v:10h slope. The downstream beach slopes appear to be similar to those in the gravel landing area. The beach materials in the areas up and downstream of the landing mainly consist of silt.

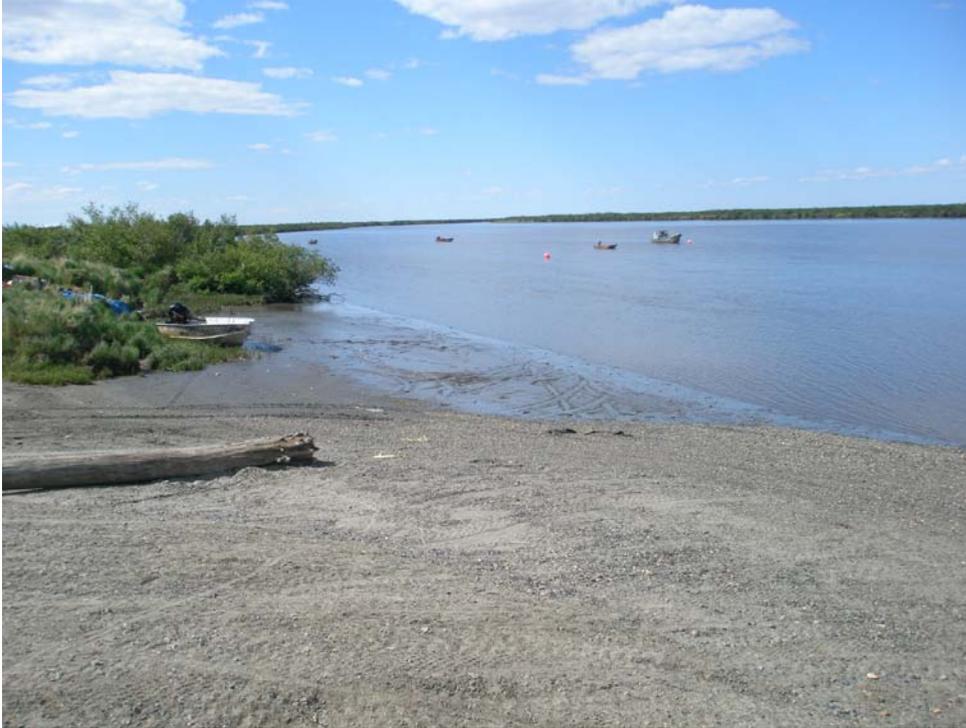
Figure 4. Beach downstream of the landing

The landing is on a straight section of river with no erosion in the area of the barge landing or upstream. The area upstream of the landing may have some minor accretion occurring. The area downstream of the landing does show signs of erosion as the river transitions into a bend below the landing. The river is approximately 830 feet in width in the vicinity of the barge landing. Water depths off of the barge landing could not be visually determined. A bathymetric survey of the river in the area of the barge landing will be completed this fall.

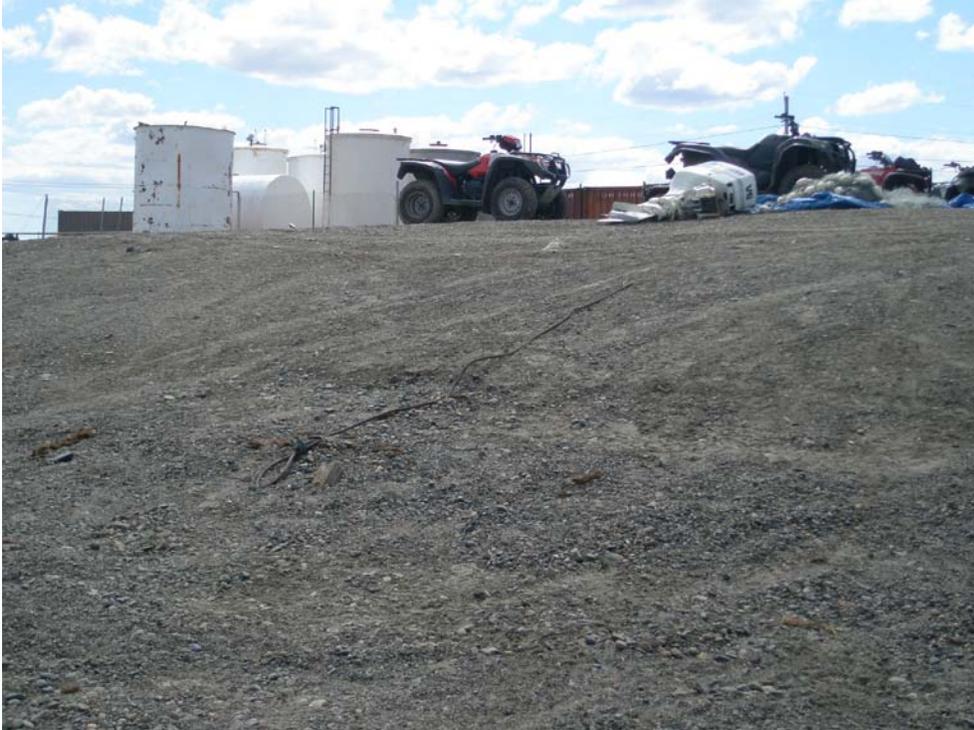
Figure 5. Existing deadman

There are currently three deadmen at the current barge landing. The barge companies use the deadmen during deliveries but the locals did not know for certain what the buried deadmen were or how deep they were buried. The terminal ends of the deadmen are 1/2-inch and 1-inch cable with end loops. The deadmen are used by the barge companies but not trusted to hold the full weight of the barges. Barge companies all use their engines to hold against the shore while moored.

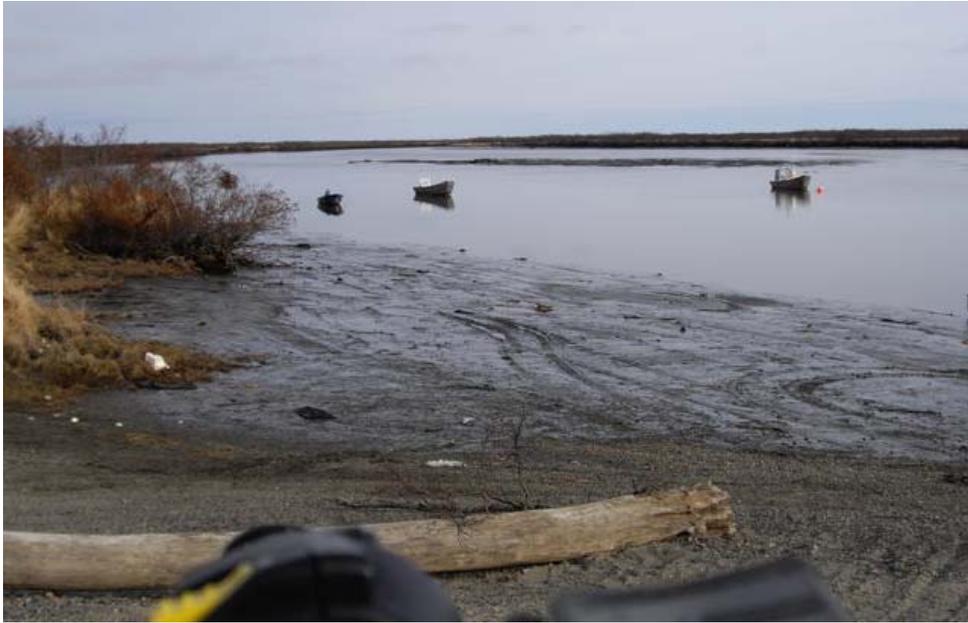
Figure 6. Photo of the exposed shoal during an extreme low tide

The locals described for us how barge operators use the existing landing. They said the barges come up the north side of the river in the deepest channel several hundred yards upstream of the landing and then wait for the tide to come across and land. A shoal roughly in the middle of the river just downstream of the barge landing makes passage from the deeper north channel to the south channel impractical even during high tides. Barges have to wait for the right tidal stage, sometimes overnight, to have enough water to make it down the south channel to the landing. The shoal is large enough to be exposed at extreme low tides. Locals note that the shoal is a fairly recent problem within the last 3-5 years. The locals are concerned that the shoal is building but they say it was made worse by the off-loading of gravel for the airport by the barges running their engines. Tugs have to maintain power to hold barges the entire time they are landed. Even with the shoal the locals say that this is the best location for the barge landing.

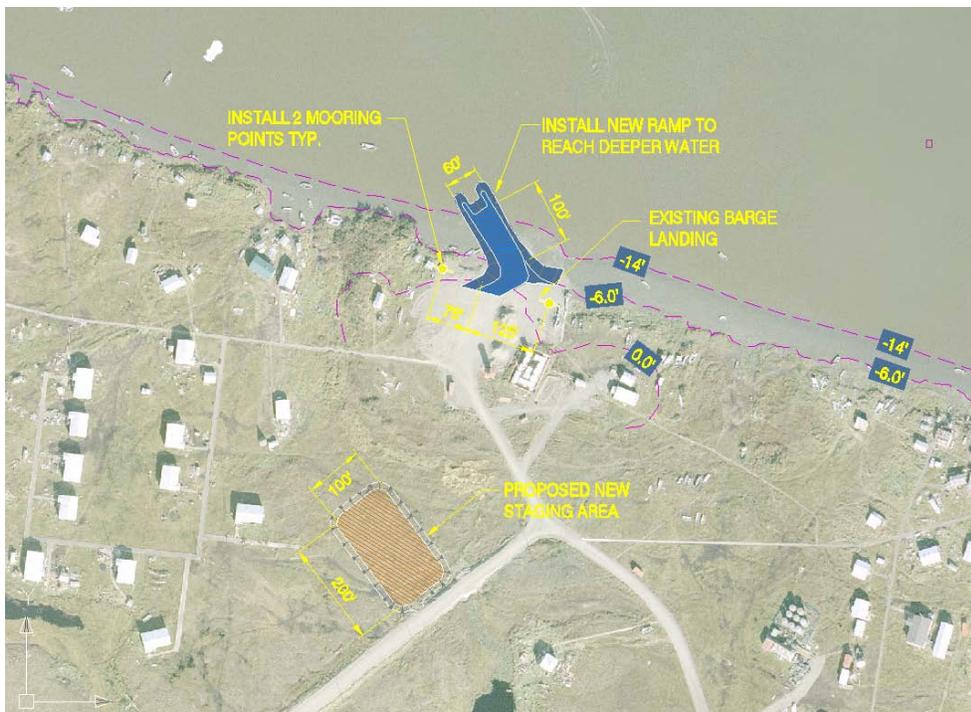
Figure 7. Proposed barge landing improvement layout

During the community meeting the group discussed the preliminary barge landing improvement layout, including an expanded gravel landing that reaches deeper water and mooring points. Several other possible landing orientations were discussed but it was agreed that the barge companies' input and surveyed depths in the area would be needed before any orientation for the landing could be decided upon. Those present all preferred the below-grade mooring point installations over the above-graded installations, due to the amount of traffic in the area.

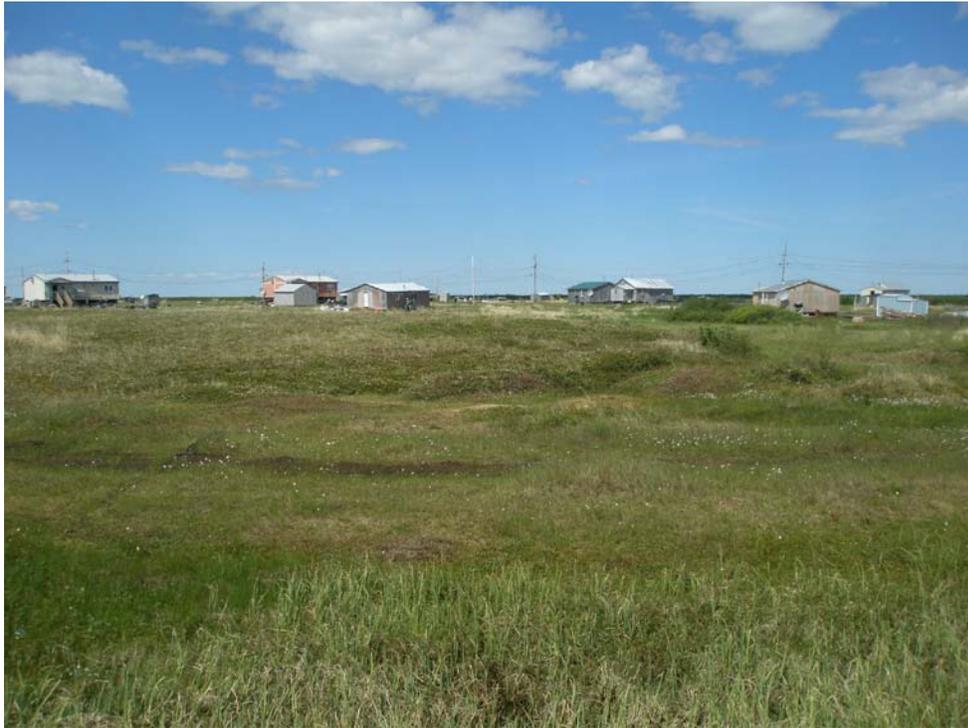
Figure 8. Proposed new staging area

The new staging is proposed adjacent to the airport access road, roughly 100 yards south of the barge landing. The staging area would begin just south of the culvert under the gravel road. The staging area is planned to be 100ft x 200ft. The area is several feet higher in elevation than most of the surrounding areas and less likely to have drainage issues. The area is vegetated with grasses and moss. Permafrost in the area is roughly 18-24 inches below grade. Survey monuments should be installed in road or in gravel pad. The surrounding areas are unstable.
