**FALLS CREEK HYDRO-PROJECT
MONTHLY CONSTRUCTION REPORT TO FERC
MAY 2006**

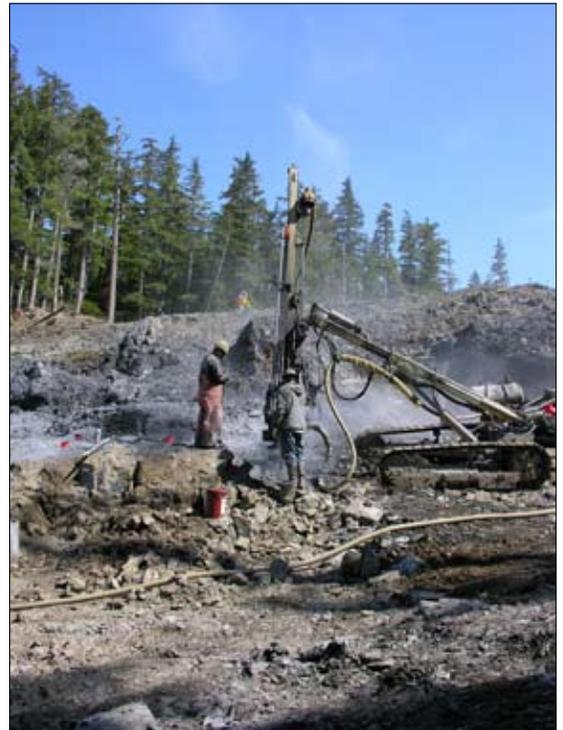
Drilling at pit #3

At this point the quality of the rock available in pit #3 is unknown but appears to be fairly "soft" and inconsistent in composition.

Development of pit #3, the first hard rock pit, began in mid-May. Drilling of blasting holes began in the third week of May. Blasting is scheduled for early in June.

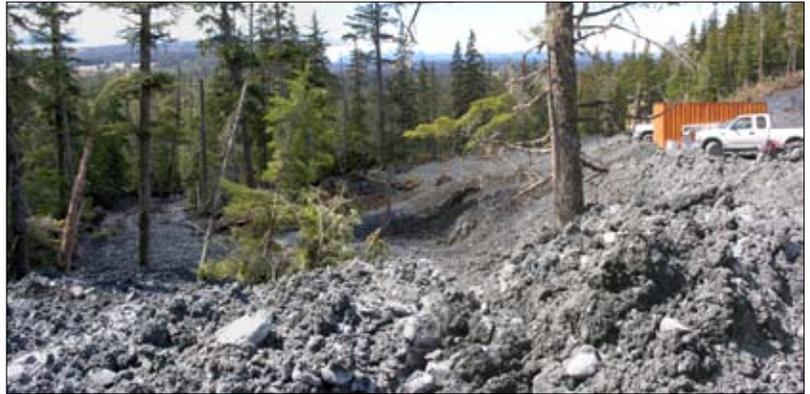
A topsoil dump area below pit # 2 has expanded to approximately 5 acres in size and runs through scrub forest. This may prove difficult to grade and revegetate depending on how firm the material becomes at the time of reveg work. The ECM met with a Glacier Bay National Park Service specialist in invasive plant control to discuss management of invasives in this location and along the road route.

Topsoil "dump" below pit #2.

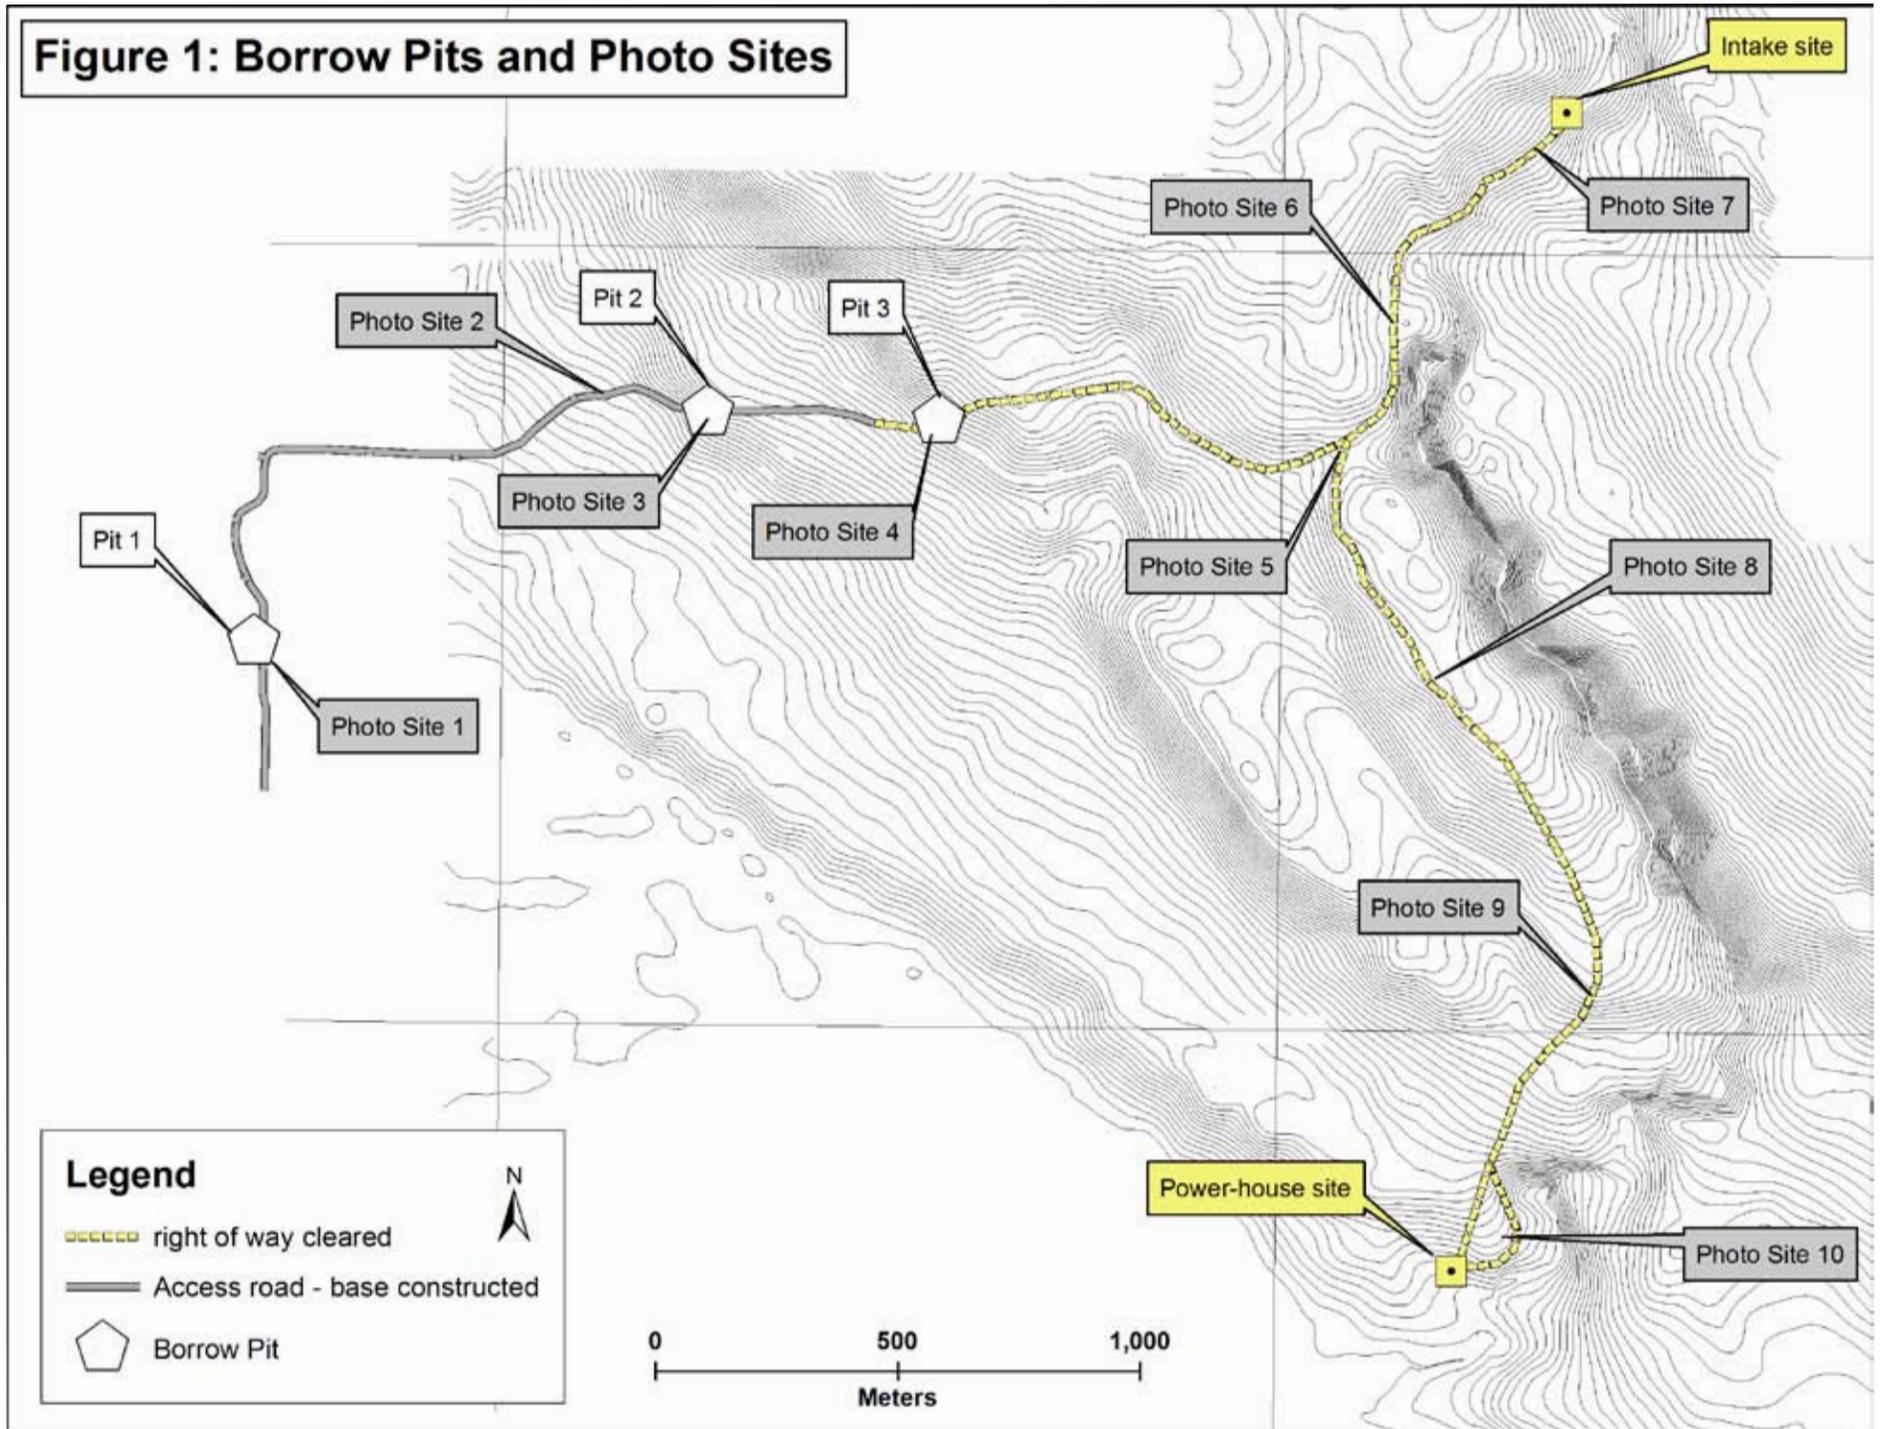
Figure 1: Borrow Pits and Photo Sites

Ten photo vantage points were established as work progressed throughout the project area. See Figure 1 for photo site locations and Appendix 1 for initial photos.
