Trip Report to the Denali Commission
Holy Cross, Alaska
November 3, 2011

2) Situation: We visited Holy Cross, Alaska October 3rd and 4th, 2011 to conduct a site visit and coordination meeting related to the potential relocation of the town's barge landing. The current location is just north of the town in Walker Slough, which is slowly being filled with sediment rendering it inaccessible by barges during low water events.

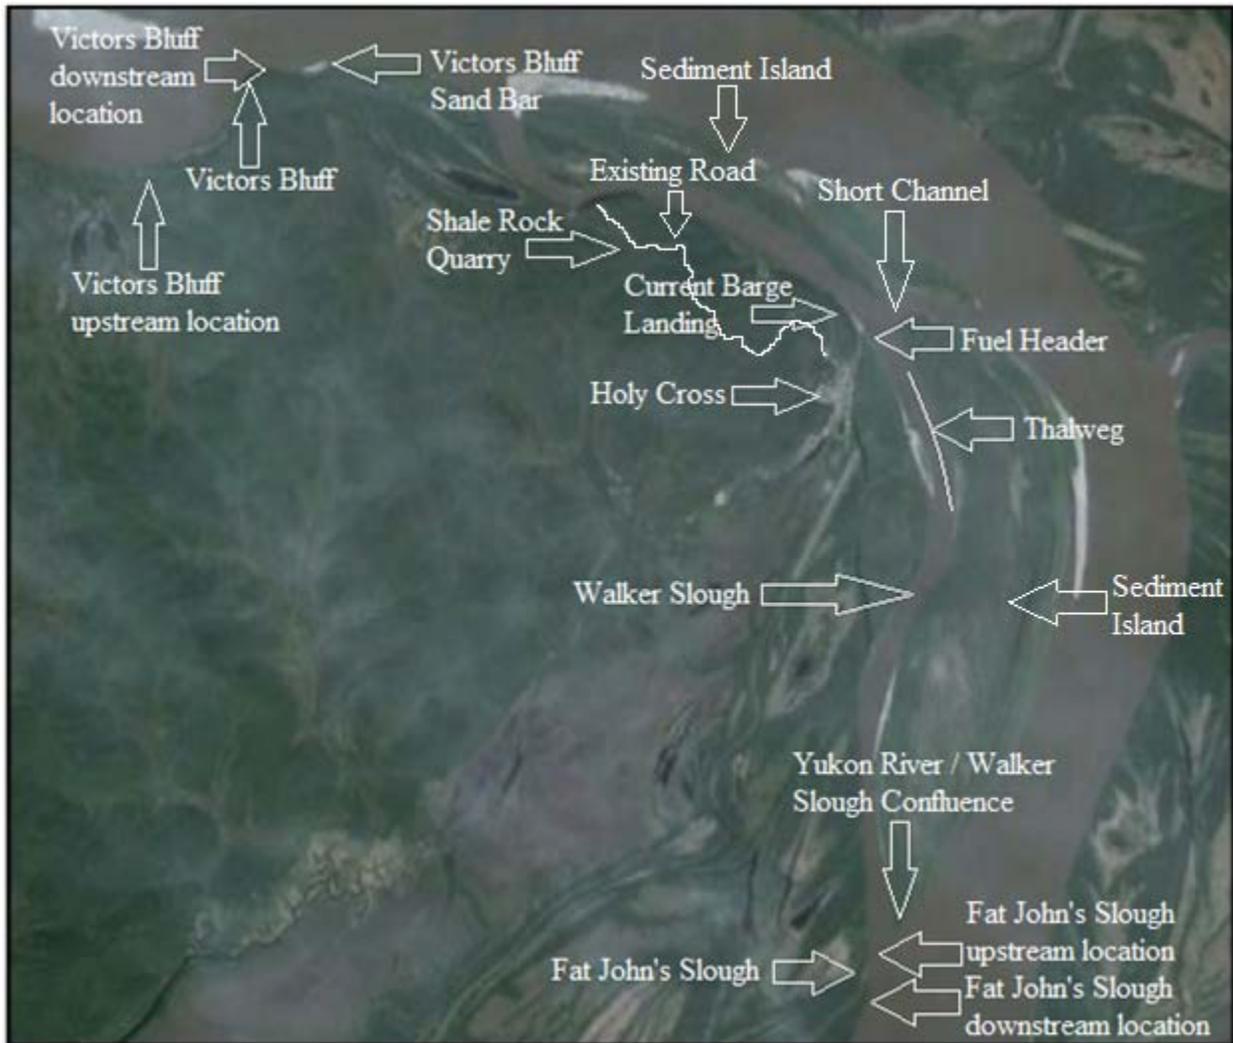
Figure 2. Aerial of Holy Cross with Victor's Bluff and Fat John's Slough locations

Victor's Bluff, a rock out cropping north-west of town, has historically kept the Yukon River from attacking the area of the existing landing, but the Yukon is continuing to migrate away from the current landing site. Aerial imagery (Figure 2) indicates that the river has

historically meandered through several hundred feet of bank on the far side from Holy Cross. Our field bathymetry measurements indicated that the thalweg (deepest part of the Yukon River) is just adjacent to the river bank on the far side from Holy Cross. We witnessed two large chunks of silt falling into the river from this steep silt bank during our brief time on the water. These observations all indicate that the river is continuing to erode the far bank and travel away from town.

Historical data indicates that Holy Cross was directly on the bank of the Yukon River into the 1930's, but after that time the river moved away from the village and formed sediment islands, which separate the Yukon River from what is now known as Walker Slough (Figure 2). A short channel connecting Walker Slough with the main river channel provides barge access to the current barge landing. This short channel is getting shallower threatening continued barge access to the existing landing site.

a. Victor's Bluff: Victor's Bluff is located north-west of town, 4 miles from the current barge landing (Figure 2). There were two locations, one upstream and one downstream of Victor's Bluff that we investigated for potential barge landing locations.

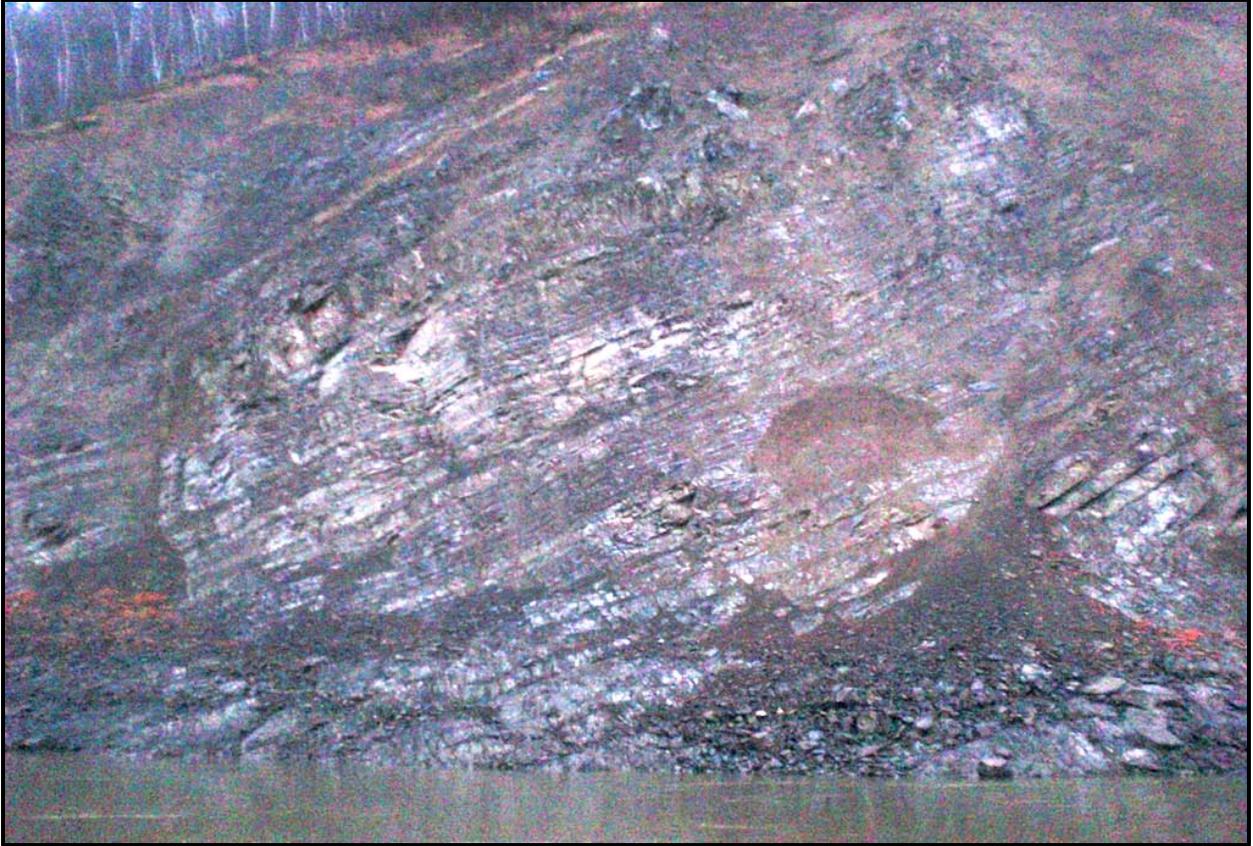
Figure 3. Victor's Bluff Shale Deposit

i. Geologic Assessment of Victor's Bluff: The geology of Victor's Bluff consists of floodplain deposits, tidal flats and estuarine deposits. A visual identification of these floodplain deposits consisted of mainly silt and fine sand particles (Figure 5 and 6). Victor's Bluff also consisted of shale bluffs (Figure 3), which has contributed to the slow erosion of the bluff. Shale in the area (Figure 4) was previously used as gravel for local roads and for the airport runway. This shale is in abundance (Figure 3 and 4) and would be a good source for constructing gravel roadways leading to a new barge landing site. The geology of the site was based on published maps and a visual reconnaissance. No subsurface investigations have been performed for this project to date.

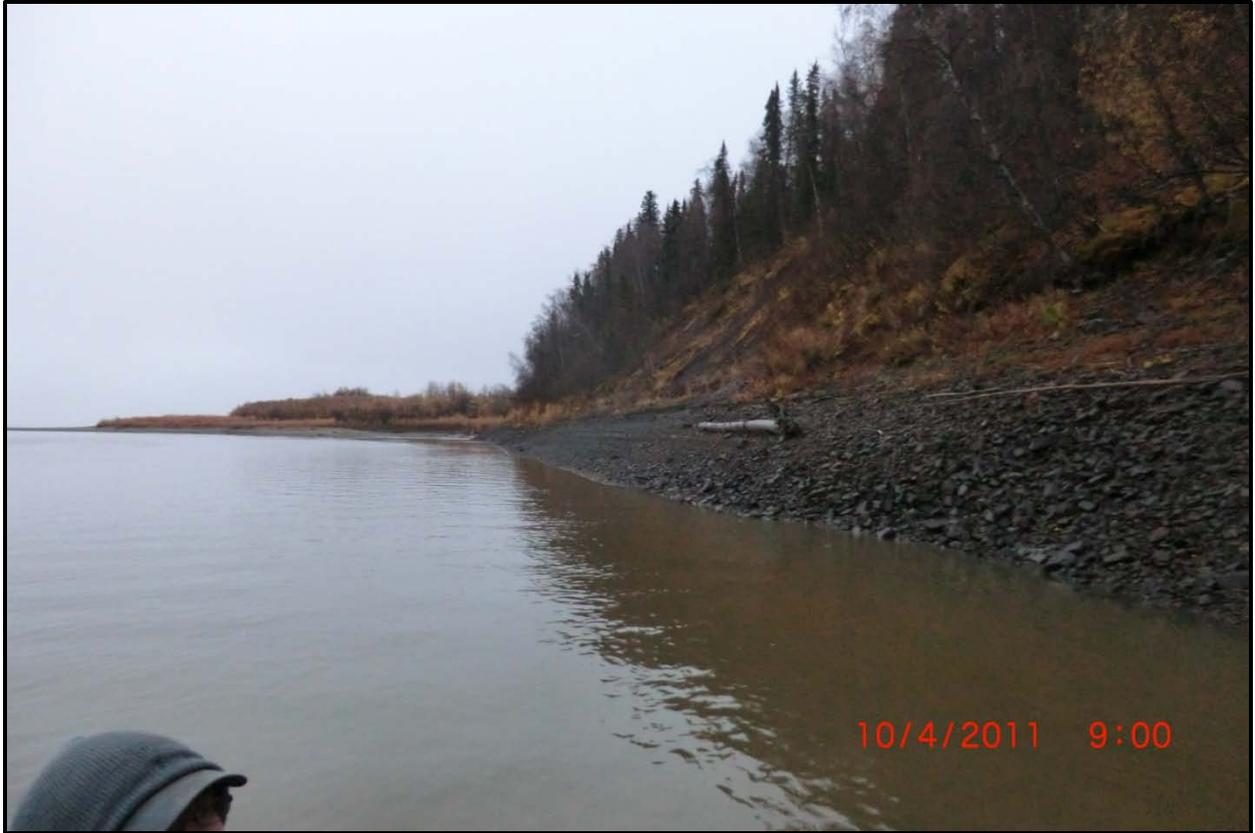
Figure 5. Victor's Bluff Downstream location with downstream sand bar in sight

The downstream location provides a fairly steep shale river bank in what appears to be a very stable condition. The bank would have to be graded to allow access and a staging area. A sand bar is present at the downstream extent (Figure 5) of this area indicating that the potential for deposition of sediment also is present in this area. Moving upstream from this sand bar would provide a buffer to help decrease the risk of having decreasing depth for a barge landing in this area.

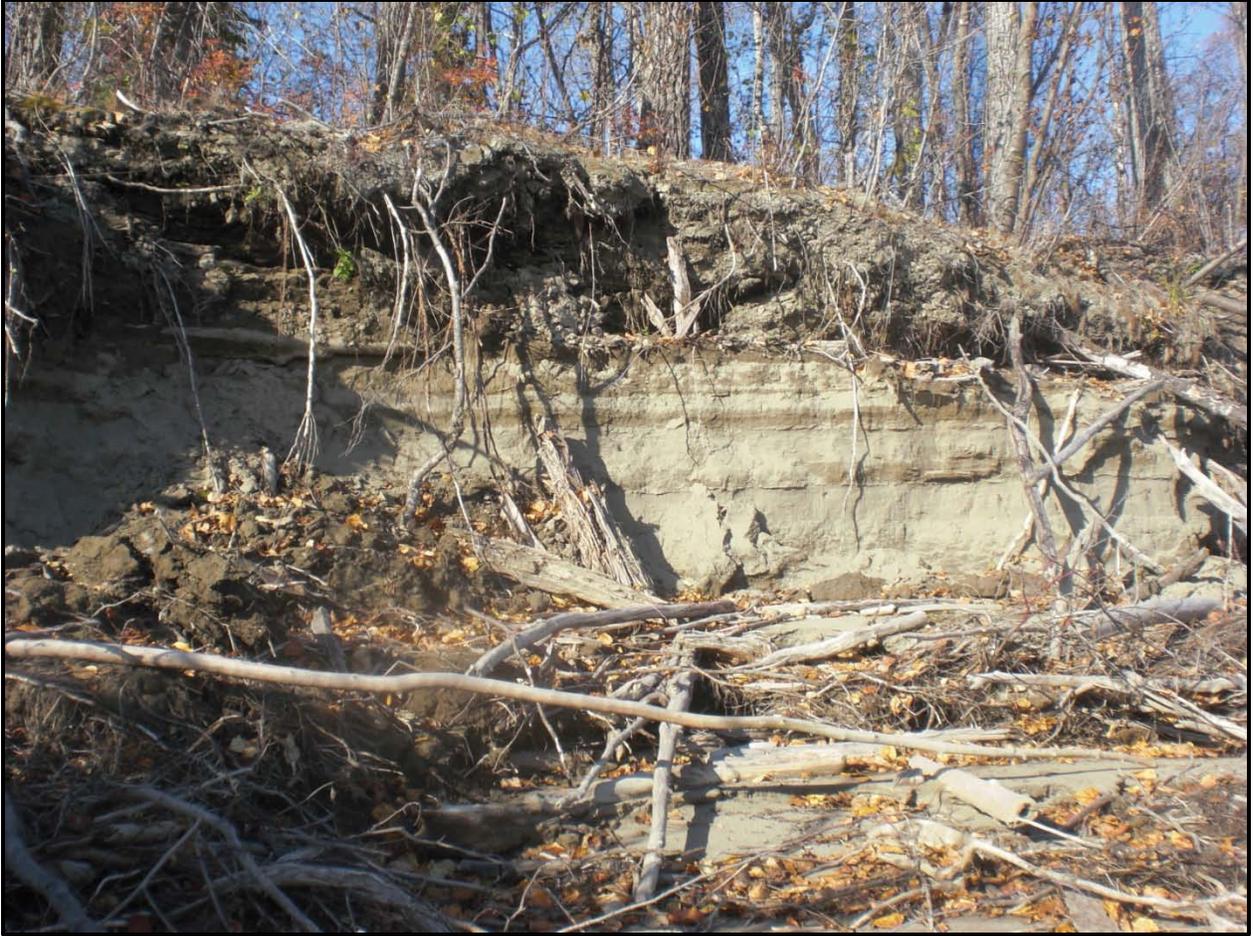
Figure 6. Fat John's Slough downriver Location

i. Geologic Assessment of Fat John's Slough: The geology of Fat John's Slough consists of floodplain deposits, tidal flats and estuarine deposits. A visual identification of these floodplain deposits consisted of mainly silt and fine sand particles (Figure 6 and 7).

ii. Hydraulic and Hydrology assessment of Fat John's Slough: Access to the potential downstream Fat John's Slough location would require the crossing of Fat John Slough. The team discussed the possible use of bridge or culverts. The possibility of closing this slough was also mentioned; however this may not be an environmentally viable solution. The river bank at this potential site was steep silt with many downed trees along the bank (Figure 6).

Both of these sites near Fat John's Slough are located in an area of Ox Bow formation from historical meandering of the river channel. While the river continues to move away from Holy Cross, this may not present a problem. However if the river were to start migrating back towards the village, this would leave these barge landing sites subject to erosion.

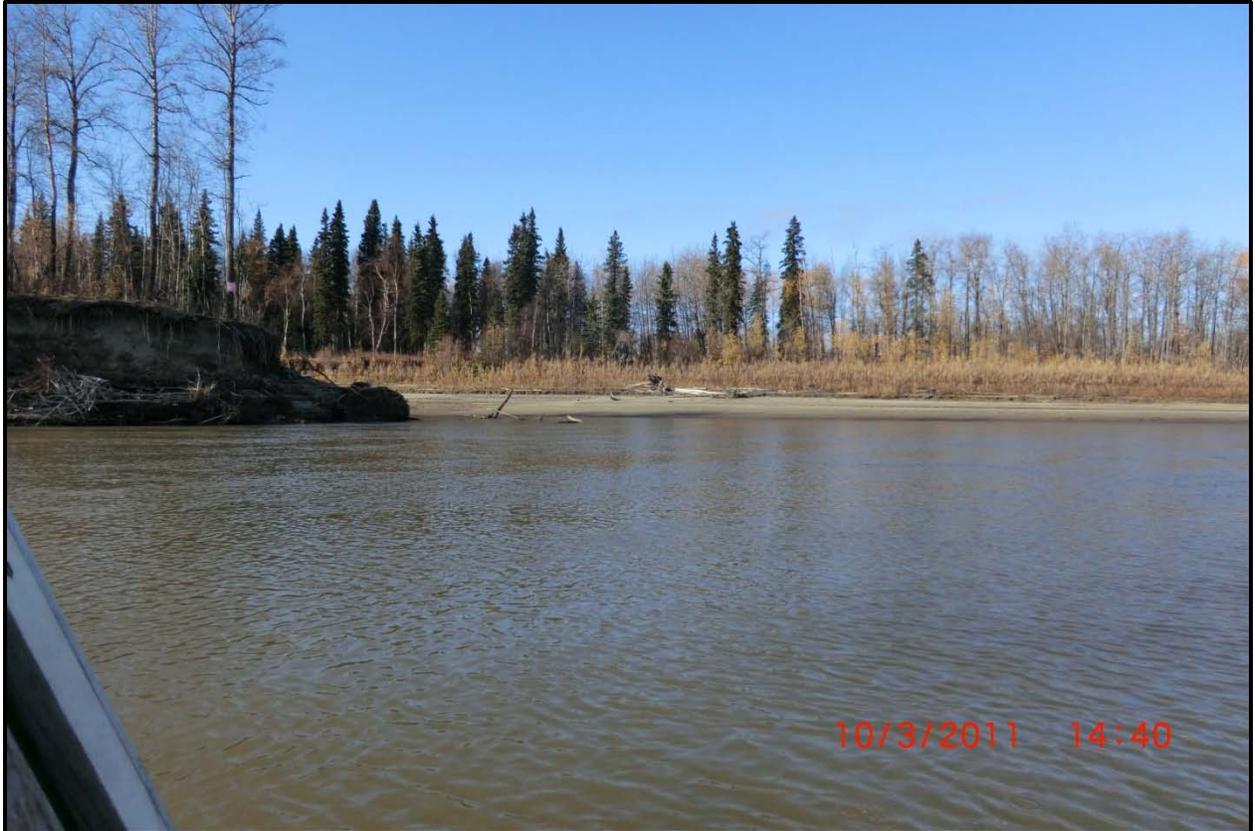
Figure 7. Fat John's Slough Upriver Location

The upstream Fat John's Slough location has a flatter slope than the downstream location, and was free of logs on the beach (Figure 7). The access problems caused by Fat John's Slough don't exist at this site; however, the channel size, of navigable water, at this location, due to the confluence of Walker Slough and the Yukon River, may cause maneuvering problems for barge access.
