ALASKA DISTRICT TRIP REPORT

Project: Denali Commission Moorings Points Phase 4 – Yukon River

Description: Kaltag, Alaska Trip Report

Date: 16 June 2011

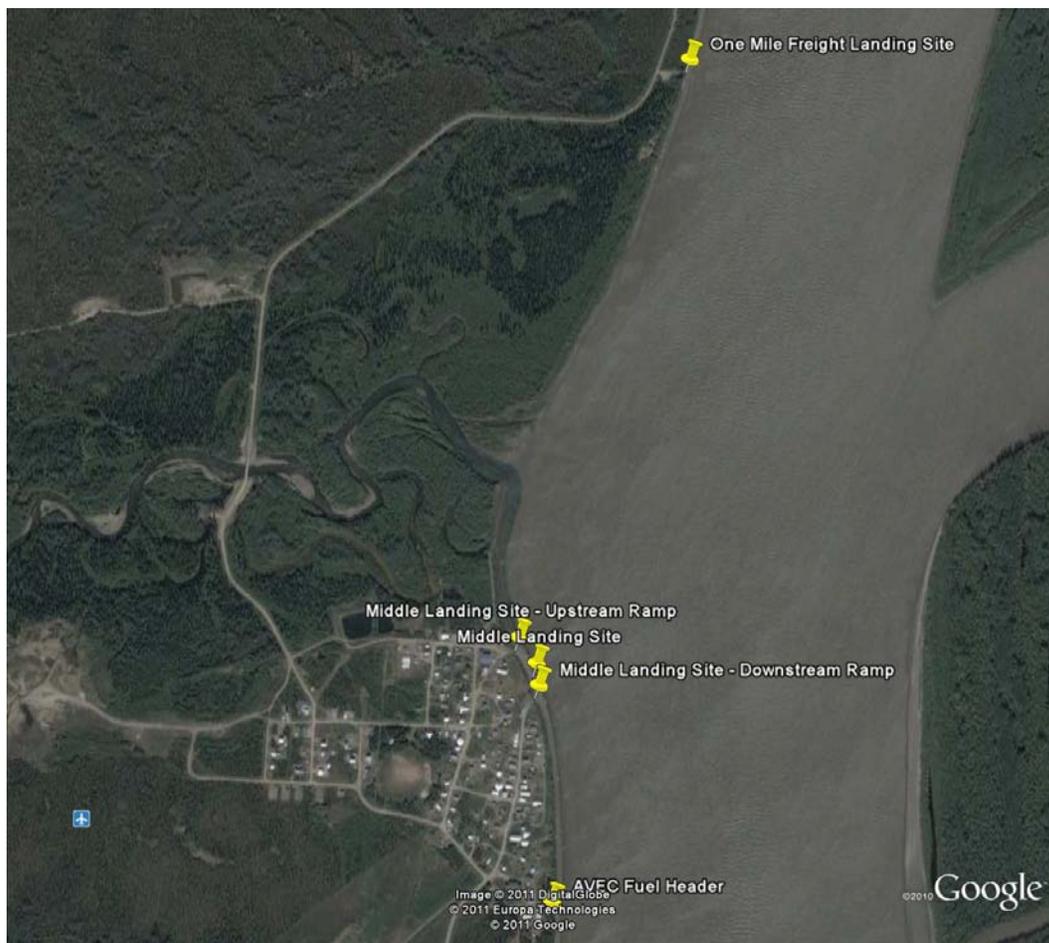
Figure 1. Overview of Kaltag barge landings and fuel headers. Yukon River flows from top to bottom.

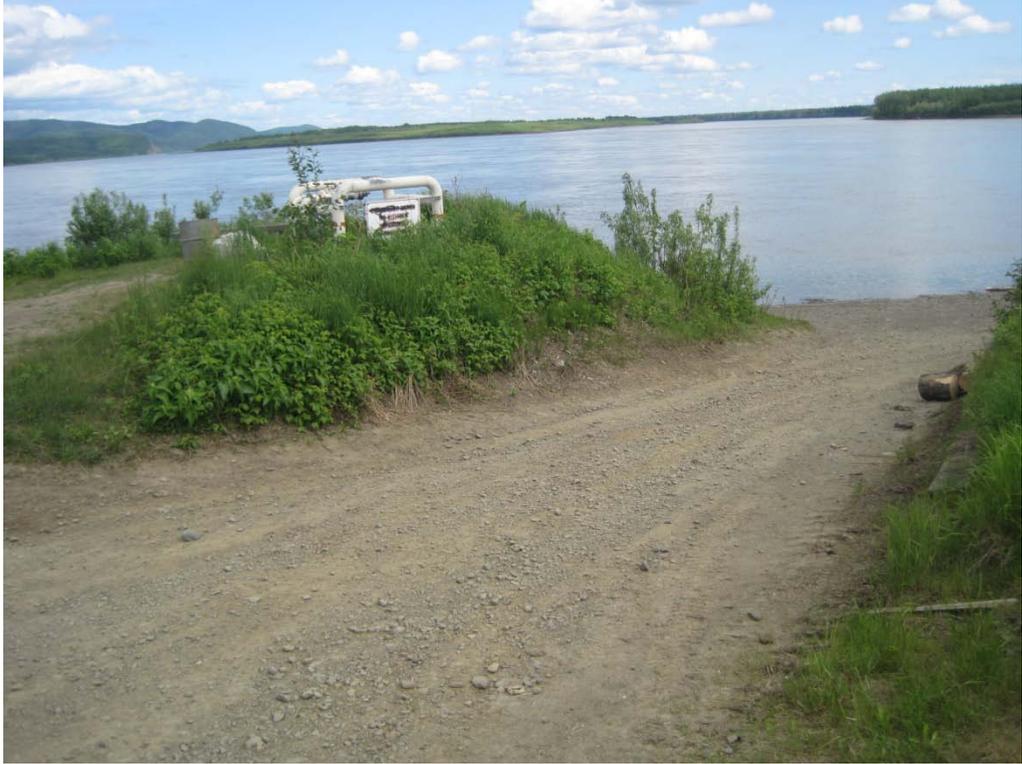
This landing site consists of two gravel ramps. The upstream ramp (Photo 1) is utilized during high water, while the downstream ramp is more accessible during low water. During the time of our visit, the ramps were bound by a broad gravel beach along the Yukon River (Photo 2). The upland area in between the two ramps is adjacent to a large yard and home (Photo 3).

A fuel header is located at the top of bank just upstream of the upstream ramp (Photo 1).

Photo 1. Upstream ramp and fuel header at Middle Landing Site.

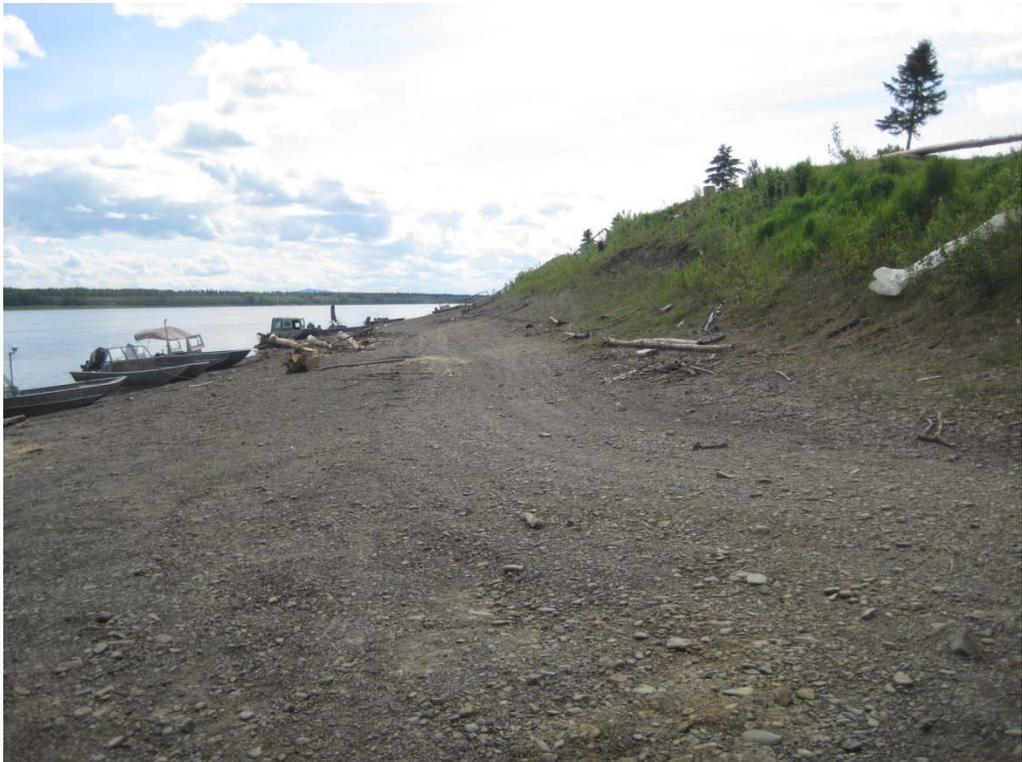
Photo 2. Beach connecting the two ramps at the Middle Landing Site, looking downstream.

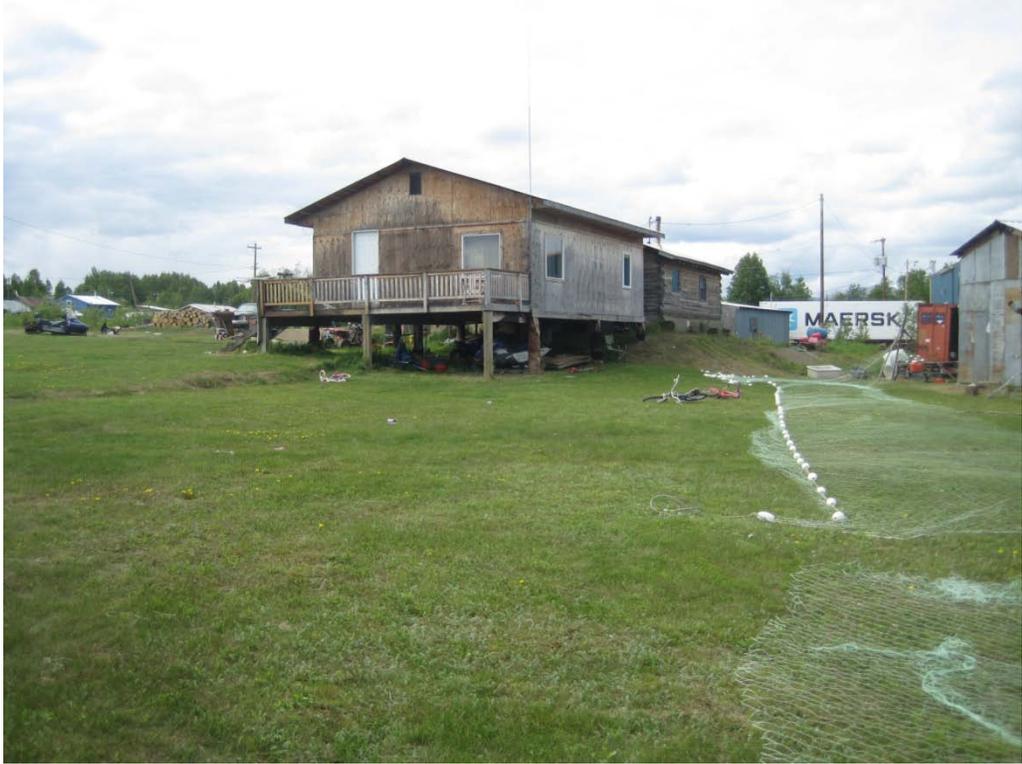
Photo 3. House and yard located between the two ramps of the Middle Landing Site.

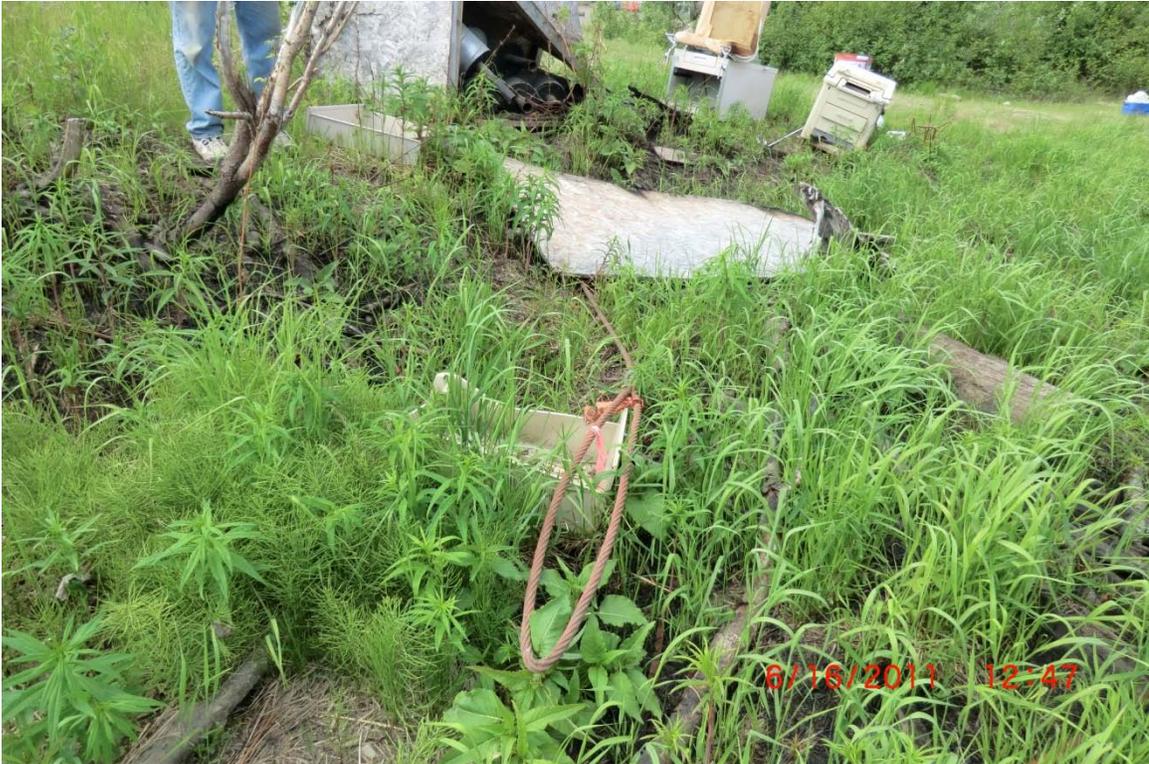
A mooring point consisting of a tie down cable was located approximately 36 feet upstream of the upper ramp (Photo 5).

Photo 5. Existing tie down cable upstream of the upstream ramp of Middle Landing Site.

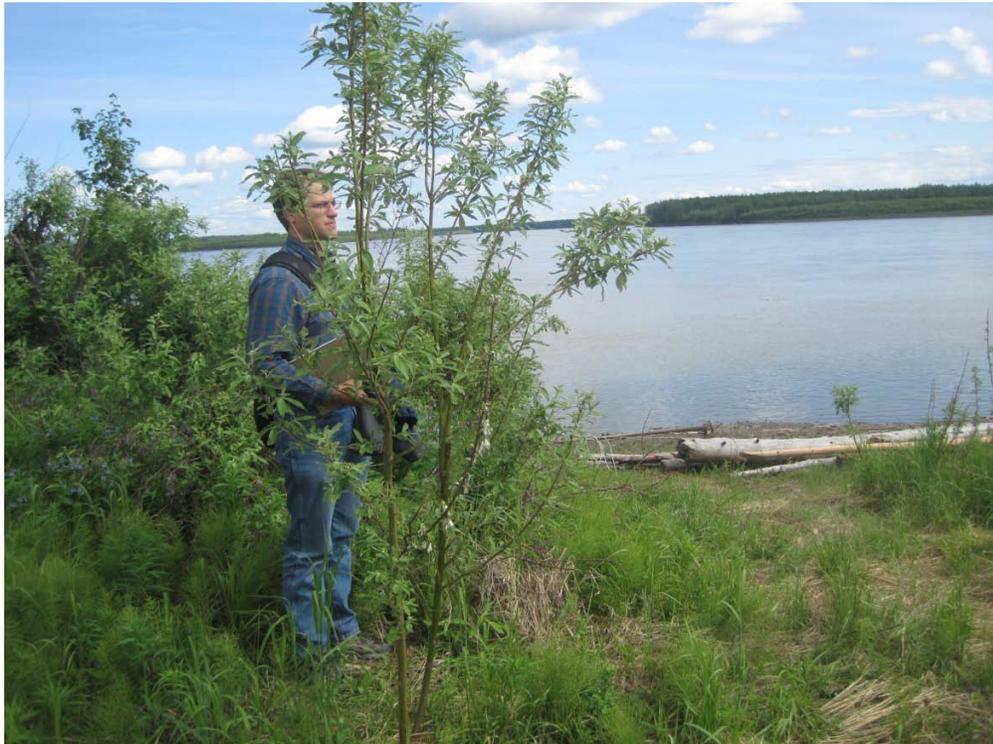
Photo 6. Corps employee standing at proposed location of most upstream mooring point at Middle Landing Site. A small 4-wheeler ramp accessing the river is to his right.

The proposed location of the most upstream mooring point is 125 feet upstream of the upstream ramp at 64 19.766' N, 158 43.483" W. This location is just upstream of a grassy 4-wheeler ramp accessing the river (Photo 6). The area is slightly vegetated. The mooring point should be placed adjacent to the top of the ramp along the edge of vegetation, roughly 10 feet back from the top of bank. An above grade mooring point would be appropriate at this location.

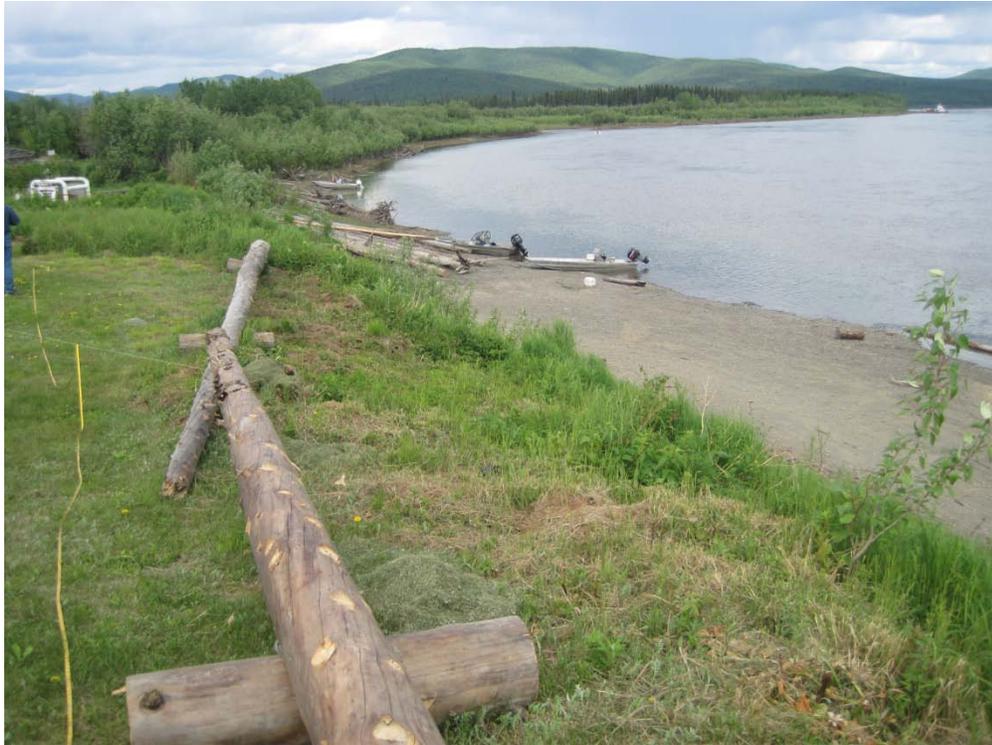
Photo 7. Looking upstream from proposed location of second most upstream mooring point at Middle Landing Site. Note the fuel header near the top left.

The proposed location of the next downstream mooring point is 125 feet downstream at 64 19.749' N, 158 43.433" W. This location is near the upstream corner of the large yard, approximately 10 feet inland from the top of bank (Photo 7). A below grade installation is appropriate here.

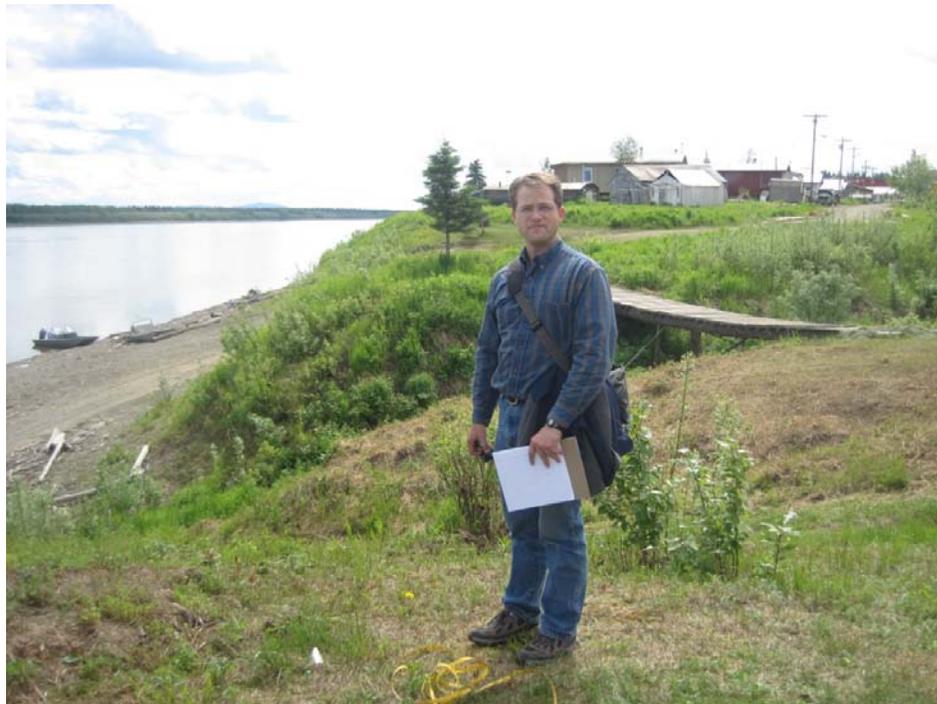
Photo 8. Corps employee standing at proposed location of second most downstream mooring point. There is a 4-wheeler path to the river directly behind the small brush behind him. A small bridge spans a gully beyond that.

The proposed location of the second most downstream mooring point is 128 feet farther downstream at 64 19.731' N, 158 43.410" W. This location is between the downstream end of the large yard and 4-wheeler trail, and a gulley spanned by a small bridge (Photo 8). A below grade installation is appropriate here.

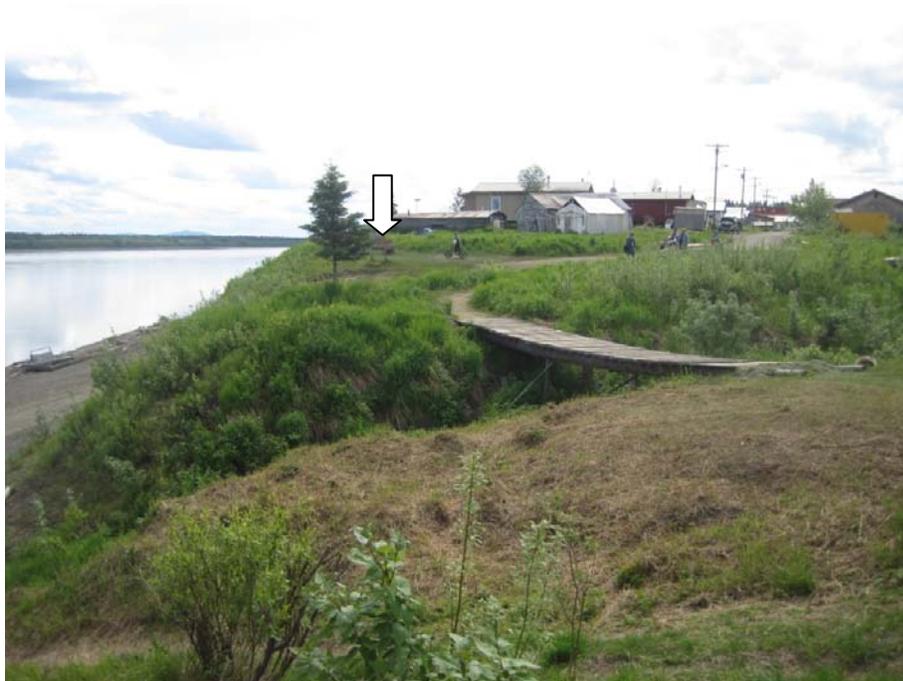
Photo 9. Proposed location of the downstream most mooring point. Location is directly in front of sign indicated by white arrow, which is partially obscured by the small tree to the left of the bridge.

The proposed location of the downstream most mooring point is 175 feet farther downstream at 64 19.701' N, 158 43.382" W. This location is just downstream of the downstream ramp and directly in front of a sign welcoming people to Kaltag (Photo 9). A below grade installation is appropriate here.

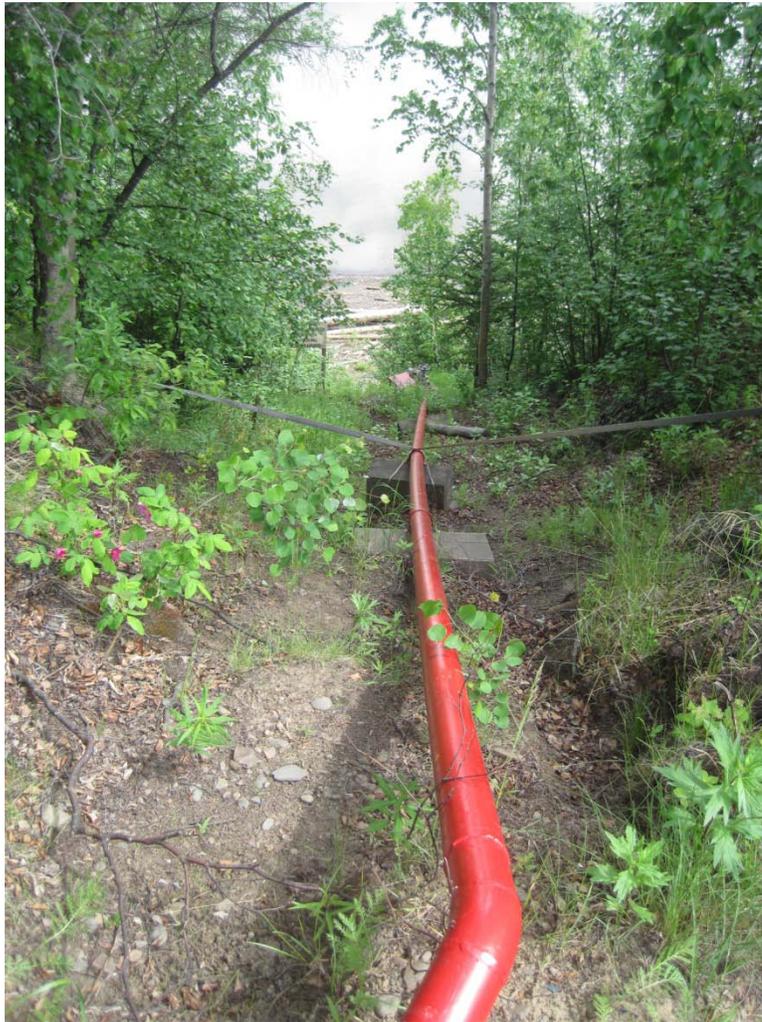
The distinguishing feature of this landing is the presence of a tall, steep, and moderately vegetated stream bank close to 100 feet high. The fuel header is approximately 1/3 of the way up the slope (Photo 10).

Potential mooring point locations were investigated both at the top of bank and along the vegetation line along the toe of the bluff slope. Both locations have limitations. Mooring points placed within the river channel will be subjected to high flow events and river ice. Equipment access to install the mooring points would also be difficult. Mooring points placed atop the high banks will likely not be utilized due to the difficult access to reach the top of bank. Access in the tight confines of the slope, various buildings, and overhead power lines will also present problems.

Photo 10. Steep, vegetated bank at AVEC fuel header. The fuel header is visible down the slope at the end of the red pipe.

Because of the limitations and difficulties presented by this site, it is uncertain whether mooring points can be effectively installed and utilized. No mooring points are recommended for this site.

Due to the uncertain effectiveness of mooring points at the AVEC fuel header site caused by the tall, steep and vegetated stream bank, no mooring points are recommended at this time.

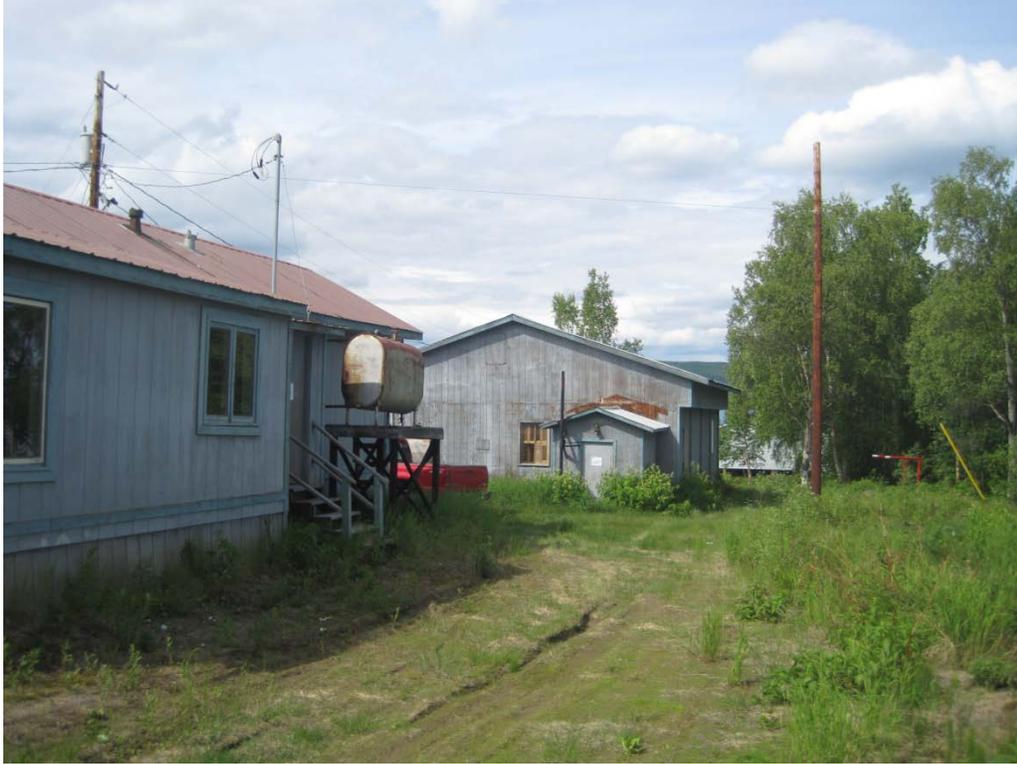
Various structures related to a former teacher housing complex are just adjacent to the top of bank in this area (Photo 11).

Photo 11. Former teacher housing structures adjacent to AVEC fuel header.

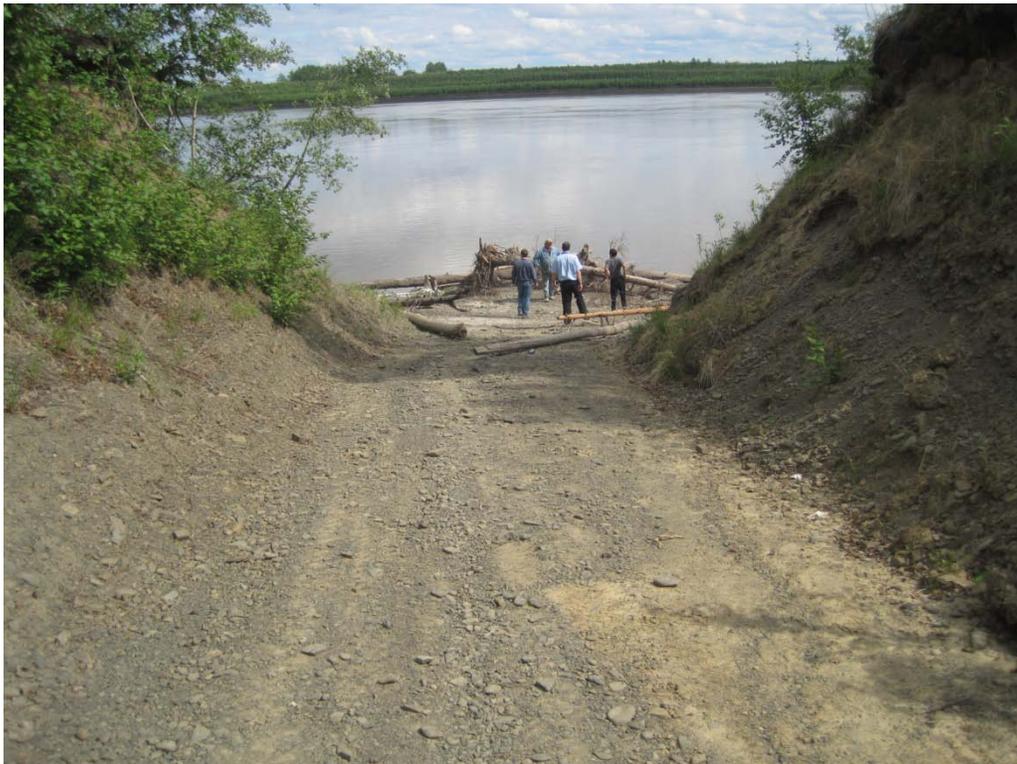
This landing consists of a long, straight gravel ramp cut perpendicular through the riverbank down to the river (Photo 12). The gravel beach has a moderate slope of 1V:3H to 1V:5H. The width of the beach from the low water level (rough water level at time of visit) and the ordinary high water level is roughly 100 to 130 feet wide.

Photo 12. One Mile Freight Landing site.

Proposed locations for two mooring points at this location are 125 feet each upstream and downstream of the center of the ramp at coordinates 64 20.518' N, 158 43.022' W, and 64 20.478' N, 158 43.041'W, respectively. Below grade installations at the top of bank at the tree/brush line (ordinary high water level) are appropriate.

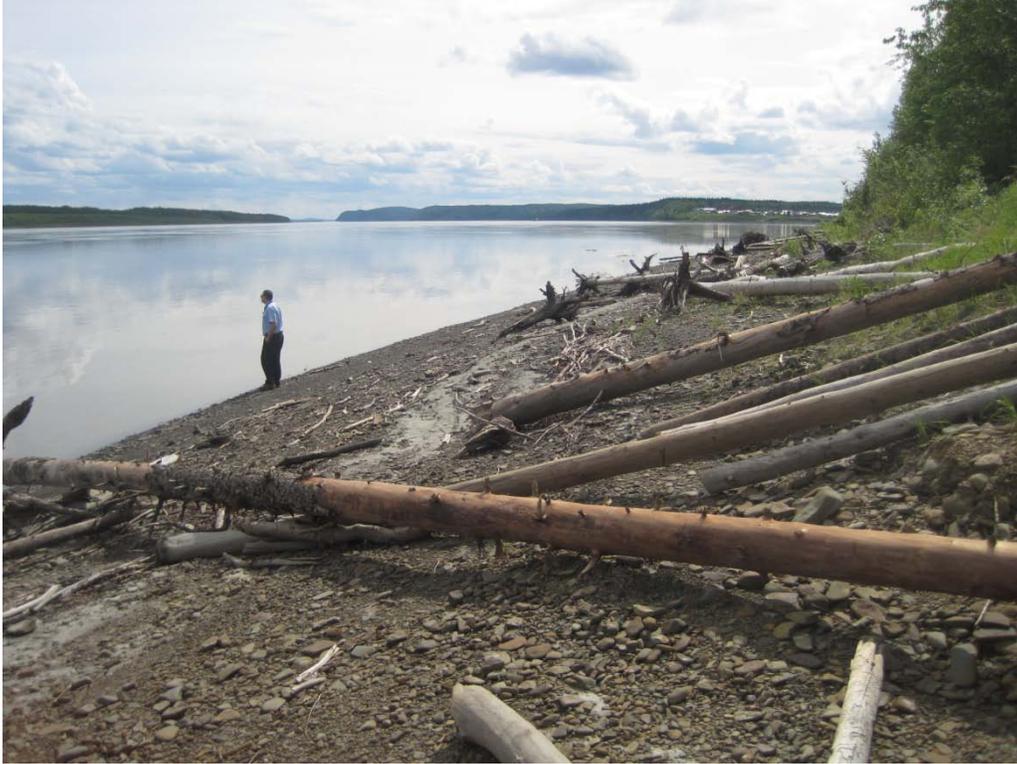
The beach along the Yukon River had many logs beached by high spring flows (Photo 13). These logs are eventually harvested by locals.

Photo 13. Beached logs at One Mile Freight Landing Site looking downstream.

Access to the proposed locations will require low water levels in the Yukon to expose the beach and may require removal of logs along the beach.

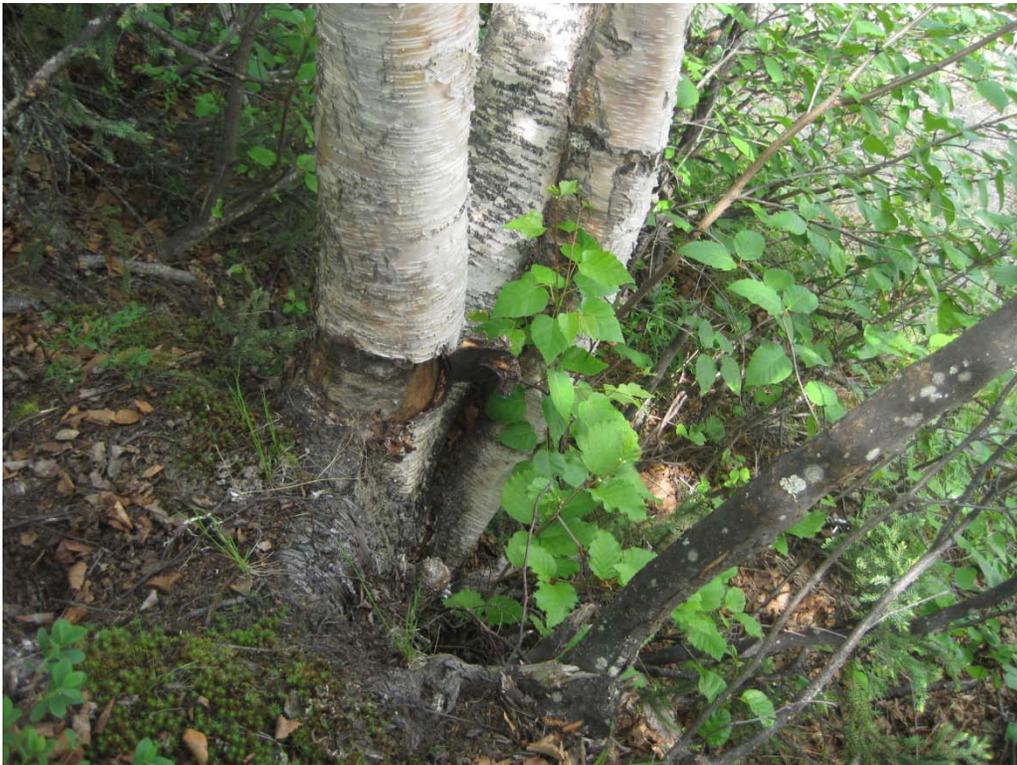
Worn bark on a tree located 125 feet upstream from the center of the ramp indicates it has been utilized as a tie off point (Photo 14).

Photo 14. Worn bark on tree indicates use as tie-off point, One Mile Freight Landing Site.

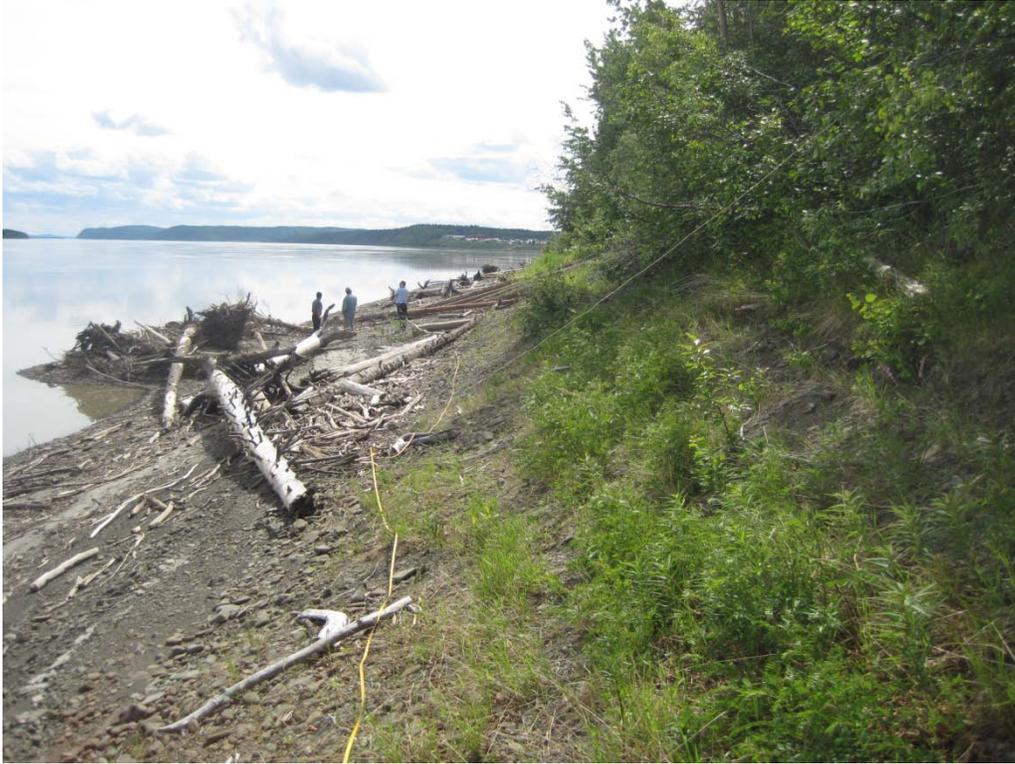
River bank slopes are steeper at the proposed upstream mooring point site (Photo 15) than the proposed downstream site. If the slope is too steep to allow suitable access of equipment required to install the mooring points, a path may need to be cleared from the ramp to the mooring point location.

Photo 15. Relatively steep bank at proposed upstream mooring point location looking upstream, One Mile Freight Landing Site.
