## **ALASKA DISTRICT TRIP REPORT**

**Project:** Denali Commission Mooring Points Phase 4

**Description:** McGrath Trip Report

**Dates:** 26 - 27 July 2011

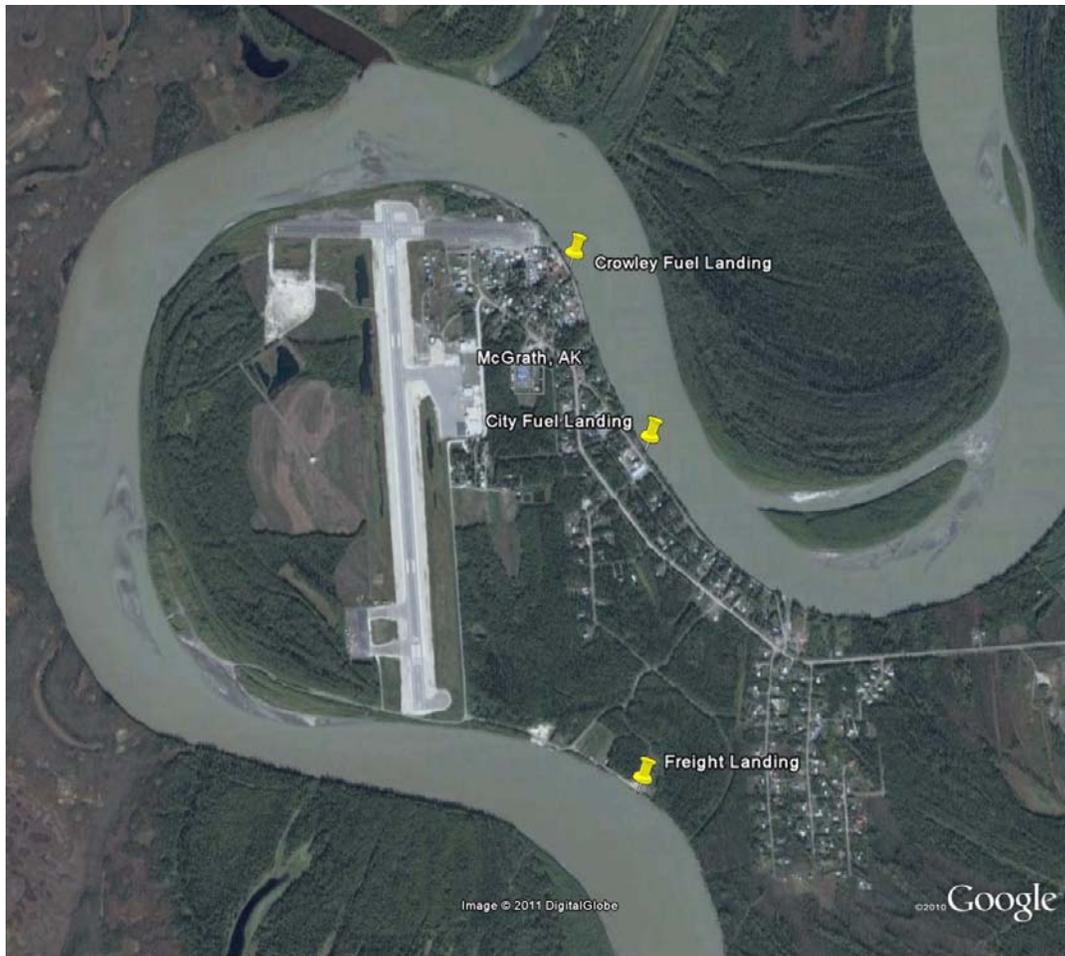
Figure 1: McGrath Barge Landing Locations. Streamflow is from top to bottom.

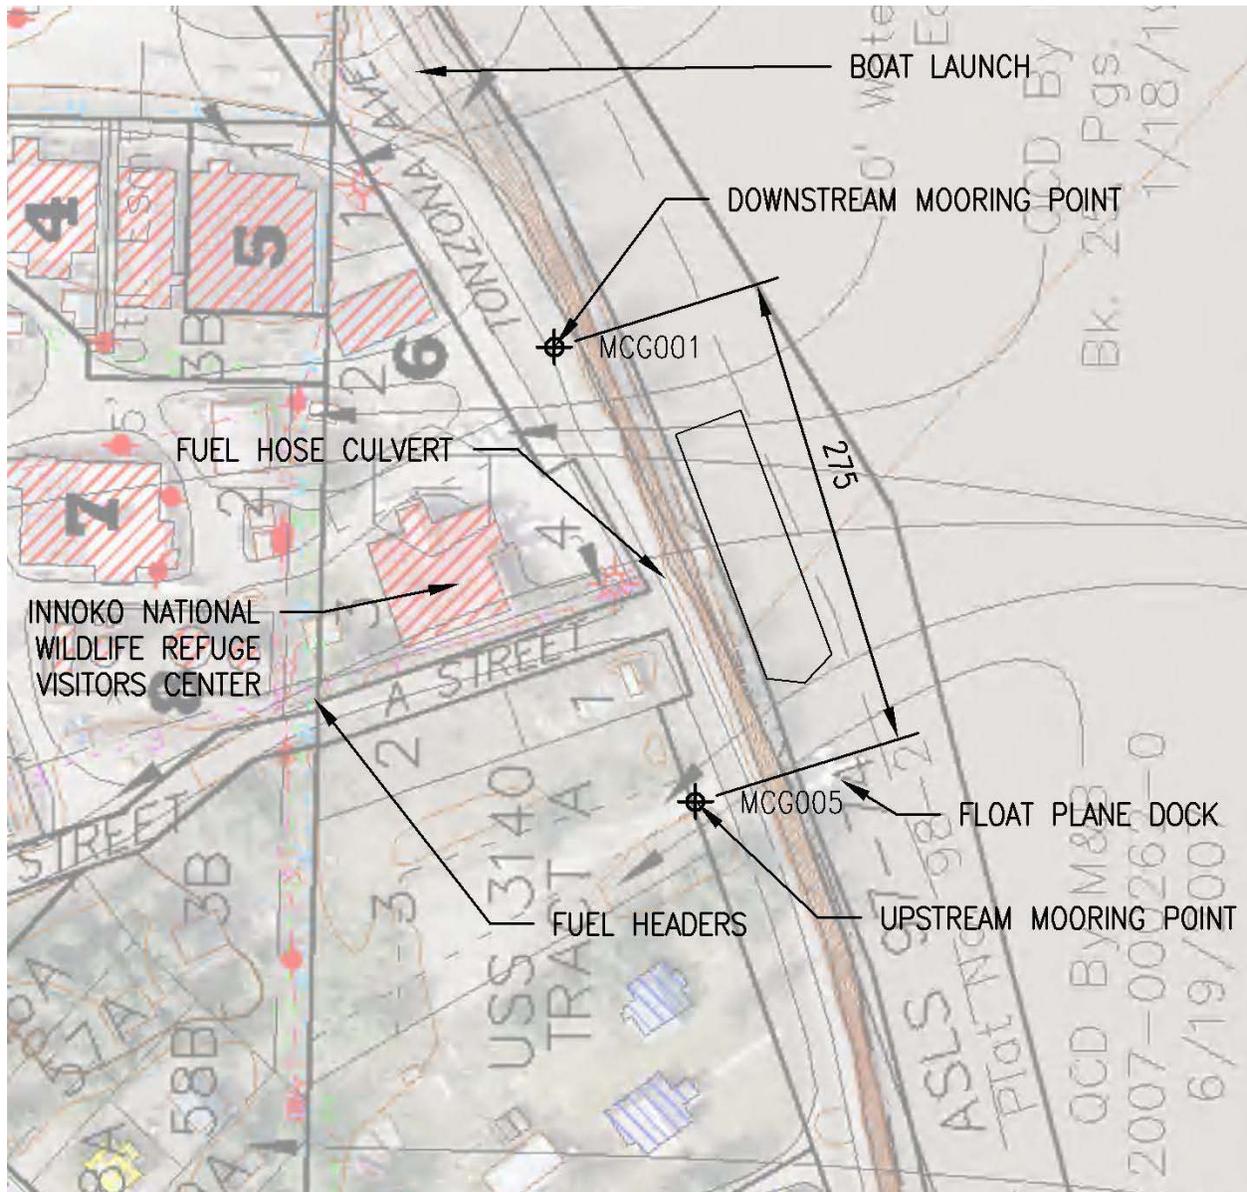
Figure 2: Proposed mooring point locations at the downstream landing site. Both mooring points are near the shoulders of Tonzona Avenue. Typical barge orientation for fuel delivery is shown.

The proposed location for the upstream mooring point at this site is illustrated in Figure 2 and shown in Photo 8. This point would secure the bow line of a barge to provide resistance to the current and prevent the vessel from drifting downstream with the current. This point is on the land side of Tonzona Avenue on city property within a driveway that was built to provide access to a church. The church is no longer there. GPS coordinates for this location are 62.95653° N, 155.59256° W. This location is approximately 125 feet upstream from the fuel hose culvert and across the street from the USFWS float plane dock. City administrator Natalie Baumgartner warned that some local citizens who believed they owned the real estate at this location could object to this recommendation; however, she is certain the land is city owned.

The proposed downstream mooring point location is approximately 275 feet downstream across the street from the bar (Photo 9–Photo 11, Figure 2). This point would secure the stern line of the barge and prevent the stern from drifting out into the river. GPS coordinates at this location are 62.95676° N, 155.59259° W. This point is on the river side of Tonzona Avenue

The city has a proposal submitted to the Federal Emergency Management Agency (FEMA) to construct erosion protection along the entire bank shown in Figure 2. Funding availability for this project is uncertain at this time.

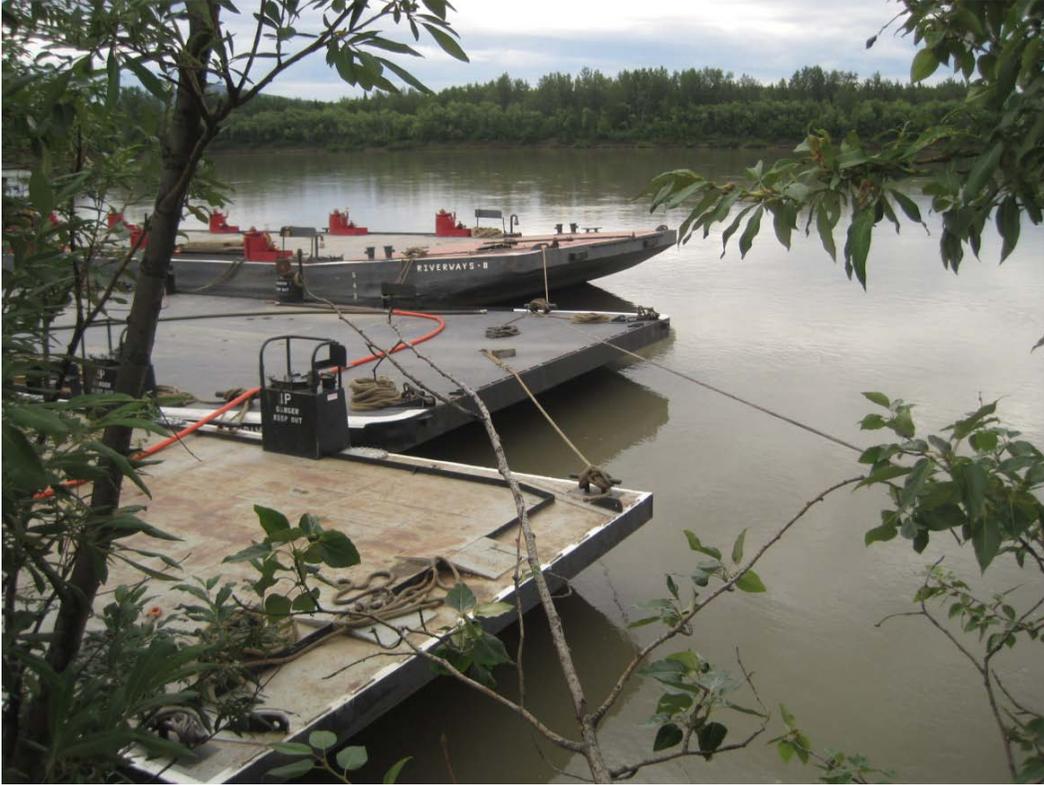
Photo 1: Three of six barges towed by the Crowley tug. One anchor line is used to moor all the barges. It can be seen extending to shore from the port side of the middle barge.

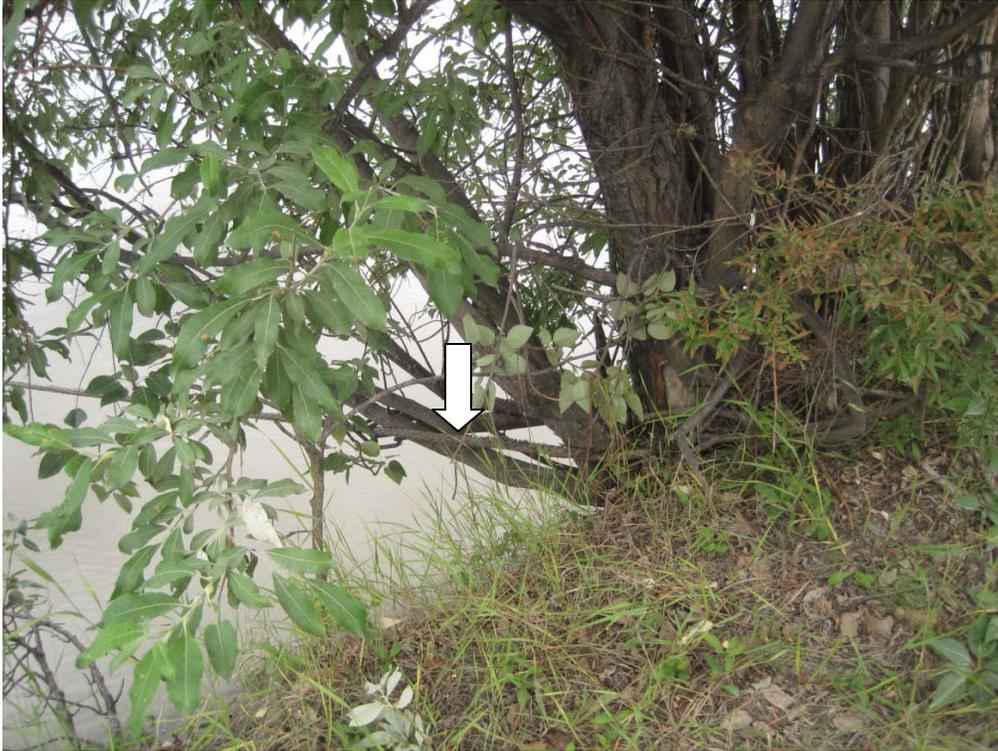
Photo 2: Tree that was used as a mooring point during Crowley fuel delivery. The anchor line is indicated by the white arrow.

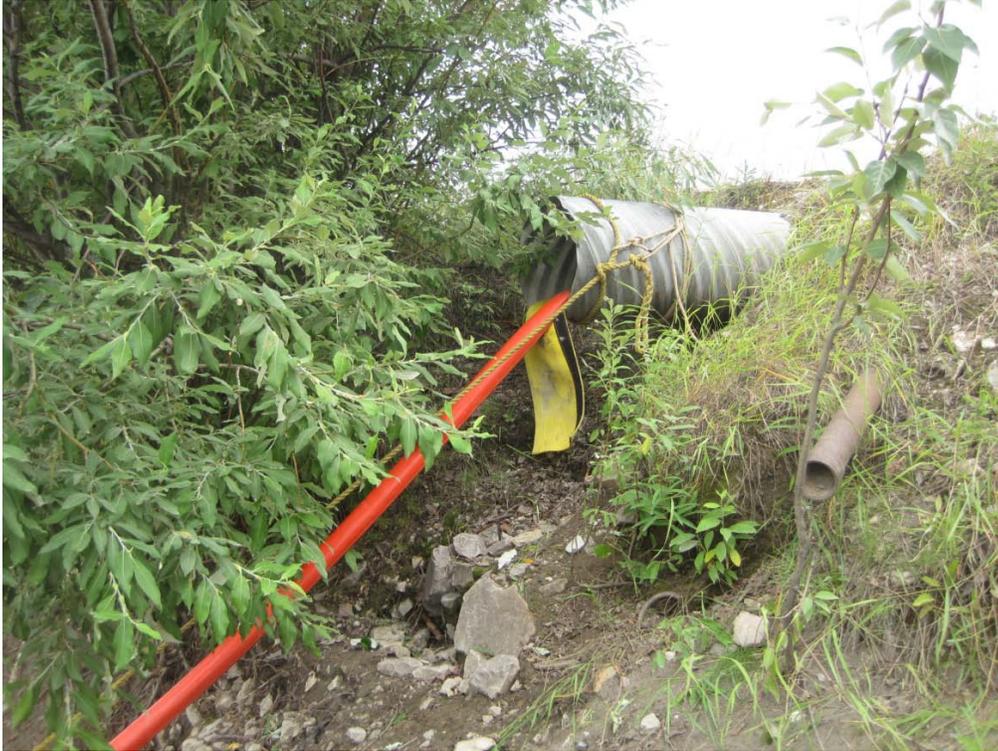
The fuel header is approximately 250 feet inland from the bank. Fuel delivery lines must cross Tonzona Avenue to access the fuel headers. It was observed that the fuel hose is passed through a culvert under the road to avoid disrupting traffic (Photo 4). From there, the hose runs along an

Photo 4: Fuel hose passing through a culvert under Tonzona Avenue.

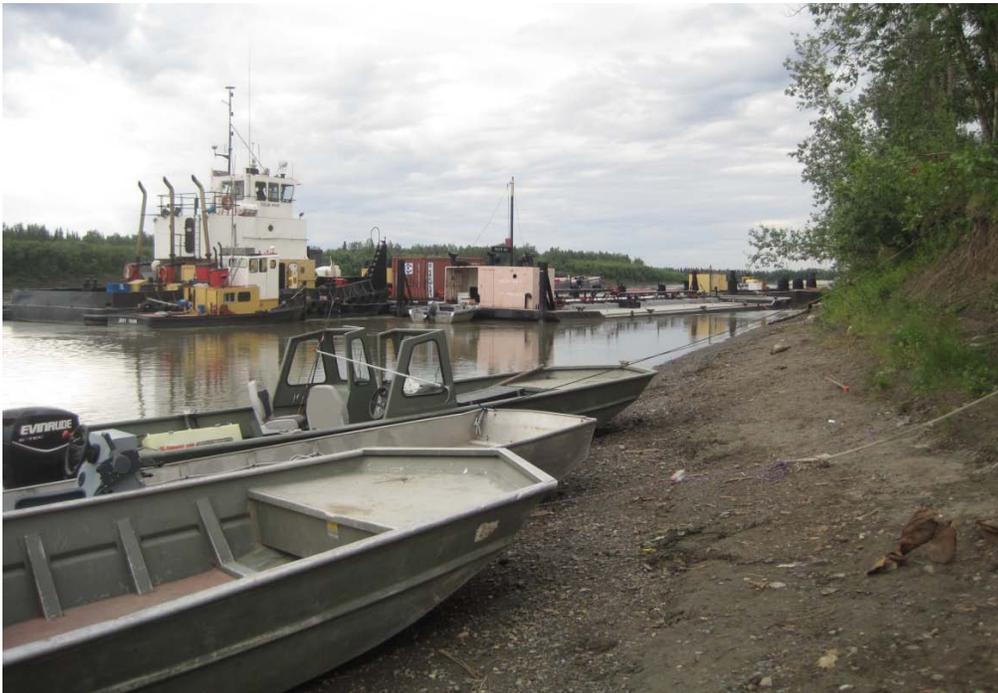
Skiffs use the bank between the boat launch and the USFWS office in the downstream portion of this reach. The boat launch is locally referred to as the AC ramp due to its proximity to the Alaska Commercial store. This is the main skiff beaching area for the community (Photo 5).

Photo 5: Crowley fuel barge moored at the Crowley fuel landing just upstream of skiffs beached adjacent to the AC ramp

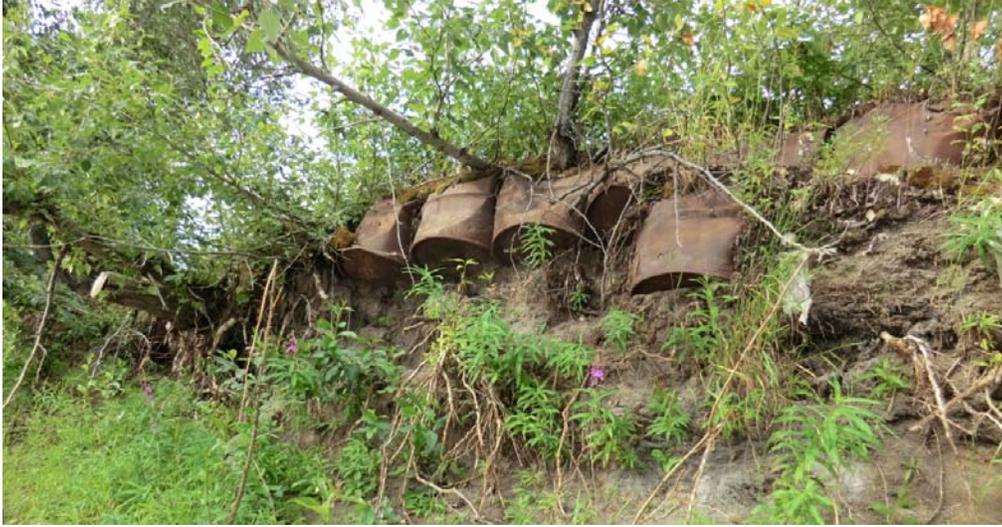
Evidence of former erosion control efforts is in the form of stacked 50 gallon barrels in sections of the bank (Photo 6). Also, garbage and debris is visible at the boat launch. Historically, the community disposed of garbage and debris in this area as a method of erosion control. The practice was discontinued many years ago. According to city representatives, the program was effective in reducing erosion rates in the area but has caused land use problems as garbage and debris are exposed by erosion.

Photo 6: Eroding stream bank in vicinity of the Crowley fuel landing with 50-gallon drums placed as an erosion protection measure.

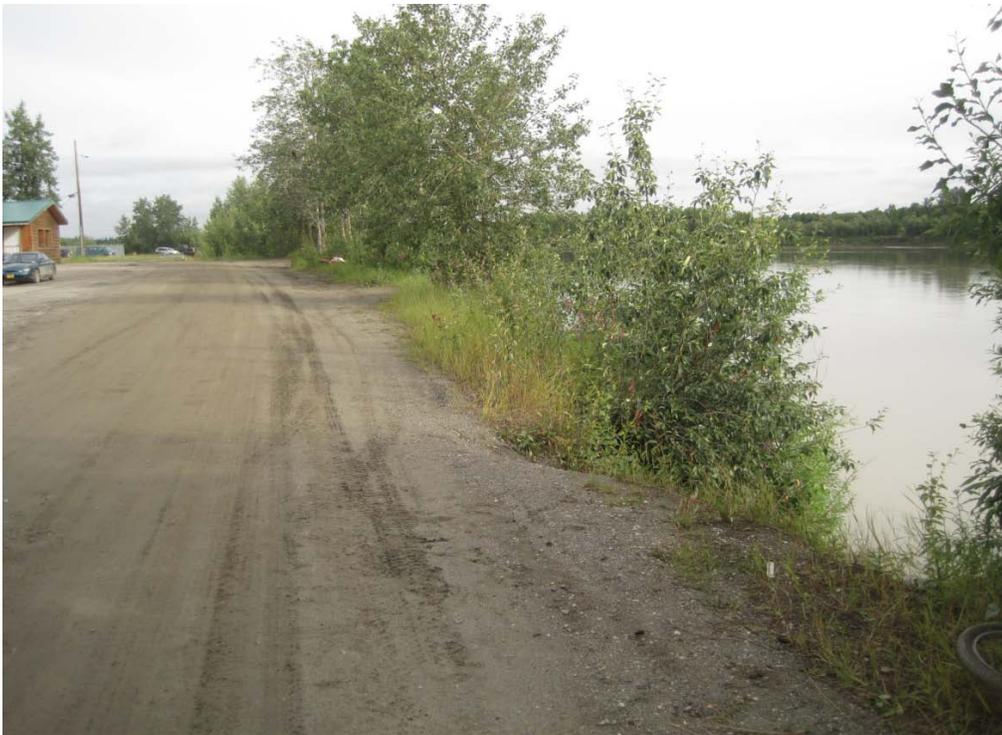
The distance between the top of bank and the shoulder of Tonzona Avenue is quite narrow (Photo 7). The Corps team measured 2 feet from the top of bank to the shoulder at the tree where the barge anchor line was attached to, 4 feet at the point where the fuel hose passed beneath the road, and 15 feet in the area across from the bar.

Photo 7: View looking downstream along Tonzona Avenue showing the narrow spacing between the edge of the road and the eroding bank.

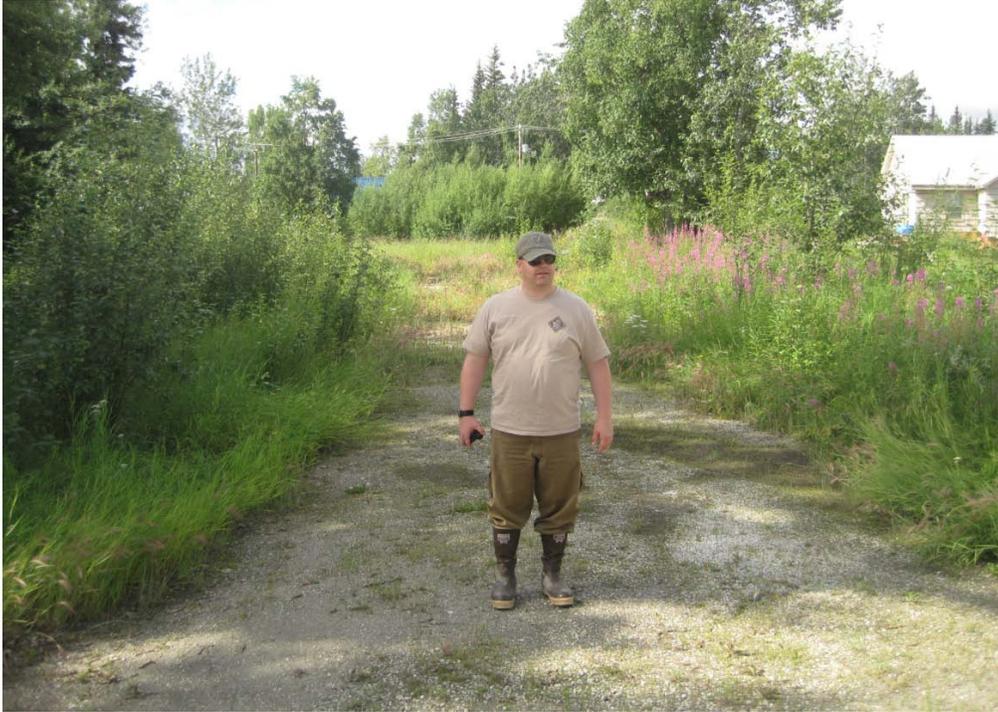
Photo 8: Corps engineer standing at proposed location for upstream mooring point at Crowley fuel landing, looking west.

Due to proximity to roads, a below grade installation is recommended at this site. While the upstream mooring point will affect traffic along Tonzona Avenue while in use, it will not prevent access to any structures. Alternate routes are available. The minor traffic inconveniences are preferred to installing a mooring point within 5 feet of an actively eroding bank. City council members were informed of this impact and it was acceptable to them even though the fuel barges generally remain moored at this location overnight.

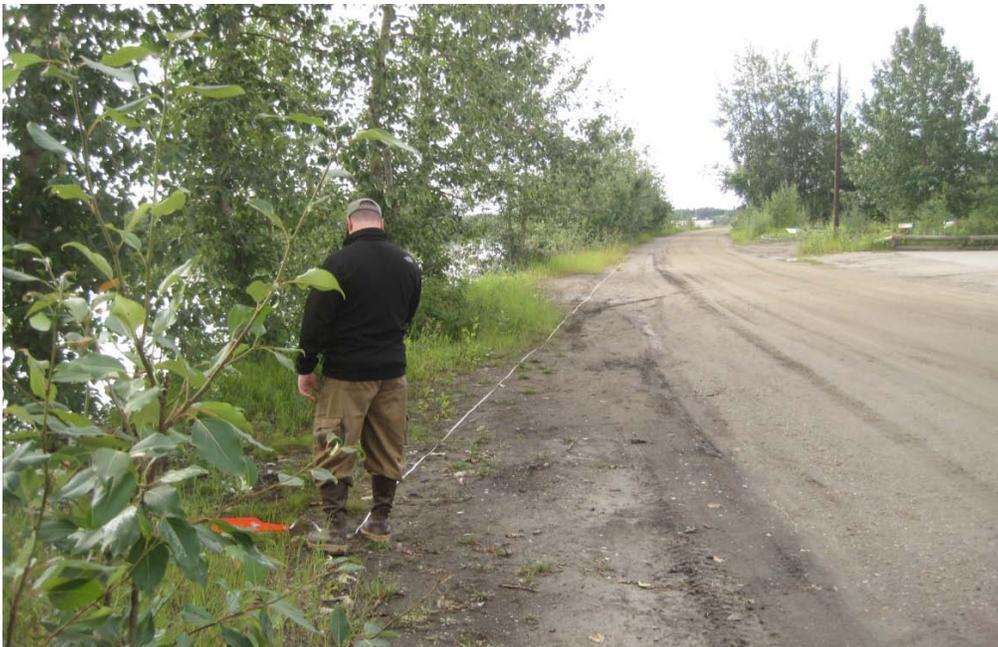
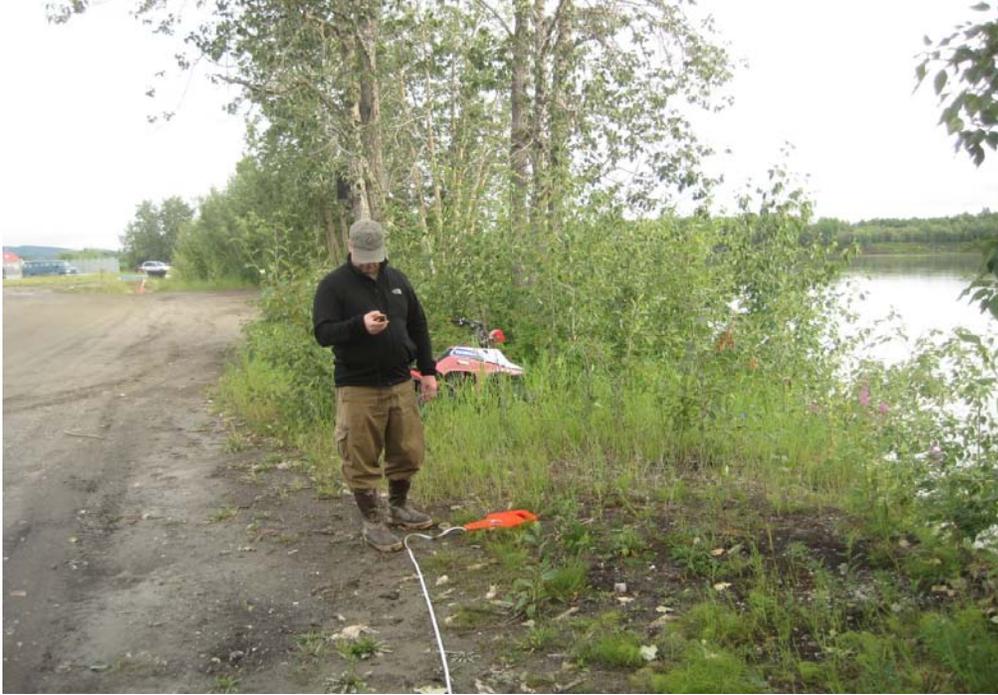
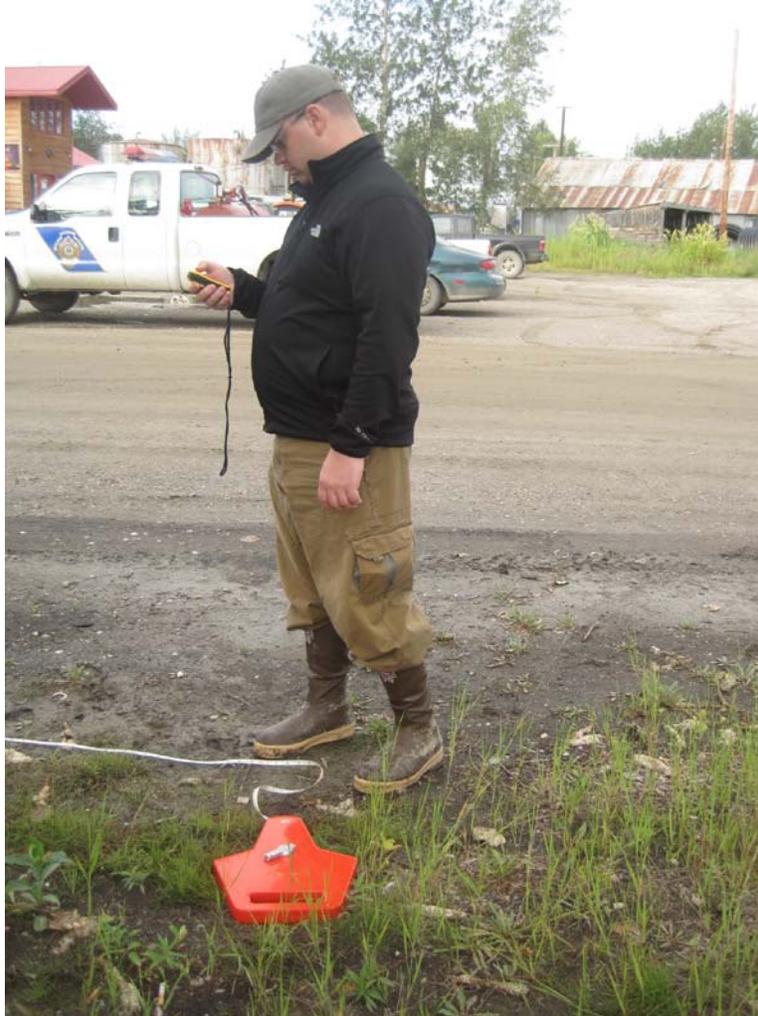
approximately 10 feet from the top of bank. This location is near the point where the bank begins to form a point bar at a major bend in the river and erosion rates are expected to be low. Also, no land was found to be available to install a mooring point on the land side of Tonzona Avenue near this location. Due to traffic along Tonzona Avenue, a below grade installation is also recommended for this location.

Photo 9: Corps engineer standing at proposed location of Crowley fuel landing downstream mooring point, looking upstream.

Photo 10: Corps engineer standing at proposed location of the Crowley fuel landing downstream mooring point, looking downstream.

Photo 11: Corps engineer standing at proposed location of the Crowley fuel landing downstream mooring point, looking west.

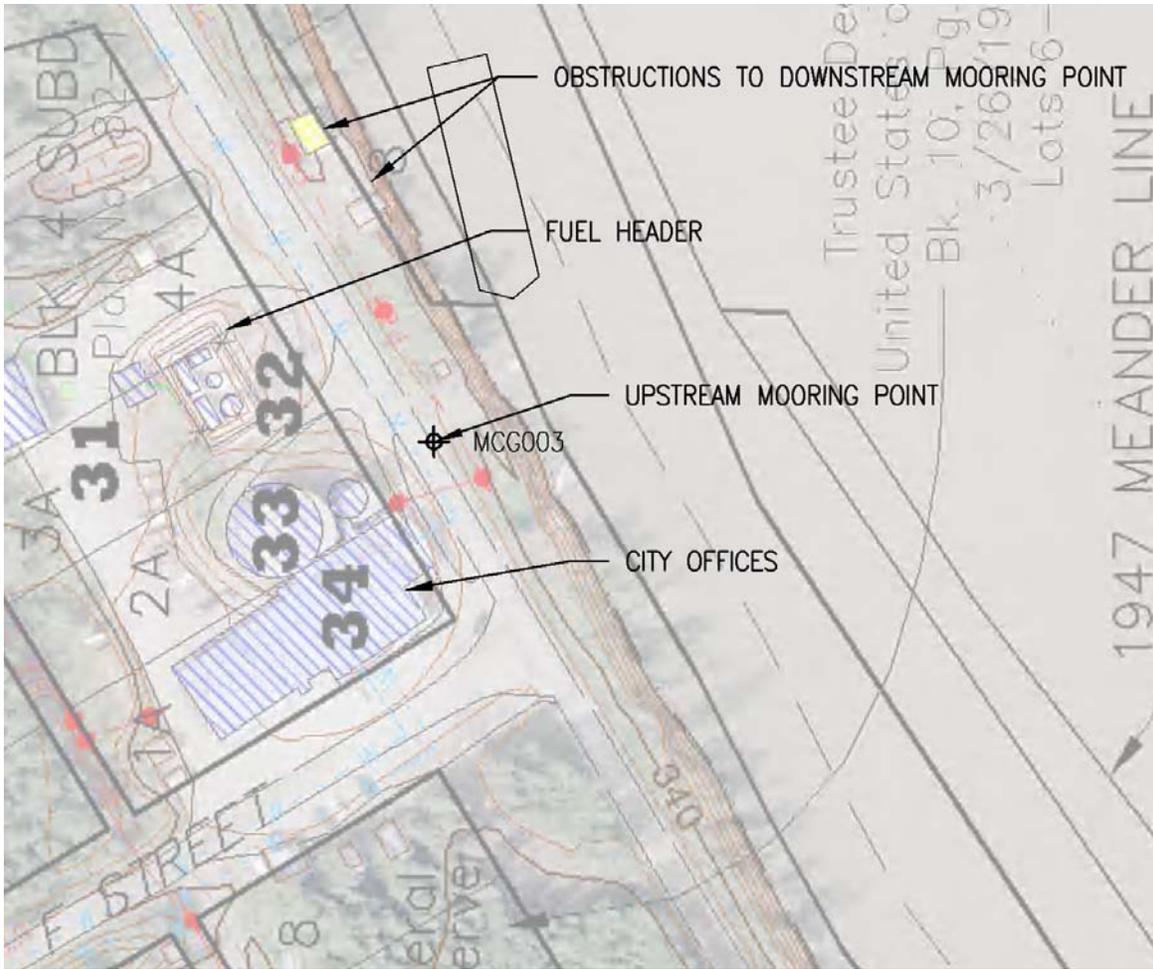
Figure 3: City fuel landing proposed mooring point and existing fuel header

The Corps recommends installing a single mooring point adjacent to Takotna Avenue near the upstream corner of the cleared area next to the water intake structure (Photo 18, Photo 19, Figure 3). This would be a bow line point similar in function to the upstream point at the downstream fuel landing. GPS coordinates of this location are 62.95046° N, 155.58800° W. Due to the proximity of this site to Takotna Avenue, a below grade installation is recommended at this location. Telephone lines run along the river side of Takotna Avenue (Photo 16, Photo 18). This mooring point must be field located to avoid any conflicts between the pile driver crane and the telephone wires.

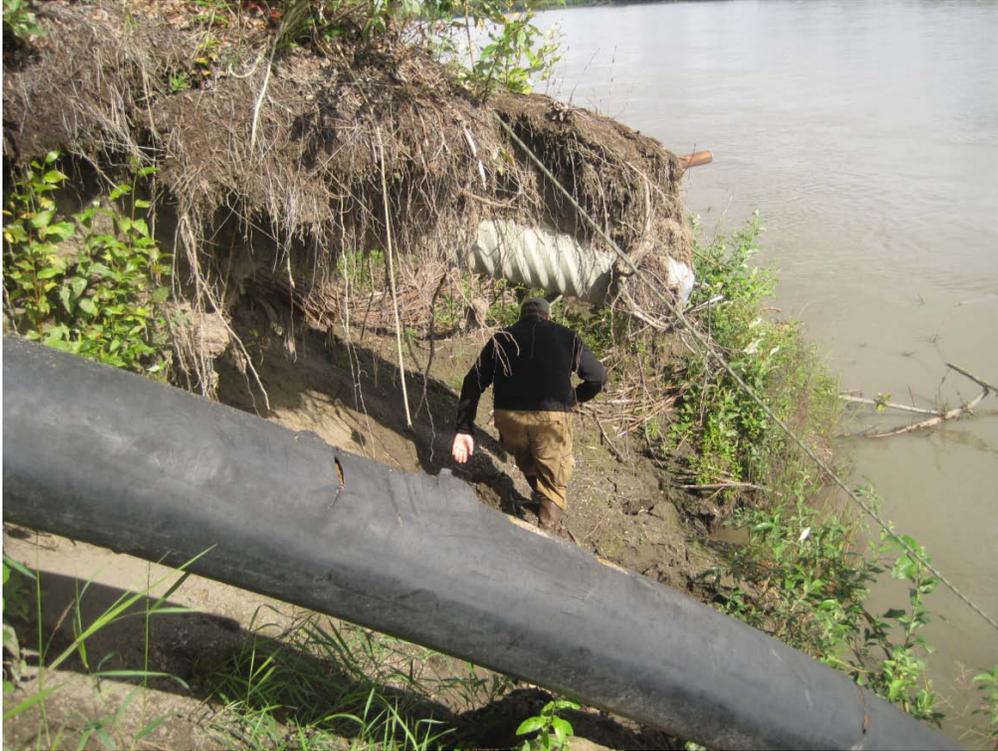
Similar to the downstream fuel landing, this landing is along an actively eroding cut bank approximately 20 feet high. Much of the top of bank is undercut several feet with vegetation stabilizing the bank materials. At one location, a culvert supports a 6-foot undercut near the water supply intake (Photo 12). The bank near the water intake is very steep, and access to the intake is provided by an aluminum ladder stored at the site (Photo 13).

Photo 12: Eroding stream bank at the city fuel landing site. Corps engineer is passing beneath a culvert that is supporting a mat of overhanging soil and vegetation above it.

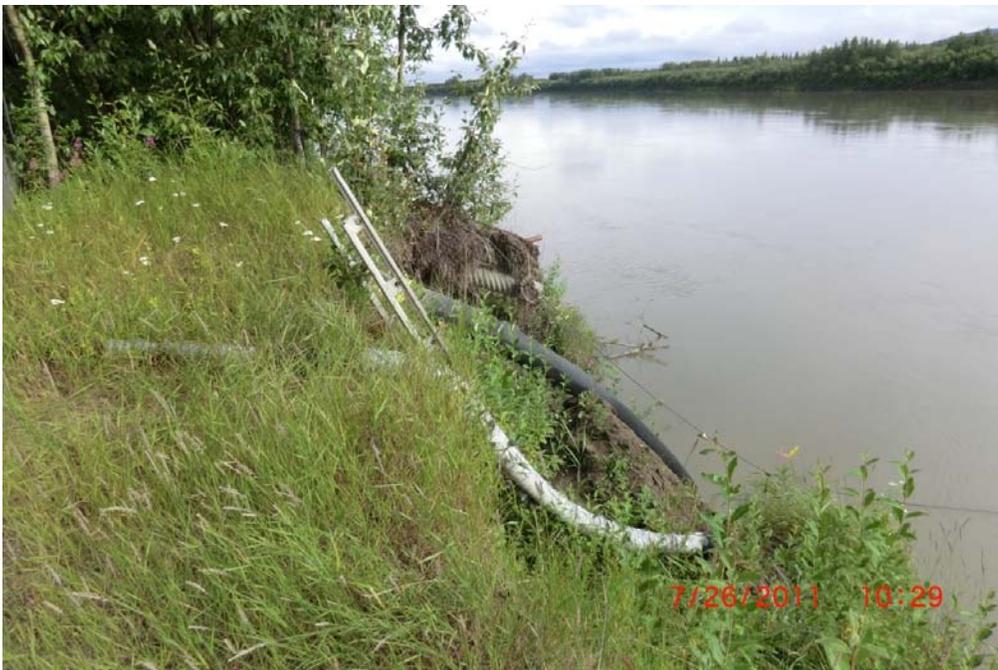
Photo 13: Eroding stream bank at the city fuel landing with ladder required to get between the river and top of bank.

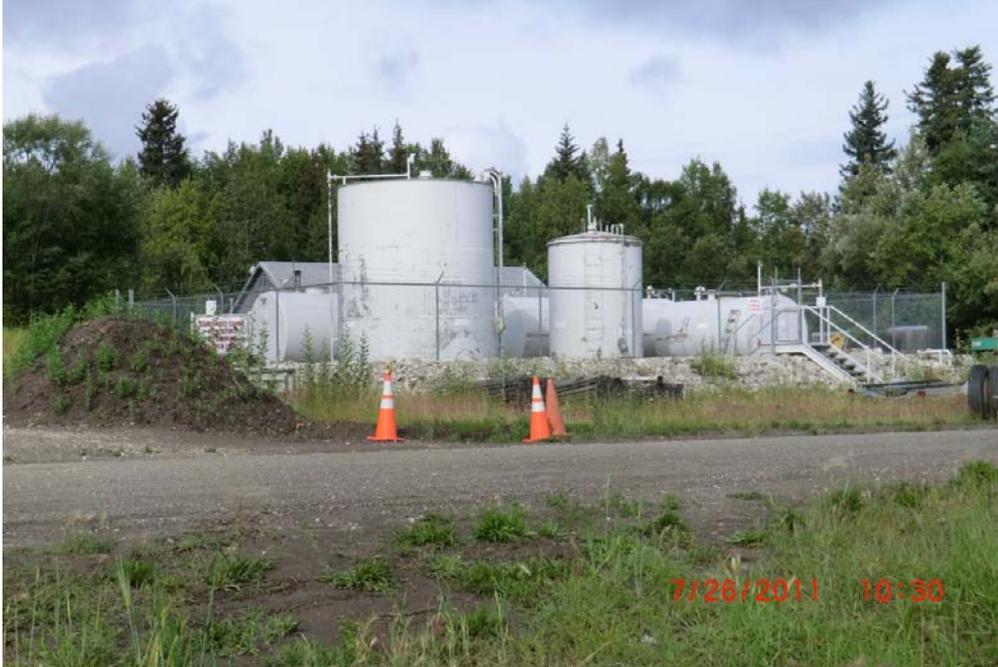
The current fuel header is within the fenced area of the tank farm across Takotna Avenue from the landing site (Photo 14). A decommissioned header was located outside the fenced area of the tank farm. City officials informed us that they recently decommissioned this header to eliminate costs associated with required inspections by the U.S Coast Guard.

Photo 14: City tank farm. The fuel header is located near the right corner of the visible fencing.

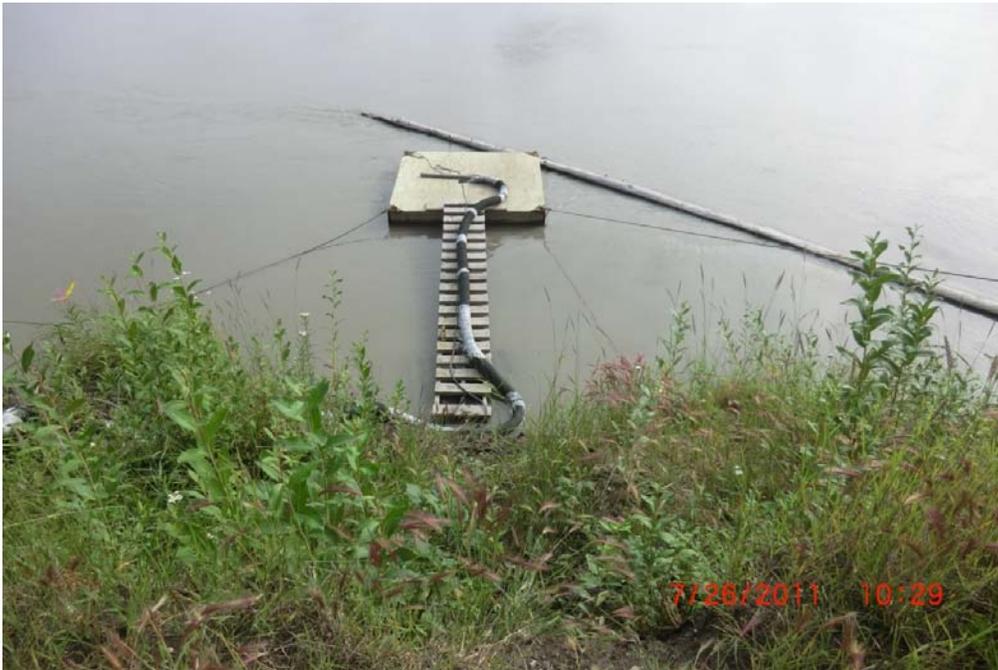
A floating water intake structure for the city water supply is just upstream of this landing (Photo 15). It is tied off to a galvanized fence post driven into the ground and a small tree.

Photo 15: City of McGrath drinking water intake structure located just upstream of city fuel landing.

Potential conflicts between barge mooring lines, the water intake structure, and water intake structure mooring lines must be avoided. City officials suggested that coordination with Jim Kaercher of KAE Engineering be initiated regarding the operation of the water intake structure. Subsequent coordination with Jim Kaercher has confirmed that installation of the proposed mooring point will not interfere with the existing water intake structure.

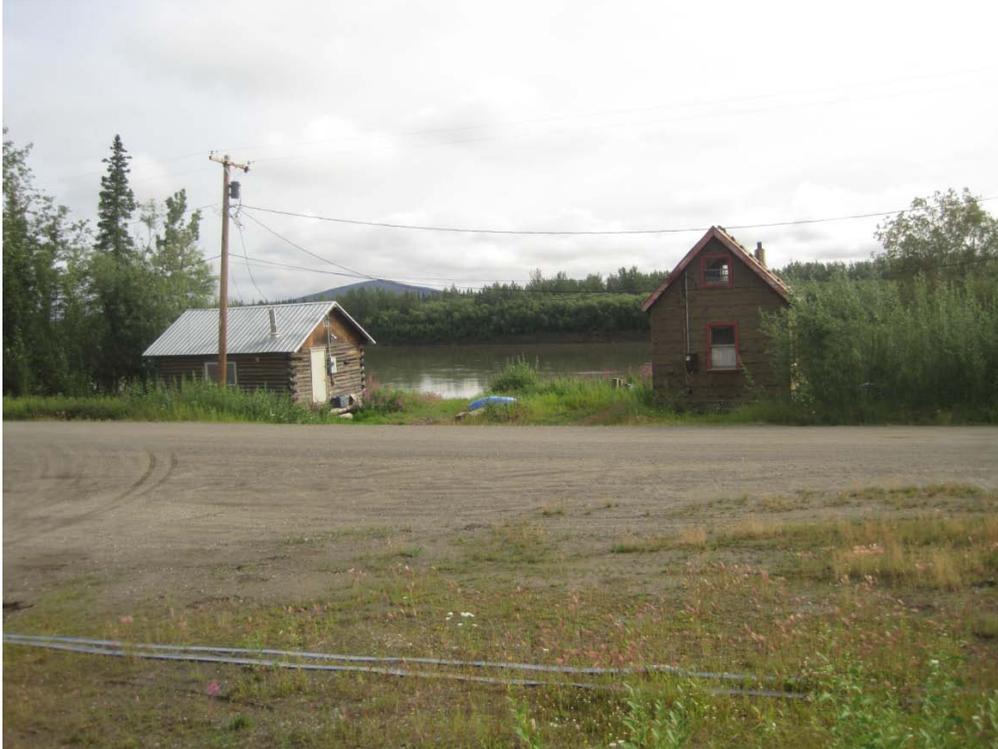
Just downstream of the tank farm are two small, currently occupied structures located between Takotna Avenue and the eroding stream bank (Photo 16). The location of these structures severely limits the potential sites for a downstream mooring point at this landing.

Photo 16: Buildings located just upstream of city fuel landing. Note telephone wires.

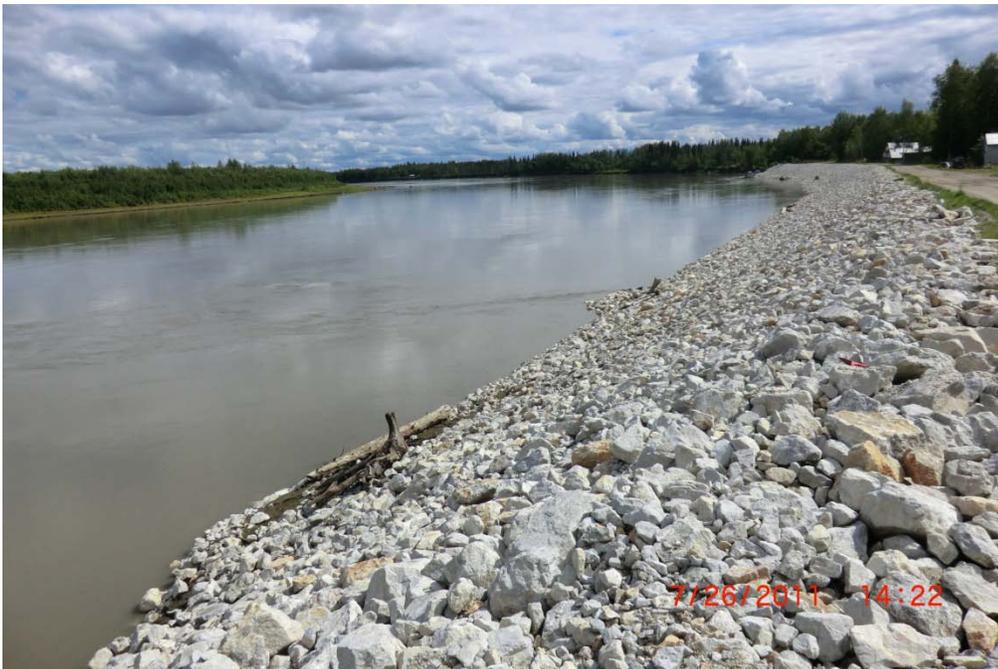
The Natural Resources Conservation Service (NRCS) is investigating construction of an erosion protection rip rap embankment along the section of bank where this landing is. The NRCS completed a similar structure slightly upstream in McGrath in 2009 (Photo 17). If this rip rap erosion protection structure was constructed, it would alter the method barge operators would use to secure their vessels against the current. They would not moor their vessels along the bank of the river because of the risk of hull damage to the barges from the rock. Either a landing area with its own mooring points would need to be incorporated into the design of the structure or fuel barges would anchor offshore and float in the fuel hoses. The likelihood of future funding availability for this project is not known.

Photo 17: Looking upstream at the riprap revetment designed by NRCS. This revetment lies upstream of the water intake structure.

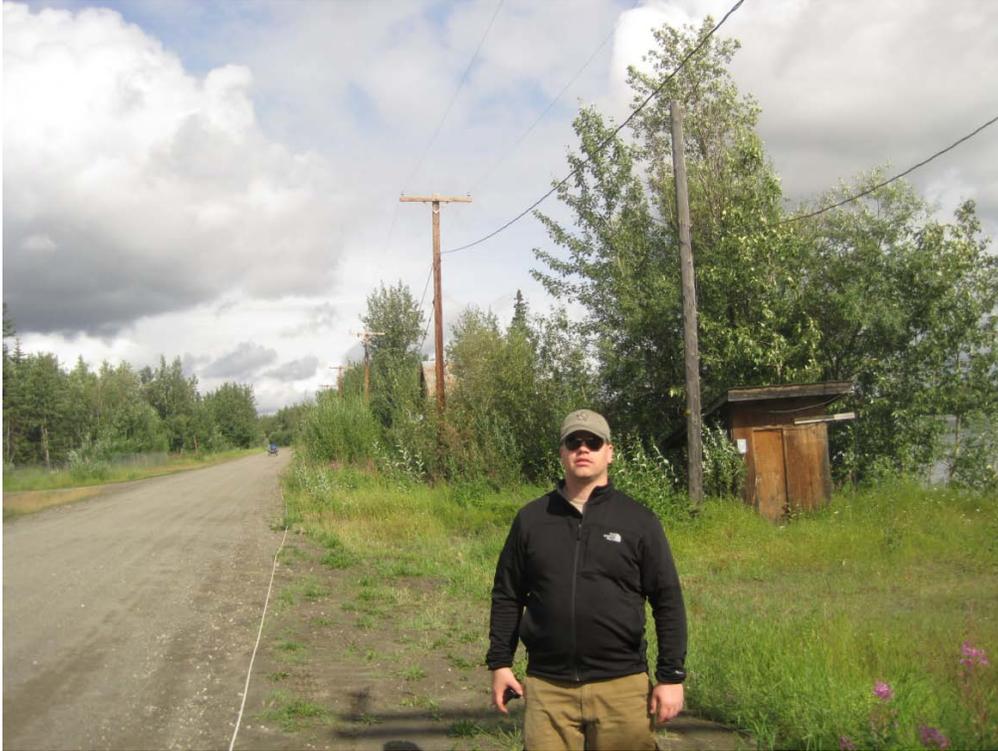
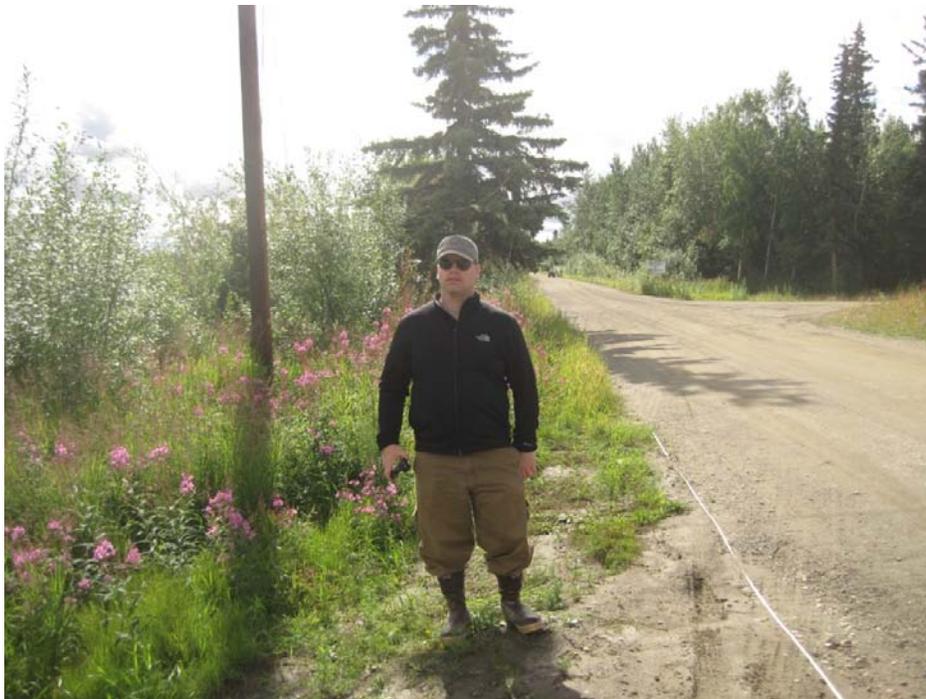
Photo 18: Corps engineer standing at proposed location of the upstream city fuel landing mooring point looking downstream. Note telephone wires.

Photo 19: Corps engineer standing at proposed location of upstream city fuel landing mooring point, looking upstream.

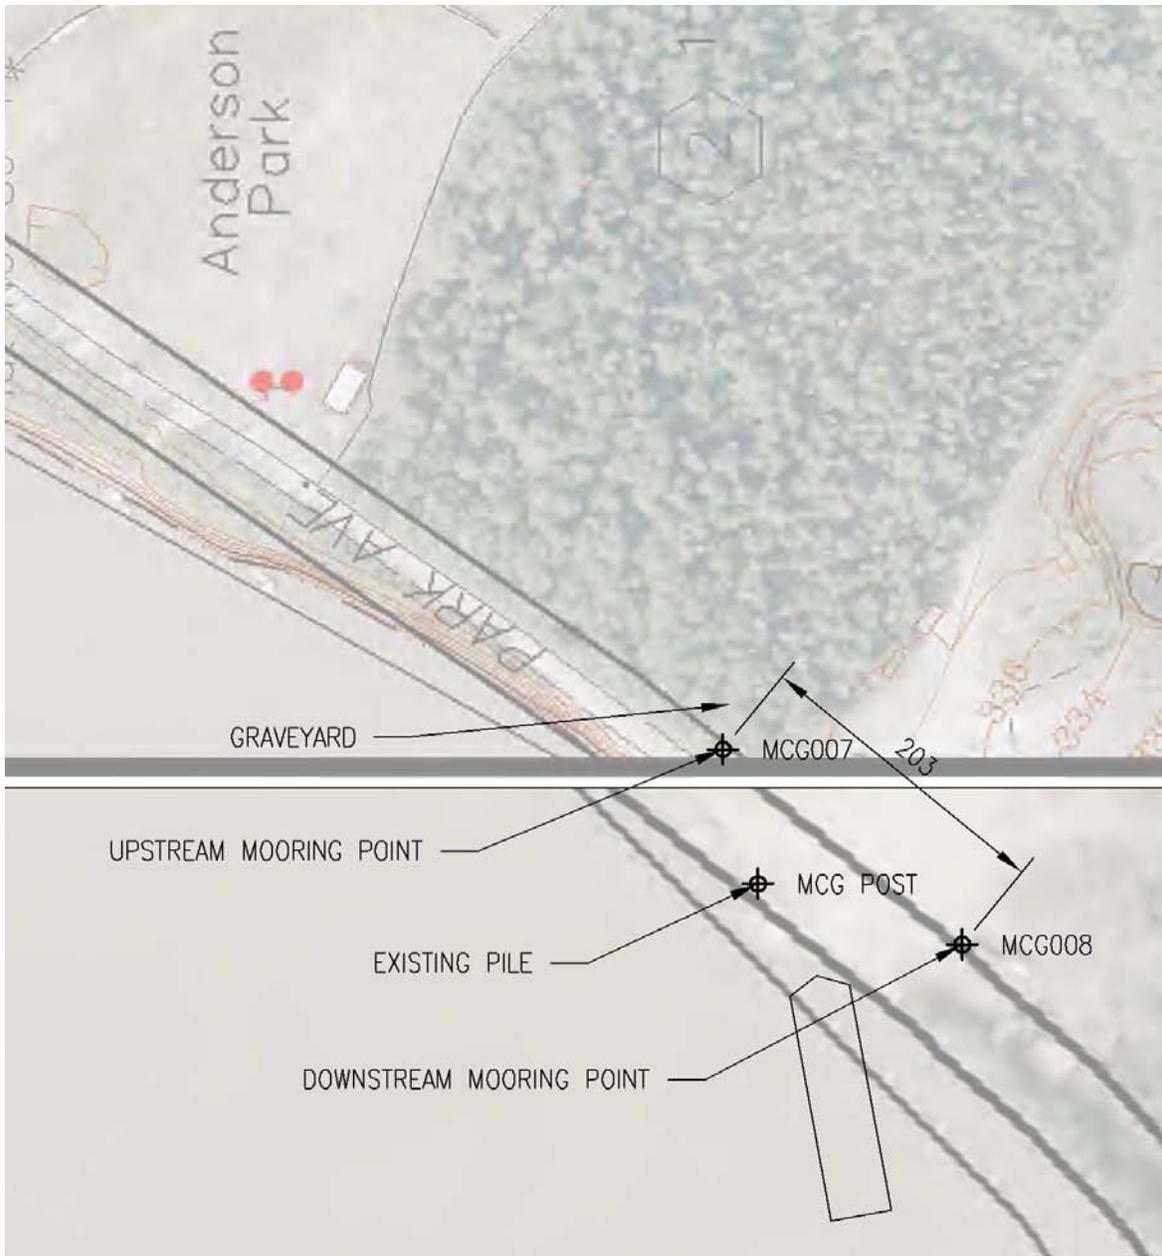
Figure 4: Freight Landing Site and Proposed Mooring Point Locations.

While the existing mooring point indicated a favorable location for an upstream mooring point, due to erosion concerns, the Corps recommends replacing it with a mooring point farther inland. The recommended location is across the access road to the landing area and approximately 20 feet upstream from where the access road meets the staging area clearing (Photo 21, Figure 4). This location is 22 feet from the top of bank and 78 feet from the existing mooring point. GPS coordinates of this location are 62.94037° N, 155.59039° W. Due to its proximity to the access road, a below grade installation is appropriate at this location. Use of this mooring point would require a mooring line to stretch across Park Avenue, which would cut off access to the staging area while the barge is unloading.

The Corps recommends placing an additional below grade mooring point 200 feet downstream along the edge of the staging area, 52 feet inland from the top of bank, and 140 feet from the existing mooring point (Photo 22 and Photo 23, Figure 4). GPS coordinates of this location are 62.94003° N, 155.58943° W.

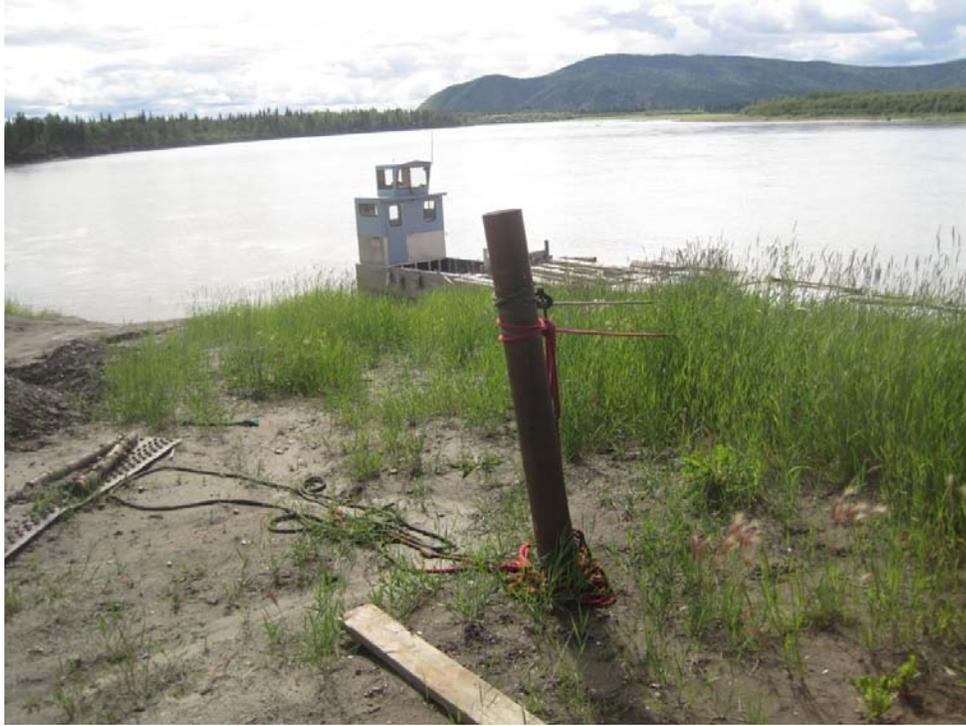
During our site visit, a small tug and barge were moored at this landing. They were anchored, via two anchor lines, to an existing mooring point consisting of a 6-inch-diameter metal pipe protruding from the ground several feet from the top of the eroding bank (Photo 20). The pipe was leaning downstream and toward the river.

Photo 20: Small tug and barge anchored to mooring point at the freight landing site. The edge of the landing ramp is visible to the left of the photo.

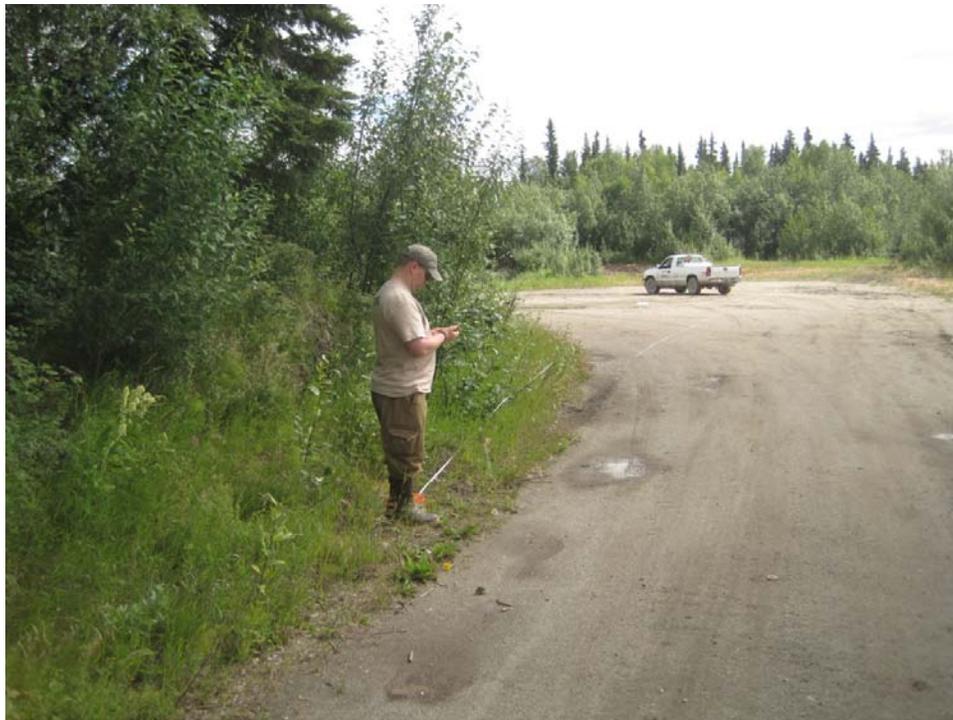
This landing consists of an unimproved ramp angling down to the river (Photo 20) with an adjacent unimproved staging area (Photo 21 and Photo 22). The landing is on a cut bank experiencing active erosion. The McGrath Barge Landing Scoping Analysis Report, completed by the Corps in January 2009, identified this area as a transition point for annual erosion rates. Immediately upstream, annual erosion rates were estimated at 1.7 feet, while immediately downstream, annual erosion was estimated at 7 feet. The rate at this site should be between those values.

Photo 21: Corps engineer standing at proposed location of upstream mooring point at the freight landing, looking downstream toward staging area.
