## **ALASKA DISTRICT TRIP REPORT**

**Project:** Denali Commission Mooring Points Phase 4

**Description:** McGrath Trip Report

**Dates:** 26 - 27 July 2011

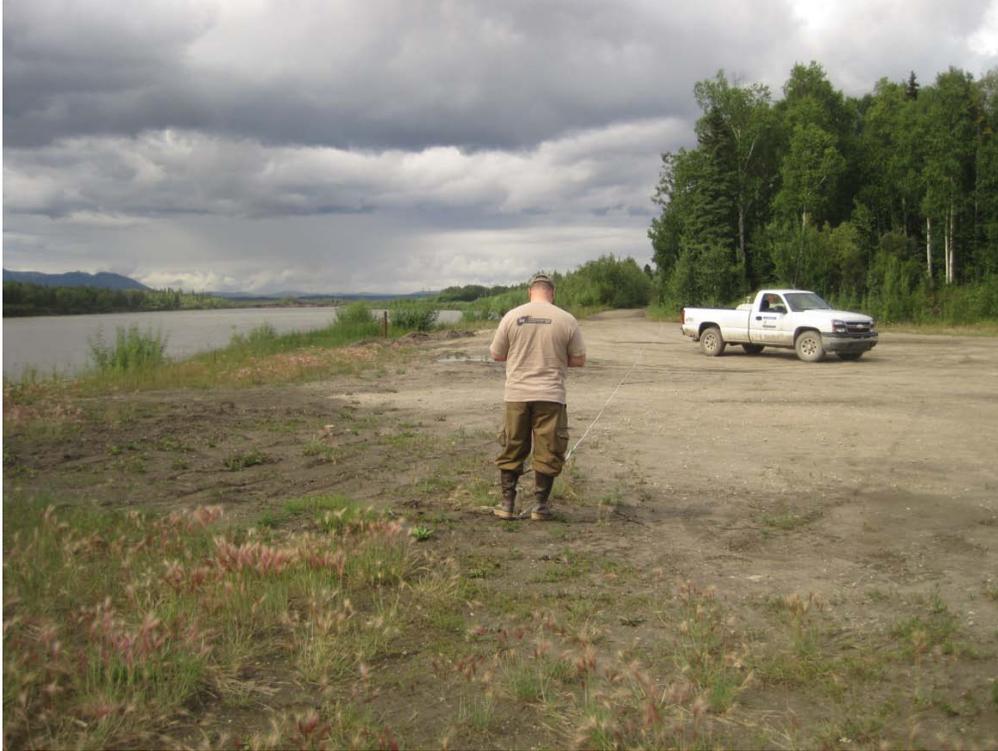
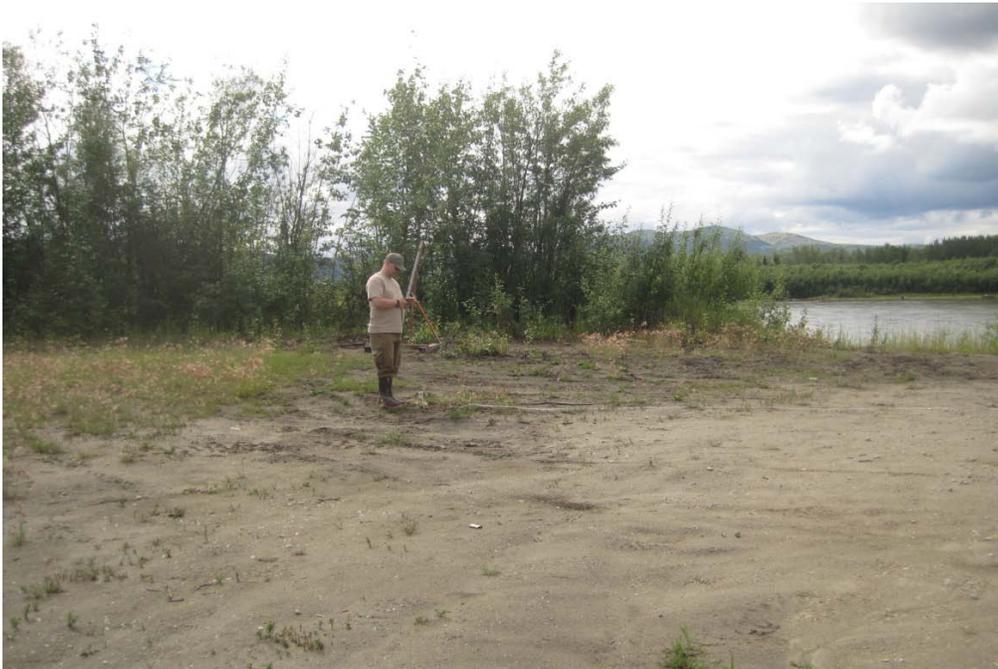
Photo 22: Corps engineer standing at proposed location of downstream mooring point at edge of staging area at the freight landing, looking upstream.

Photo 23: Corps engineer standing at proposed location of downstream mooring point at edge of staging area at the freight landing, looking toward river.

The Corps recommends placing an additional below grade mooring point 200 feet downstream along the edge of the staging area, 52 feet inland from the top of bank, and 140 feet from the existing mooring point (Photo 22 and Photo 23, Figure 4). GPS coordinates of this location are 62.94003° N, 155.58943° W.
