## ALASKA DISTRICT TRIP REPORT

**Project:** Denali Commission Moorings Points Phase 4 – Yukon River

**Description:** Nulato, Alaska Trip Report

**Date:** 16 June 2011

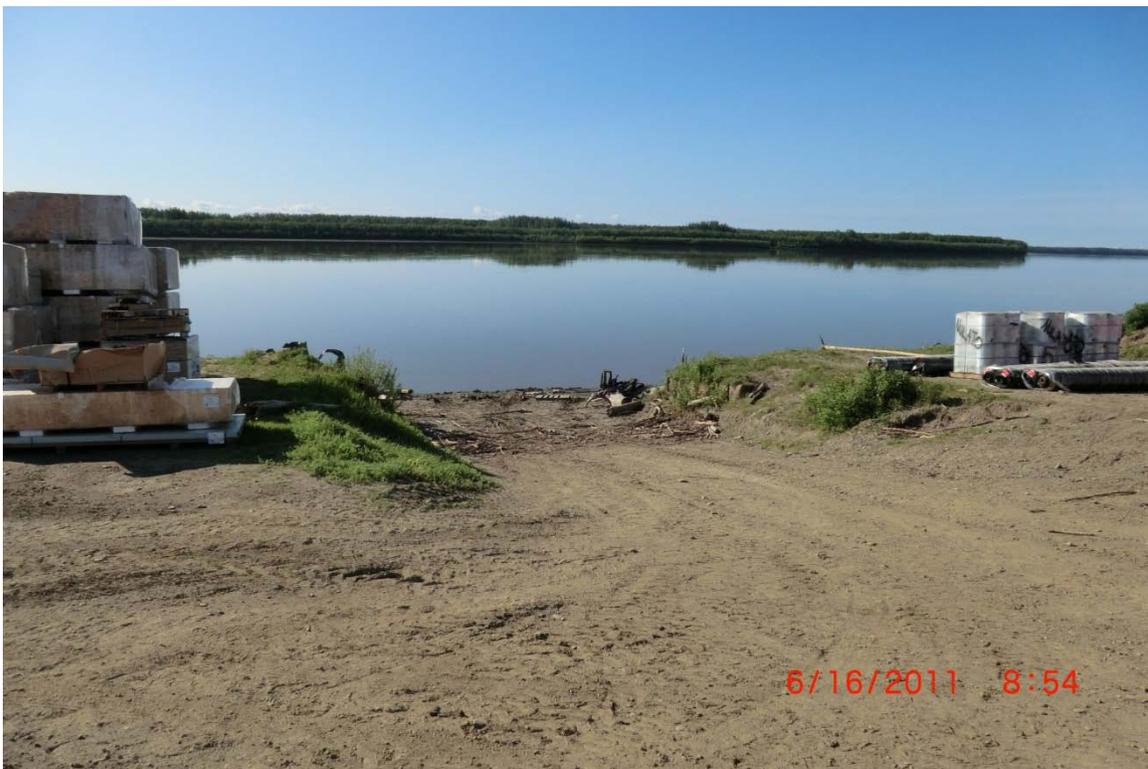
We arrived at the freight landing site at 0935 hours. This landing site consists of a dirt ramp perpendicular to the river (Photo 1), with erosion protection consisting of culverts on both sides (Photos 2 and 3).

A staging area is adjacent to the landing. While on site, much material was stored in the staging area (Photo 1) because there had been a recent barge delivery. A majority of the materials seemed to be related to an airport improvements project in the village.

Photo 1: Nulato freight barge landing site and portion of staging area

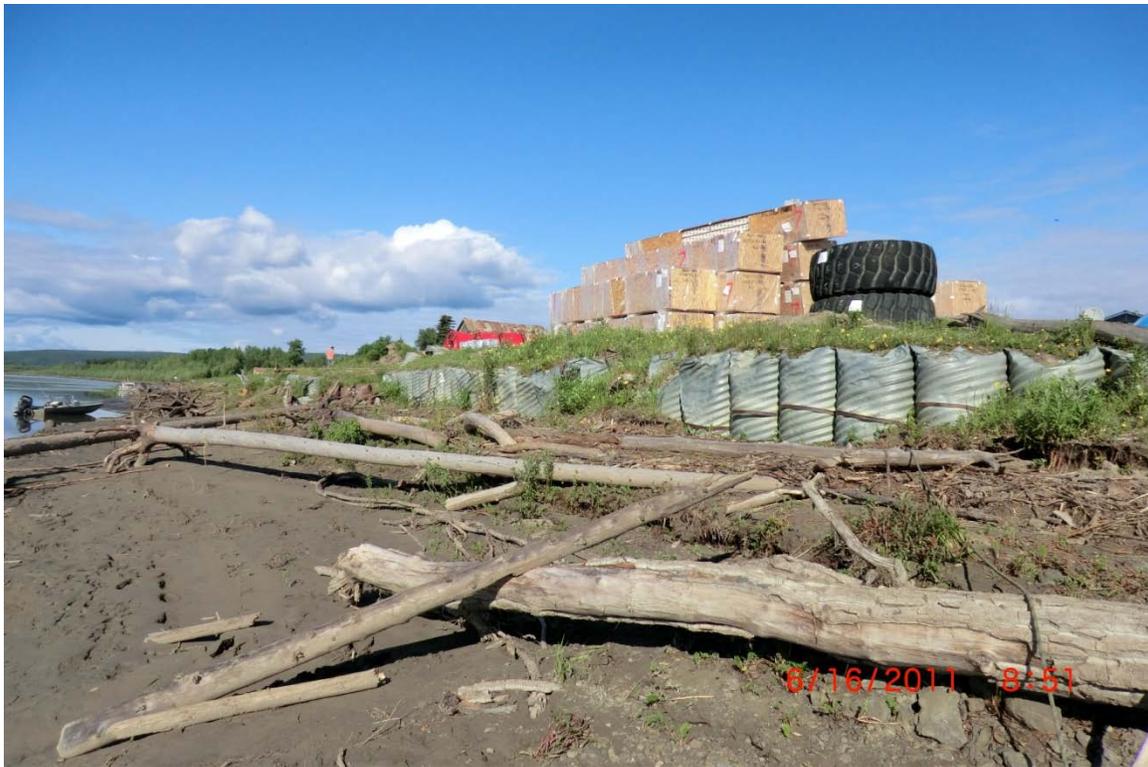
Woody debris from a recent high water event was scattered along the bank and staging area (Photos 2 and 3).

Photo 2: Nulato freight barge landing looking downstream. Note culvert erosion protection

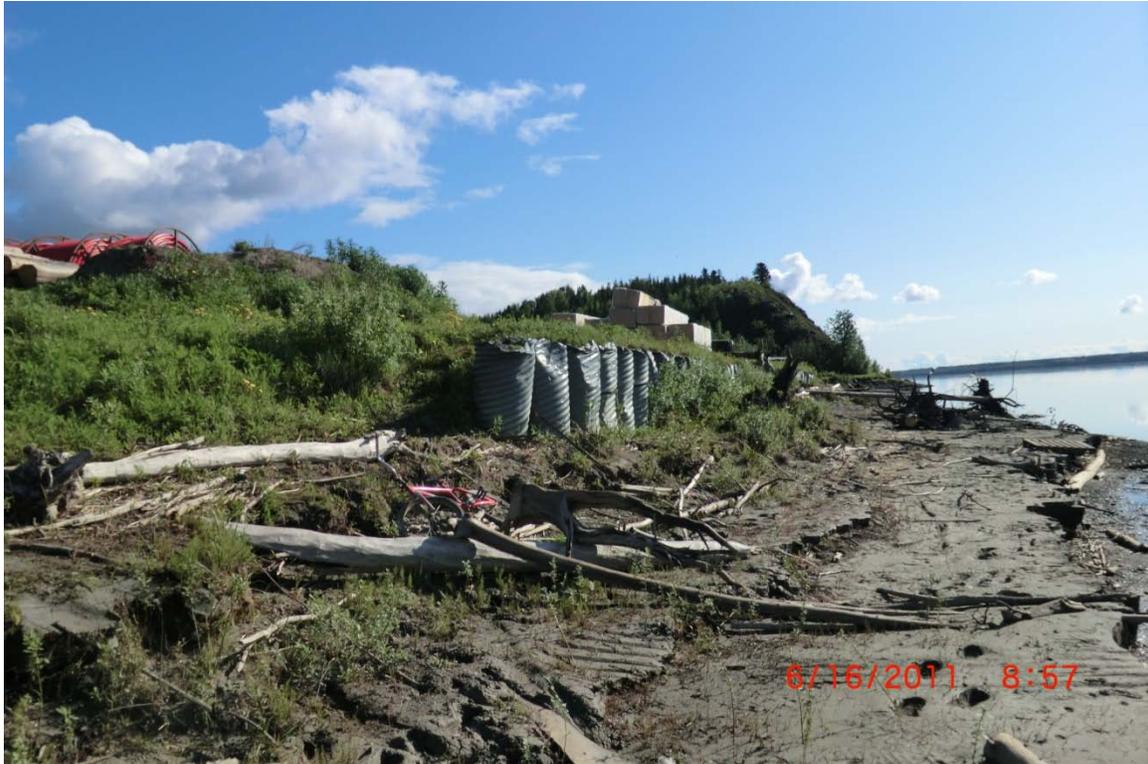
Photo 3: Nulato freight barge landing looking upstream. Note culvert erosion protection

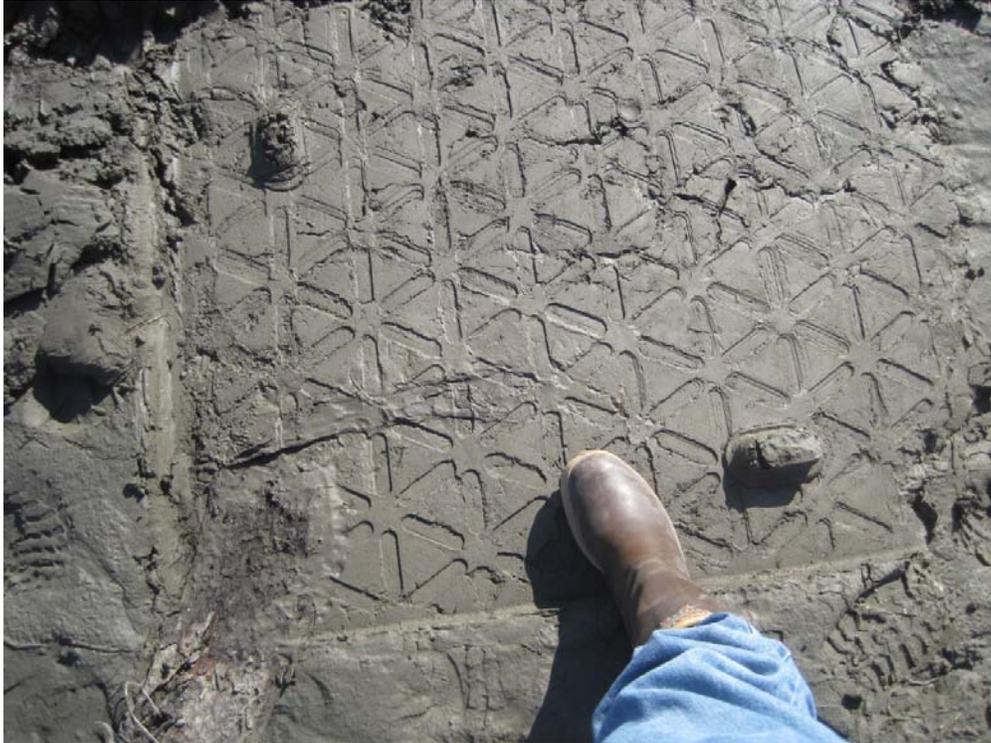
Imprints of Duramats were still evident in the mud from the most recent delivery (Photo 4). Duramats are temporarily placed by some barge operators to provide a more stable surface to offload equipment across.

Photo 4: Duramat imprint in freight landing site mud

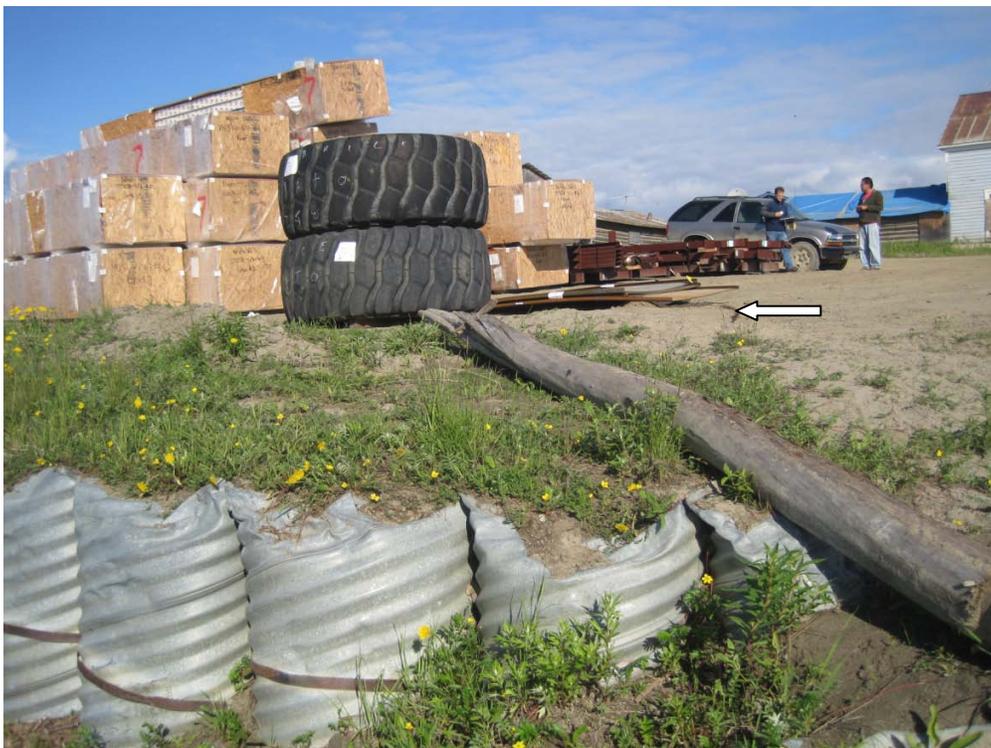
An old deadman, consisting of a broken tie-down cable, was at the upstream end of the landing in line with the upstream end of the erosion protection and just upstream of large tractor tires stored at the landing area (Photo 5).

Photo 5: Upstream end of landing area. Broken tie-down cable is evident to the right of tractor tires and indicated by arrow.

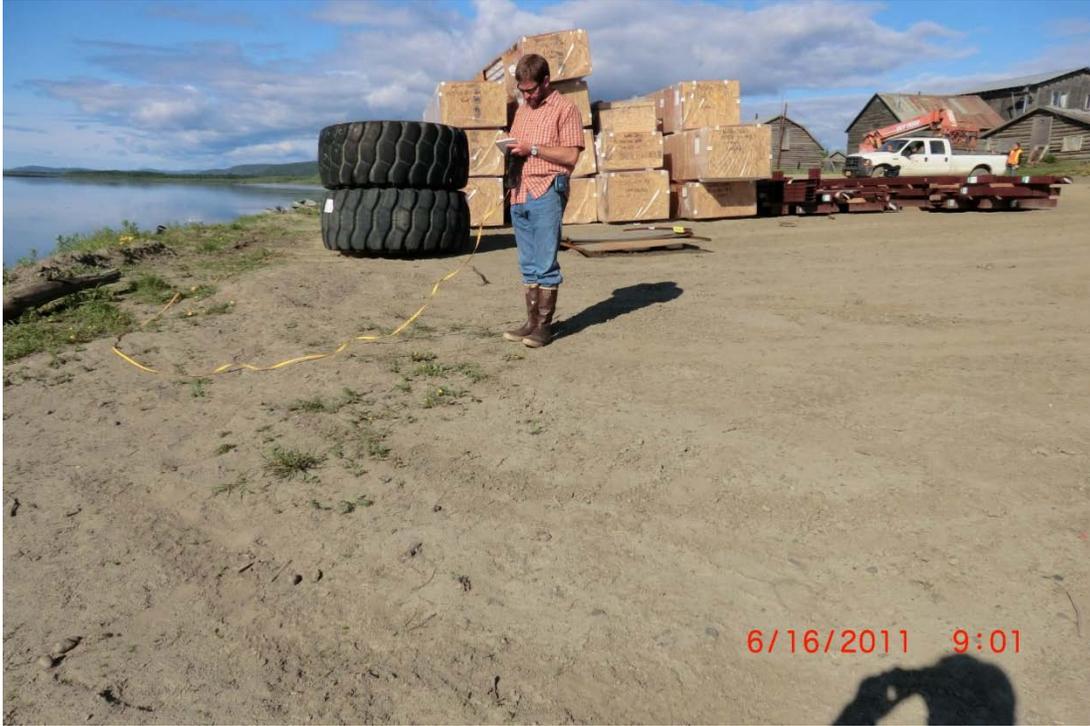
The proposed location of the upstream mooring point is 80 feet upstream of the center of the ramp, 5 feet upstream of the broken cable deadman, and 20 feet inland from the face of the erosion protection (Photo 6). This mooring point is recommended to be a below-grade installation to avoid conflicts with the staging area. The coordinates of this proposed mooring point are 64 43.121' N 158 06.101' W.

Photo 6: Corps employee standing at proposed location of upstream mooring point

Installation of two below grade mooring points, as described in this report, is recommended at the freight landing.

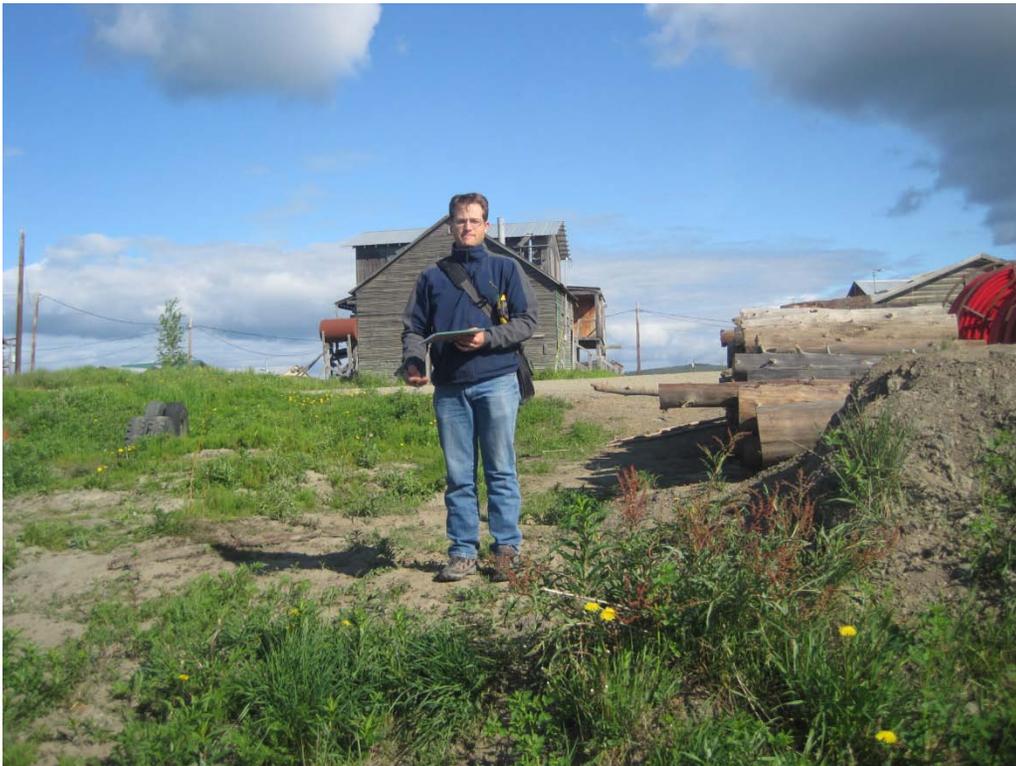
The proposed location of the downstream mooring point is 75 feet downstream of the center of the landing ramp adjacent to the downstream end of the small vegetated hill and 20 feet inland from the erosion protection (Photo 7). A below-grade installation is recommended for this mooring point to minimize staging area impacts. The coordinates of this proposed mooring point are 64 43.109' N 158 06.152' W.

Photo 7: Corps employee standing at proposed location of downstream mooring point. Note vegetated small hill to the right.

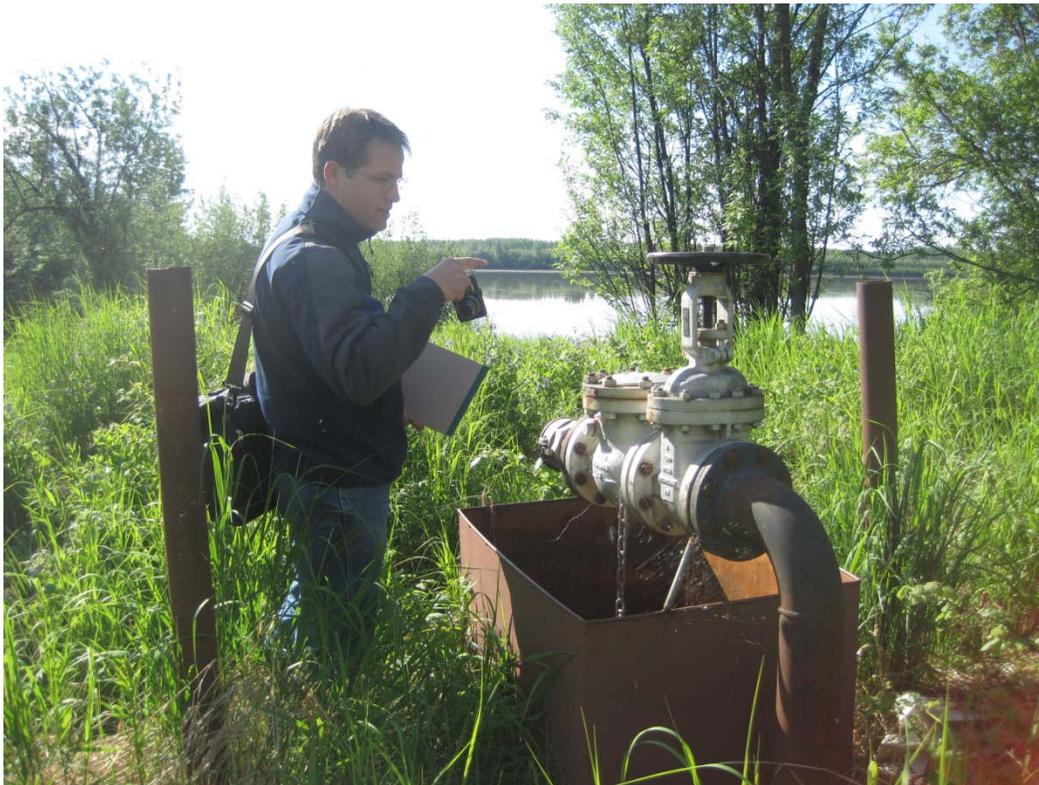
We arrived at the city fuel header at 1015 hours (Photo 8). We did not have previous knowledge of this particular header. Based upon the existence of fuel residue and a worn path to the header, it appeared to still be in use. Paul Mountain explained that fuel barges moor at the freight landing site and that fuel deliveries are made via a hose run from the freight landing site. The Alaska Village Electric Cooperative (AVEC) fuel landing site lies across the mouth of a creek. Many skiffs are moored in the creek adjacent to the city fuel header (Photo 9). No mooring points are recommended at this site.

Photo 8: City fuel header. Yukon River is in background.

There is no need for mooring points at either the city or school fuel headers.

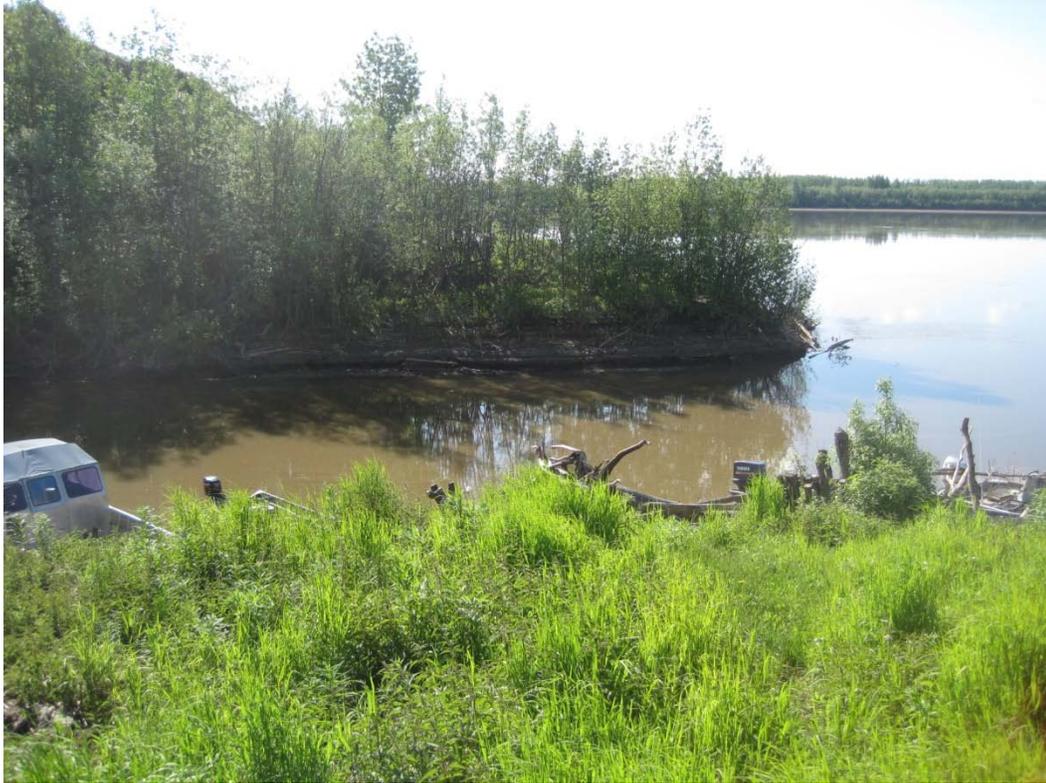
Photo 9: Mouth of creek located between city fuel header and AVEC landing site. Note skiffs moored in mouth of creek.

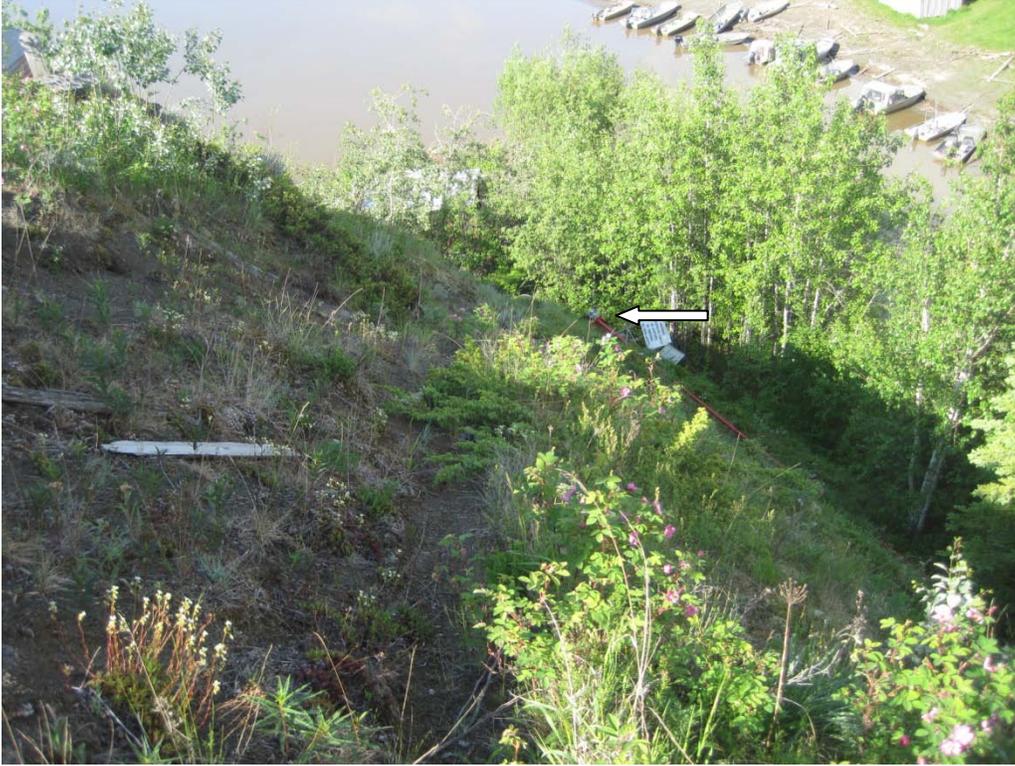
The fuel header is near the base of this steep and rocky bluff, approximately a hundred feet inland from the Yukon River (Photo 10).

Rock is very prevalent throughout this location and could make it difficult for drilling.

Photo 10: AVEC fuel header located at base of bluff to the right

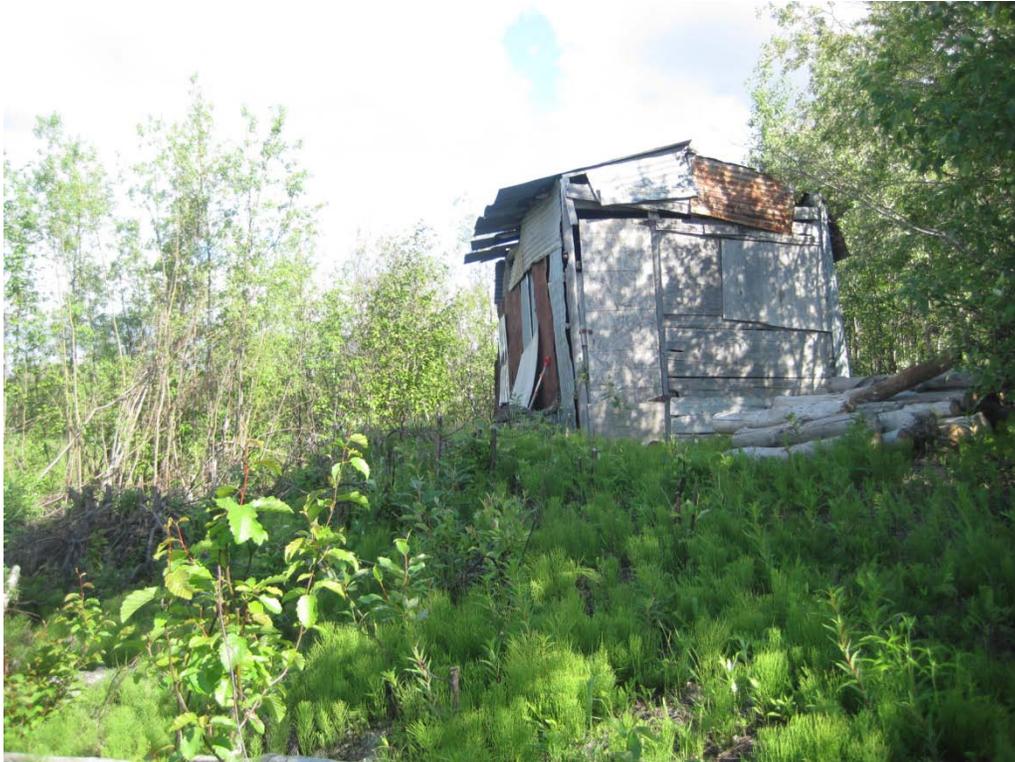
There is a smokehouse between the river and the fuel header (Photo 11).

Photo 11: Smokehouse near AVEC fuel header

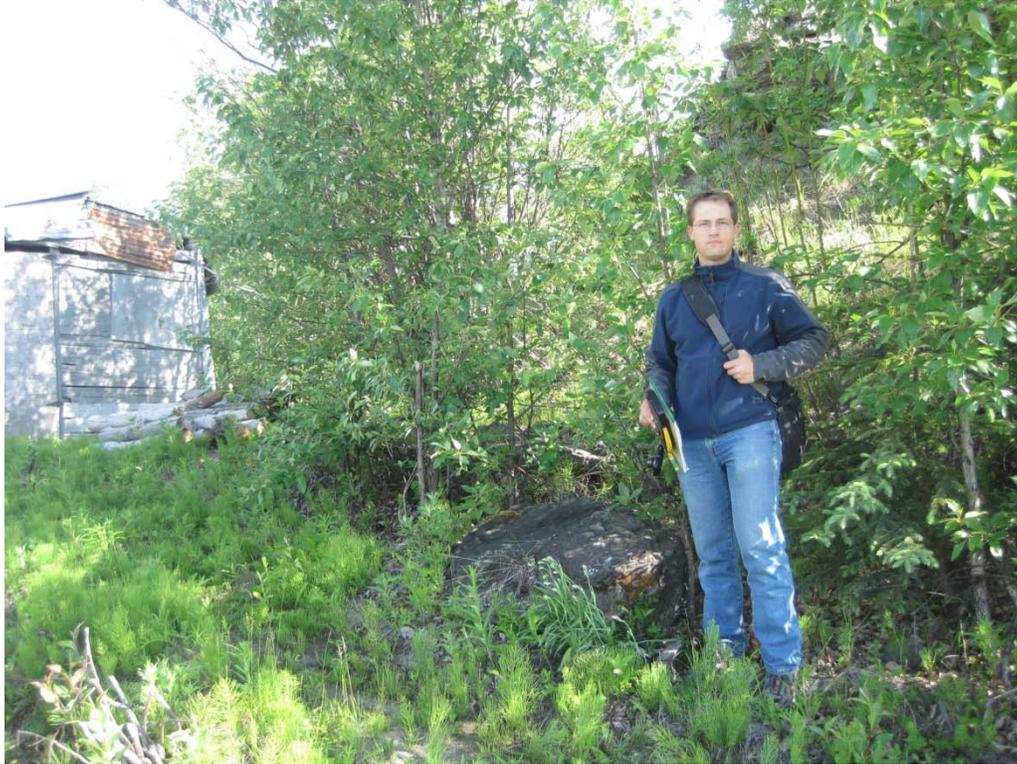
The best location for a single mooring point appeared to be at the base of the bluff on the river side of a small boulder. The boulder is approximately 38 feet toward the Yukon River from the side of the smokehouse closest to the Yukon River (Photo 12). An above grade installation would be appropriate at this location.

Due to real estate concerns, it does not appear that a mooring point can be installed at this landing. The entire area at the base of the bluff appropriate for mooring point installation is a Native allotment. This information was obtained from Craig Adams at the Bureau of Indian Affairs

Photo 12: Corps employee standing at potential location for AVEC fuel landing mooring point.

Due to the presence of a Native allotment, no mooring points are recommended for the AVEC fuel header.

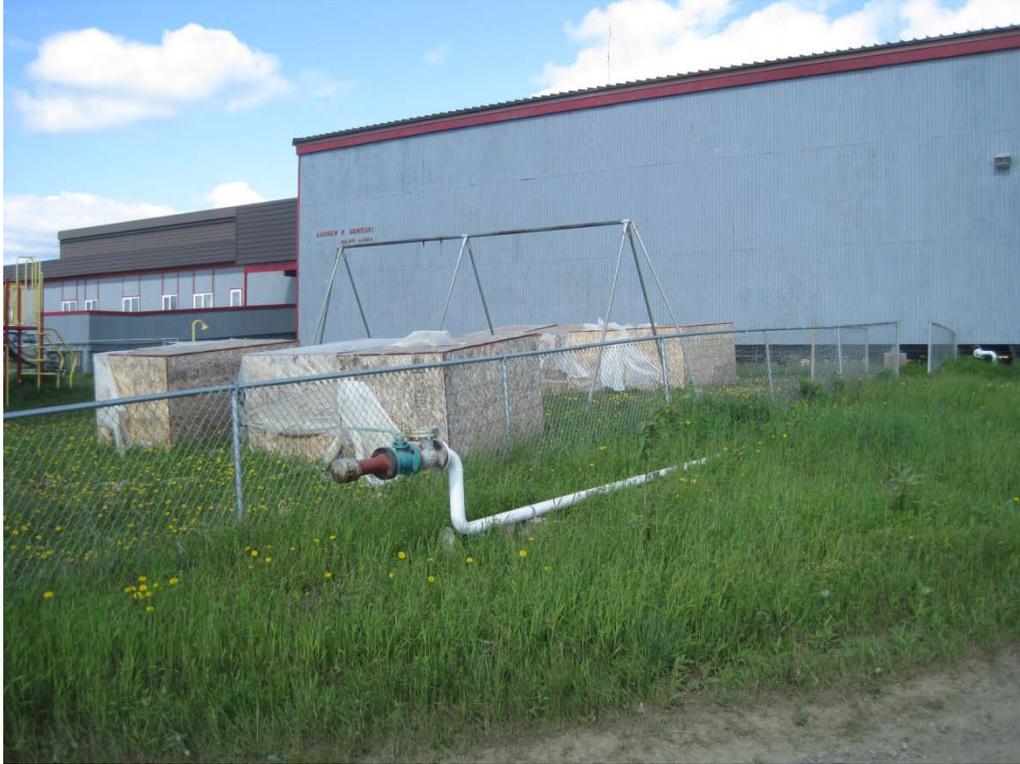
We arrived at the school header (Photo 13) at 1210 hours following the public meeting. We were informed by the barge companies that mooring points are not needed here. No mooring points are recommended at this site.

Photo 13: School fuel header
