SITE VISIT MEMORANDUM

DATE March 19, 2009

PROJECT NO. 06144 Selawik Clinic

SUBJECT Site Visit

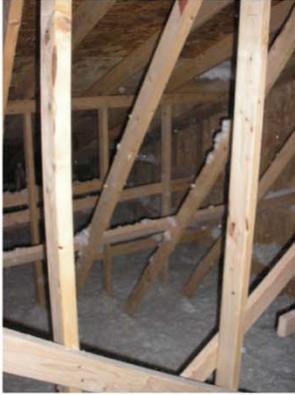
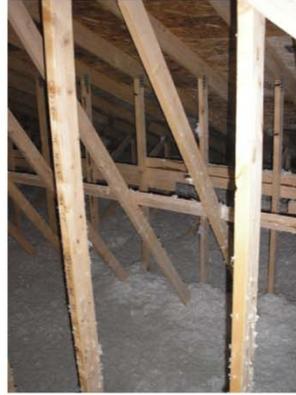
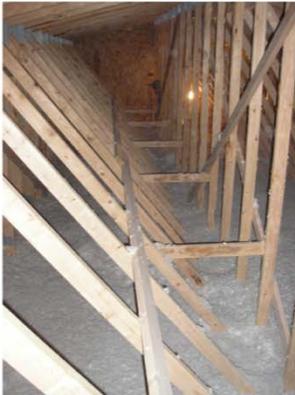
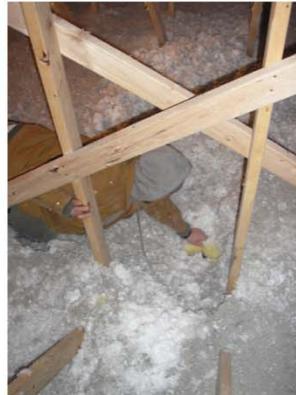
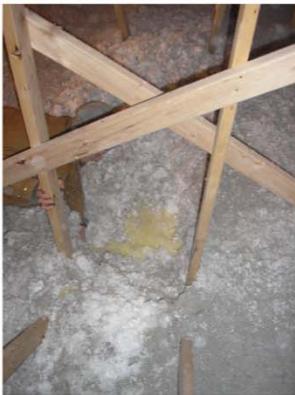
Attic-01.JPG

1. The temporary attic access above Laundry 131 to facilitate installing the blow-in insulation permitted me to gain access to the attic space to verify all insulation had been installed according to the contract documents. The R-19 batt ceiling insulation and blown in installation in the attic is complete. Some minor work remains in the attic including the installation of the draft stop doors. Gideon assures me the temporary access will be sealed back up when access is no longer required.

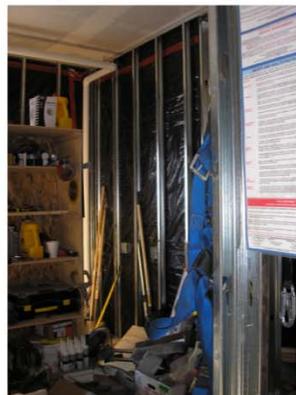
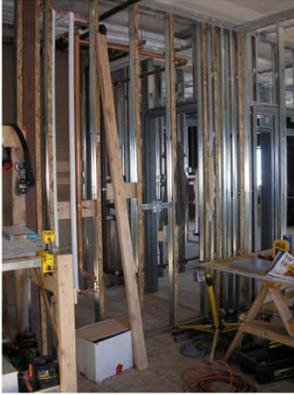
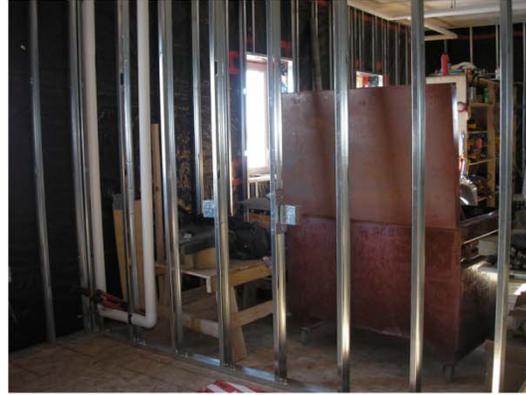
Dental-01.JPG

11. We discussed the proposed location of a new dental suction in the northeast corner of Dental 120. This will require modification of the casework to be provided in this area. Additionally, the drain line for the dental suction will be routed inside the wall behind to the sink along the same wall. A new dedicated circuit and exhaust fan unit will need to be supplied to this location once the owner has finalized the equipment selection and layout.

12. The remainder of dental suite equipment shall be owner supplied and owner installed, which shall include but not be limited to a new central console, new treatment columns, new dental chairs and new floor and wall mounted cabinets on the west and east walls of Dental 120. Once the owner has finalized the equipment selection and layout we can coordinate with the contractor to provide in floor blocking for all floor mounted equipment, all backing for all wall mounted cabinets and verify the location of receptacles won't conflict with any owner provided and installed equipment.

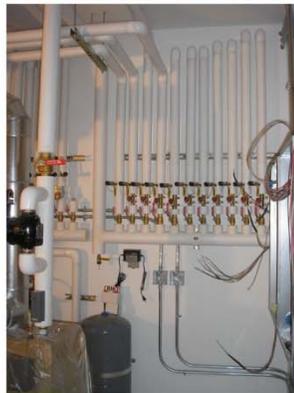
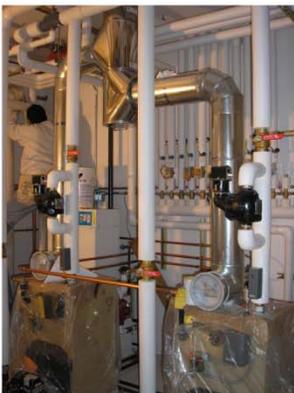
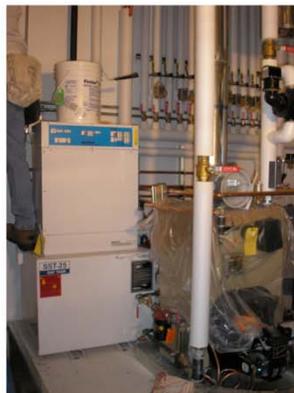
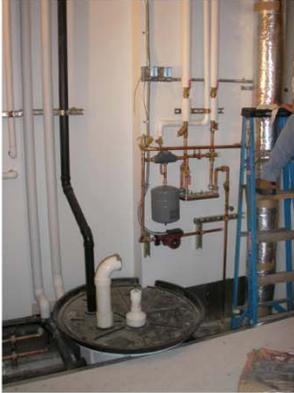
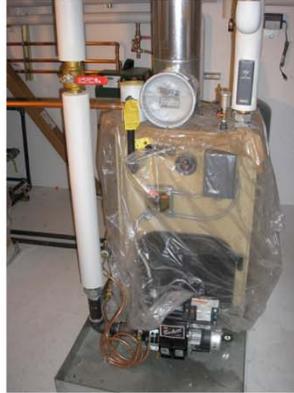
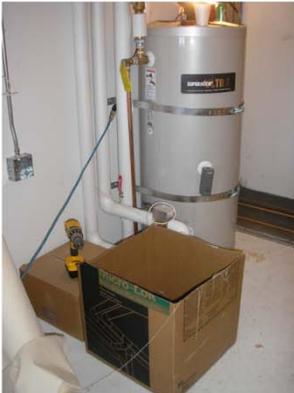
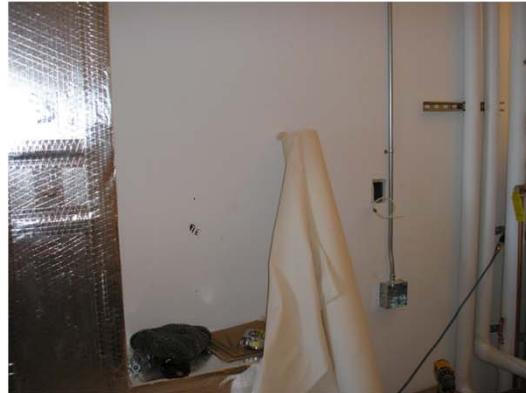
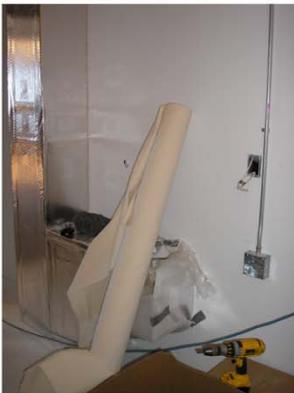
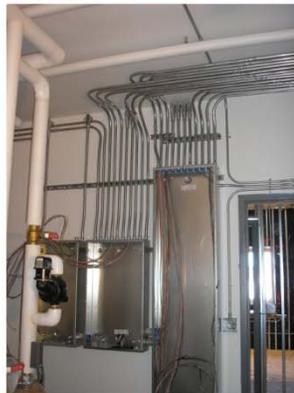
Mech-01.JPG

2. No issues to report regarding the site as it's snow covered.
3. A majority of the interior framing is in place. Mech 129 has gypsum board installed to allow installation of surface mounted mechanical and electrical items.

10. We discussed the proposed location of a new dental air compressor in Mech 129. We recommend the area to the right and above the combustion air assembly. Dedicated power will need to be provided to this location. Additionally, dedicated outside air will need to be piped into this location. See area reserved for compressor on photo.

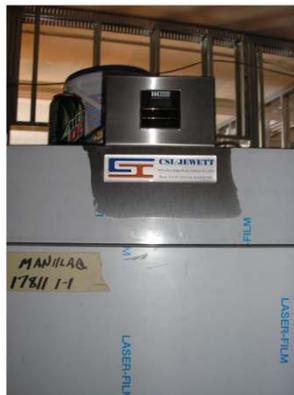
Morgue-unit.JPG

4. The owner provided contractor installed morgue unit is in the building awaiting completion of Morgue 119.
5. Gideon requested we verify the shelf unit layout in File 108 will still work with the baseboard unit. The layout has been verified, but a wall anchor extension will be required to safely secure the two shelf units in front the of the baseboard unit.

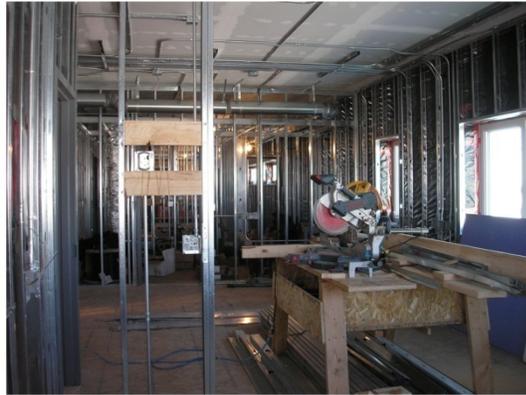
Reception-01.JPG

7. Gideon requested a dimensioned drawing of the pigeon hole casework at the Reception counter. A detailed drawing will be forthcoming.
8. The 4-inch accent opening trim as shown on detail 15/A4.1 and exterior elevations shall be installed over the corrugated j-trim to provide look similar to detail 15/A4.1

9. The electrical contractor pointed out that at previous clinics the VHF antenna cabling was surface mounted after construction was complete. I will work with the owner to provide a below counter rough-in location for a j-box with associated conduit and pull string for the VHF antenna cabling in the reception area.
