November Monthly Report for the Falls Creek Hydro-electric Project
FERC # P-11659

**Falls Creek Hydroelectric Project (P-11659)
MONTHLY CONSTRUCTION REPORT TO FERC
November 2006**

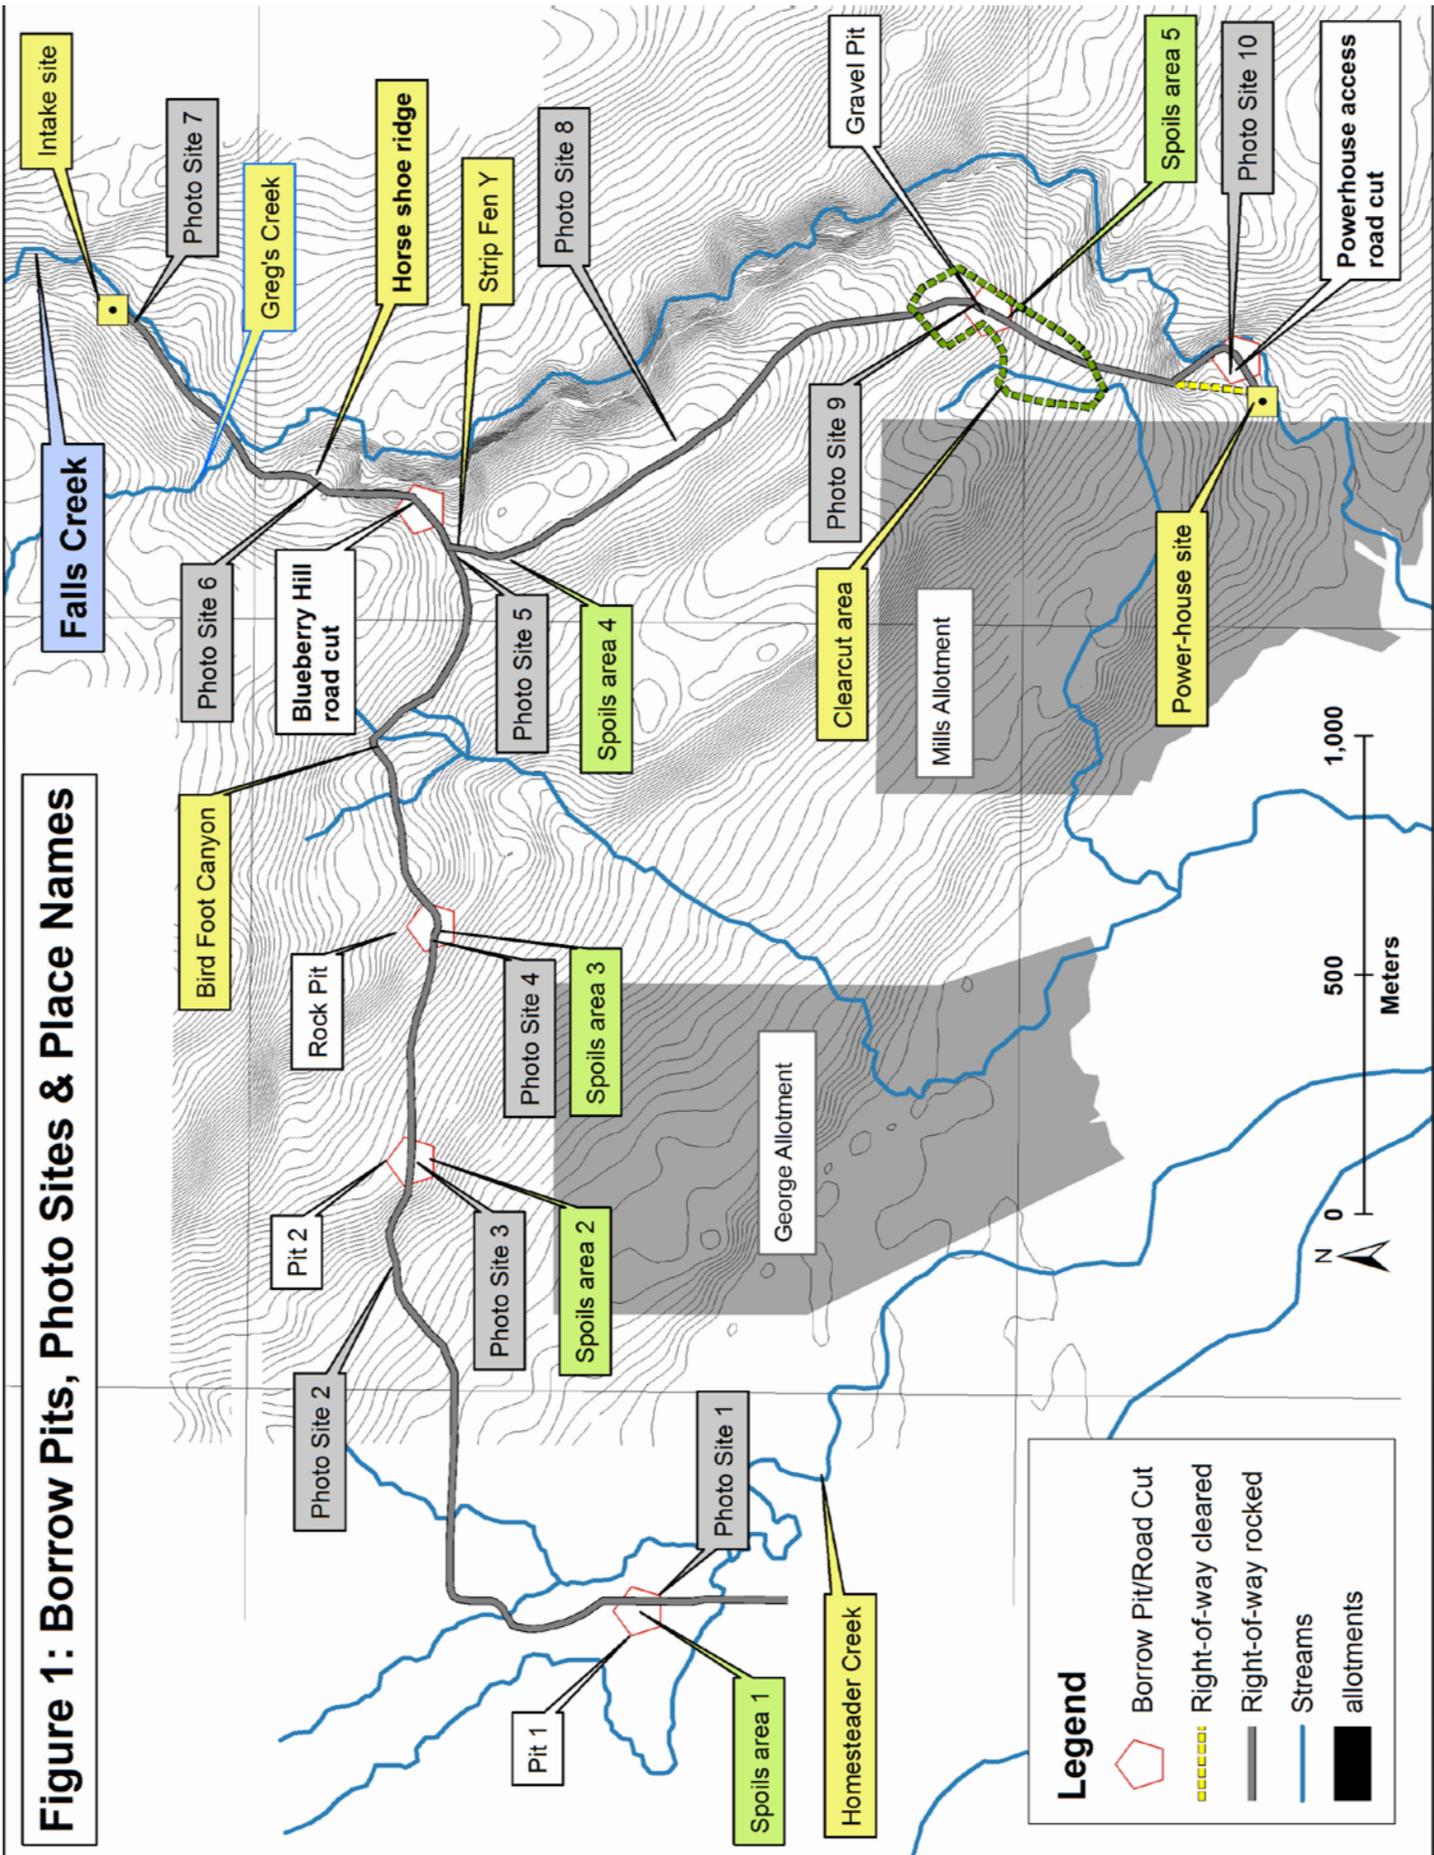
Figure 1: Borrow Pits, Photo Sites & Place Names

Ten photo vantage points have been established throughout the project area. Very little change occurred at photo points this month. Only one station was updated. See Figure 1 for photo site locations and Appendix 1 for this month's photos.

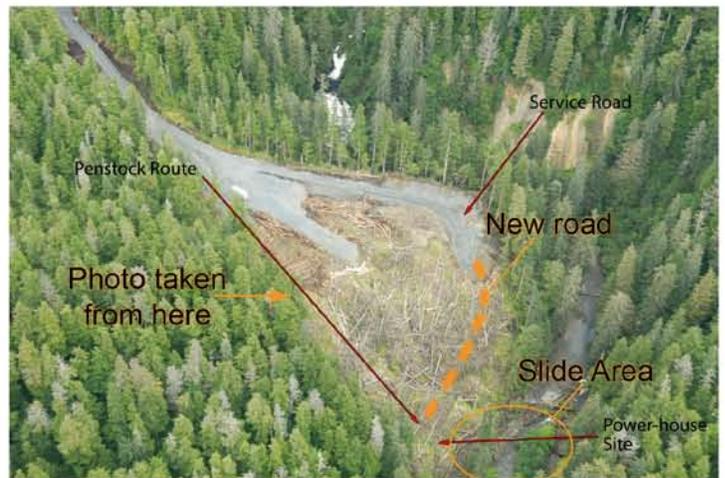
Previous report photo (10) indicating photo location for this month's shot.
