DISTRICT TRIP REPORT

Project: Denali Commission Moorings Points Phase 4 – Yukon River

Description: Tanana Trip Report

Date: 7 June 2011

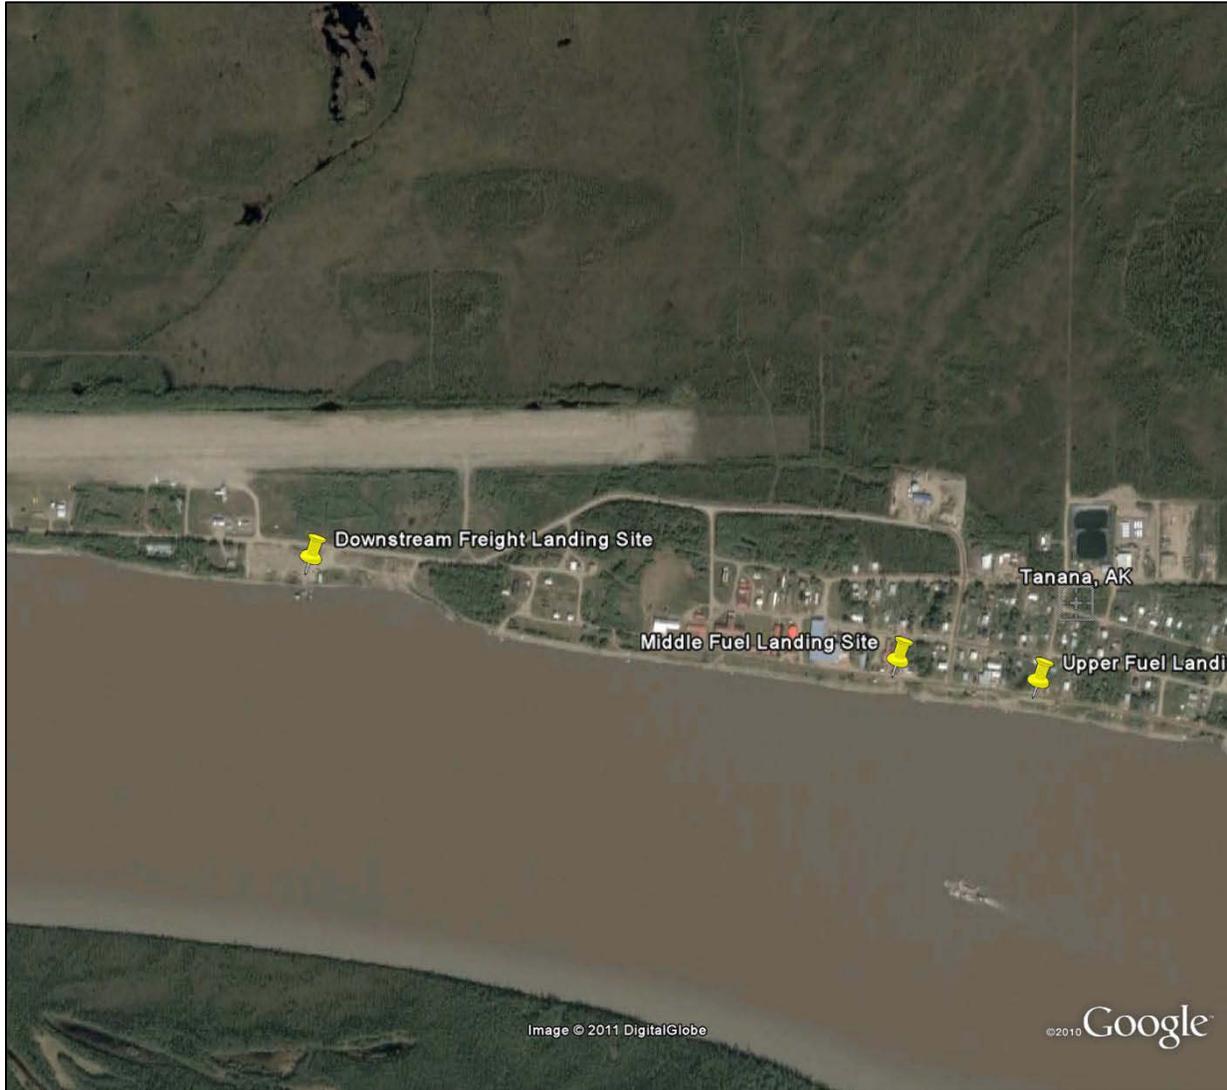
Figure 1. Tanana Barge Landing Locations

The freight landing is the downstream landing in Tanana located adjacent to the airstrip (Figure 1). It consists of an unimproved ramp with minimal gravel perpendicular to the river (Photos 1 - 3). No fuel header was observed at this landing, it appears to be used solely for freight.
